Lincoln Creek

Segment 1

Appendix 5

(Pictorial Presentation)

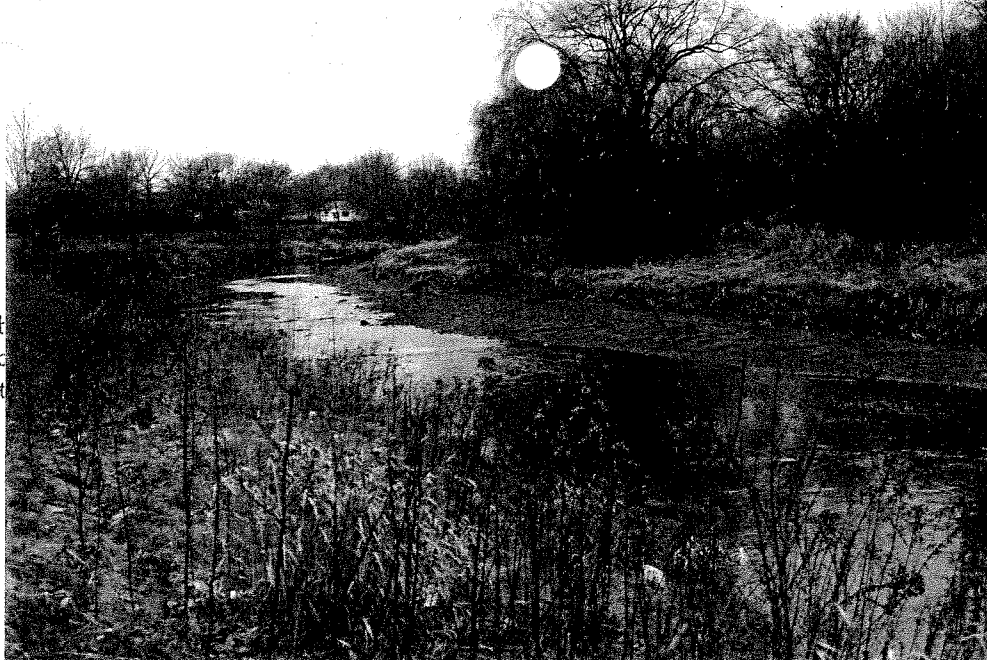
Looking upstream from 25th St.  
from atop the same bank which  
the previous picture was taken.  
This photo shows the absence of  
significant bank erosion and  
increased bar formation along the  
inside of the channel. This should  
be compared to the previous photo  
showing extensive erosion along  
outside of the channel bend.

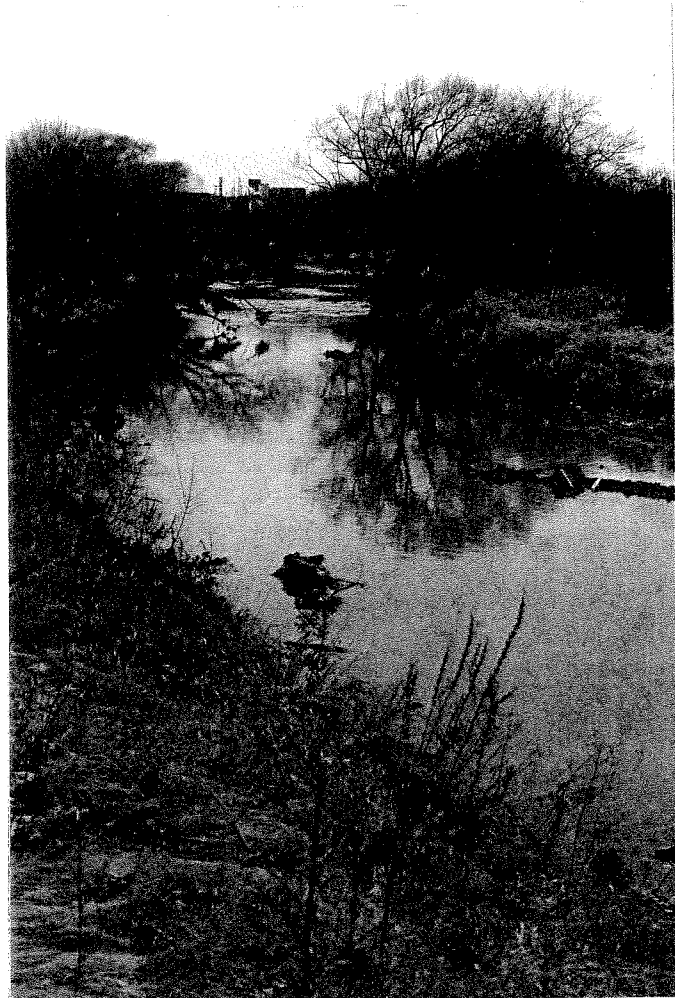
Looking upstream from 27th St.  
Start of a series of deep pool  
and riffle/run complexes. This  
This is one of the fish collection  
areas.

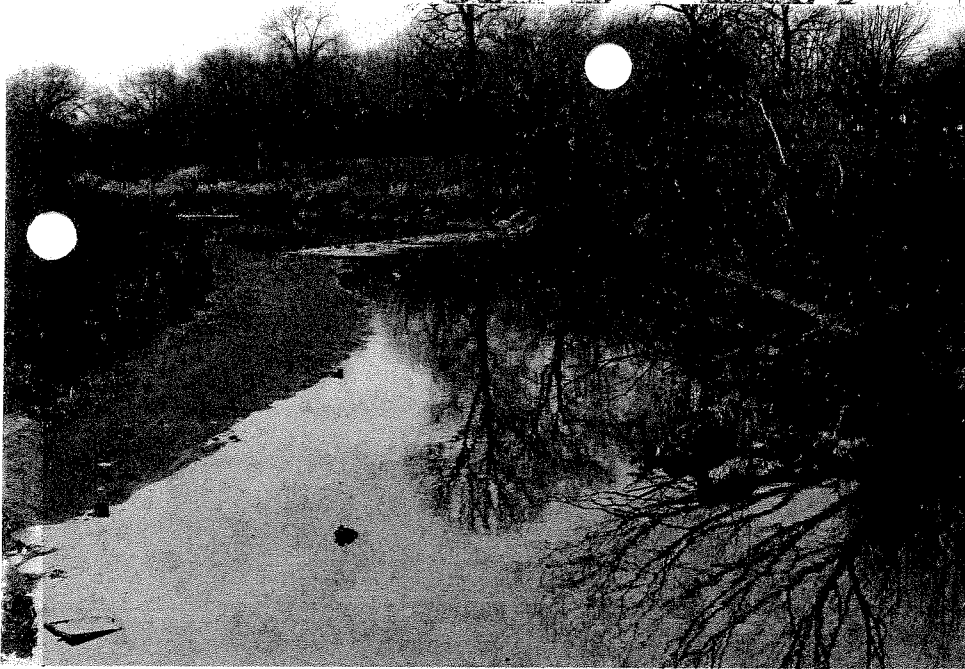
Photo taken at the same location as previous photo but following pool drawdown. Note extent of bank erosion and sedimentation. Sediments are frequently scoured and redeposited following runoff events.

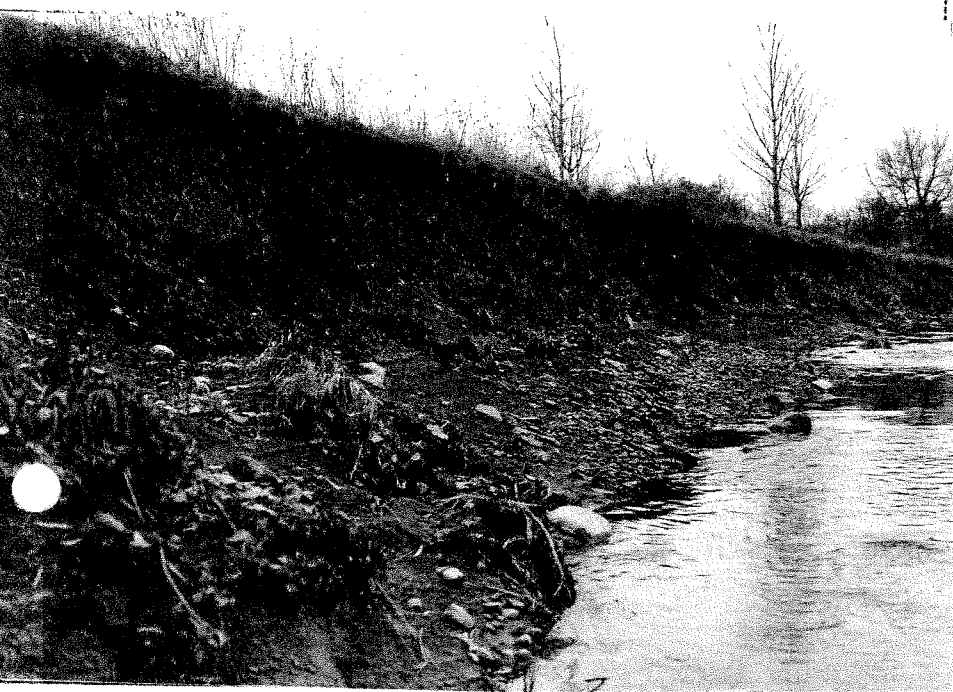
Looking upstream along left bank from 25th St. showing extent of bank erosion along outside bends of channel.

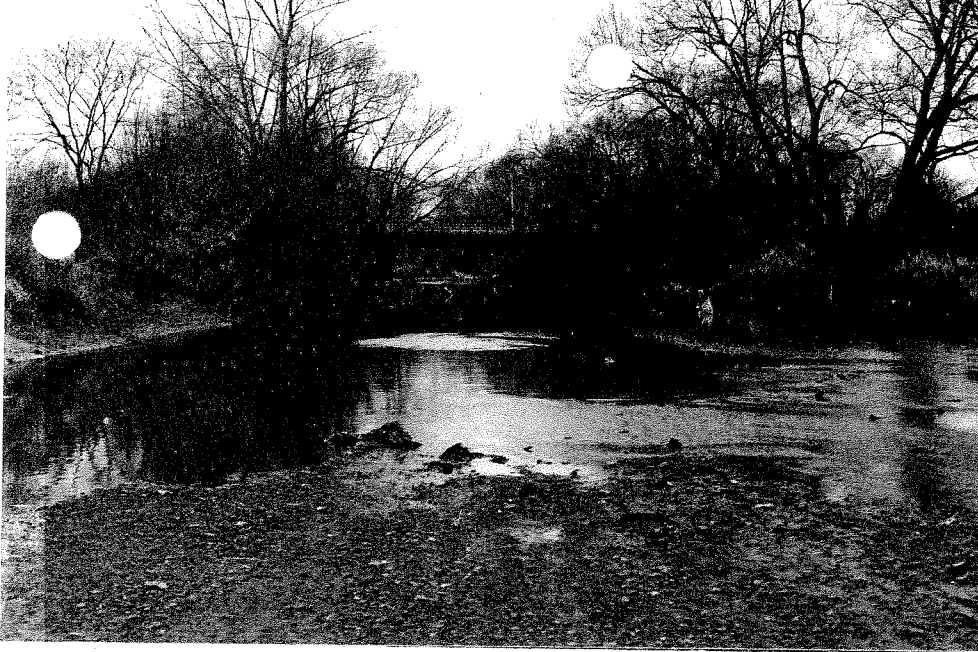
Looking upstream toward Villard Ave. bridge. Pool drawdown to 200' downstream. Maximum depth about 5', average 3'. Sedimentation and bar formation evident following pool drawdown. Fish collection site in 1975.

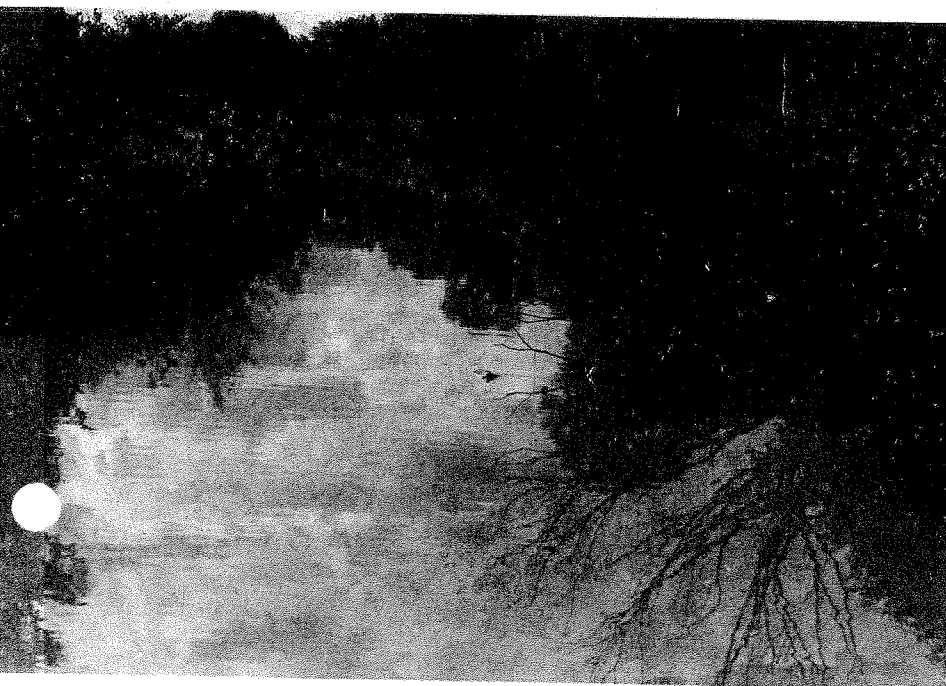
Looking upstream from the pedestrian bridge across from St. Michels Hosp. near 23rd. St. Photo was taken when the pool was being maintained by the dam at Estabrook park. Notice extensive bar formation along inside of bend and erosion along outside of bend.

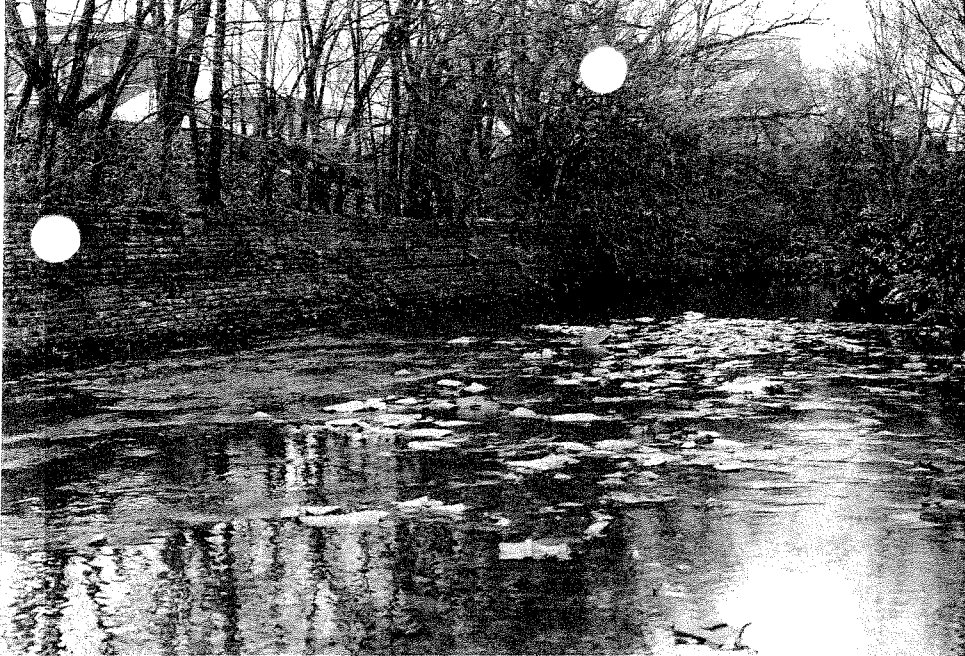
Looking downstream a short distance from Glendale Ave. bridge. Typical shallow riffle/run complex up to 2' in depth.

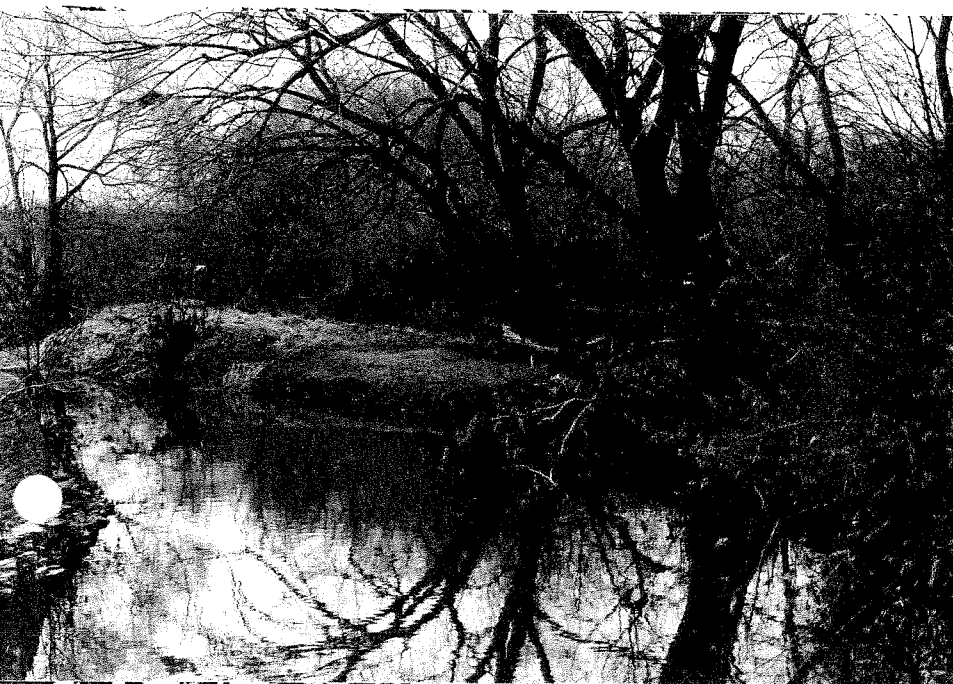
Looking upstream of Glendale Ave. bridge. As in previous photos, notice the extensive bar formation along the right bank up to 4' in height and a distance of 25' from masonry wall. Constriction of flow no doubt contributes to flooding problems upstream. Channel widths decrease from 40' to as little 15' upstream as a result of these deposits. Pool depth 3' or more.

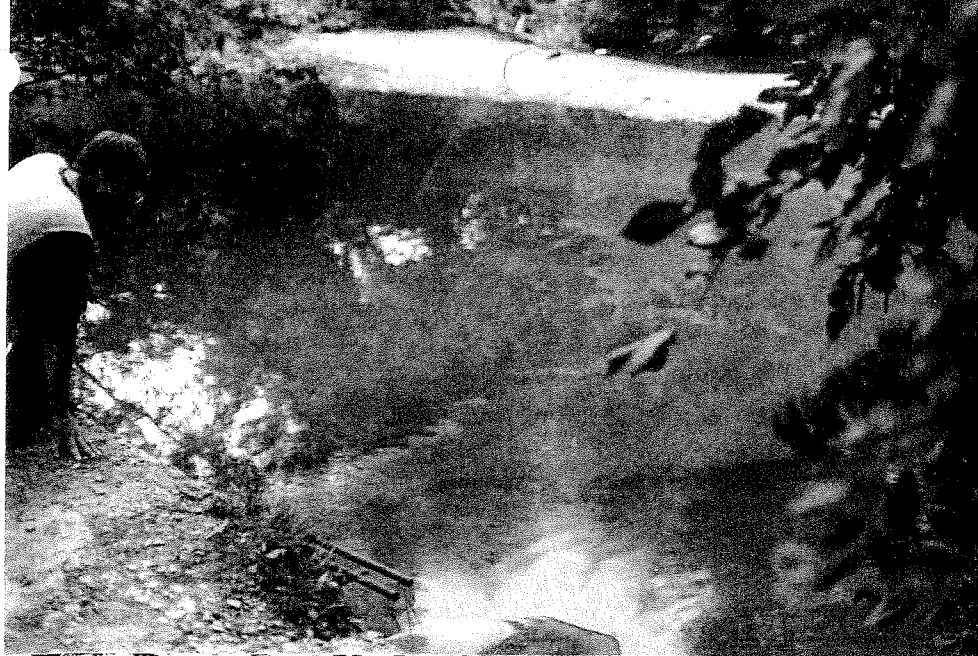
Storm sewer outfall at 35th and Congress St. Note discoloration of water and floating oil sheen. These conditions are fairly prevalent.

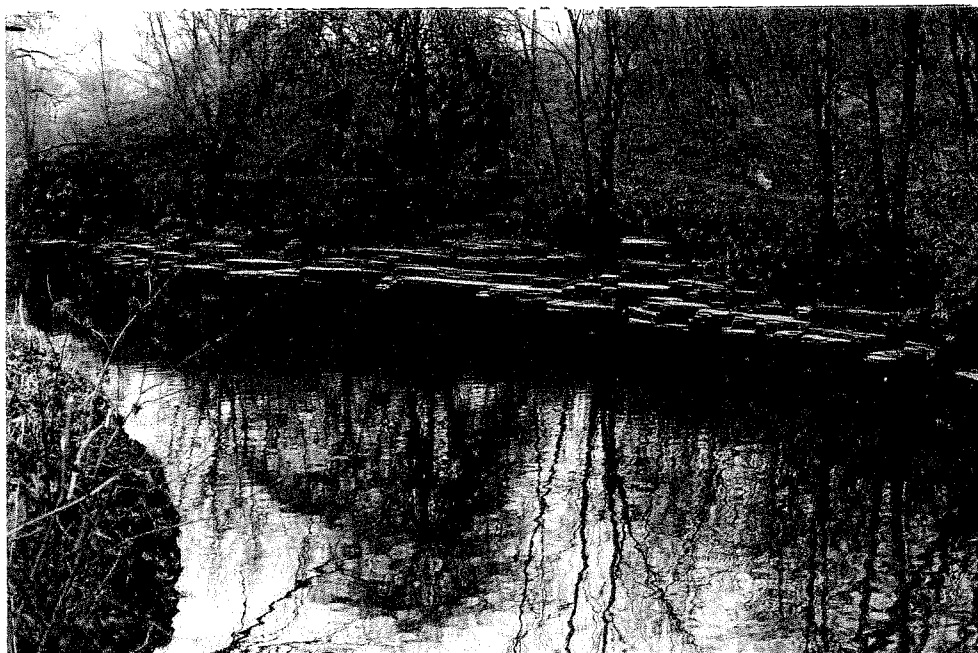
Looking downstream from a location between Glendale Ave. and 35th St. showing the masonry wall and dolomite outcropping. A short distance downstream is where the channel constricts to 15' as the result of sedimentation and bar formation.

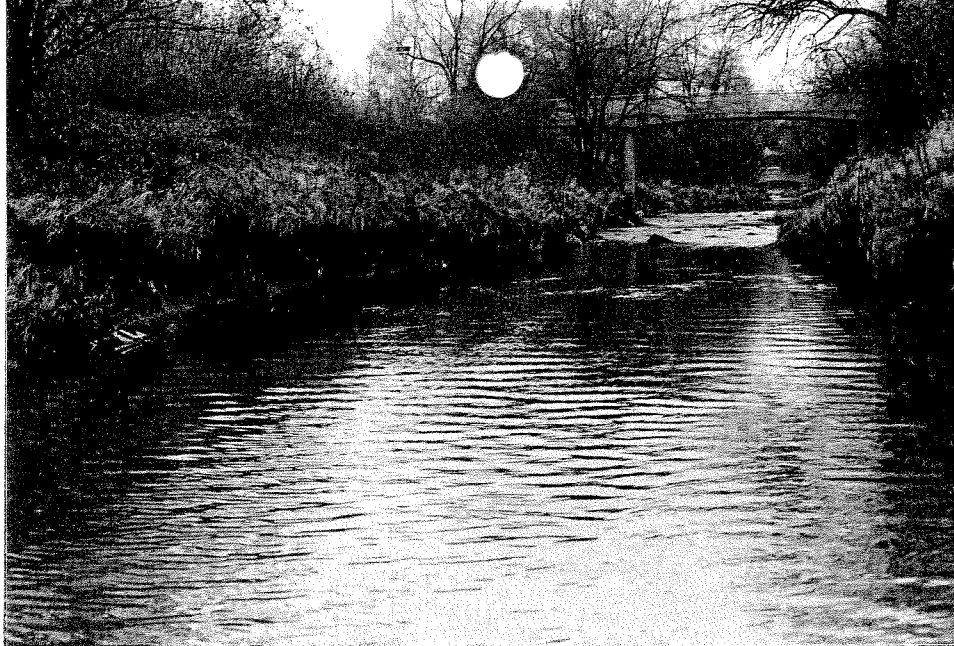
Looking upstream from 39th St.  
This is typical of shallow run  
/riffle segment. Banks are steep  
and generally eroded.

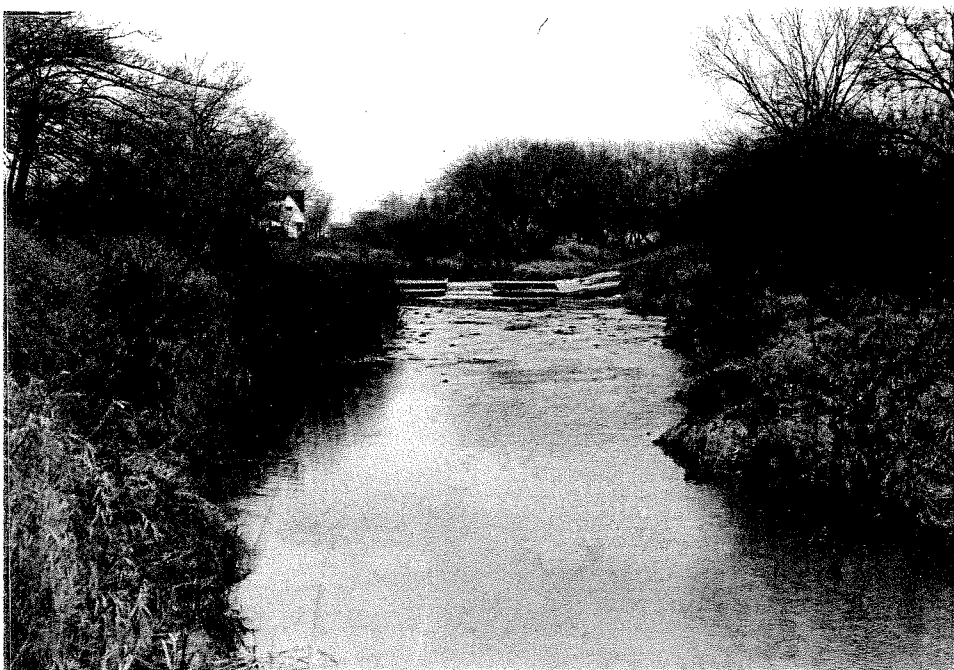
Looking upstream towards concrete  
drop structure located at the top  
of segment 4 near 47th St. This  
site was included as a 1984 fish  
collection site. Deep pool (5')  
located immediately below the  
drop structure. Generally a shal-  
low, riffle and run segment.

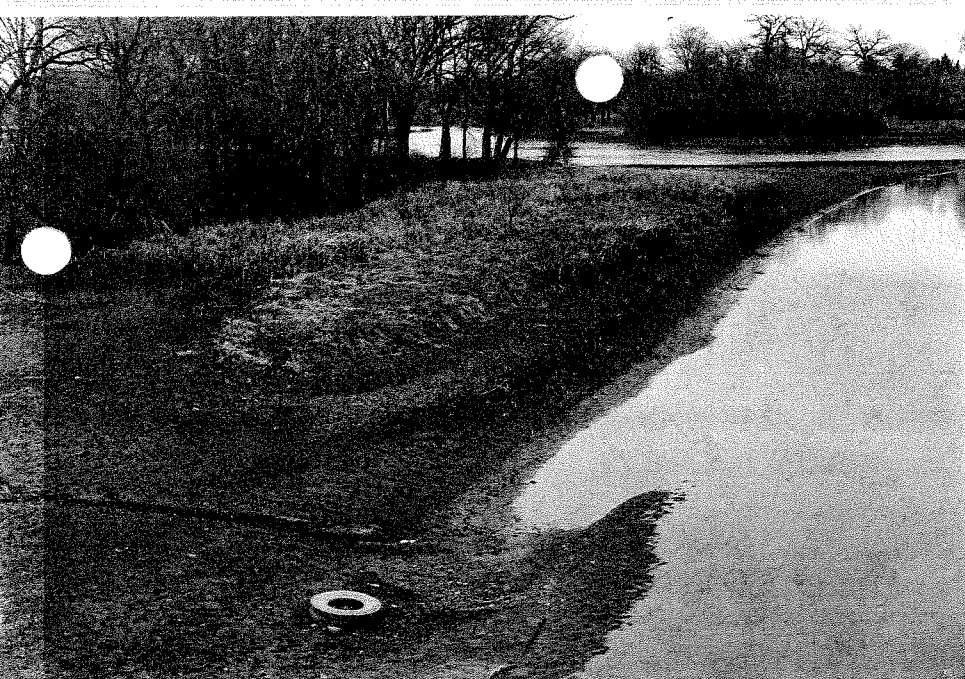
Looking downstream of Milwaukee River Parkway bridge. One of the Milwaukee river channels is in the background with a smaller Milwaukee river side channel and Lincoln Creek in the foreground. Sedimentation and bar formation evident along both banks. Pool formed by Estabrook park dam had been lowered earlier in September.

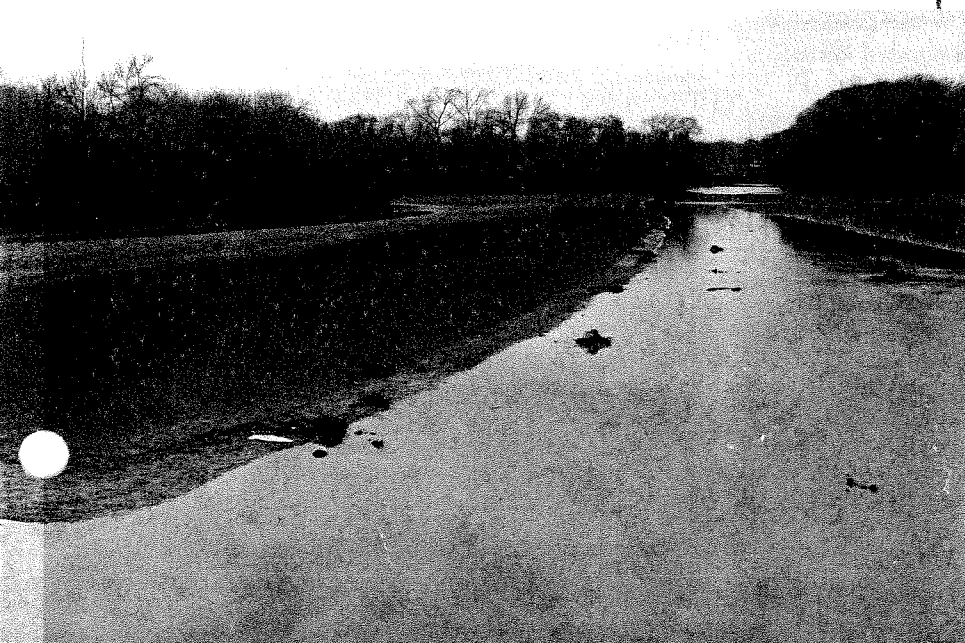
Looking upstream of Milwaukee River Parkway bridge toward confluence of Lincoln Creek and Milwaukee River's western most channel. Sedimentation and bar formation evident along both banks up to 4 feet in height.
