Summary of Closure AOCs #5, #8, and #11

Fraser Shipyards, Inc.

Superior, Wisconsin

SEH No. FRASE9401.00

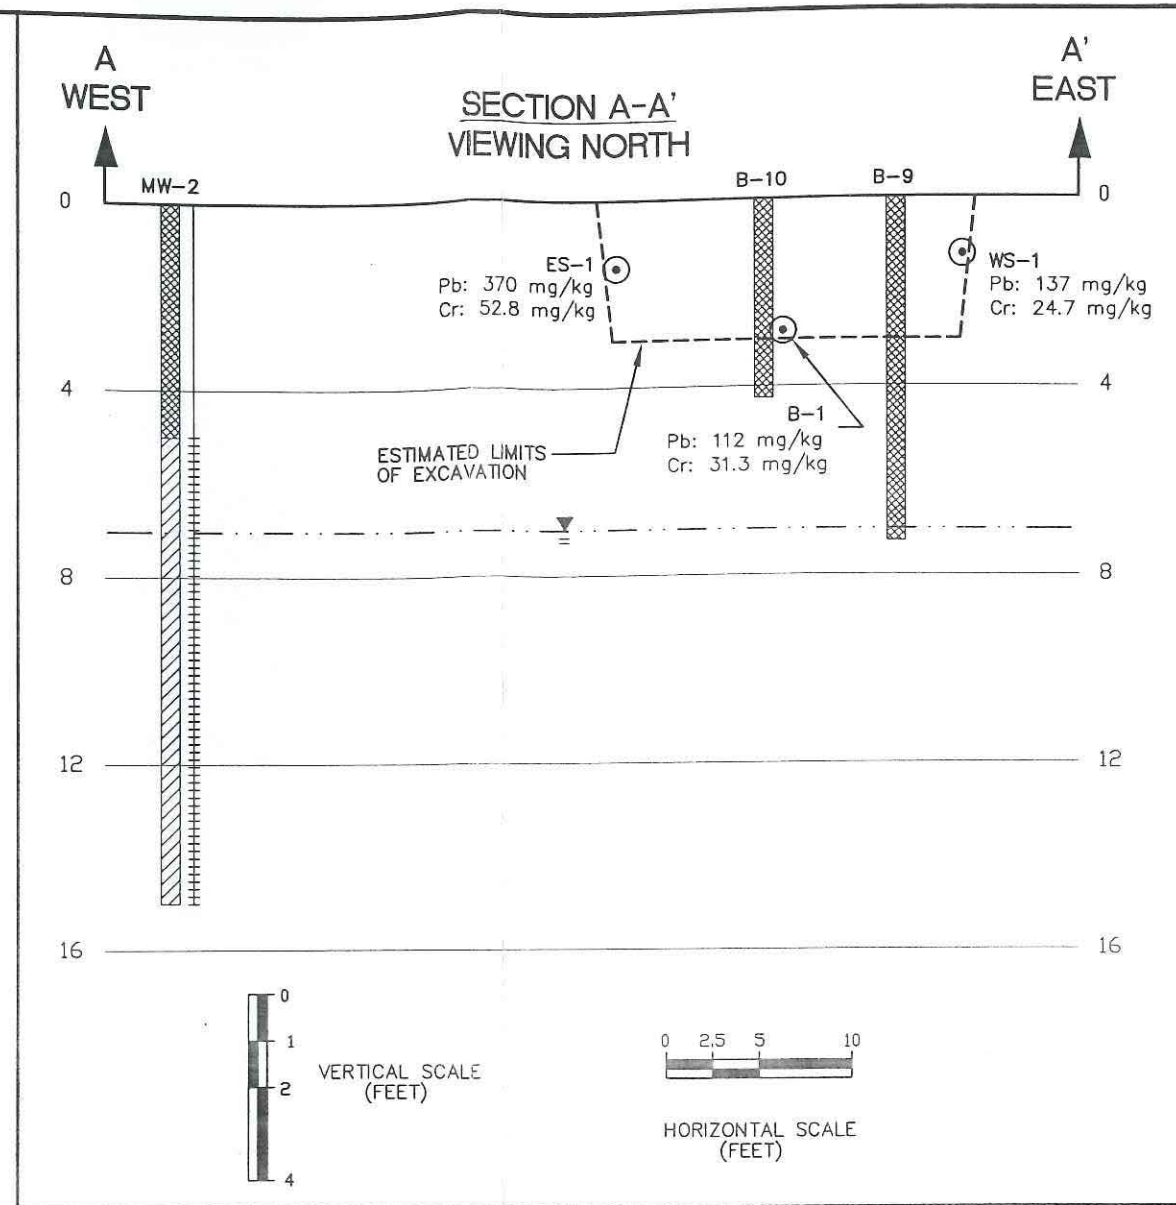
3
7

Additional surface soil samples were collected on August 16, 1997 in order to determine if surface soil concentrations of select heavy metals pose a significant threat. Laboratory results of the surface samples (B-11, HA-1, HA-2, HA-3) ranged from 20.4 mg/kg to 66.1 mg/kg for total lead and 14.9 mg/kg to 22.2 mg/kg for total chromium. Neither lead nor chromium surface soil concentrations exceed the ch. NR 720 industrial RCL standards. Soil analytical results are summarized on Table 1, "Soil Analytical Results." Site investigation detail is presented on Figure 3, "AOC #5 Detail."

In an effort to further investigate the potential of dissolved lead contamination in groundwater at AOC #5, six hydraulic probe groundwater samples were collected on October 1, 1997. Groundwater samples were brought to the surface with a peristaltic pump, filtered and submitted for laboratory analysis of dissolved lead. Results indicate dissolved lead concentrations ranging from none detected above laboratory detection limits to 1.06 µg/l, in compliance with the ch. NR 140 Groundwater Quality Standards. Groundwater analytical results are summarized in Table 2, "Groundwater Analytical Results." Site investigation detail is presented on Figure 3.

A remedial excavation was performed at AOC #5 to address lead and chromium contaminated soils. Approximately 18 cubic yards of contaminated soil was removed from the AOC on April 18, 2000. The excavation limits measured 10 feet wide by 20 feet long by 3 feet deep in the area shown on Figure 3

A total of five samples were collected from the soil excavation side walls at 2 feet below grade and the excavation bottom at 3 feet below grade. The soil samples were analyzed for lead and chromium. Results of the soil analysis indicated lead concentrations ranging from 15.8 mg/kg to 370 mg/kg. Soil chromium concentrations ranged from 4.21 mg/kg to 52.8 mg/kg.

Confirmatory laboratory analysis results following remedial excavation at AOC #5 did not indicate exceedances of ch. NR 720 Residual Contaminant Levels (RCLs) for industrial sites (industrial RCL for lead = 500 mg/kg; industrial RCL for hexavalent chromium = 200 mg/kg). Four successive quarterly rounds of groundwater were collected that demonstrated compliance with the requirements of ch. NR 140 (lead concentrations less than ES of 15 µg/l) and s. NR 726.05(3). Notice of conditional closure by the WDNR was dated August 17, 2000.

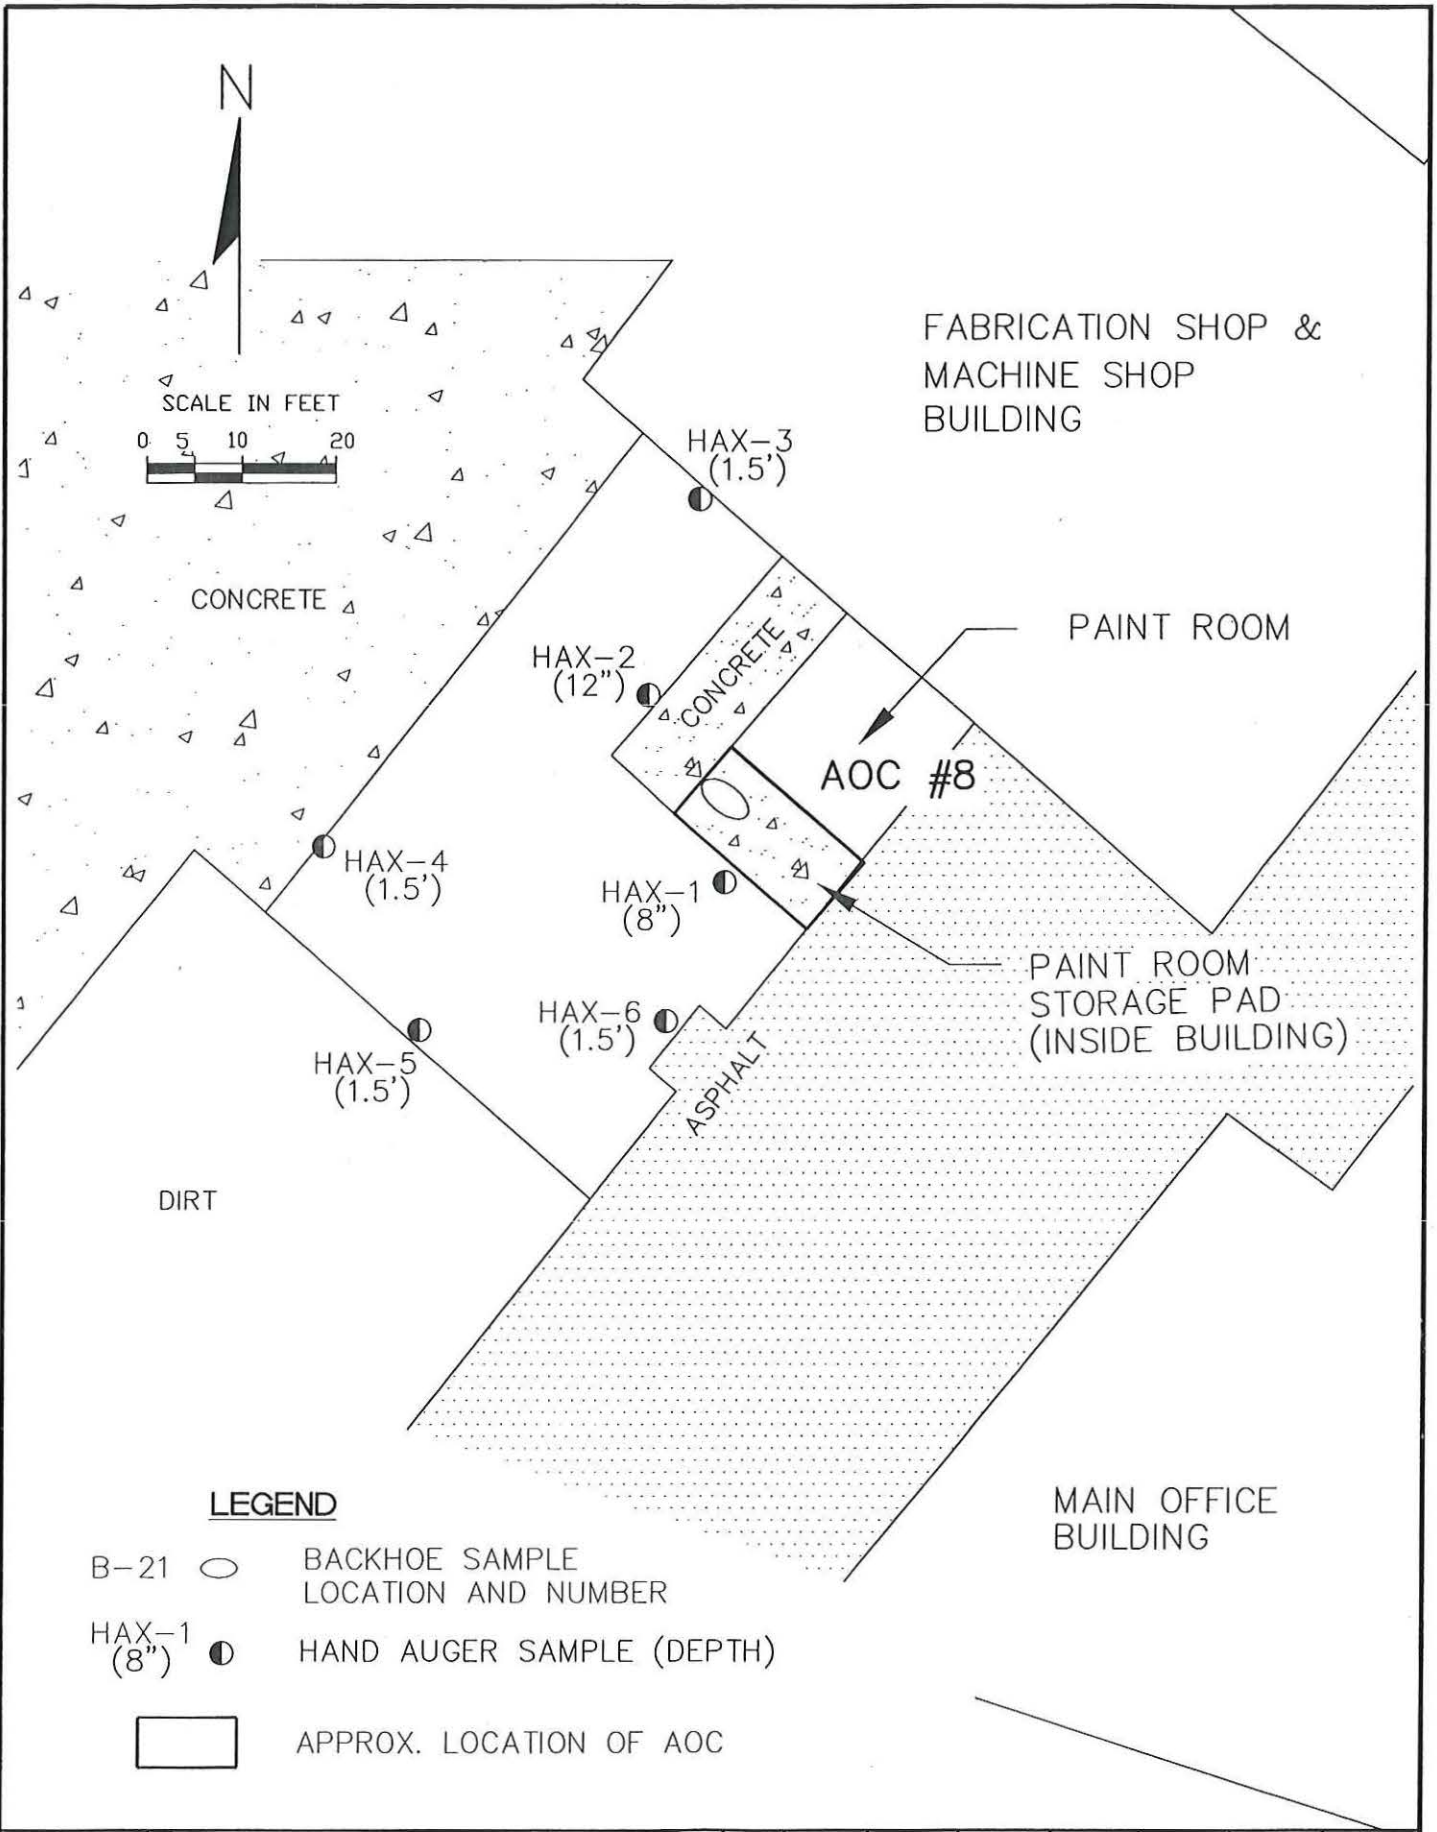
4
7

AOC #8 was initially investigated for the presence or absence of contaminated soils associated with potential release from materials staged at the AOC. The investigation consisted of two soil samples (B-20 and B-21) obtained from a shallow test pit from the 0 to 1 foot (B-20) and 2 to 2.5 foot (B-21) depth interval on January 25, 1994. Two soil samples were collected from the shop floor adjacent to the storage pad with a hand auger on August 23, 1995 (HAX-1 and HAX-2) from the 8 to 12 inch depth interval to define the extent of contamination.

Laboratory testing indicated benzene and toluene at concentrations of 0.0058 µg/g and 0.15 µg/g, respectively, were detected closer to the surface (B-20), while no VOCs above laboratory detection limits were found at the 2 to 2.5 foot depth interval (B-21). Low level concentrations of various hydrocarbon compounds which appear to be petroleum and manufacturing related were detected at the surface of the shop floor in the area adjacent to the AOC. The total VOC concentration at HAX-2 was 24 µg/g.

Additional soil sampling at AOC #8 was conducted to further define the degree and extent of VOC contamination. Four additional hand auger soil samples (HAX-3, HAX-4, HAX-5, HAX-6) were obtained on August 15, 1996. The samples were collected at a depth of approximately 18 inches. These additional floor samples indicated

very low concentrations of naphthalene (0.033 µg/g) at HAX-3, chloromethane (0.028 µg/g) at HAX-4, and o-xylene and styrene (0.035 µg/g to 0.138 µg/g) at HAX-3, HAX-4, HAX-5 and HAX-6. The concentrations are below proposed or final generic soil cleanup levels based on protection of groundwater or human health from direct contact. Total lead and chromium at the four additional hand auger locations (HAX-3, HAX-4, HAX-5, HAX-6) are either not detectable or below the ch. NR 720 RCLs Table 1 values for non-industrial sites. Soil analytical results are summarized on Table 1. Site investigation detail is presented on Figure 4, "AOC #8 Detail."

Fraser constructed a concrete floor over the unpaved area at AOC #8 inside of the shop to prevent downward migration of any surficial contaminants in the building. Following those investigative and remedial actions, Fraser requested formal closure of AOC #8. Documentation submitted to the WDNR was reviewed and notice of "No further action required" was provided in July 16, 1997.

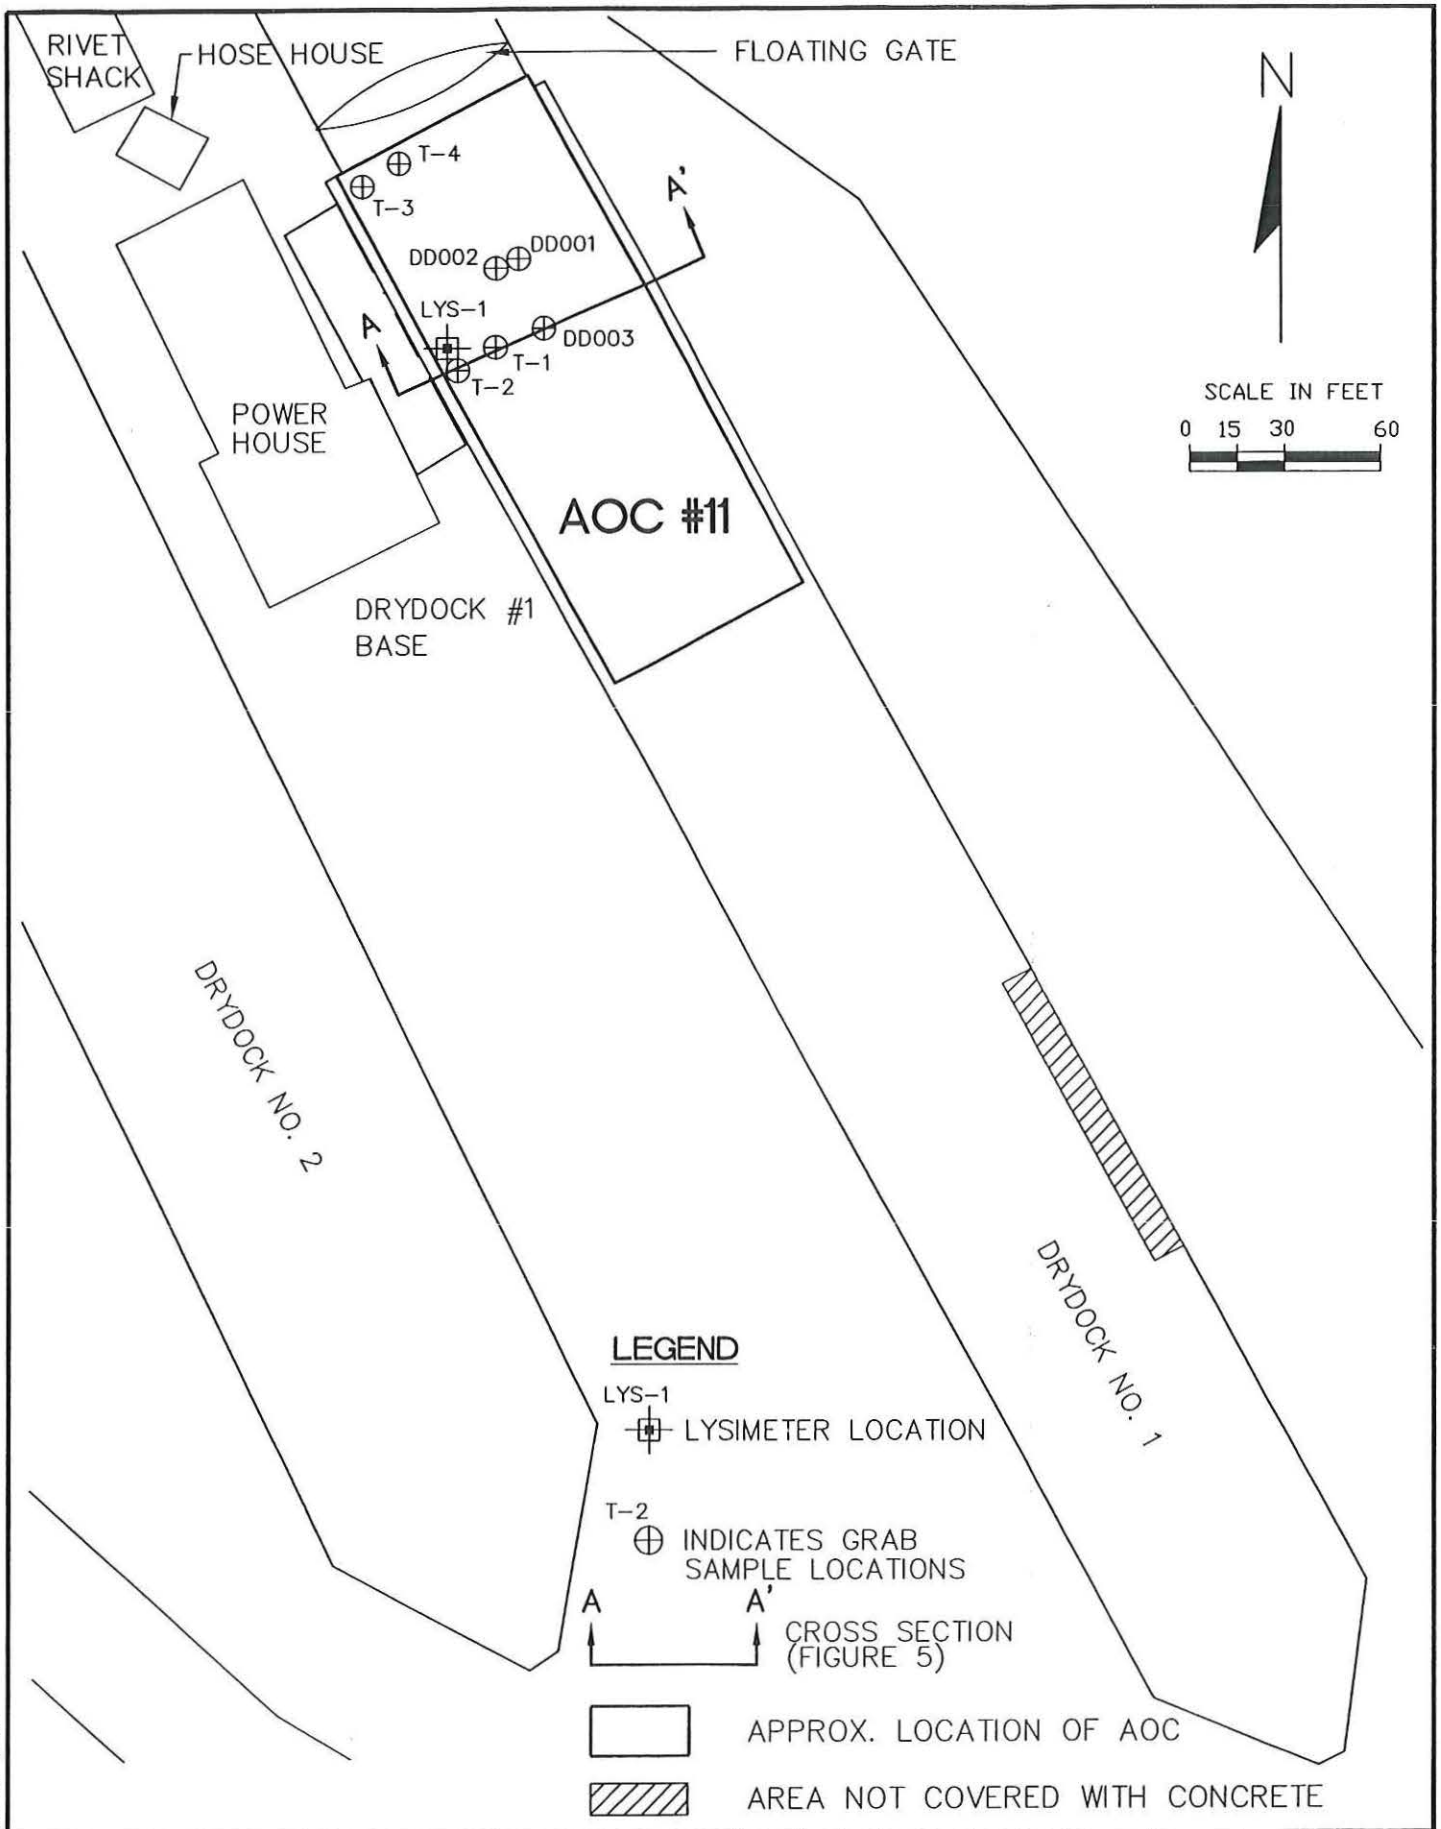
1	03/03/97		RJH	10/00	CW	01/97			
NO.	DATE	ISSUE/REVISIONS	DRAWN BY	DESIGN	FIELD REVIEW	QC CHECK			
		FRASER SHIPYARDS, INC.		FIGURE 5 AOC #11 DETAIL		PROJ. NO. FRAS9401 DATE 03/03/97	5 7

Laboratory results indicated the presence of lead concentrations ranging from 30.1 mg/kg to 272 mg/kg at a depth of six to 10 inches into the red clay floor. Lead concentrations at the clay surface ranged from 832 mg/kg to 958 mg/kg.

Additional investigation of AOC #11 was conducted on August 12, 1996 with the installation of a seepage lysimeter. The purpose of the lysimeter was to document that groundwater contamination had not occurred below the dry dock floor. Two soil samples submitted for laboratory analysis of lead collected at the time of the lysimeter installation indicated no detectable concentrations of lead at the 0 to 0.5 foot and 2.0 to 2.5 foot depth intervals. These samples were collected in close proximity to sample T2 which had a surface lead

The first round of groundwater sampled from the seepage lysimeter indicated a dissolved lead concentration of 6.94 µg/l which is below the ch. NR 140 ES of 15 µg/l but above the PAL of 1.5 µg/l. The second round of sampling indicated no detectable concentrations of dissolved lead. Groundwater analytical results are summarized on Table 2. Site investigation detail is presented on Figure 5, "AOC #11 Detail."

In order to prevent migration of potential contaminants into the stone base, Fraser poured concrete over the northern two thirds section of Dry Dock #1 during July and August 1994. Approximately two feet of crushed stone was placed directly below the concrete over a floor of natural red clay. Prior to placement of the stone and concrete, seven soil samples were collected from the dry dock base at depths ranging from zero to 10 inches below top of clay, and submitted for laboratory analysis of lead.

Dry Dock #1 construction, gate detail and placement of concrete over AOC #11 have effectively confined residual lead, which may be present, to the clay surface under the concrete dry dock base. This has been demonstrated in both soil and groundwater samples collected from the seepage lysimeter. Soil samples as well as groundwater samples do not indicate that they are impacted by lead. Dry Dock #1 construction and gate detail are shown in Figure 6, "Dry Dock #1 Cross Section and Figure 7, "Gate Detail."

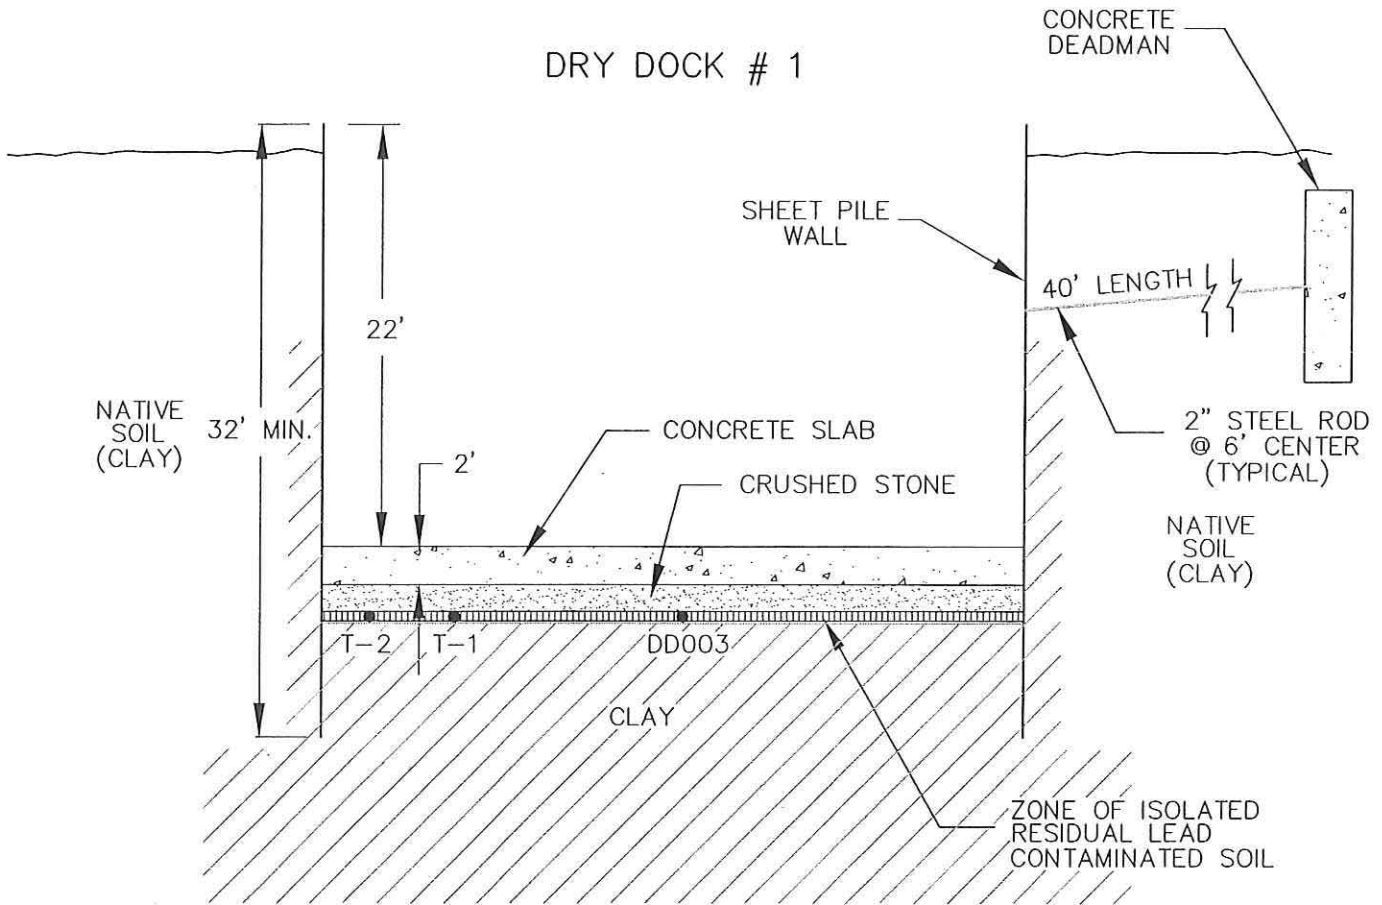
6
7

SAMPLE	ug/g	VERTICLE LOCATION
T-1	927	TOP OF CLAY
T-2	832	TOP OF CLAY
DD003	34.1	6" INTO CLAY
