**An Environmental Investigation
Summary Report of a Historical
Industrial Property
Located at 133 Oak Street in
West Bend, Wisconsin**

EIS Brake Parts
129 Worthington Ridge
P.O. Box 1315
Berlin, Connecticut 06037

August 1994

EnviroAudit Ltd. File # 4-94-010

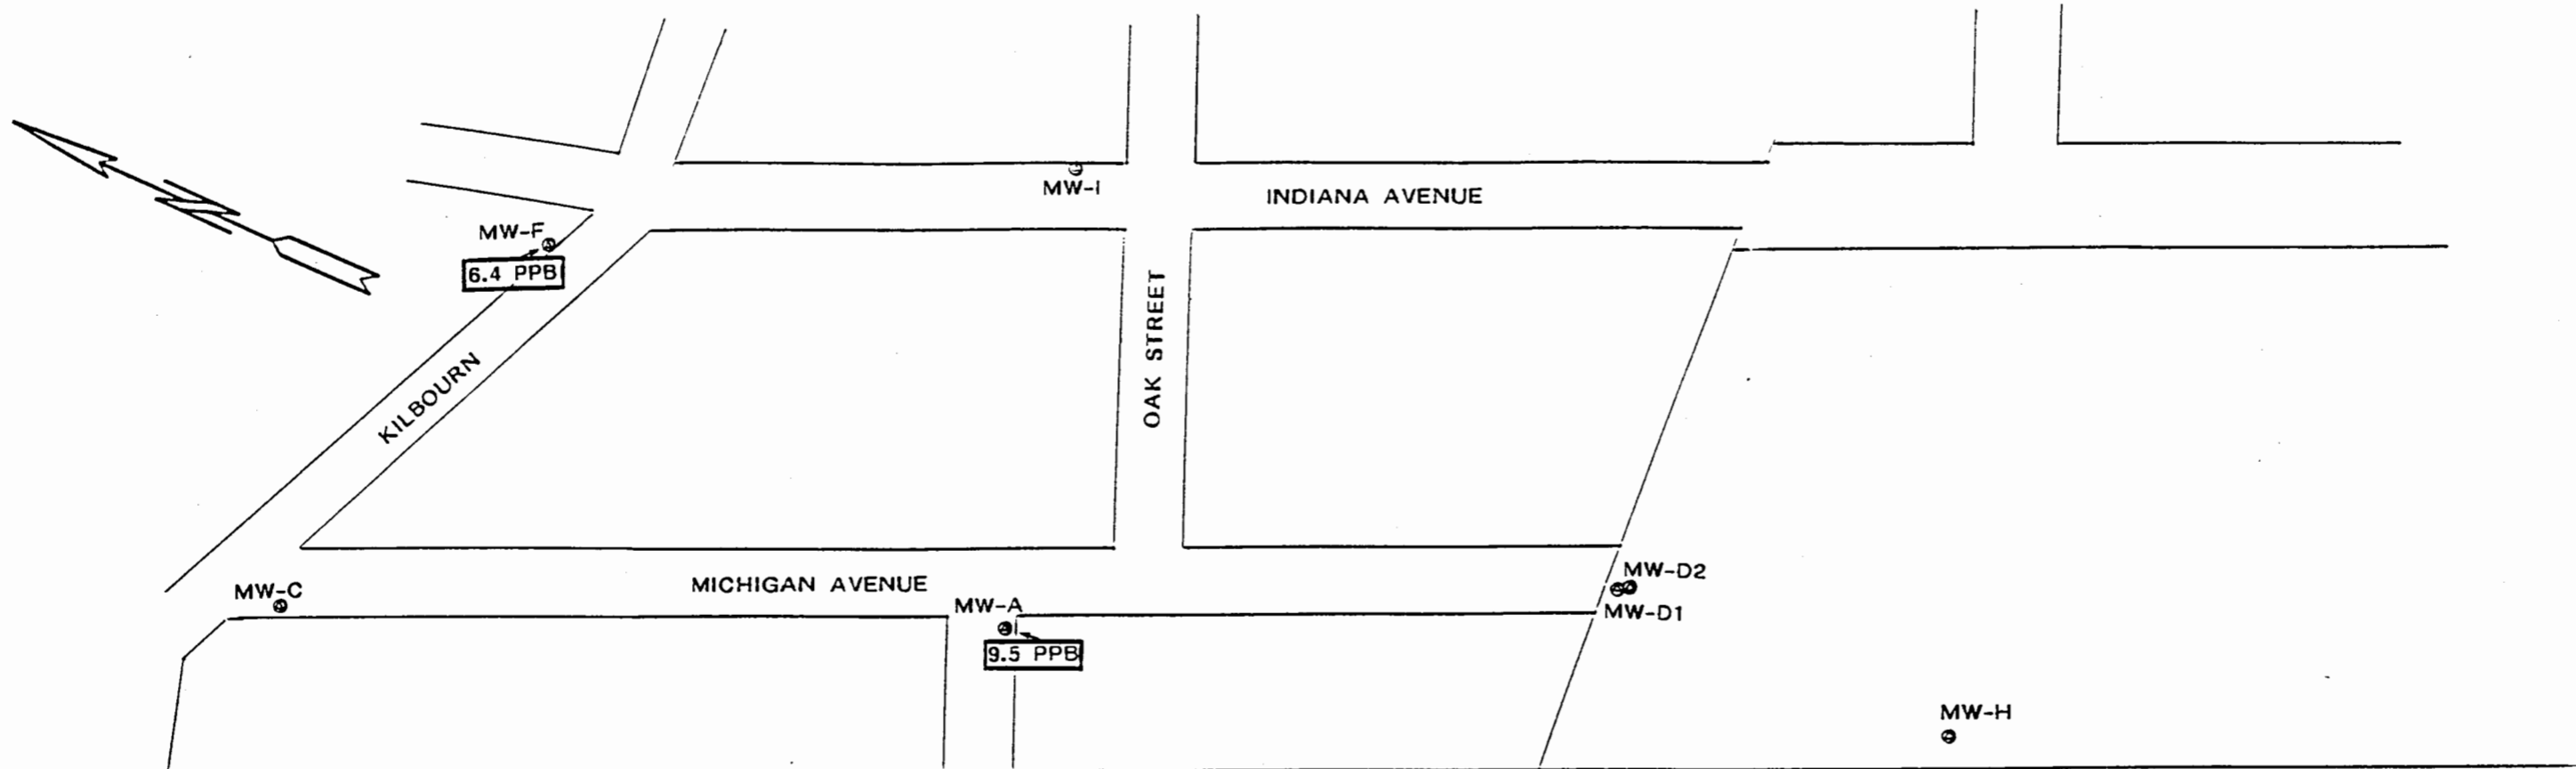
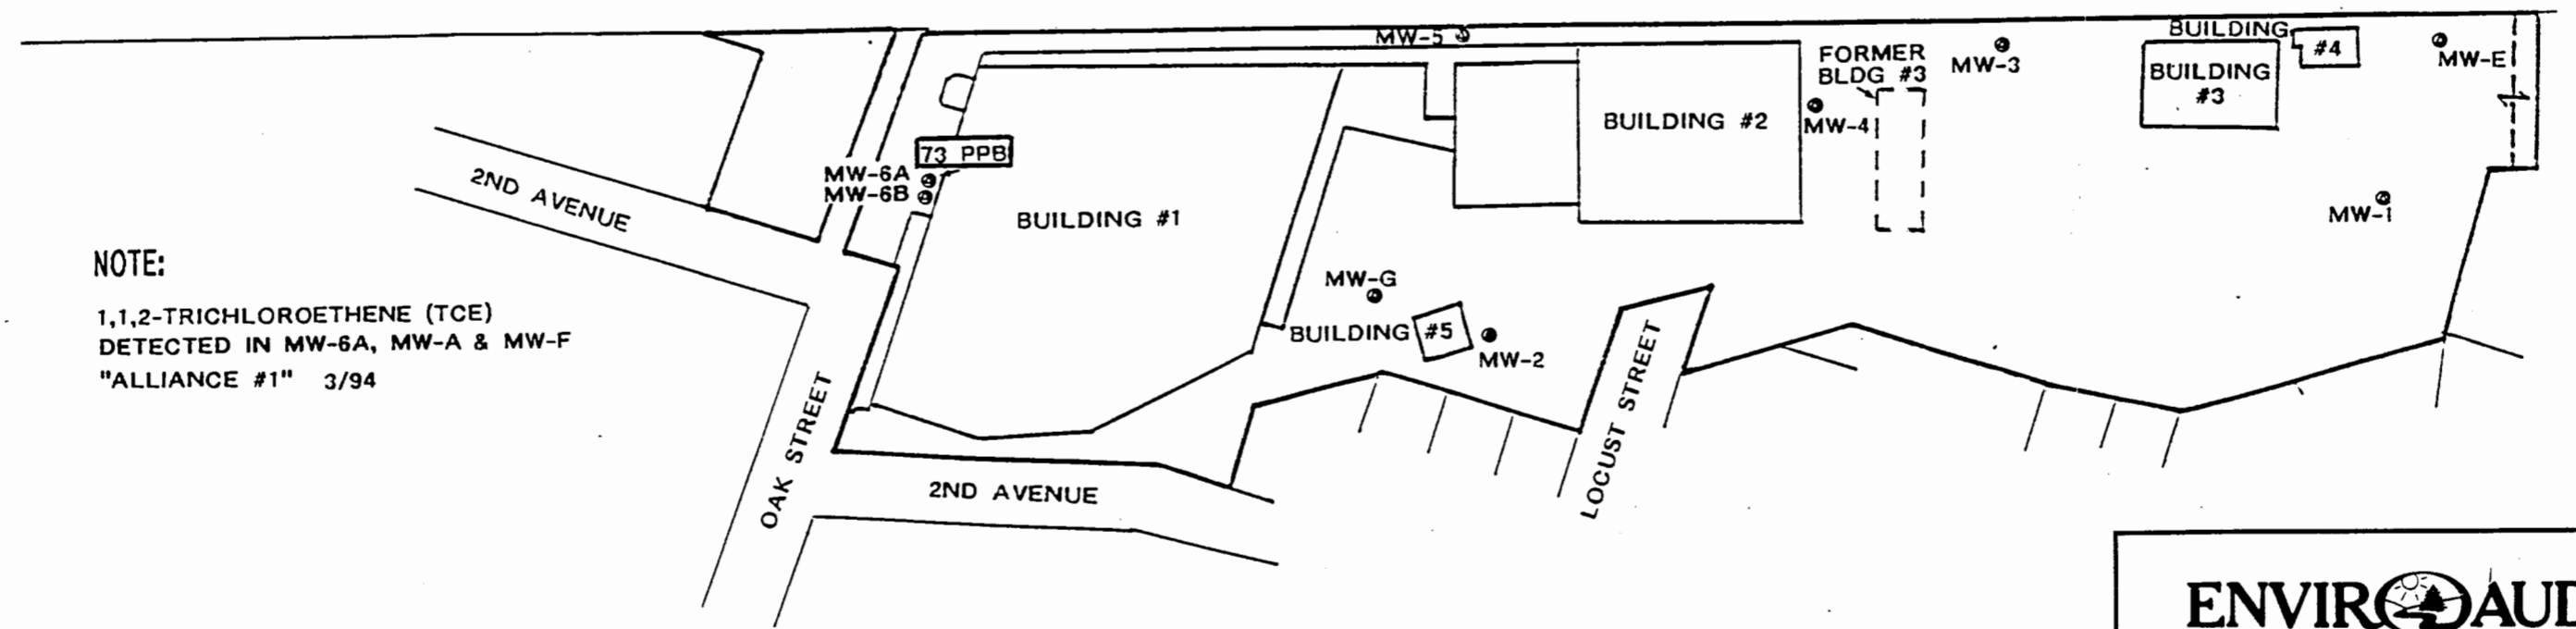
ENVIROAUDIT LTD	
TCE IN GROUNDWATER	
133 OAK STREET, WEST BEND, WISCONSIN	
PROJECT # 4-94-010	FIGURE 6 - 1

NOTE:
 1,1,2-TRICHLOROETHENE (TCE)
 DETECTED IN MW-6A, MW-A & MW-F
 "ALLIANCE #1" 3/94

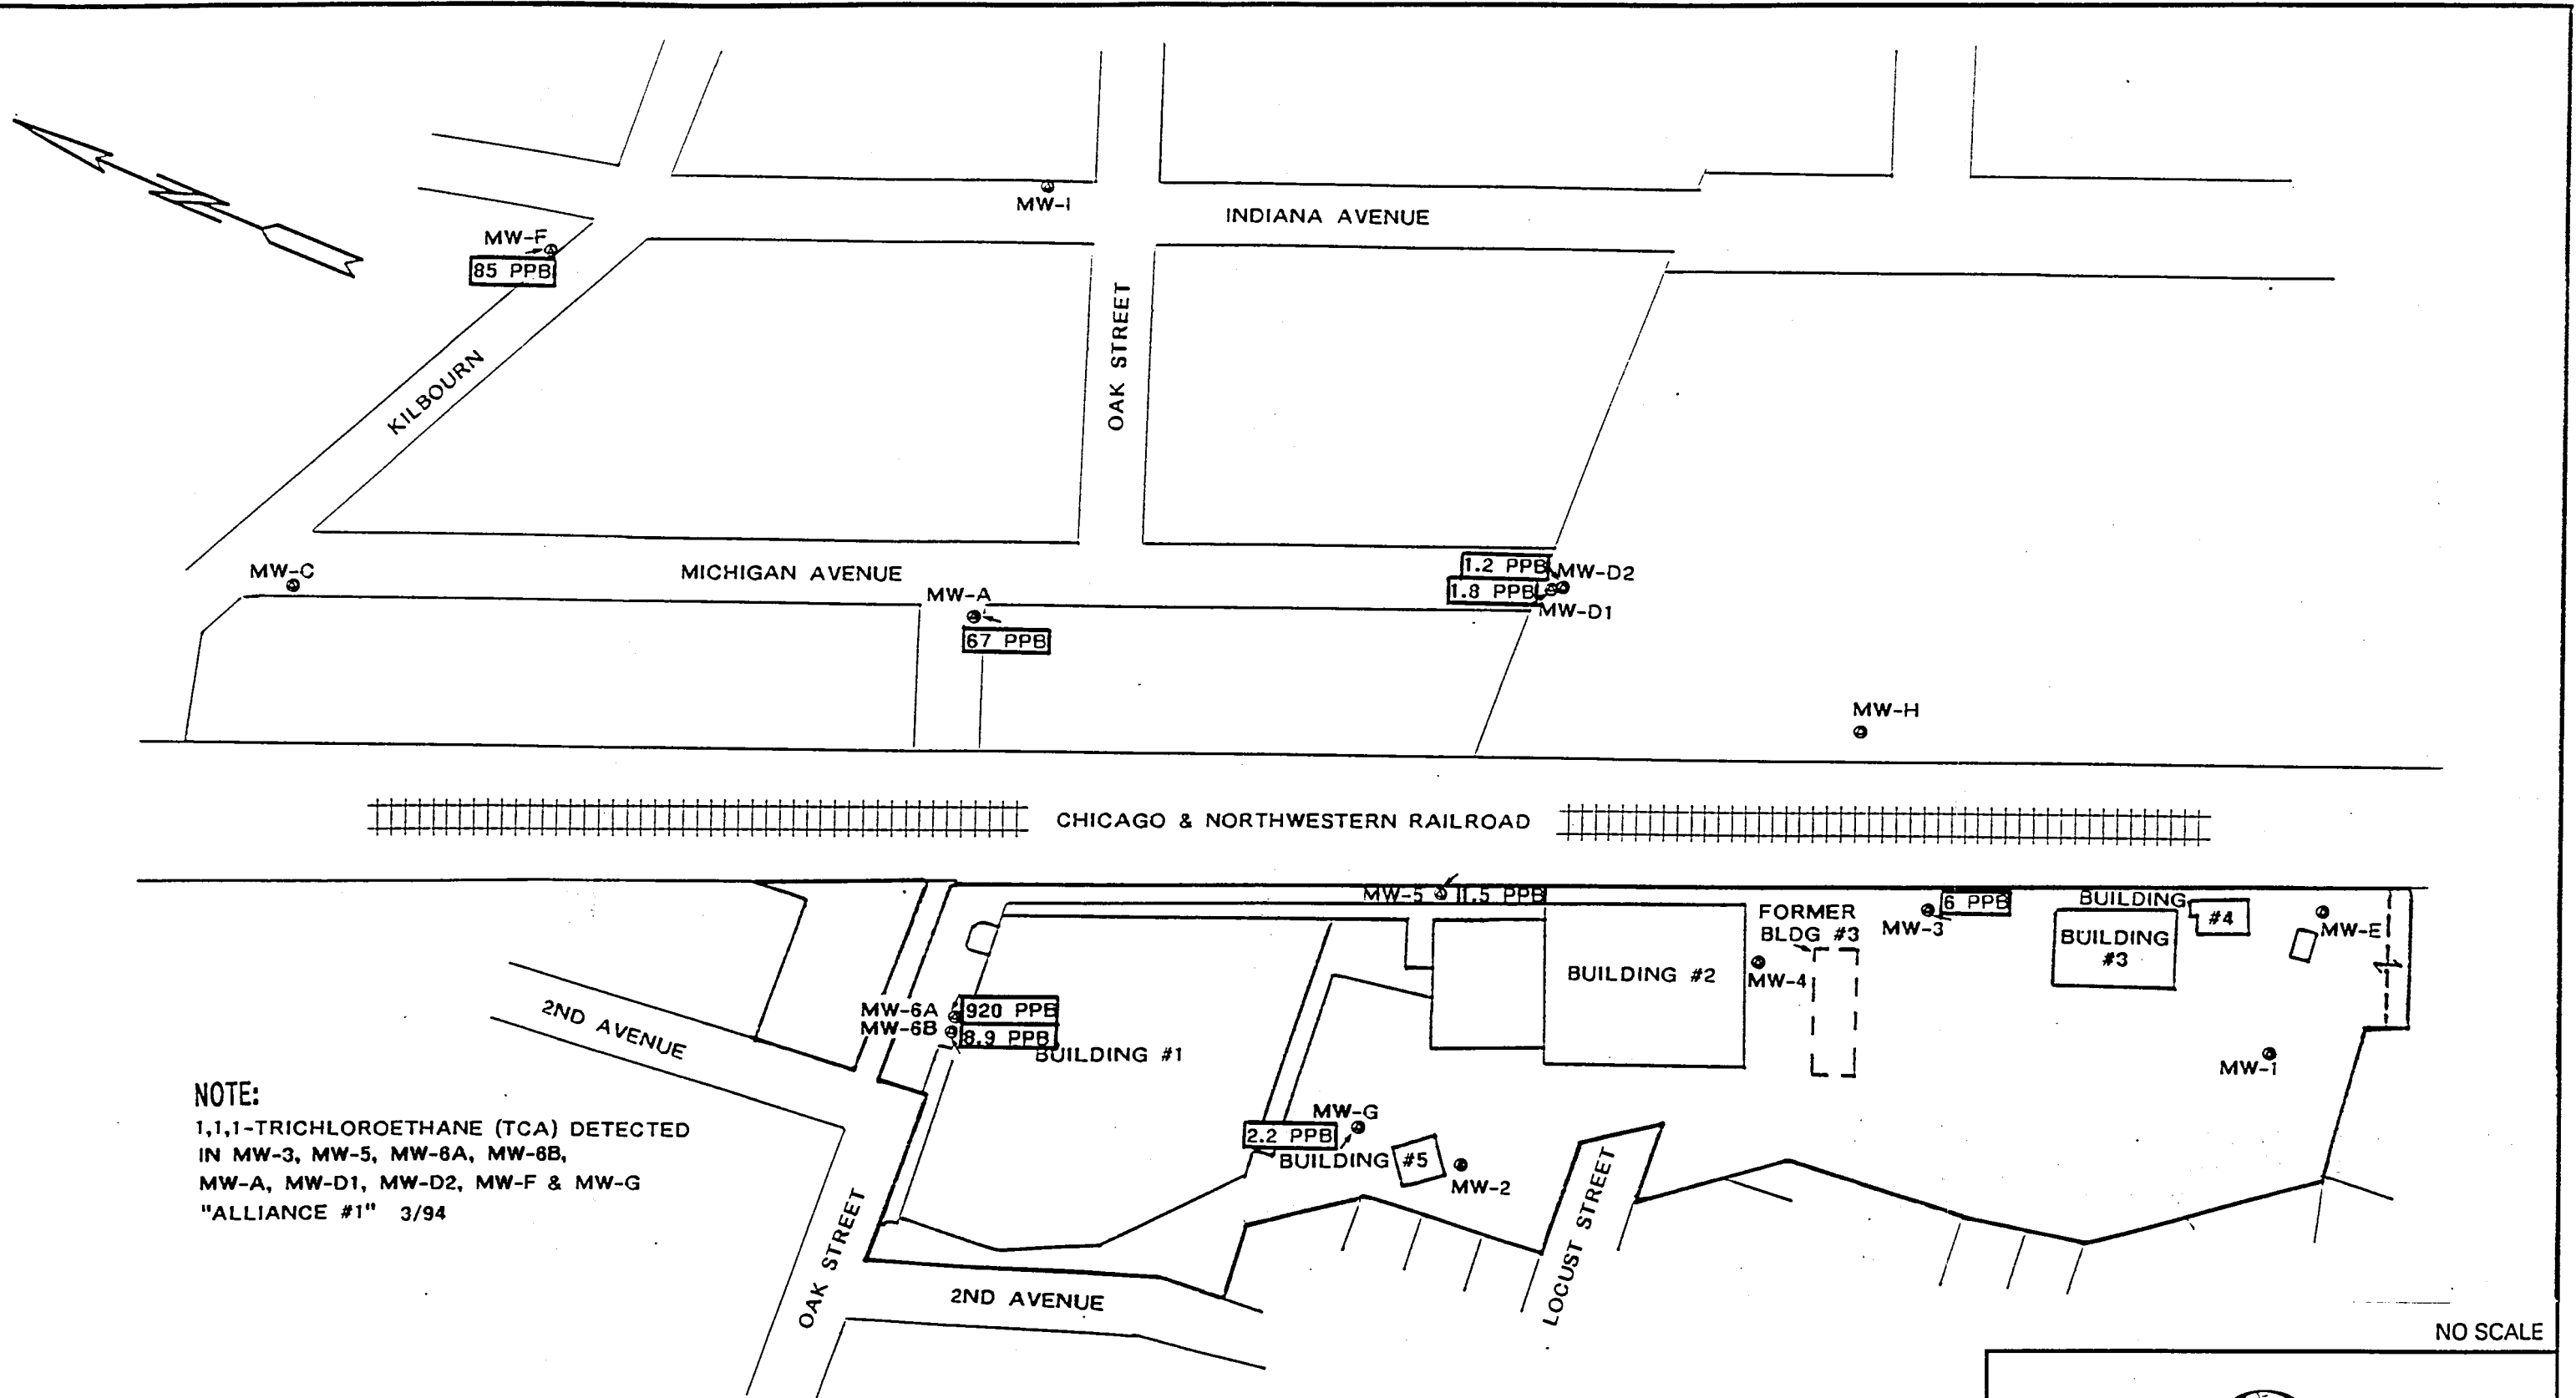
NOTE:
 1,1,1-TRICHLOROETHANE (TCA) DETECTED
 IN MW-3, MW-5, MW-6A, MW-6B,
 MW-A, MW-D1, MW-D2, MW-F & MW-G
 "ALLIANCE #1" 3/94

It is expected that the groundwater remediation relating to the solvent release will be located in front of Building #1 near MW-6 and will include a traditional pump and treat air stripper system. The second area requiring remediation is near the wood waste area (MW-3) and will include a pump and treat system with a carbon filtration system. Since the release has not migrated, is limited in area, is difficult and costly to dispose of, no soil removal in this area is recommended. Depending on the results of the groundwater extraction system, this area may require bio-remediation in place. Therefore, the final determination on the need and extent of bio-remediation will await the groundwater results. Upon receipt of the WDNR's written approval of the investigative work submitted to date, a proposed remediation equipment design report will be submitted to the WDNR in order to gain approval of the two groundwater systems, prior to installation.

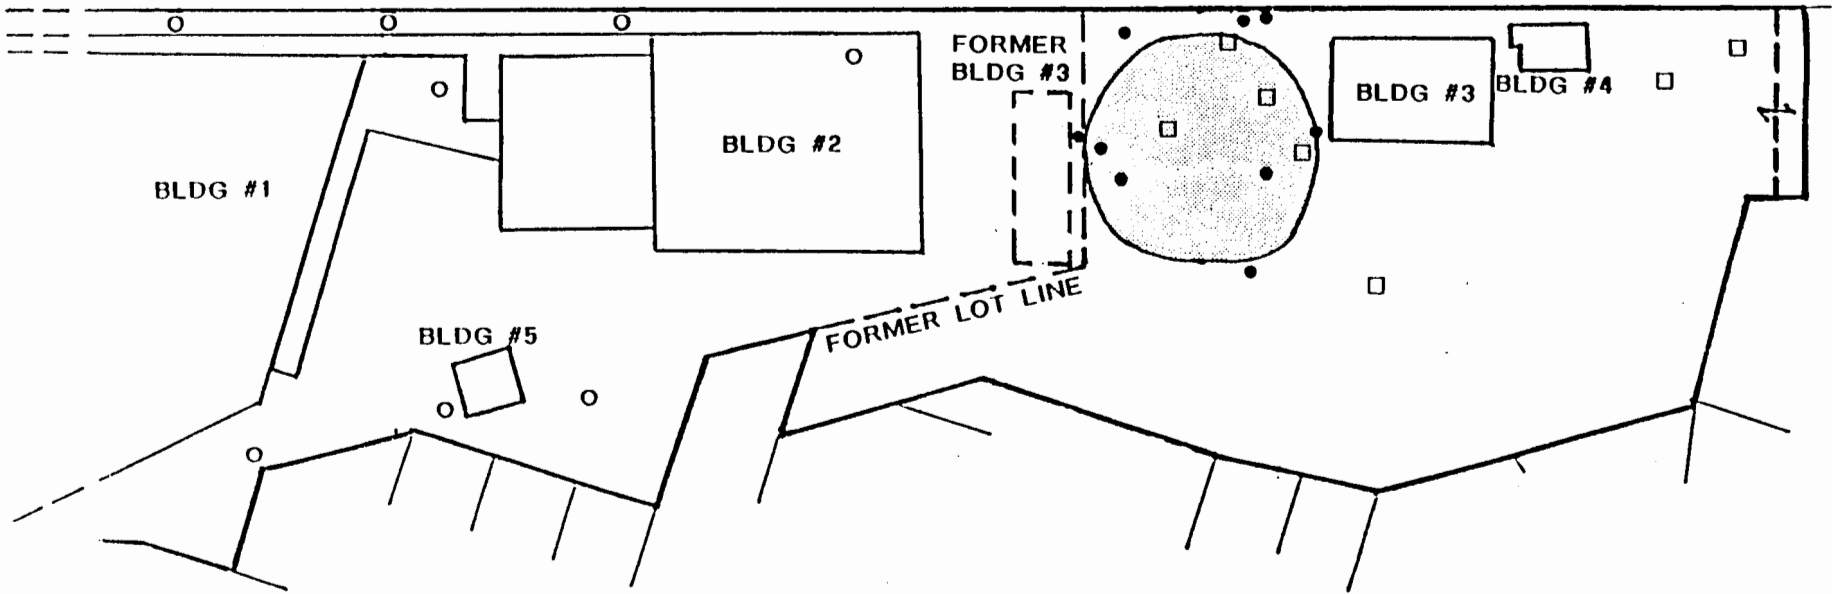
- = WARZYN SOIL SAMPLE LOCATIONS
- = WARZYN TEST PIT LOCATIONS
- = DELTA SOIL SAMPLE LOCATIONS
- (shaded) = APPROXIMATE EXTENT OF WOOD PRESERVING WASTES IN SOIL
