BRRTS ID No. 02-36-176478

Site Name: W C L Turntable Former Roundhouse

Client:	City of Manitowoc	Project:	Cap Maintenance Inspection Summary
Site Name:	Wisconsin Central Ltd. - Former Turntable and Roundhouse Area	Site Location:	River Point District, Manitowoc, Wisconsin

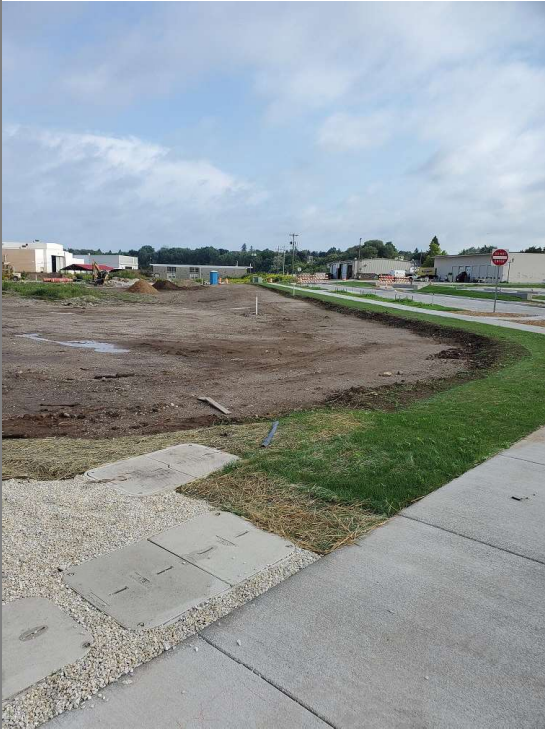
Title: Looking north-northeast - area grubbed of vegetation and former roundhouse and turntable structures removed as approved by DNR. Portions of the closed case area are under the recently constructed ROW.

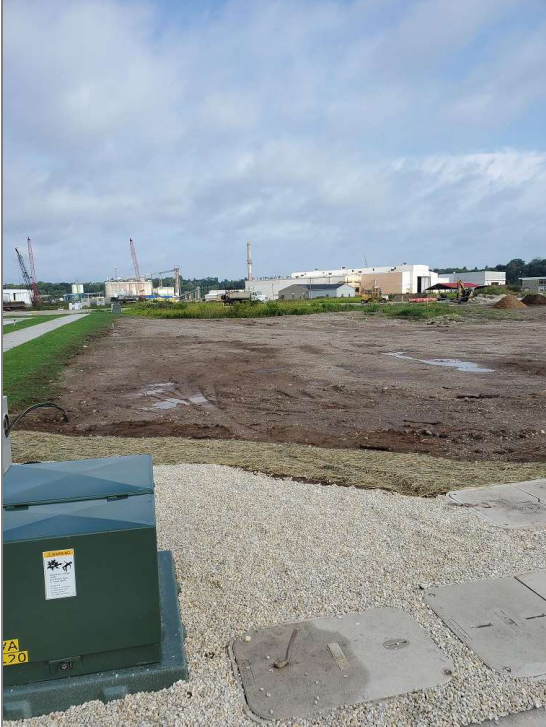
Title: Looking northwest - area grubbed of vegetation and former roundhouse and turntable structures removed as approved by DNR. Portions of the closed case area are under the recently constructed ROW.

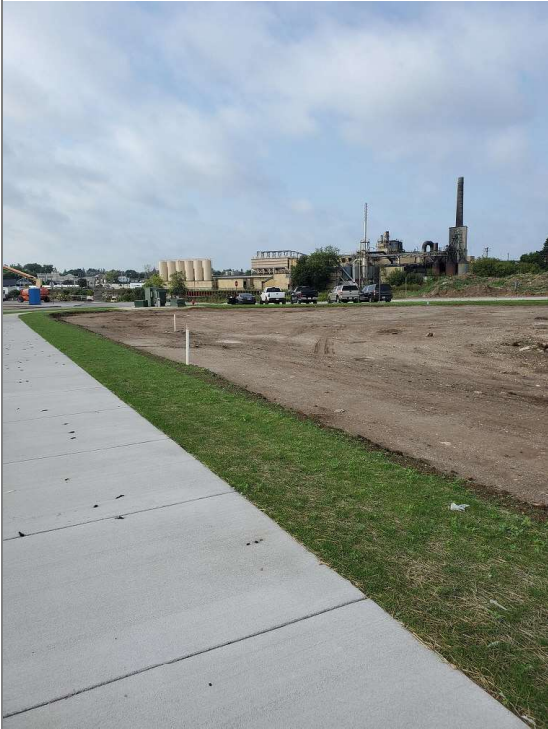
Title: Looking south-southwest - area grubbed of vegetation and former roundhouse and turntable structures removed as approved by DNR. Portions of the closed case area are under the recently constructed ROW.

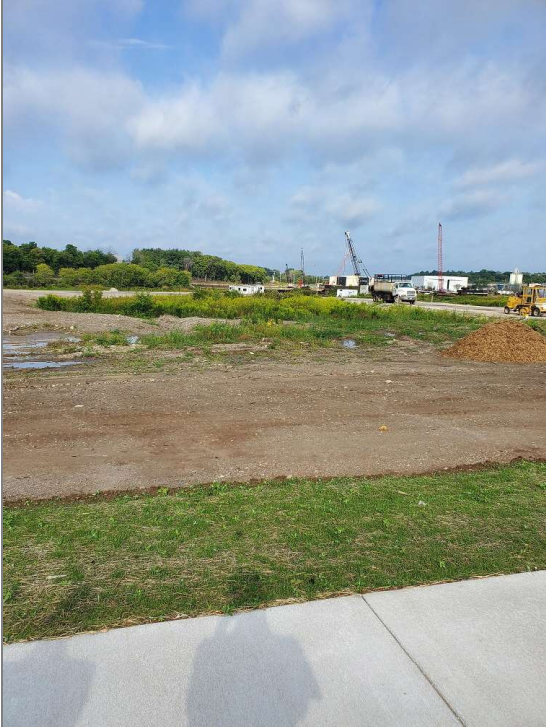
Title: Looking west-northwest - area grubbed of vegetation and former roundhouse and turntable structures removed as approved by DNR. Portions of the closed case area are under the recently constructed ROW.

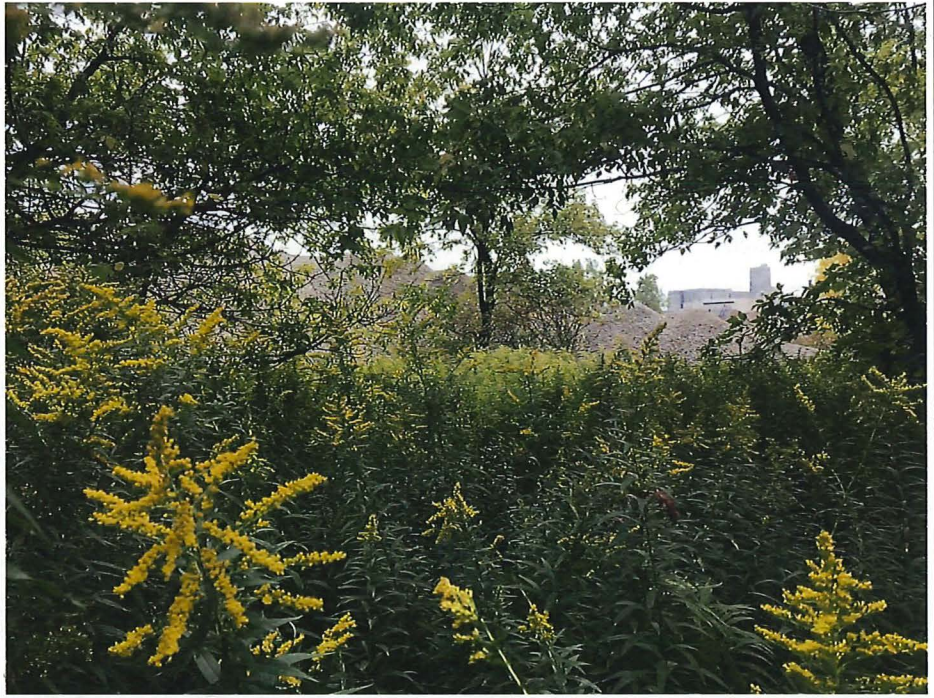
Photograph ID: 1

Photo Location: Inside east end of cap	
Direction: Looking east	
Survey Date: 9/29/2020	
Comments: Typical vegetation present on east end of cap

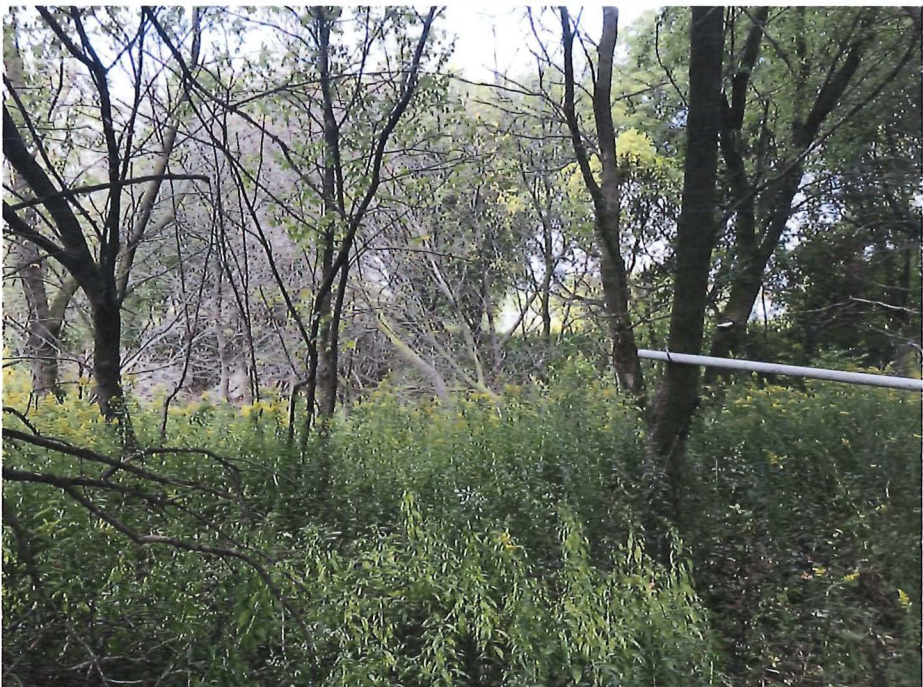
Photograph ID: 4

Photo Location: Inside south end of cap	
Direction: Looking northwest	
Survey Date: 9/29/2020	
Comments: Typical vegetation present near center of cap

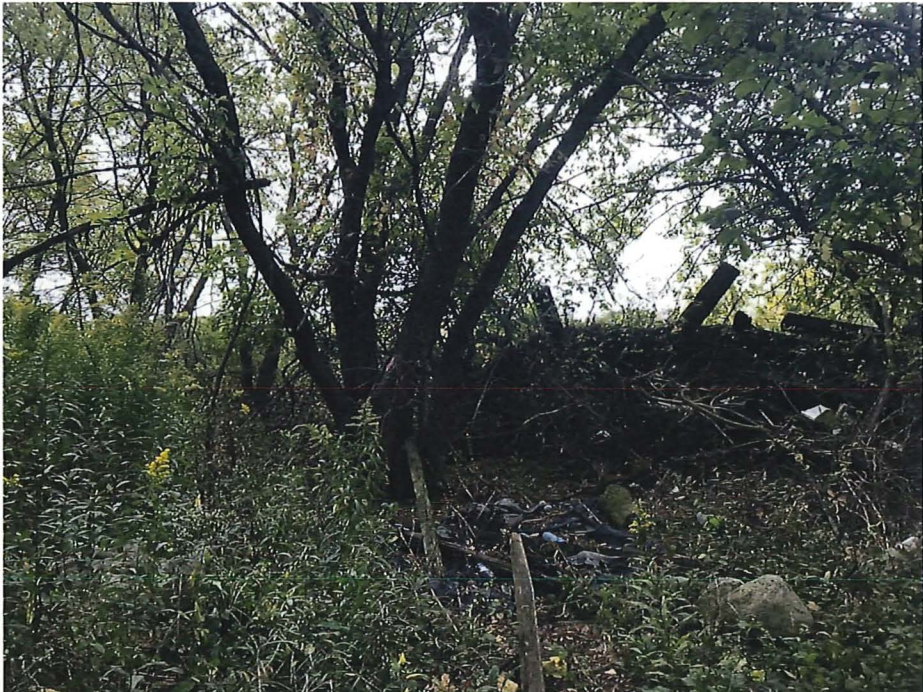
Photograph ID: 5

Photo Location: Inside south end of cap	
Direction: Looking southeast	
Survey Date: 9/29/2020	
Comments: Typical vegetation/debris present on south end of cap

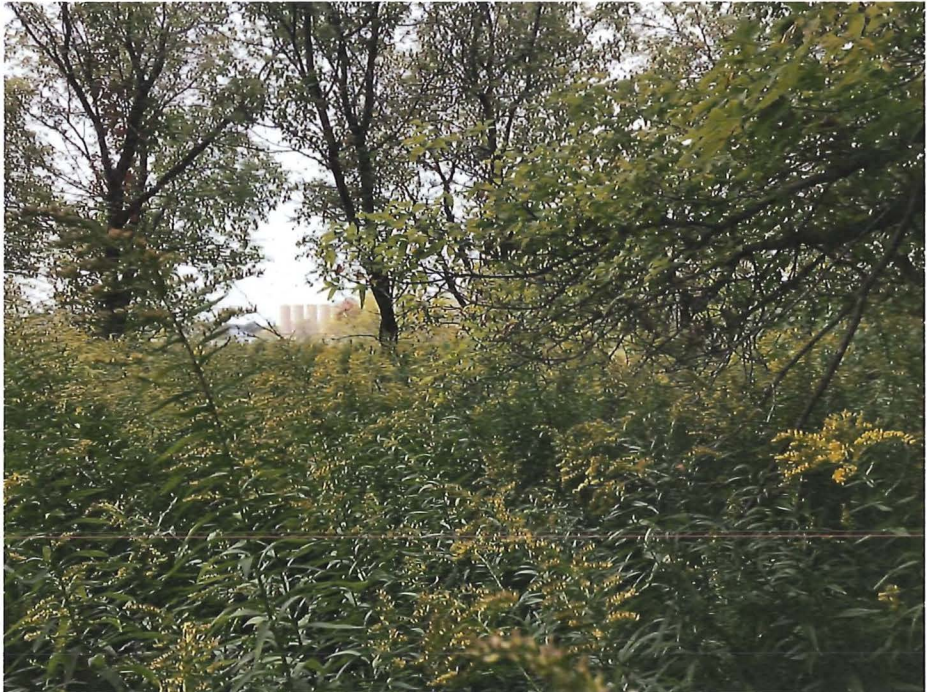
Photograph ID: 7

Photo Location: Inside southeast end of cap	
Direction: Looking southeast	
Survey Date: 9/29/2020	
Comments: Typical vegetation present on southeast end of cap

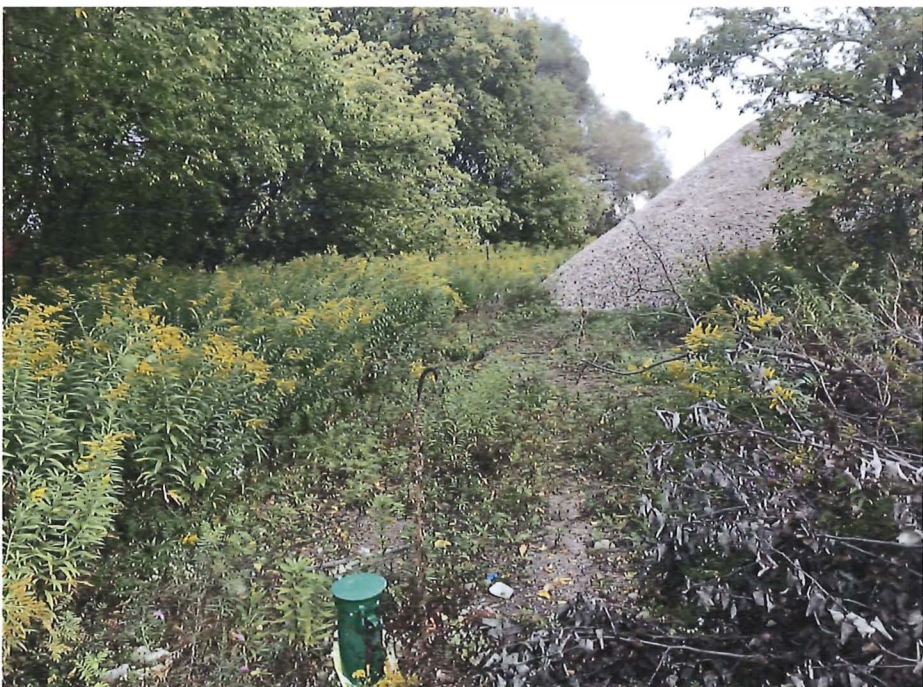
Photograph ID: 12

Photo Location: Southeast of cap area	
Direction: Looking northeast	
Survey Date: 9/29/2020	
Comments: View of the eastern edge of the cap (tree line, left), as seen from the southeast

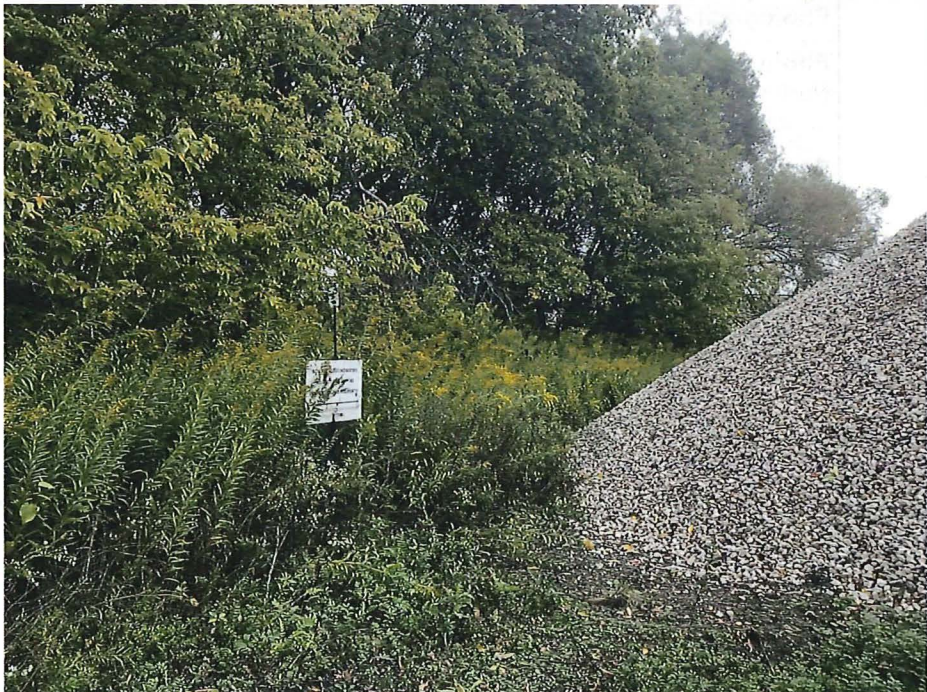
Photograph ID: 14

Photo Location: East end of cap	
Direction: Looking northwest	
Survey Date: 9/29/2020	
Comments: View of the cap (tree line, left), as seen from the east; a sign was damaged during demolition activities east of the cap area

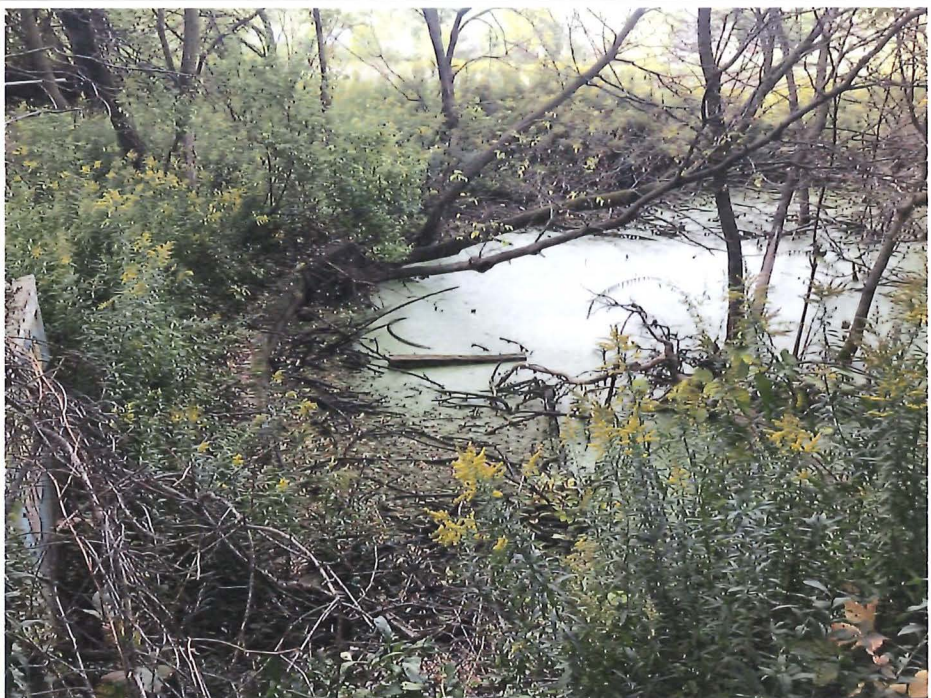
Photograph ID: 16

Photo Location: Northeast side of former turntable	
Direction: Looking south	
Survey Date: 9/29/2020	
Comments: View of former turntable

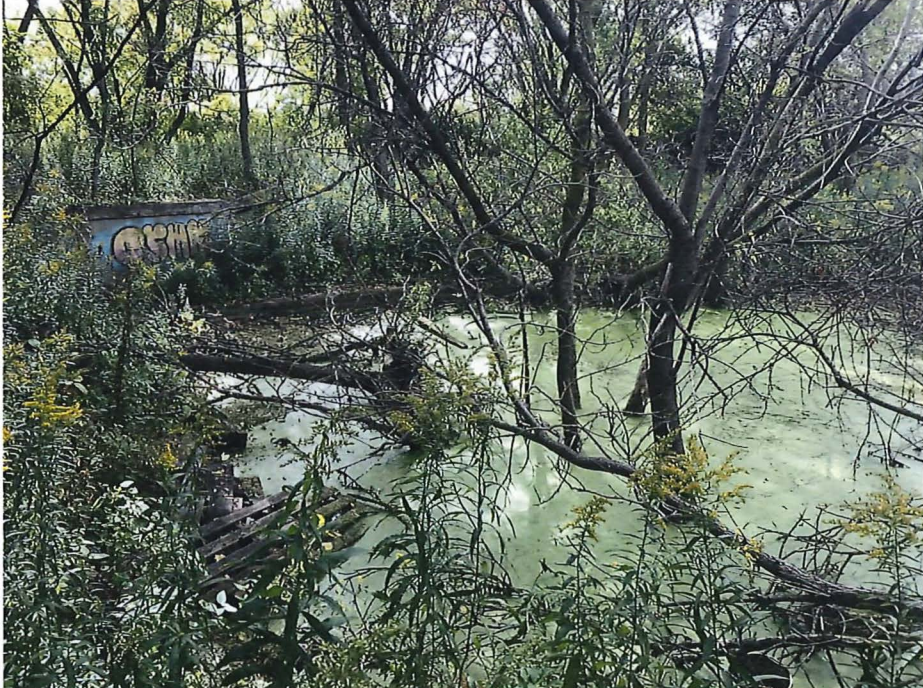
Photograph ID: 18

Photo Location: Northwest side of former turntable	
Direction: Looking east	
Survey Date: 9/29/2020	
Comments: View of former turntable

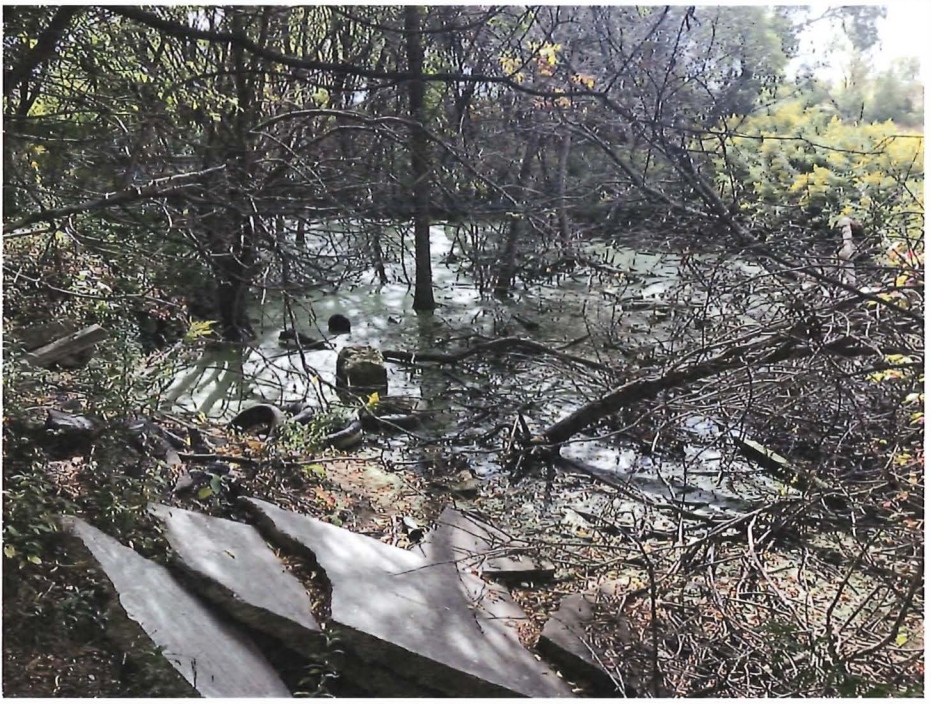
Photograph ID: 20

Photo Location: Northwest side of former turntable	
Direction: Looking southeast	
Survey Date: 9/29/2020	
Comments: View of former turntable

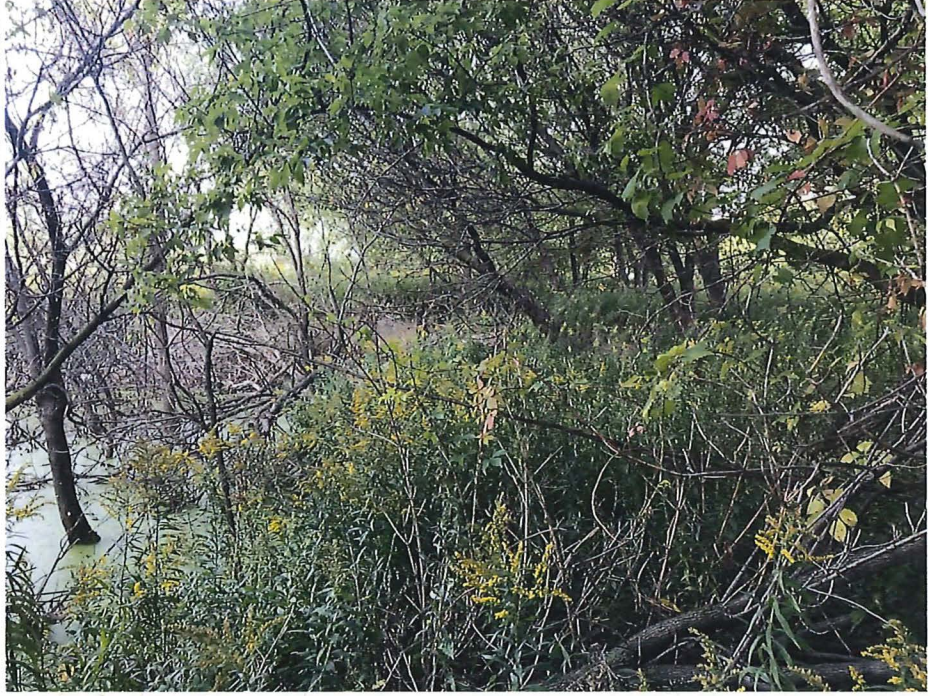
Photograph ID: 21

Photo Location: West side of former turntable	
Direction: Looking south	
Survey Date: 9/29/2020	
Comments: Typical vegetation present west of the former turntable

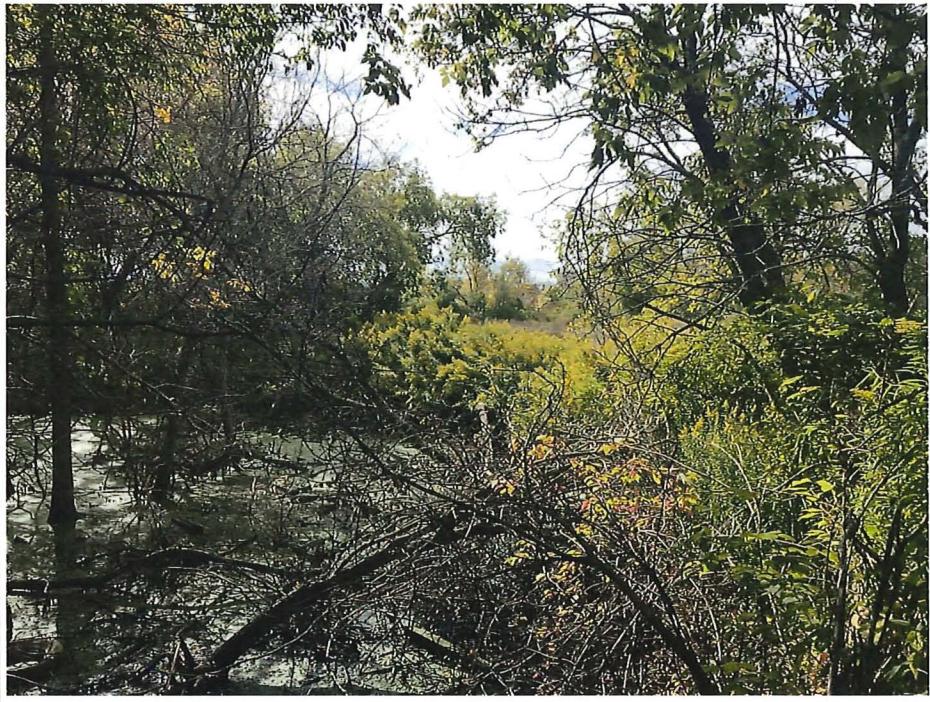
Photograph ID: 22

Photo Location: West side of former turntable	
Direction: Looking southeast	
Survey Date: 9/29/2020	
Comments: Typical vegetation present west of the former turntable
