Installation Documentation and Maintenance Plan for Vapor Mitigation System

3935 N. Palmer Street, Milwaukee, Wisconsin

Post Mitigation Report For

The Hunn Family Trust, 3935 N. Palmer St., Milwaukee, WI

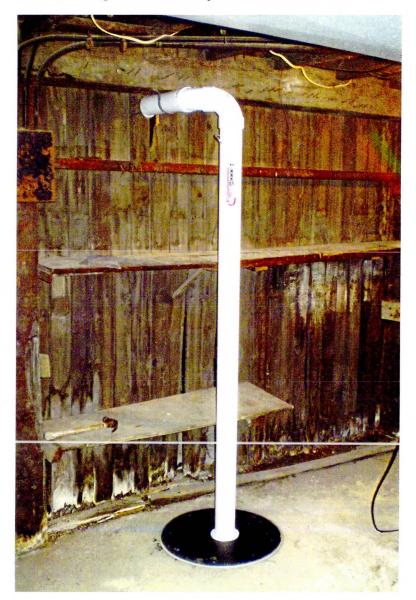
Photo 1: Main pick-up point (P2), located near the middle of the building. Vapor mitigation system installed February 6, 2014, by Acura Services, LLC.

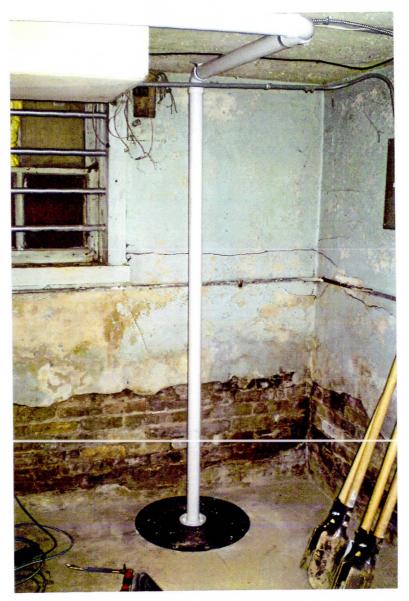
Photo 2: Pick-up point (P3), located nearest the source, southwest corner of the building. Vapor mitigation system installed February 6, 2014, by Acura Services, LLC.

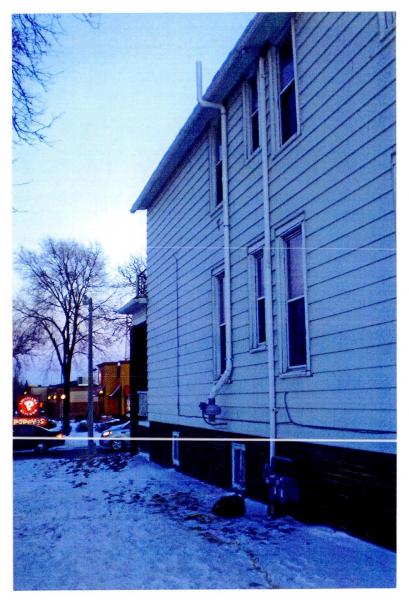
Photo 3: Vent pipe located on the north side of the building. Vapor mitigation system installed February 6, 2014, by Acura Services, LLC.
