DATE: October 12, 2000

SUBJECT: Novak Property Inspection

I inspected the Novak Property with John Schultz of Triad and Steven Ziesmann of Godfrey & Kahn on October 10, 2000. During the inspection environmental problems were identified. There are three categories of problems. There is a wastewater discharge of water contaminated by lime on the site, there is no wastewater discharge permit for this site. There are visible signs of spills of petroleum products on site. The site has the characteristics of a salvage yard and there is a failure to implement best management practices as required in the recycling of scrap and waste materials general permit. No stormwater permit has been applied for or issued to this site

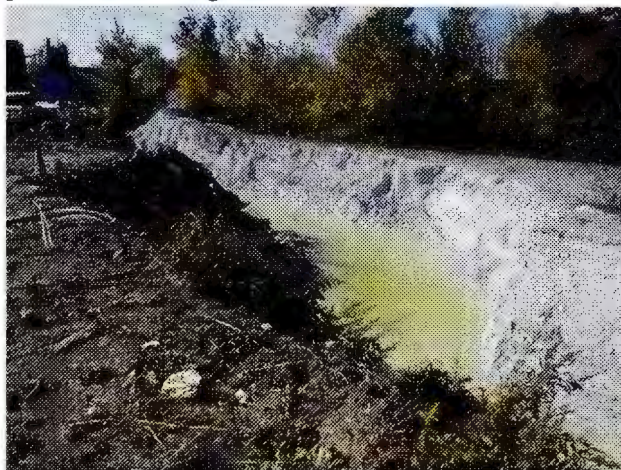
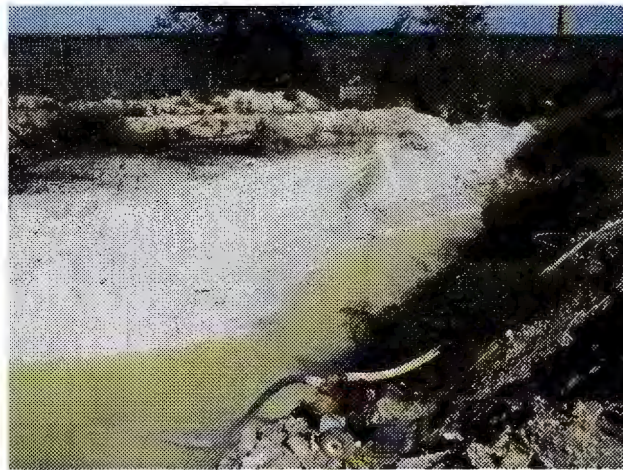
The most significant problem is the discharge of water contaminated by the lime pits. The lime pit has been reduced to two areas. Both have ponded water. I tested the pH of one with pH paper. It had a pH in the 12-13 area. There did not appear to be a safe approach to the other pit. Shown below is the northern pit that I did not go into.

The water in the two lime pits should be pumped to the sanitary sewer on a daily basis to reduce seepage from the site.

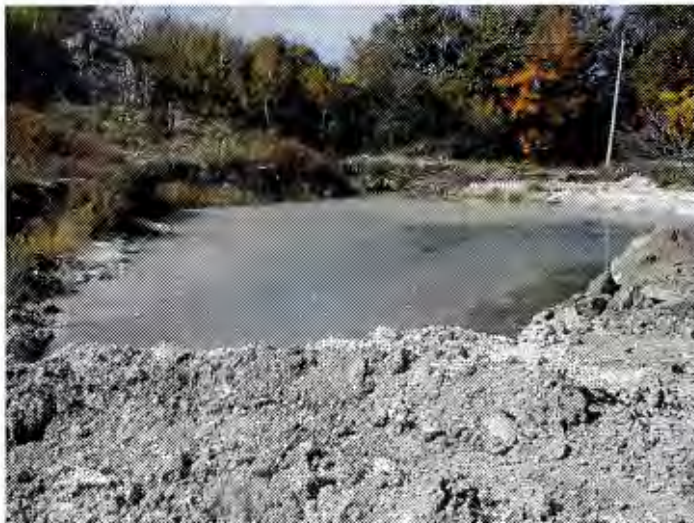
The pit immediately north of the fire station is shown on the right. This water was sampled with pH paper and had a pH in the 12-13 range. There appeared to be little lime left in this area. There appears to be sufficient fill material in the berm on the left to complete abandonment of this pit immediately.

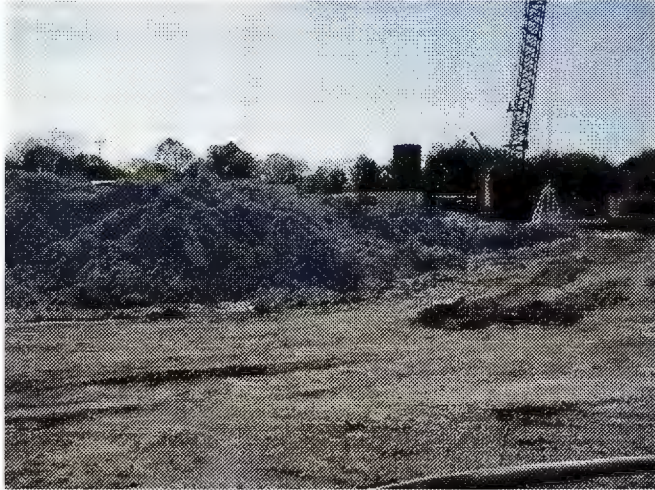
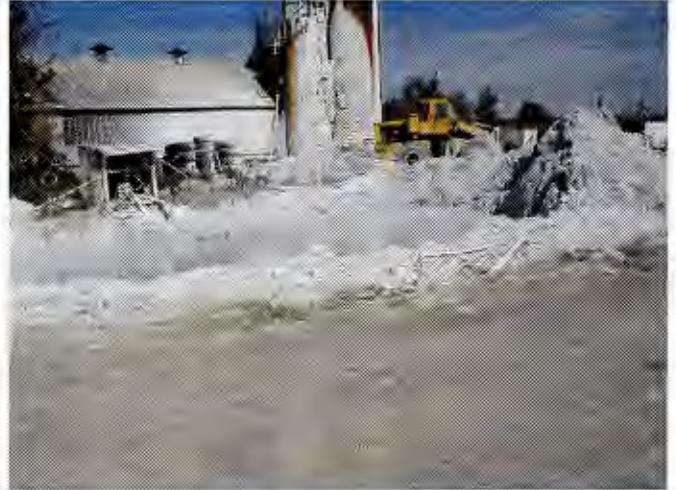
The lime is being removed from the pits and sold to a tannery. It is initially removed with a clam shell. To prepare it for sale it is placed in a slurry and screened. This is done

in the pit shown below on the right. The tanks shown are used for storage of the slurry.

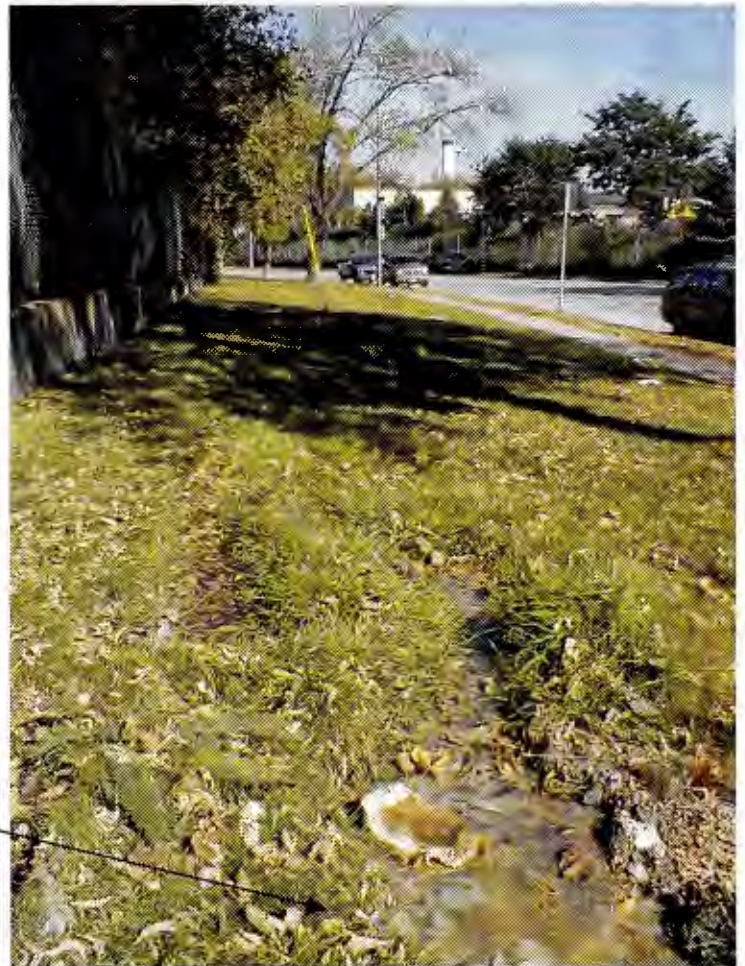
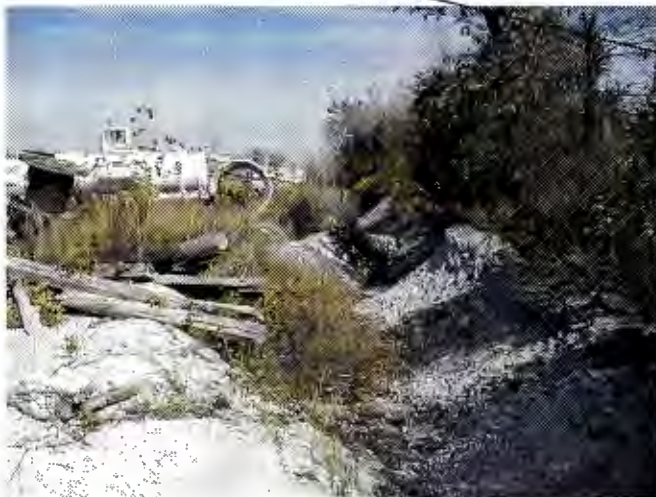
(pH paper)

The problem at this site that needs immediate attention is the seepage of the high pH water along W Becher Place. We walked this area and sampled several puddles in the grass along the sidewalk. I found they had a pH in the 12-13 range. There is a collection system behind the retaining wall shown on the left. The collection system appeared to be plugged. The water was seeping below the retaining wall. The inspection was made on a clear sunny day. The ground in this area was saturated. There was visible soil movement when we stepped in the wet areas. There also were tire tracks in the lawn, possibly from lawn mowing equipment.

Inside the fence there is a trench that parallels W Becher Place. The trench intercepts some surface water discharge but is too shallow to intercept the groundwater seeping from the site.

Water in the puddles along the sidewalk should be neutralized to a pH less than 9.0.

The ruts should be filled to prevent pooling.

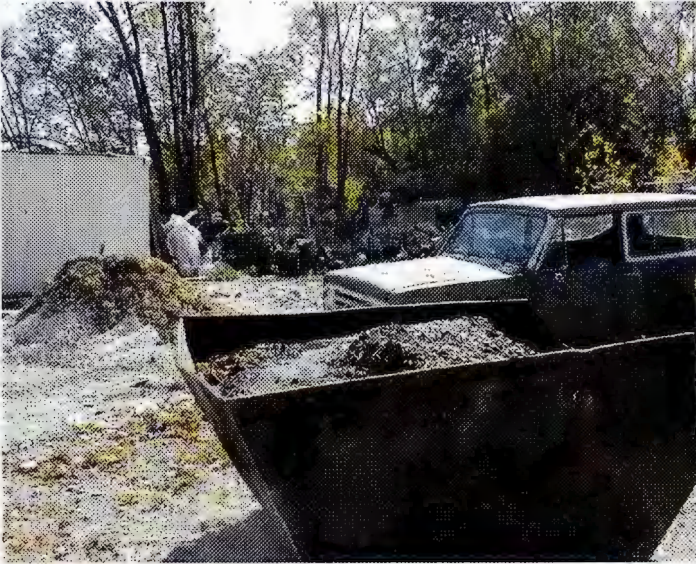
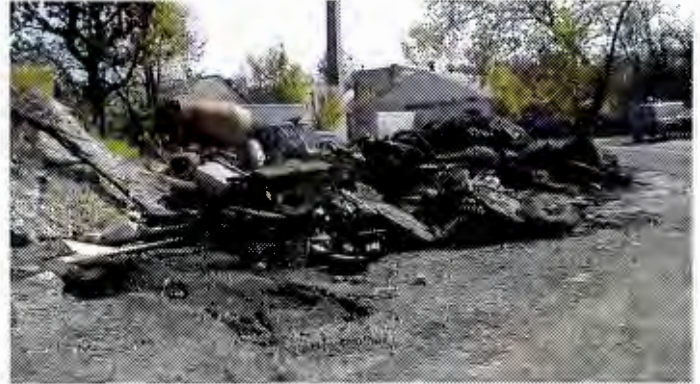
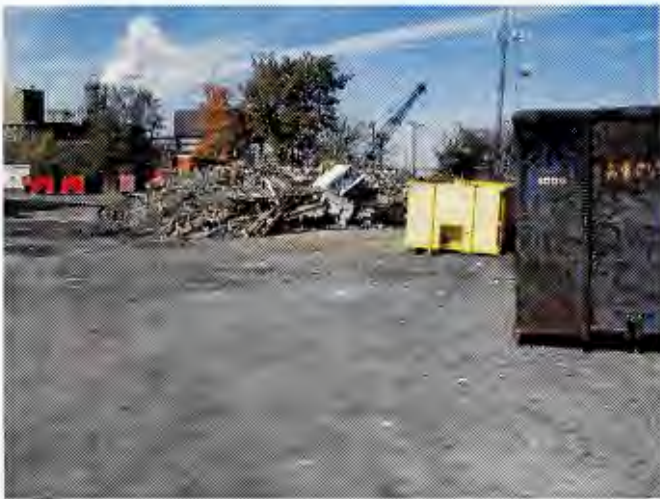
The yard has significant scrap material. There is mechanical equipment in various stages of disassembly, scrap metal, foundry slag, and tires on site. There were petroleum stains on the ground in several areas.

Foundry slag (above)
Unknown in lugger box (right)
Scrap Metal (lower right)
Tires (below)

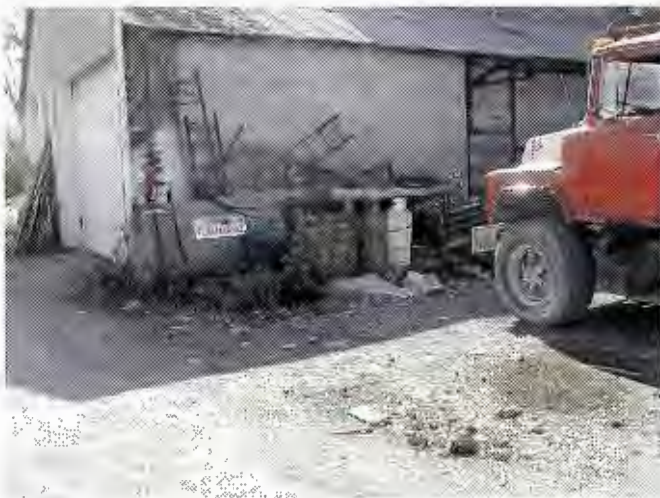
Harbor Skimmer(below)

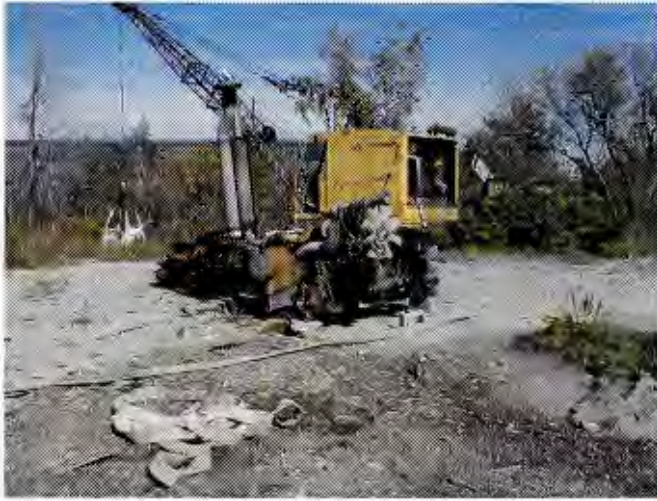
Partially disassembled truck

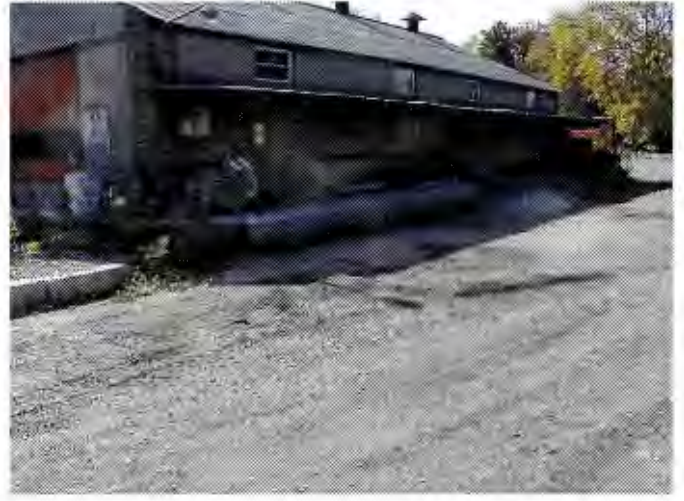
Petroleum stain outside bldg 2

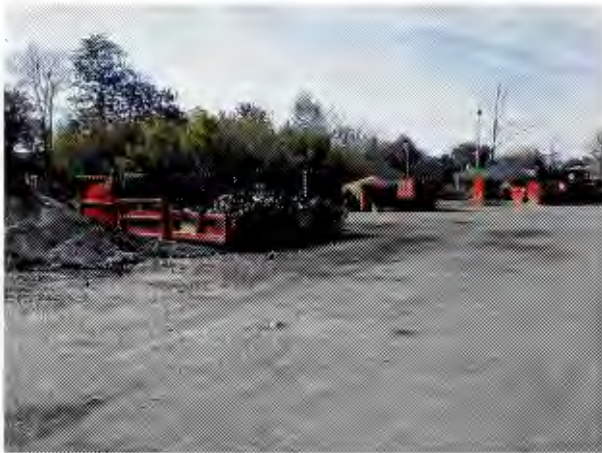
Sorce Services operates on this site. They use the site to transfer and consolidate the waste prior to taking it to a landfill. The waste on site in their area of the property was roof shingles.
