BRRTS Number: 02-41-191377

Site Name: Silver Spring Terrace

Remediation & Redevelopment Continuing Obligation Review
Form 4400-232 (Revised 2/11)

Review Date: 8/30/12

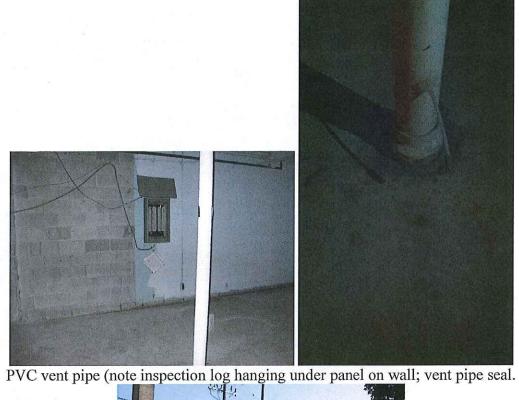
White PVC vent pipe along ceiling.

6. **Are additional actions by the RP or property owner warranted at the site? (The intent is to return the site to compliance with continuing obligation. If further remedial action is needed, determine if the site meets the NR 726 reopening criteria.) ☑ No But see comment below. ☐ Yes Describe any actions needed to return the site to compliance, and identify who's responsible: (Add AC 186, use AC 99 for actions not listed under AC186)
The SSDS is in compliance; however, installation of an inexpensive manometer would promote easier inspection & confirmation that the system vent fan is operating properly (see attached Bing Shopping web page for examples).
