Re: Work Plan Addendum
Bob's Service Station
Falun, WI
NWD ID No. 148

This status report, covering the period from April 1994 to the present time, documents the completion of the work proposed in our original work plan dated April 26, 1994, with the exception of the remedial investigation report preparation. Results to date are presented in this letter report, along with a proposed work plan for additional investigation site work.

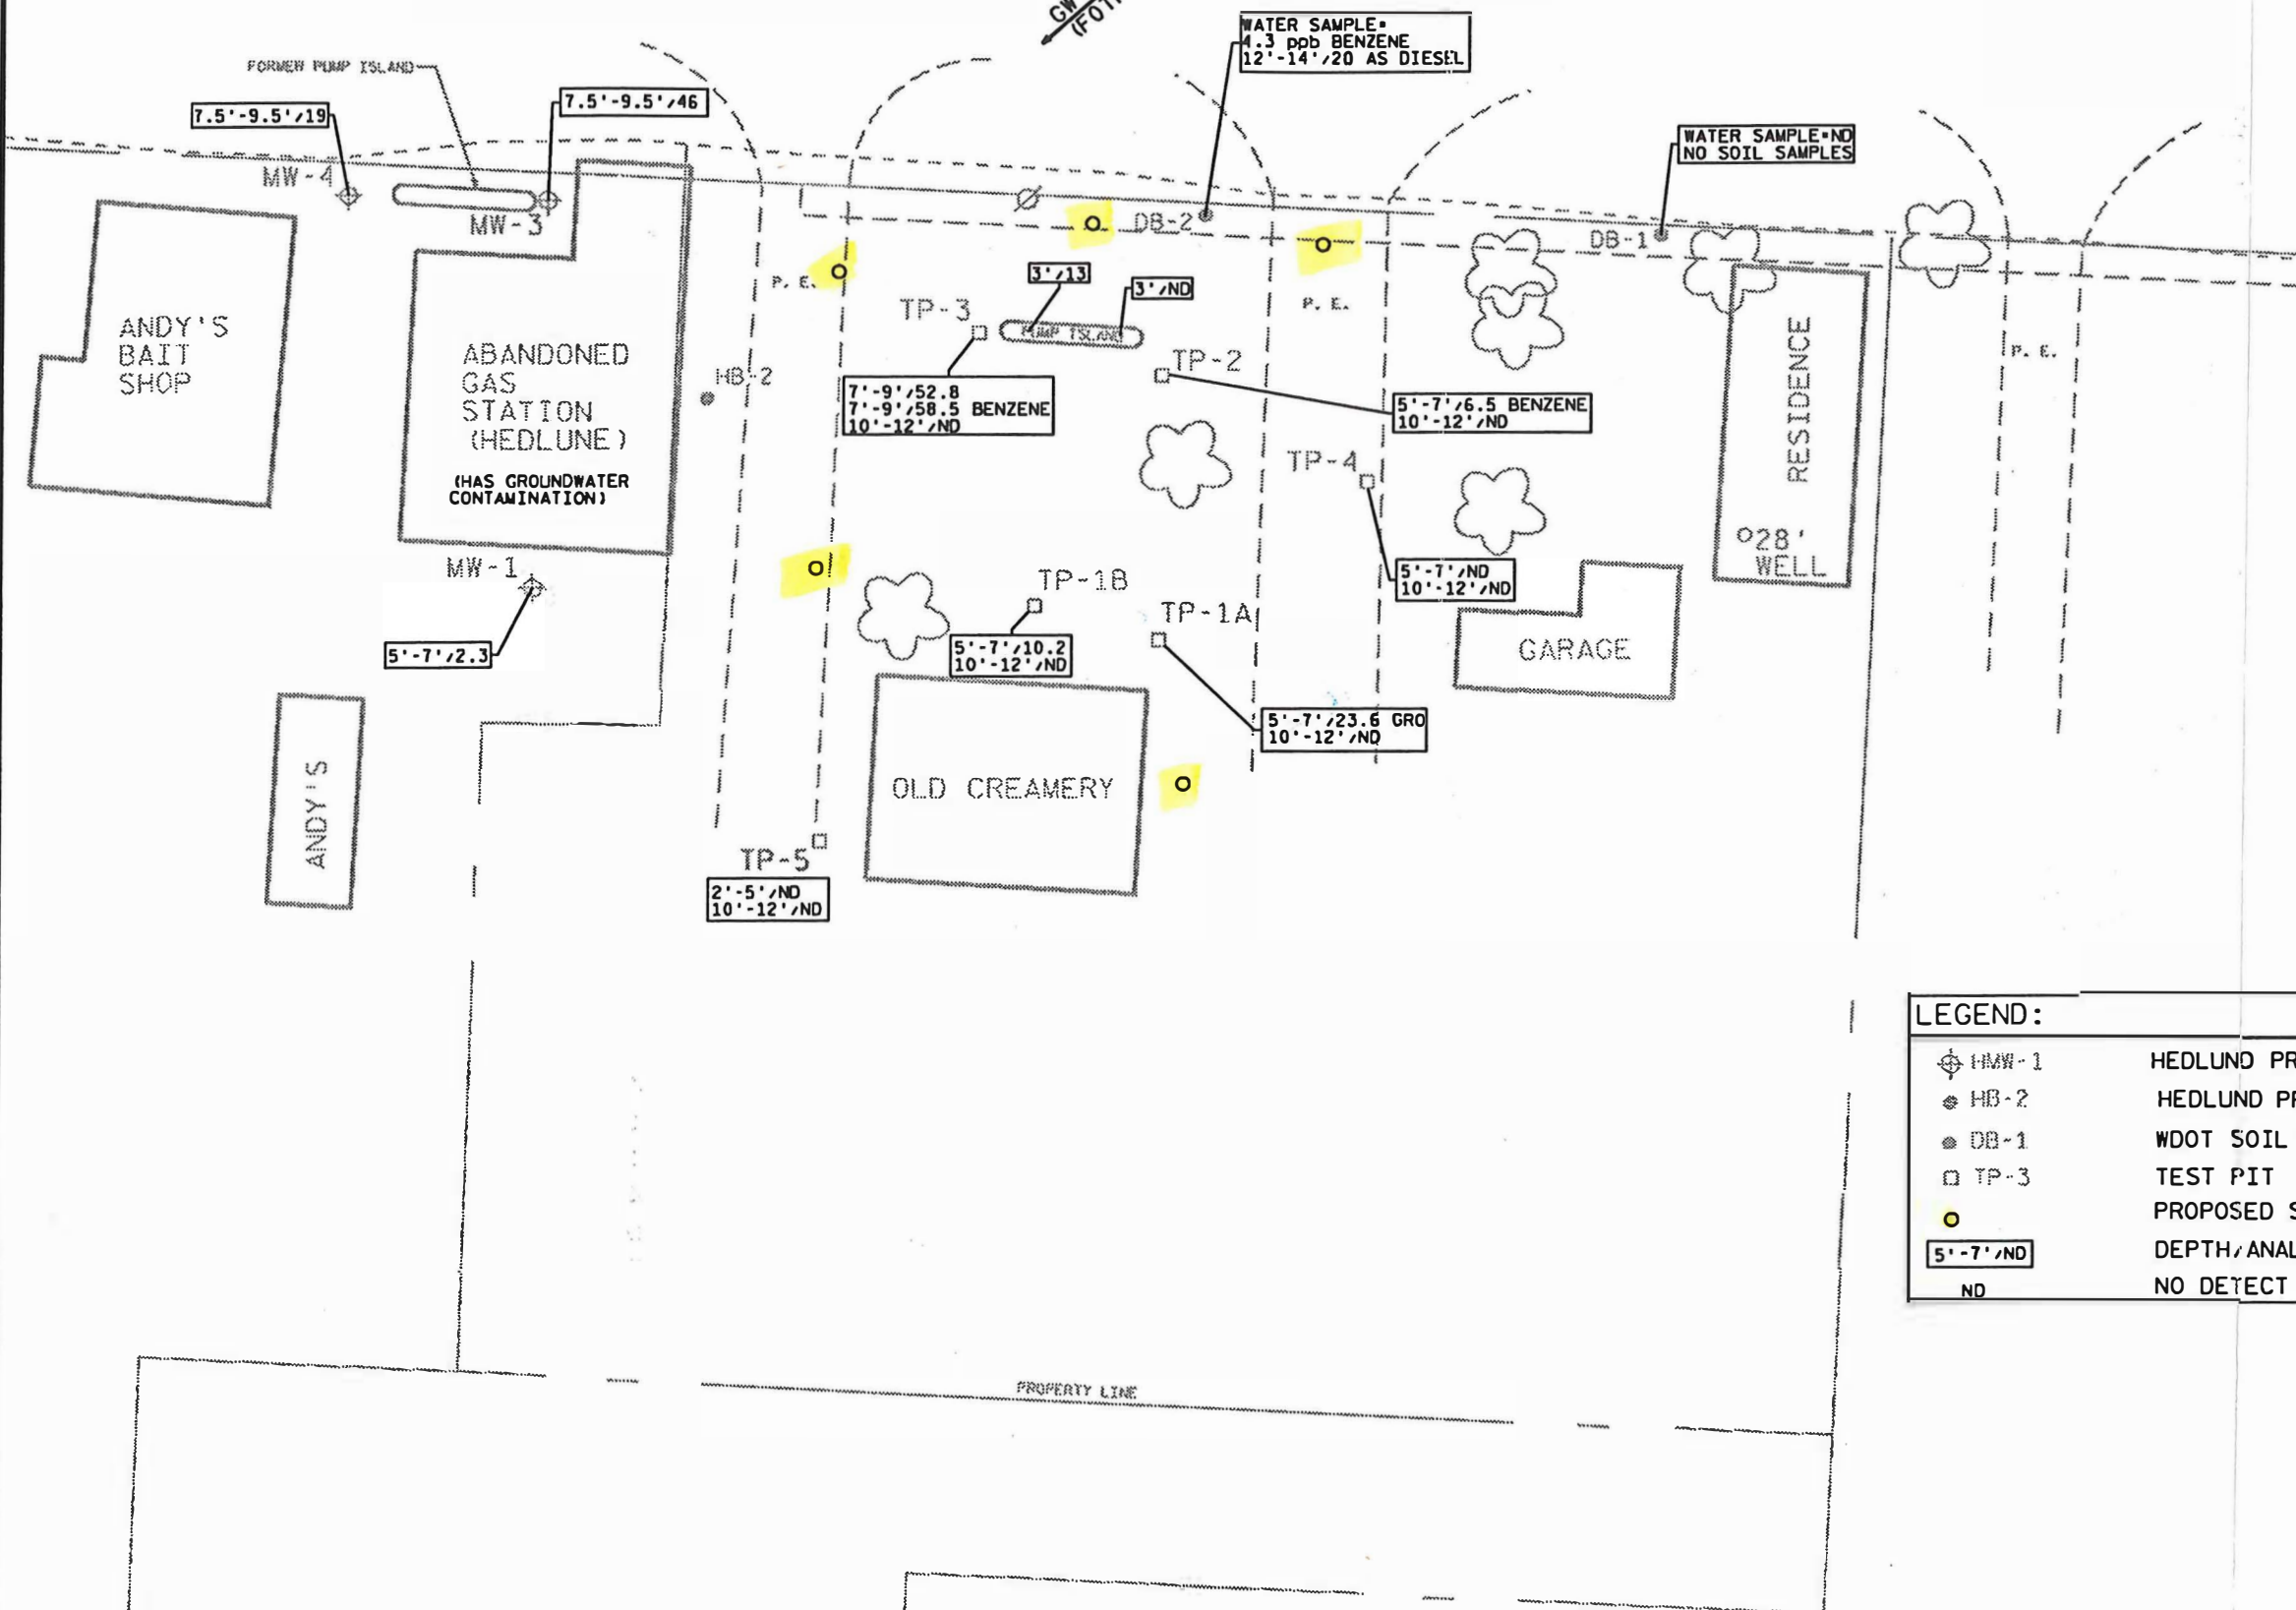
SITE PLAN

A total of five test pits have been installed at the site as part of the remedial investigation. Figure 1, "Site Plan," shows the location of the test pits. On-site soils were found to be consistent with previous reports: brown fine sands with shallow layers of gray clay. Soil layers varied significantly and were classified according to the Unified Soil Classification System (USCS) as SW, SM, SP, and ML in the upper five feet and ML from five feet to the terminus of each boring.

The soil sampling conducted to date has not determined the full extent of petroleum contamination at the site. Elevated levels of GRO and/or benzene were detected in the five to nine foot range of soil samples TP-1 through TP-3. Numerous VOCs were detected in these

samples, as well. TP-4 and TP-5 were determined to be clean, except for a small detection of dichloromethane in the lower sample of TP-4. The proposed work plan for the additional site investigation is presented below.

As shown on Figure 1, Ayres Associates proposes the installation of five soil borings. The intent is to further define the vertical and horizontal degree of soil and potential ground water contamination near the former underground gasoline tank area. Contamination to the east has been defined. The additional borings should define the extent of soil contamination for the remainder of this site.
