ENVIRONMENTAL SITE ASSESSMENT REPORT

HEDLUND DX

FALUN, WISCONSIN

PROJECT 8040-03-00

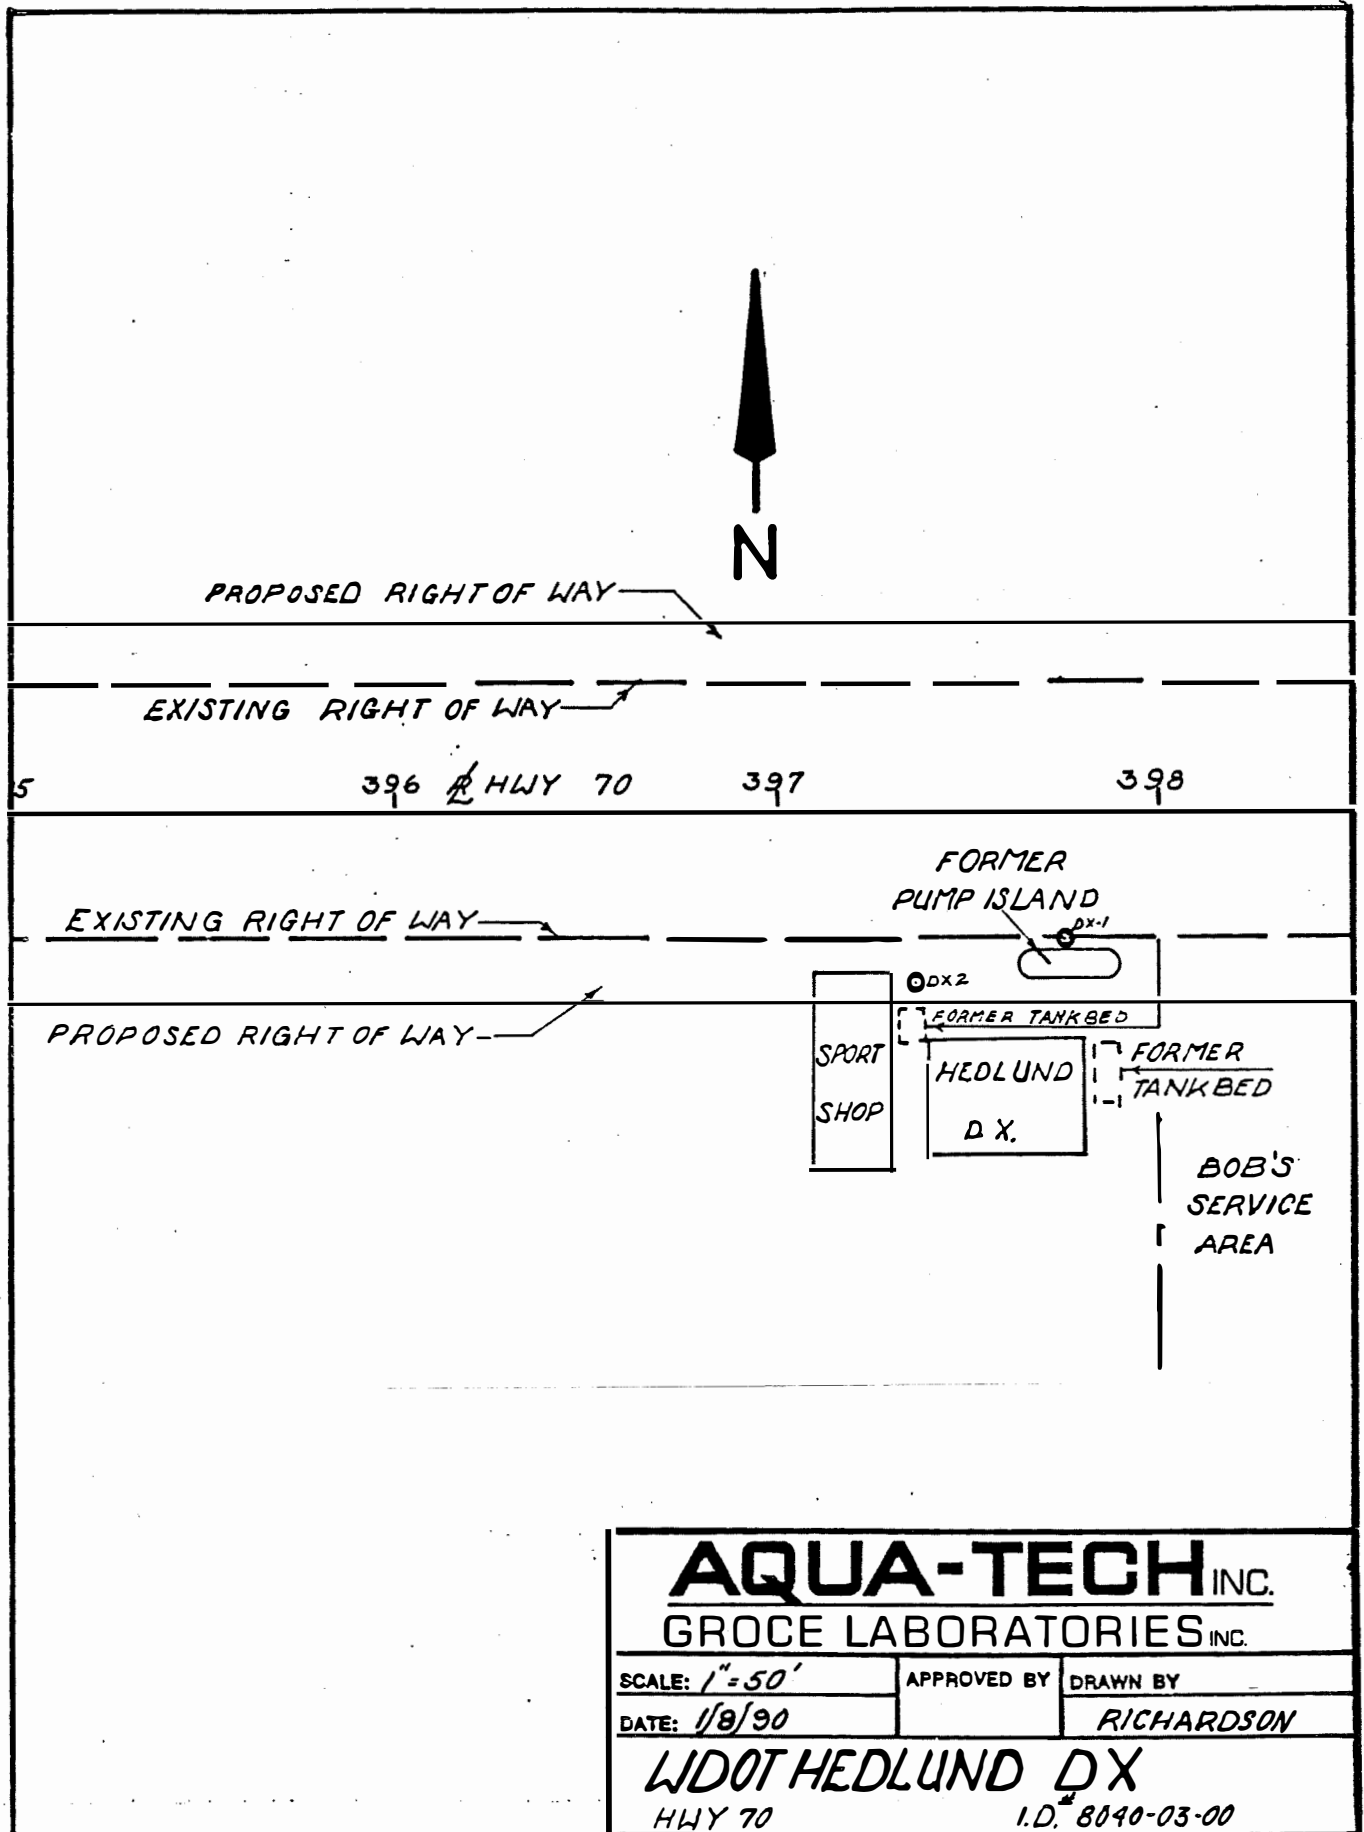
FIGURE 3-1  
SITE FEATURES AND SAMPLING LOCATIONS

On November 7, 1989, Aqua-Tech collected two subsurface soil samples and one groundwater sample within the boundaries of WDOT's proposed right-of-way acquisition. No samples were collected on the portion of the Hedlund DX property which is not being considered for right-of-way purchase. See Figure 3-1 for sampling locations.

Subsurface soil sample DX-1 was collected at the 5-to-7 foot depth interval approximately 5 feet north of the pump island.

Subsurface soil sample DX-2 was collected at the 4-to-6 foot depth interval, 40 feet west of sample DX-1 at the northwest corner of the station building.

Groundwater sample WDX-1 was collected to determine whether any gasoline components had migrated from the tank bed area via groundwater (See Figure 3-1). Samples were collected by inserting a clean stainless steel bailer down the hollow stem augers and transferring the contents to two 40 ml. glass vials. The vials were then sealed, taking care

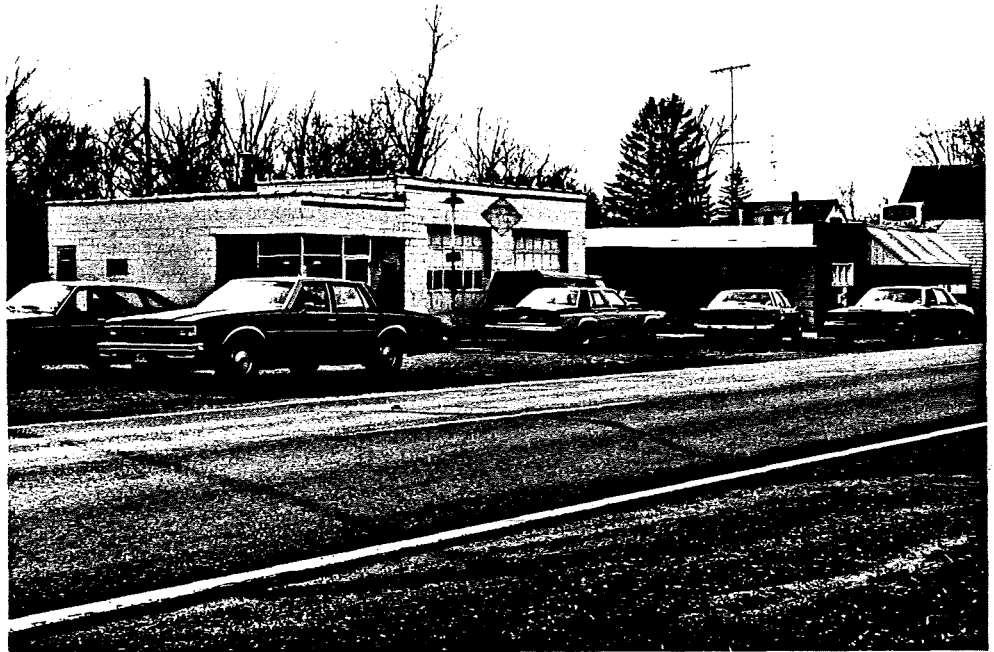
The former underground storage tanks were located at the northeast and northwest corners of the station building. The former pump island platform is located north of the building approximately 25 feet from the existing edge of pavement of STH 70. See Appendix C for a site photograph.

DESCRIPTION: &gt; Hedlund DX located west of Bob's Service Station (not shown)

&gt; Andy's Bait Shop is in the right background.
