Subject: ENVIRONMENTAL SITE ASSESSMENT REPORT  
Property: Hedlund DX Site  
Project ID# 8040-03-00

PHASE III  
ENVIRONMENTAL ASSESSMENT REPORT  
FOR THE  
HEDLUND DX SITE  
VILLAGE OF FALUN, BURNETT COUNTY, WISCONSIN

PREPARED FOR THE  
WISCONSIN DEPARTMENT OF TRANSPORTATION  
PROJECT 8040-03-00

PREPARED BY  
AQUA-TECH, INC.  
140 SOUTH PARK STREET  
PORT WASHINGTON, WISCONSIN 53074  
ATI PROJECT 91036

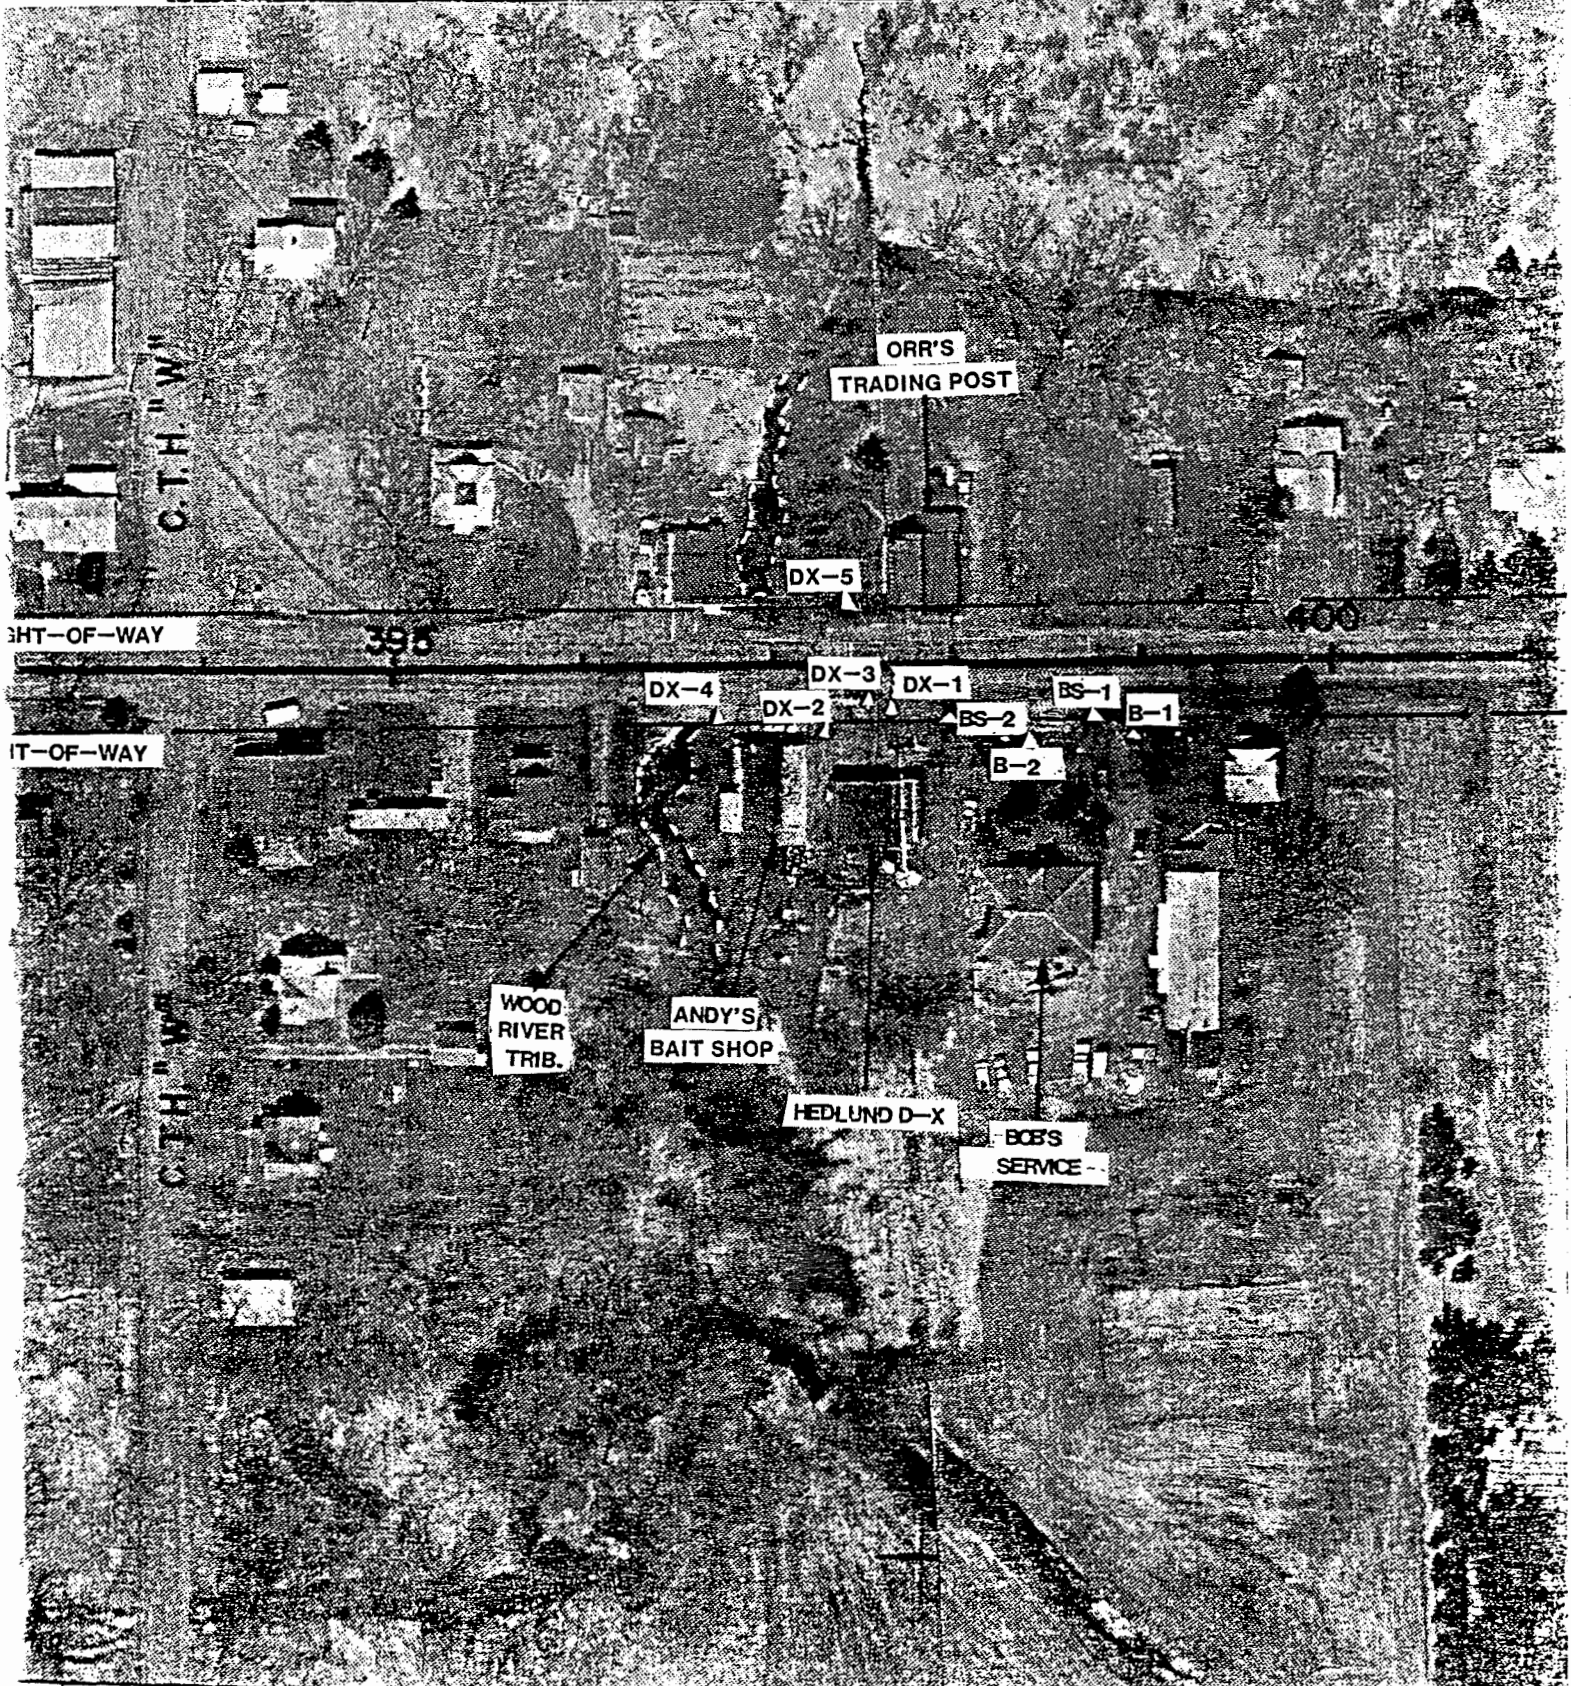
FIGURE 3-1

On June 7, 1990, Aqua-Tech completed three soil borings and collected two subsurface soil samples and two groundwater samples for laboratory analyses. See Figure 3-1 for boring locations.

Boring DX-1	0 - 12 feet
Boring DX-2	0 - 6+ feet (boring terminated at 6 feet)
Boring DX-3	0 - 12 feet
Boring DX-4	0 - 10 feet

Contamination identified within the current right-of-way at the Hedlund DX site extends from the eastern property boundary to a small tributary of the Wood River to the west. It is not known how far contaminated soil extends north. However, cuttings from boring DX-5 completed on the north side of State Highway 70 did not produce PID readings above background levels. If contaminated soil is assumed to extend north to the centerline of State Highway 70, a volume of approximately 900 cubic yards of contaminated

Petroleum contaminated groundwater appears to extend along the entire width of the current WDOT right-of-way in front of the Hedlund DX site and the adjacent Andy's Bait Shop to the west. The small tributary to the Wood River bordering Andy's Bait Shop to the west may be acting as a groundwater boundary preventing further westward migration

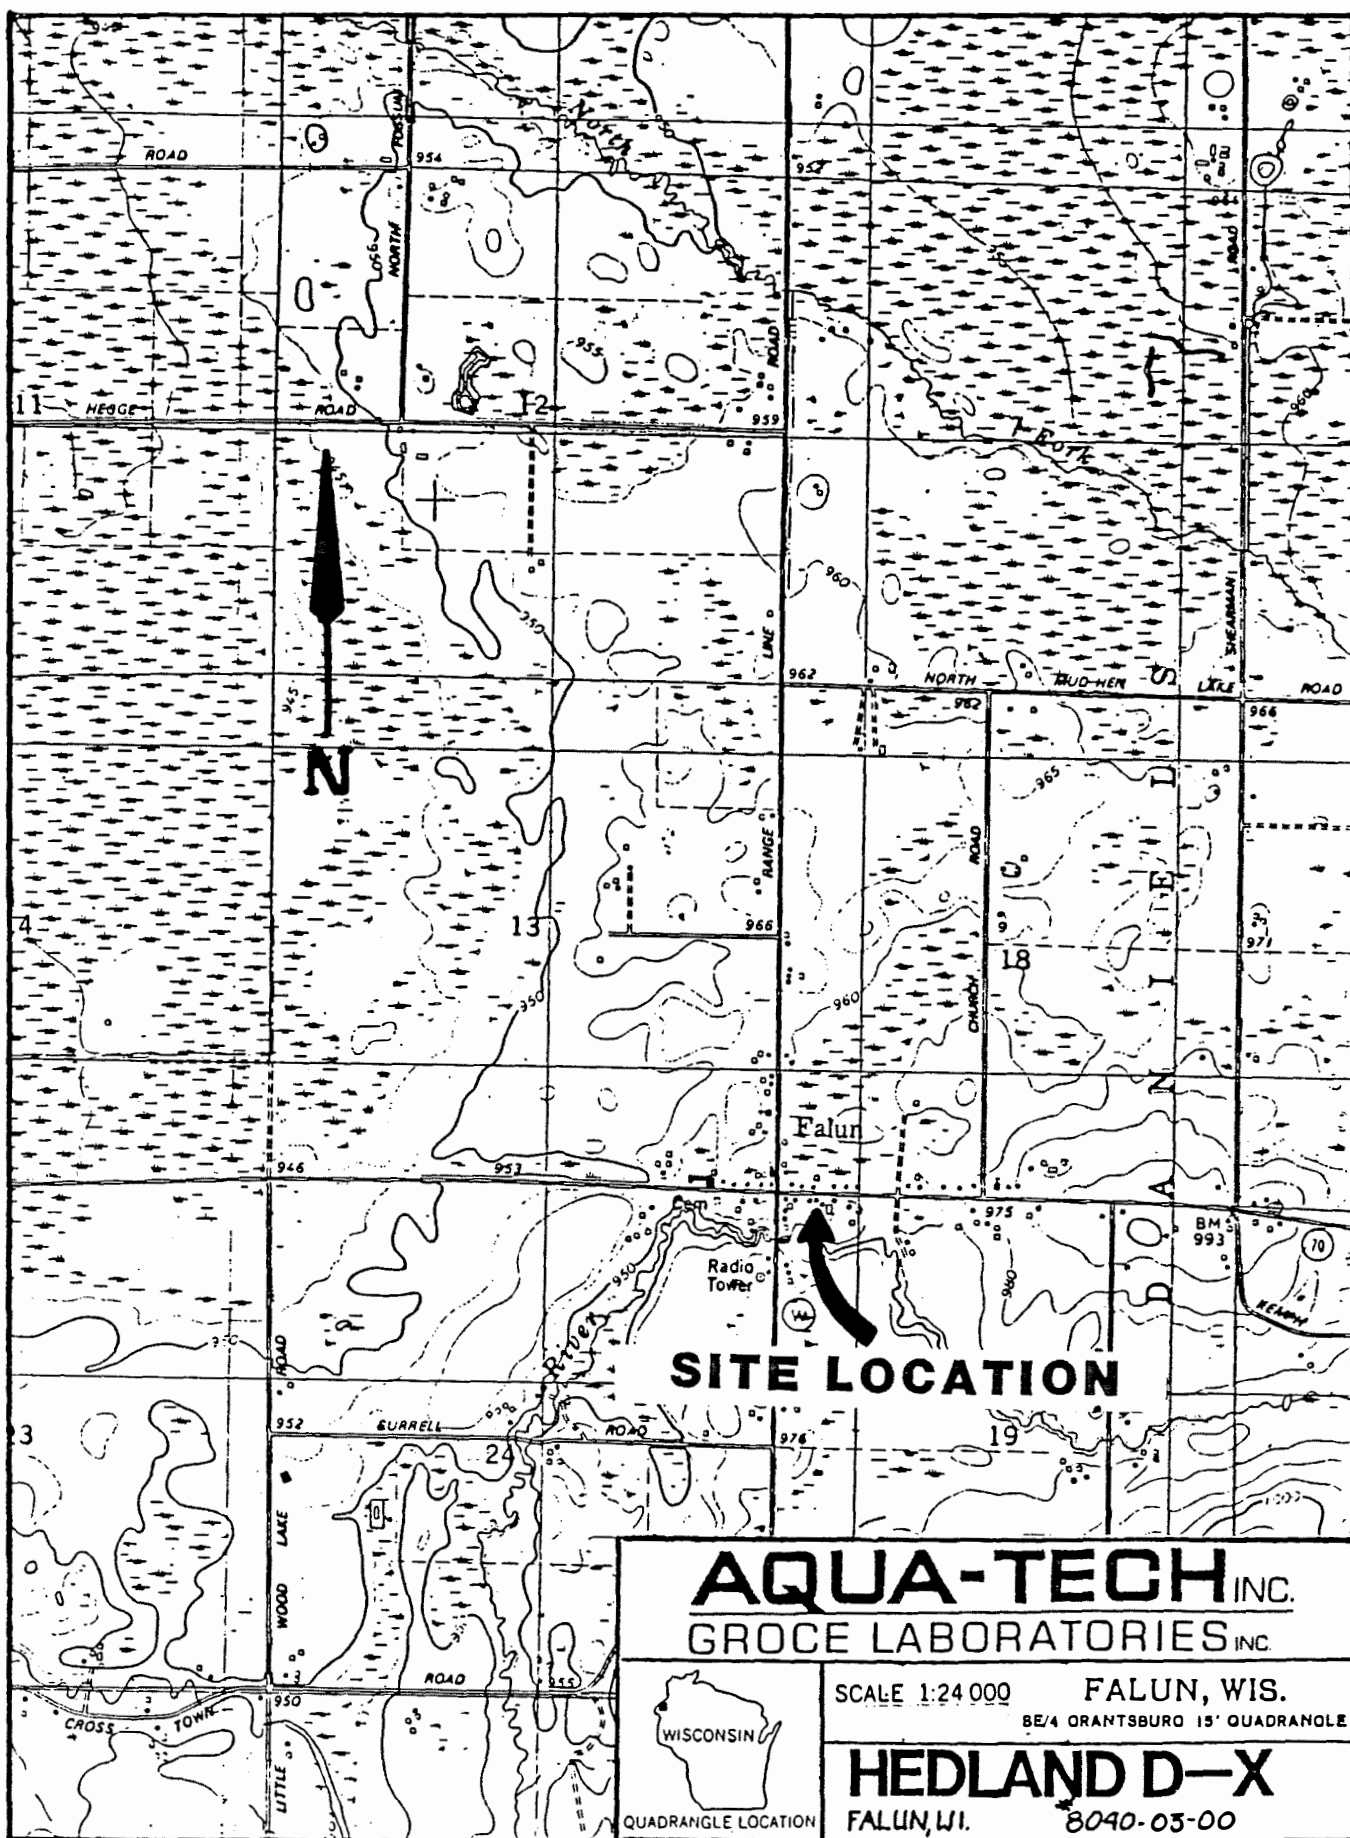
FIGURE 2-1  
SITE LOCATION

The Hedlund DX Service Station is an abandoned vehicle service and gasoline station located on less than one acre of land in the unincorporated village of Falun, Wisconsin. It is located on the south side of State Highway 70 approximately 350 feet east from the intersection of State Highway 70 and Range Line Road in Burnett County, Wisconsin (See Figure 2-1).

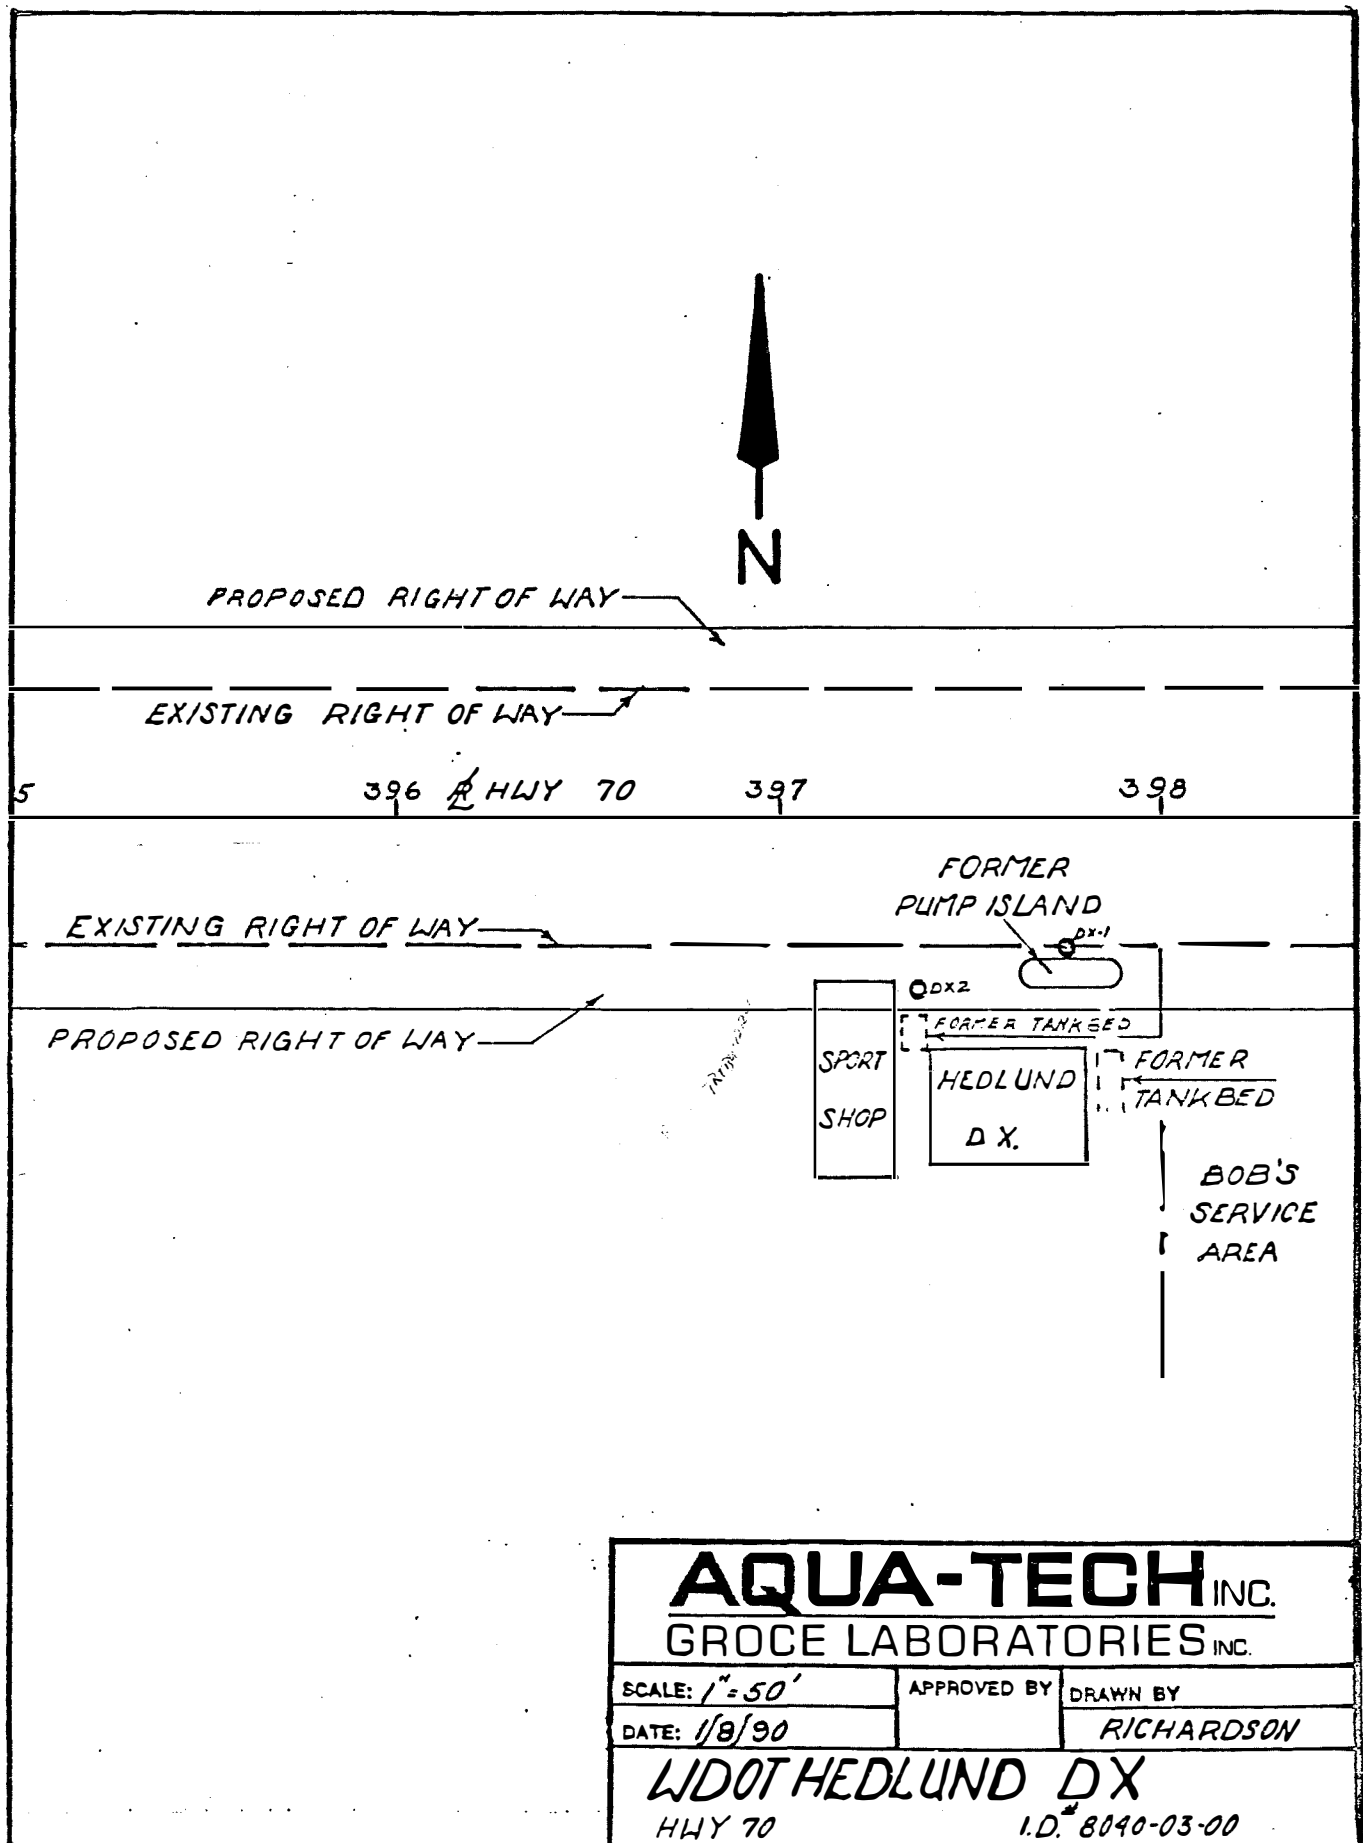
FIGURE 3-1  
SITE FEATURES AND SAMPLING LOCATIONS

Groundwater sample WDX-1 was collected to determine whether any gasoline components had migrated from the tank bed area via groundwater (See Figure 3-1). Samples were collected by inserting a clean stainless steel bailer down the hollow stem augers and transferring the contents to two 40 ml. glass vials. The vials were then sealed, taking care

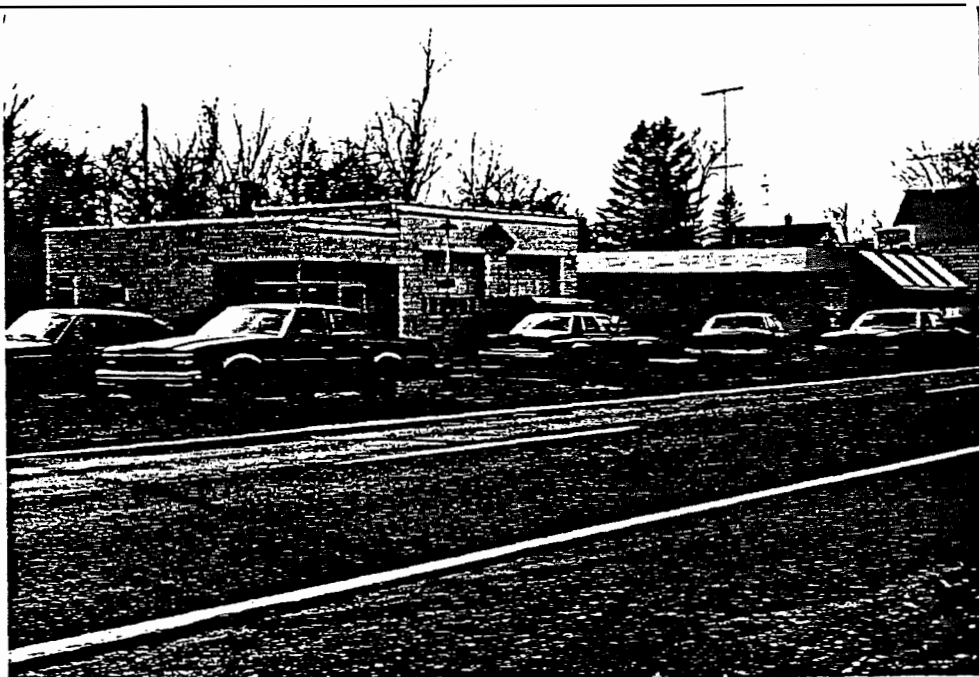
DESCRIPTION: &gt; Hedlund DX located west of Bob's Service Station (not shown)

&gt; Andy's Bait Shop is in the right background.
