**Phase I  
Environmental Site Assessment**

**SAG No. 082  
Former Mellen Mart  
511 State Trunk Highway 77 East  
City of Mellen,  
Ashland County, Wisconsin**

**November 2003**

**AYRES  
ASSOCIATES**

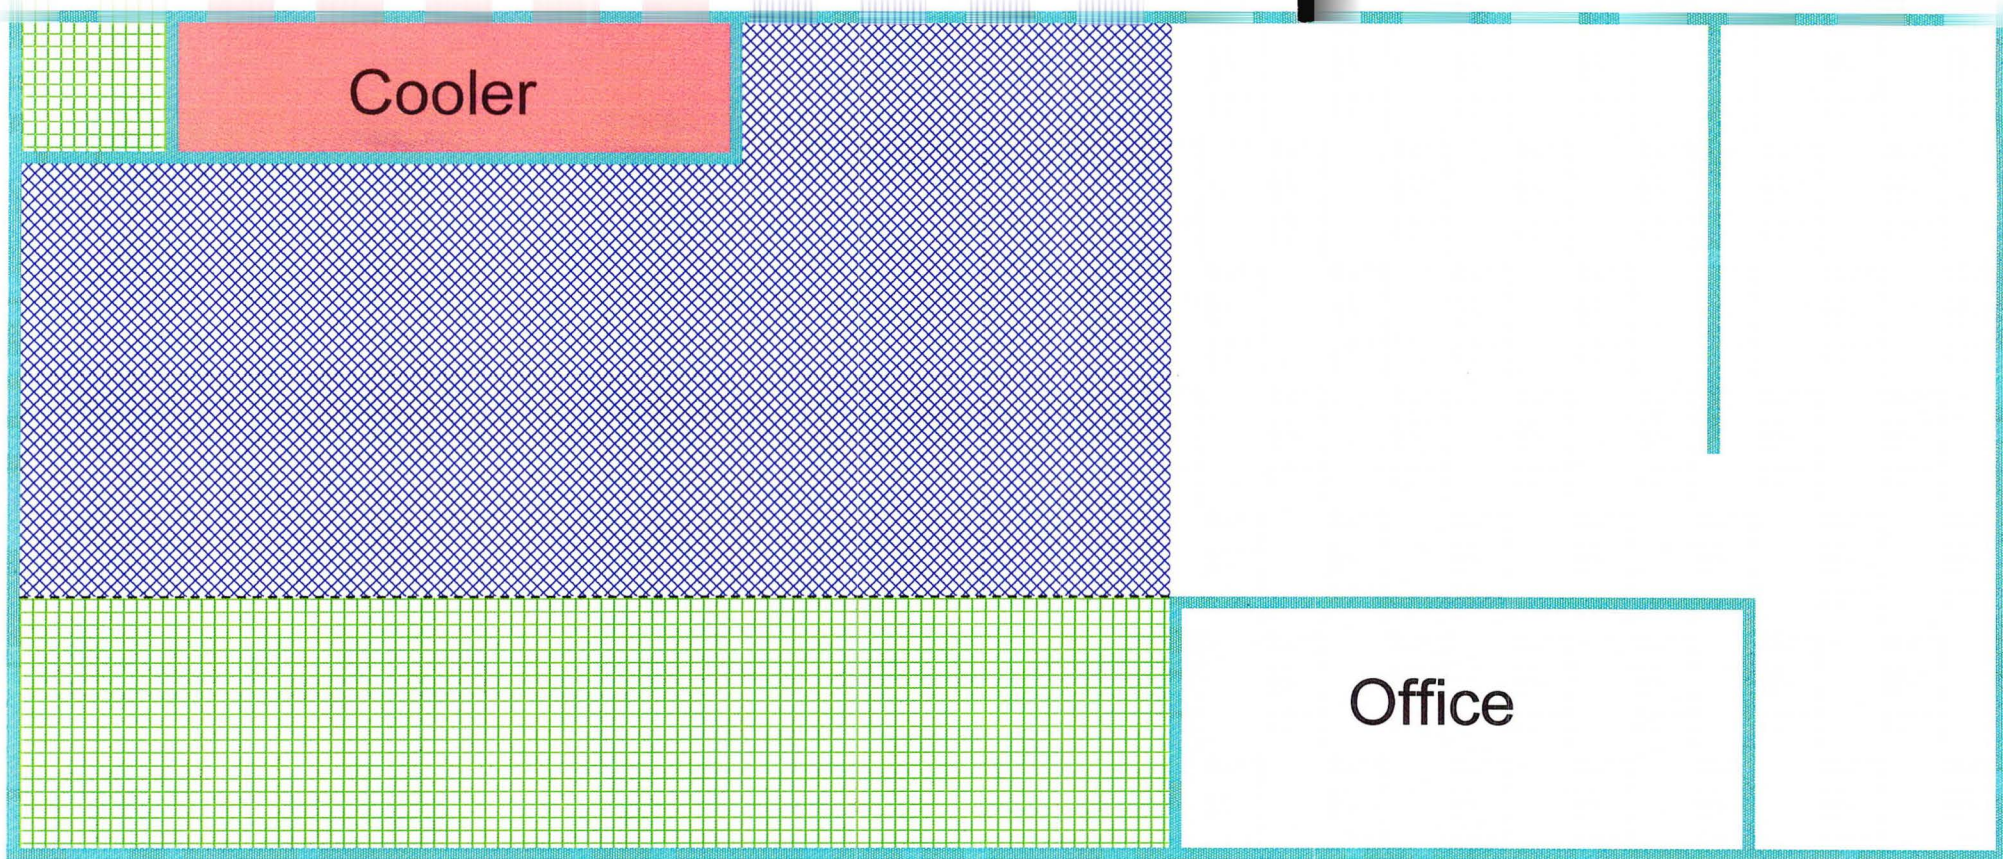
Asbestos-containing linoleum under subfloor

- The septic system will need to be properly abandoned.
- All friable and Category 1 ACM needs to be removed prior to demolition. Due to the quantity of friable ACM, State of Wisconsin regulations require that both the WDNR and Wisconsin Department of Family Health and Services be notified 10 business days prior to the abatement activities. A fee of \$150 is involved with this notification. Other specific recommendations for asbestos removal are in Appendix B of this report.

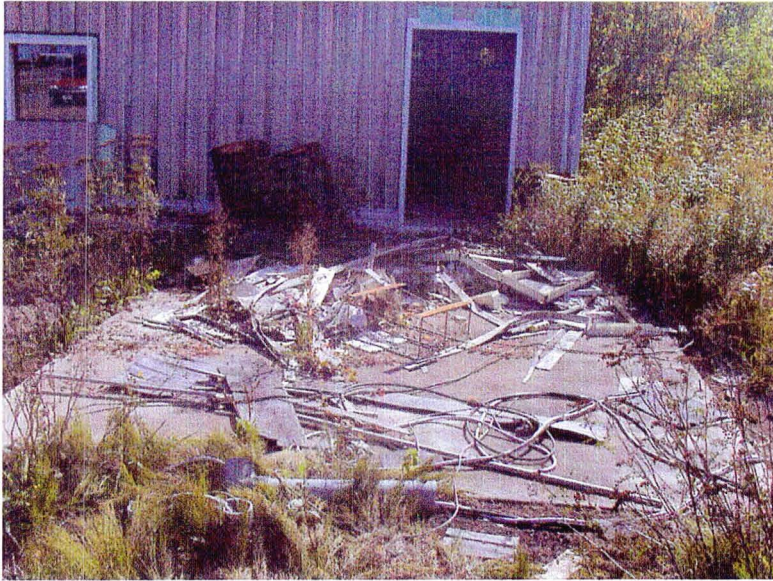
Debris on concrete pad, outside southwest building entrance

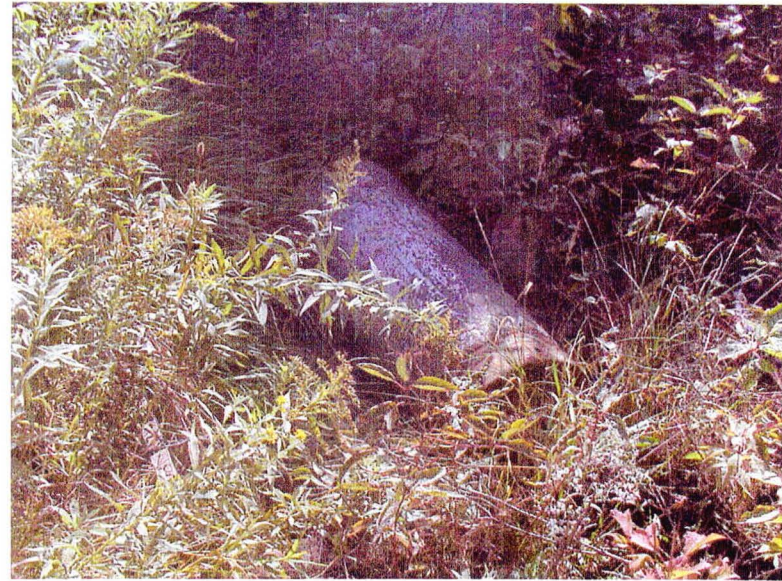
Empty, rusted propane tank in grass along south side

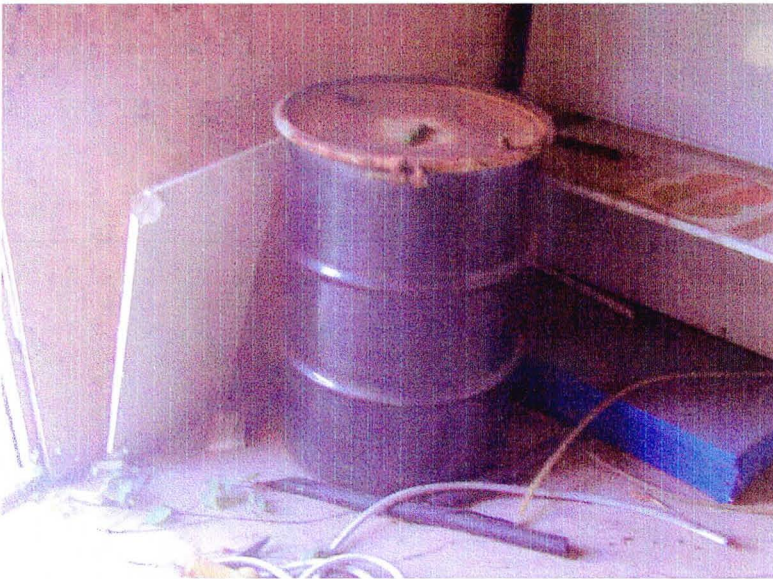
Empty 55-gallon drum inside southwest entrance to building

- The abandoned drums need to be properly disposed. Arrangements should be made as soon as possible for proper disposal. The drums, especially the open drum, pose a threat if they are tipped or damaged.

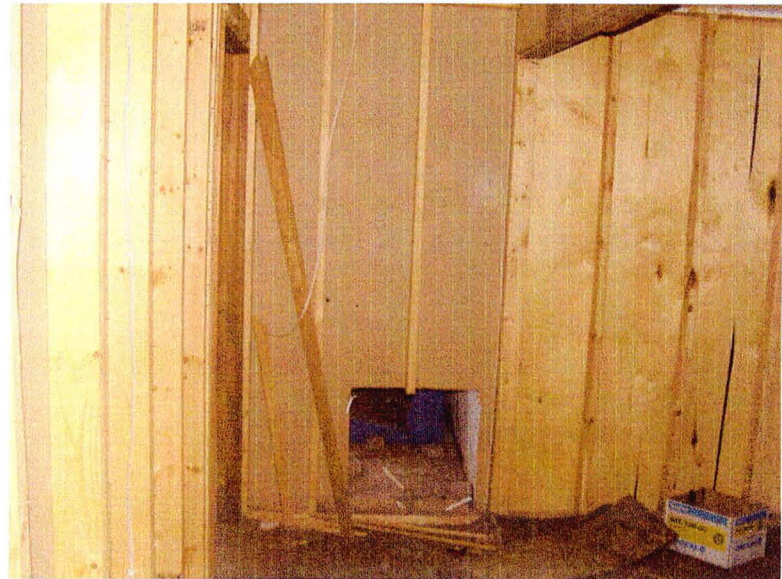
View of possible heater vent hole inside building

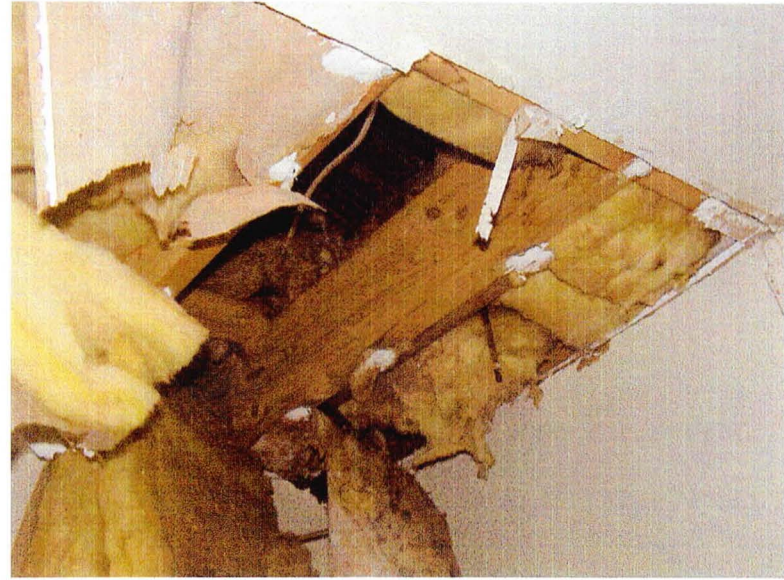
Fiberglass batt insulation inside cooler area

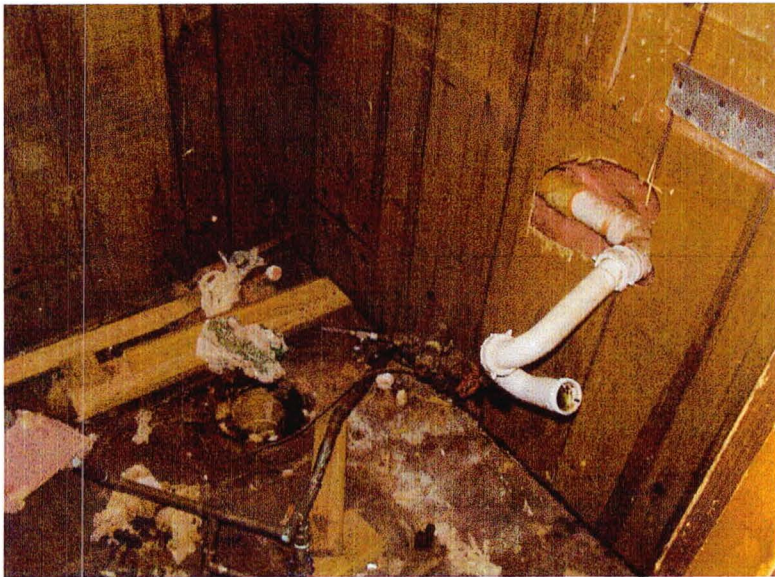
Disconnected bathroom plumbing

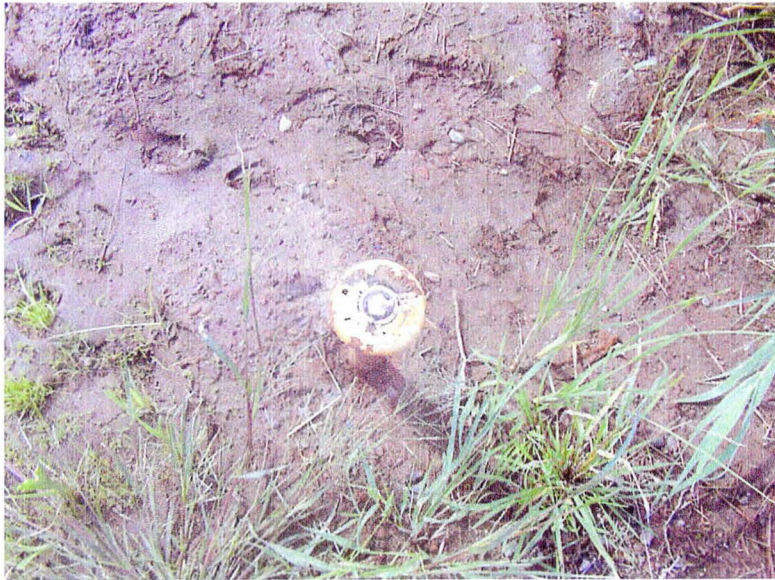
Valve/pipe in grass swale along the NE edge of property

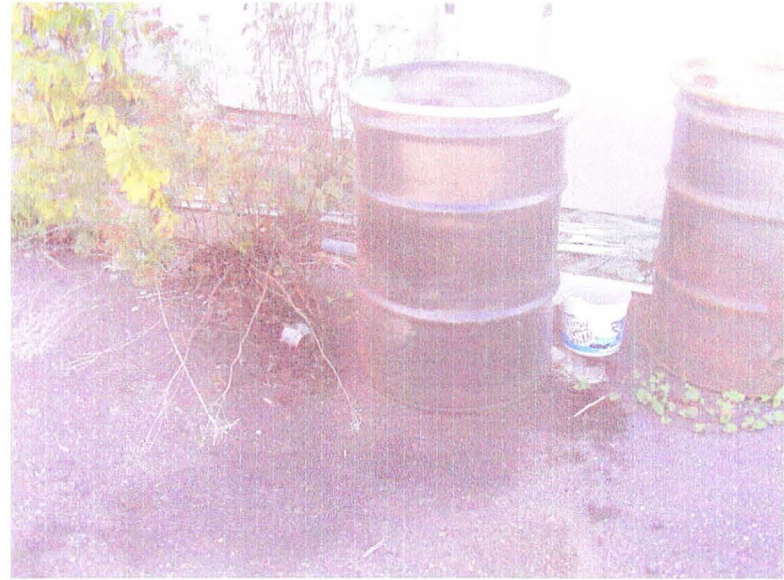
Outside the south entrance of the building were five more 55-gallon drums. Drum No. 2 was open and its lid was partly resting on top of the barrel. The drum was filled with liquid and had a strong petroleum odor. It is assumed the some of the liquid was rain water from the drum being open to the air. Drum No. 6 was full and labeled "diesel." This drum looked newer than the rest of the drums because of the lack of rust. Seven more drums, which contain soil and water, exist on the north side of the building. The soil and water contents were collected in the barrels during tank removal

Barrels nos. 5 and 6 (barrel to left is full and labeled "diesel")

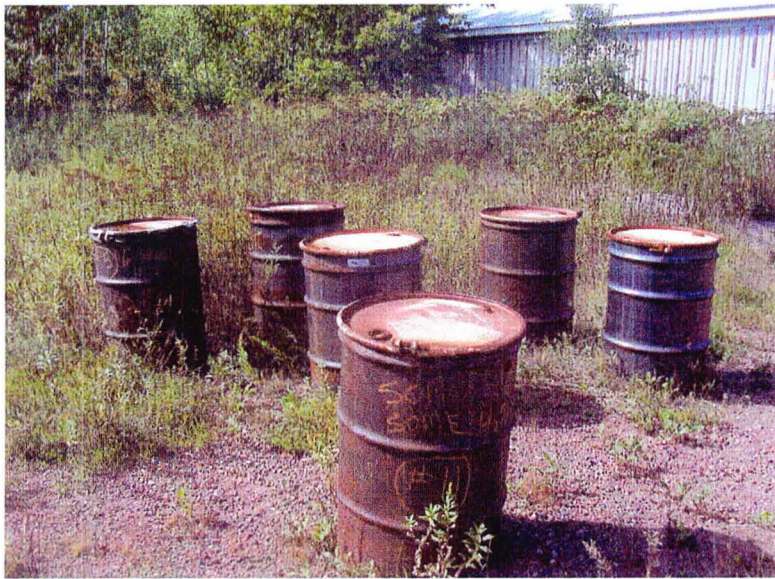
As mentioned previously, 13 drums were found on site. Labels were placed on each of the drums during the site visit. Five of the drums are empty. The drum lids were rusty and could not be removed. Therefore, tapping the drums and trying to move them was used to estimate the volume of the containers. The contents of the full barrels were noted based on the crayon markings from the tank removal. The contractors that placed the soil in the drums marked with crayon the percent of water and soil inside the drum.

55-gallon drums filled with soil and some water along north side

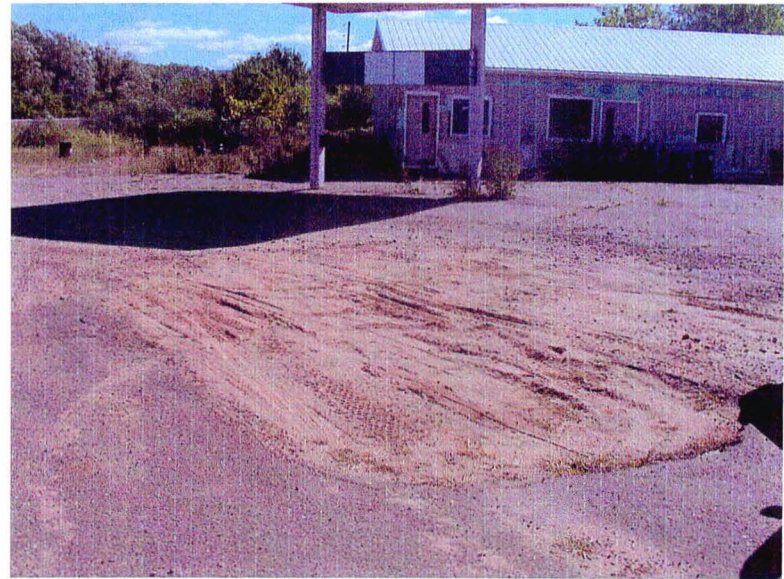
Fill area in former location of USTs
