A REPORT FOR
AN UNDERGROUND STORAGE TANK
CLOSURE SITE ASSESSMENT AT
435 WOODWARD AVENUE
BELOIT, WISCONSIN

PREPARED FOR:
JOHN SHEEHY
THE URSULA BORGERDING ESTATE
1000 EAST DEAN ROAD
MILWAUKEE, WISCONSIN 53217

PREPARED BY
KRISTINE M. STEHR
GEOLOGIST
CBC ENVIRONMENTAL SERVICES
140 EAST RYAN ROAD
OAK CREEK, WISCONSIN 53154

December 11, 1989

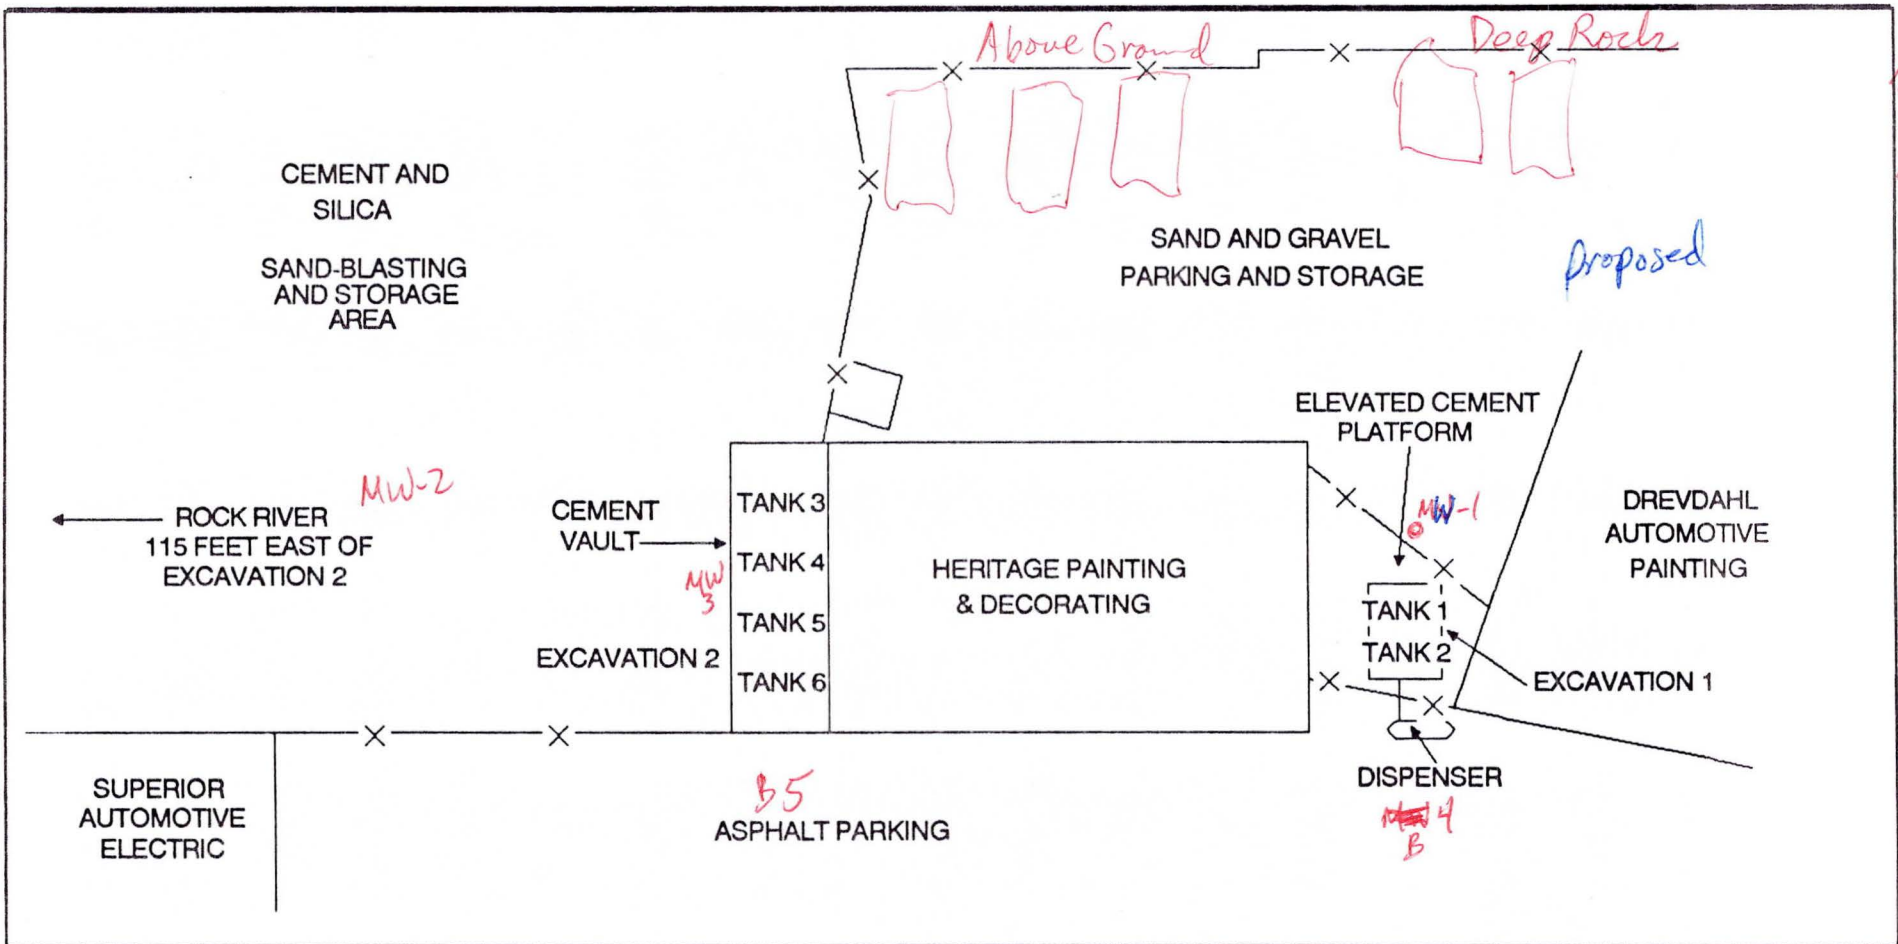
FIGURE 1
SITE PLAN MAP

Autoquip, Incorporated retained CBC Environmental Services to evaluate the soils in the two (2) excavations containing the six (6) underground storage tanks (Figure 1). The investigation was performed to satisfy the Wisconsin Department of Industry, Labor, and Human Relations (DILHR) requirements for soil sample collection and analysis.

The soils surrounding the tanks in Excavation 1 were contained in a cement vault. Composite samples of the excavation soils were collected to represent the north and south ends of the excavation. Additionally, samples from

under the dispenser and piping associated with Tanks 1 and 2 were collected.

Soils surrounding the tanks in Excavation 2 were contained on the base and to the north, south and west by a cement vault that stood two (2) feet above the ground surface. The soils were contained on the east by the west wall of the Heritage Painting and Decorating building. The soils in the excavation smelled strongly of gasoline and in some areas appeared to be coated with an oily substance. Composite samples of the soils were collected to represent the north and south ends of the excavation near the ground surface, and the center of the excavation near the base of the tanks, five (5) feet below the ground surface.

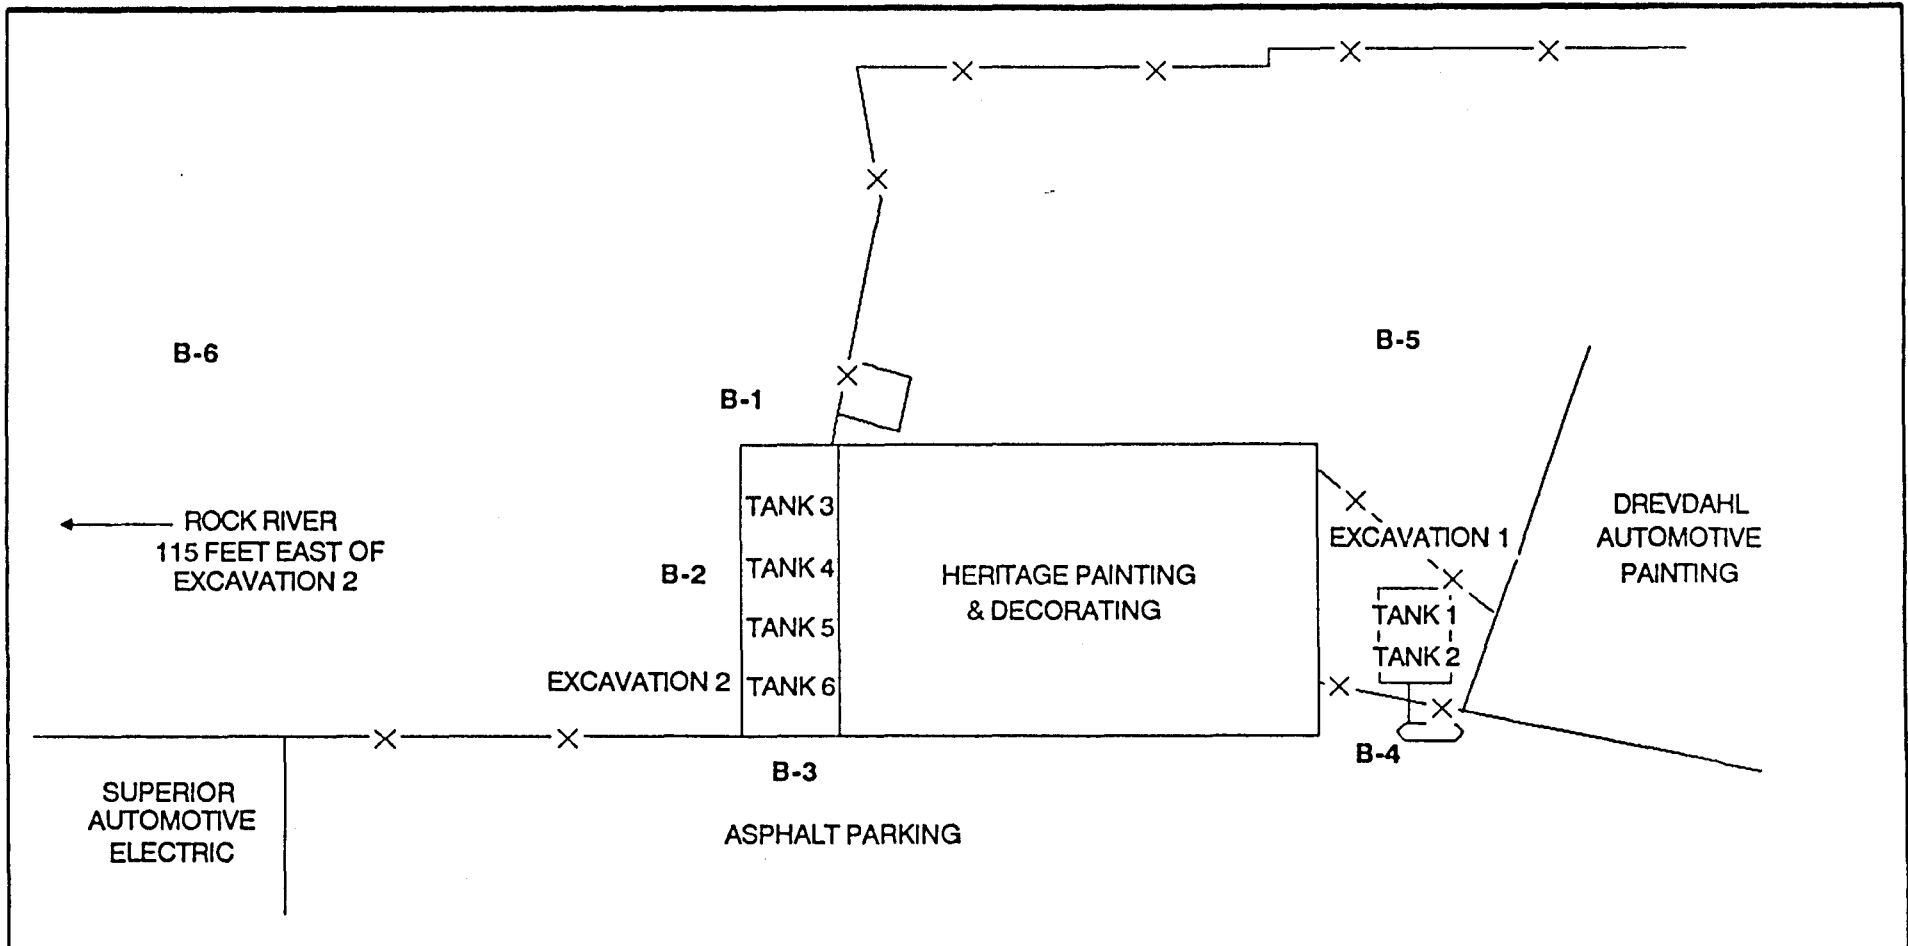
PROPOSED SOIL BORING LOCATIONS

- 1) evaluate the extent of contamination around Excavation 2 (borings B-1, B-2 and B-3),

- 2) determine if the soils around the dispenser at Excavation 1 have been impacted by the operation of underground storage tanks 1 and 2 (B-4),

- 3) investigate the impact of the May 24, 1984 documented gasoline spill on the subject property (B-5),
 - 4) determine if the contamination has migrated toward the Rock River (B-6).

The presence of volatile compounds detected in the soils of Excavation 2 warrants further investigation. The concentrations of benzene, toluene and xylene detected in the water in Excavation 2 require remedial action. CBC Environmental Services recommends a hydrogeologic investigation to determine the vertical and lateral boundaries of the contamination. The investigation will include the following scope of work:

- * Six (6) boreholes will be drilled to a depth of twelve (12) feet below the ground surface or to a depth at which uncontaminated soils are found. If ground water is encountered before a depth of fifteen (15) feet is reached, augers will be advanced five (5) feet below the ground water table for the purpose of installing monitoring wells.
