June 7, 2023

Former V&L Stripping
Vapor Mitigation System – Operation and Maintenance Plan
864 Mather Street
Green Bay, WI 54303
BRRTS #02-05-216722

D.1 VAPOR MITIGATION SYSTEM MAINTENANCE PLAN

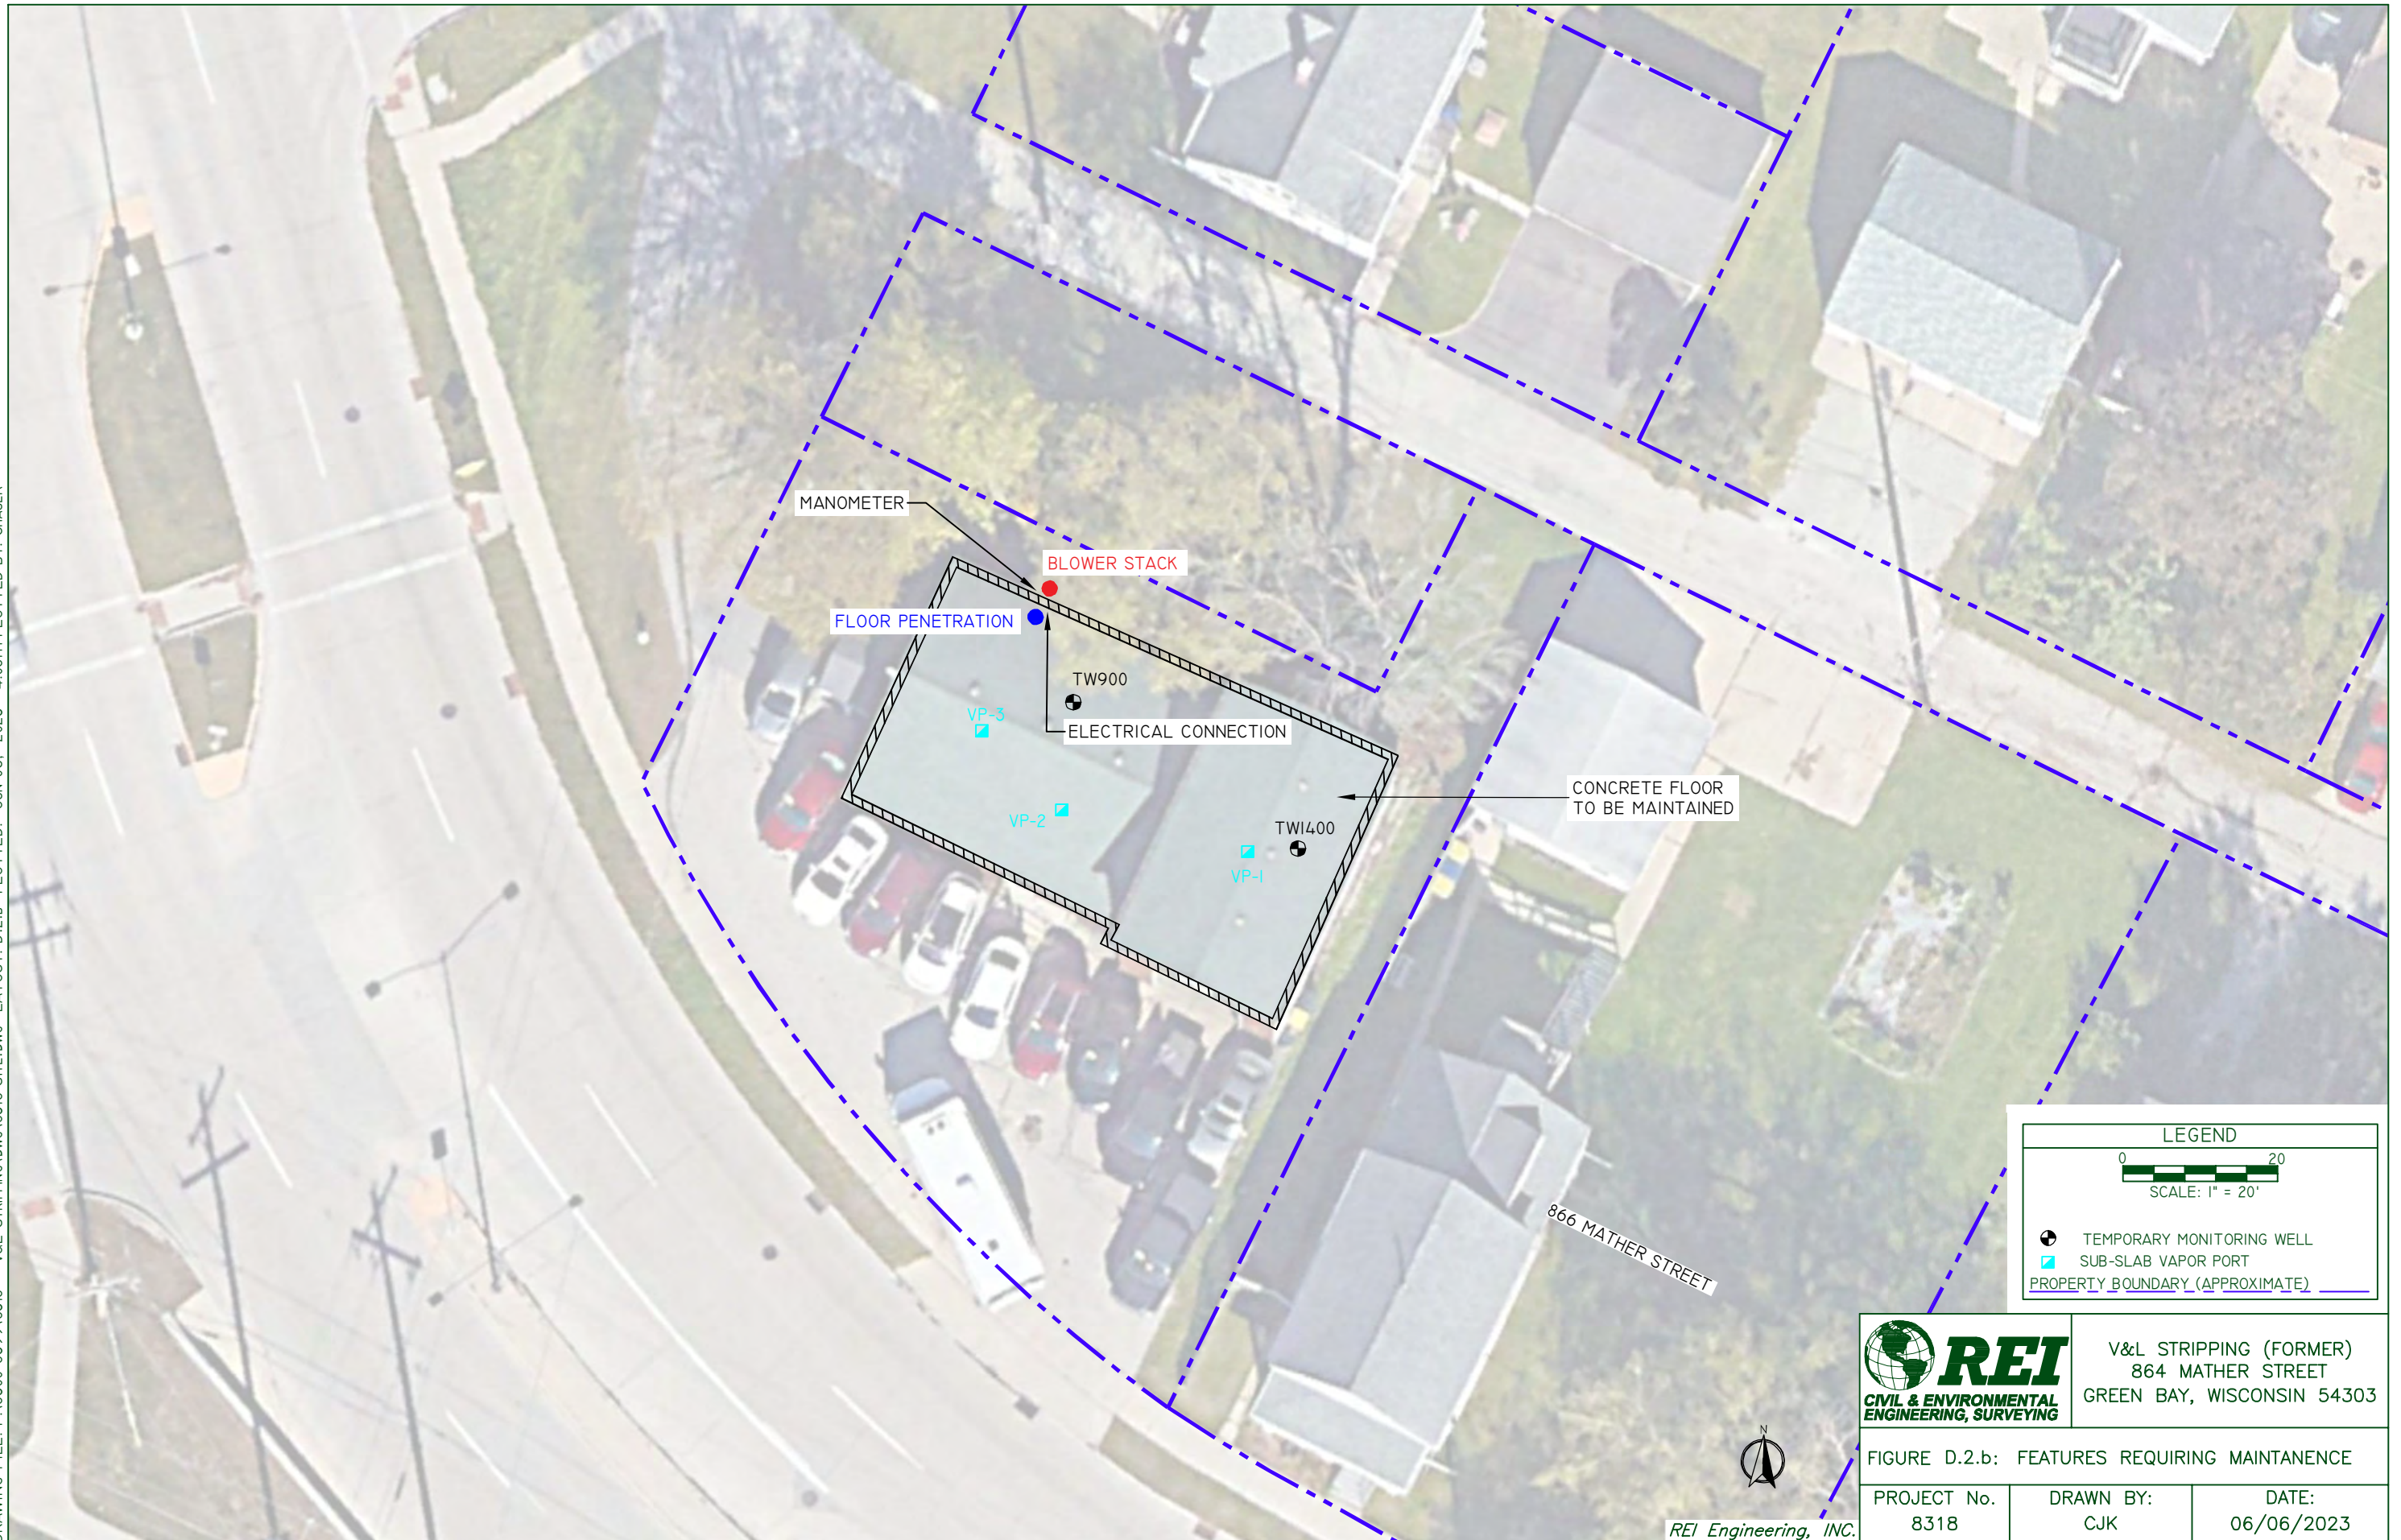
FIGURE D.2.b: FEATURES REQUIRING MAINTENANCE

The system layout and concrete floor requiring maintenance is shown on Figures D.2.b and D.2.c. Manufacturers specifications are attached. If problems are noted during the annual inspections or at any other time during the year, repairs will be scheduled as soon as practical. Repairs would be necessary if the following items are not found satisfactory during inspection:

- Sealing of cracks and penetrations in the concrete floor
- Blower replacement (with similar CFM or higher model)
- Electrical cord replacement
- Outlet replacement
- Manometer replacement

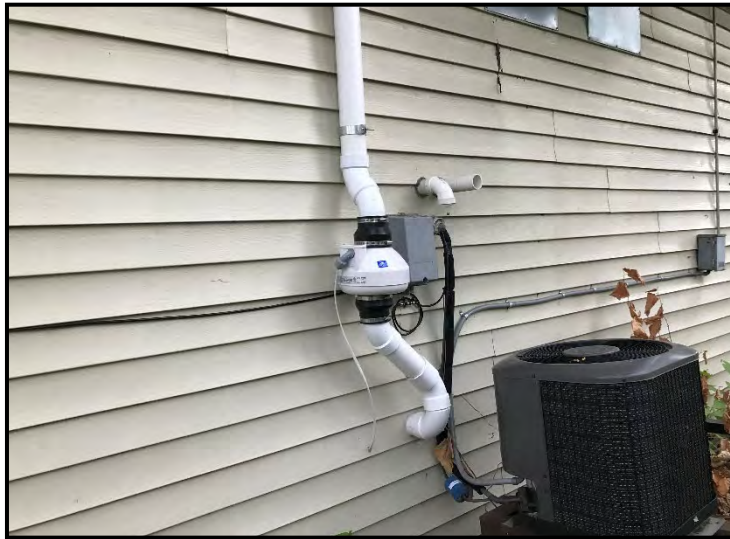
Fan location - near northwest corner of building

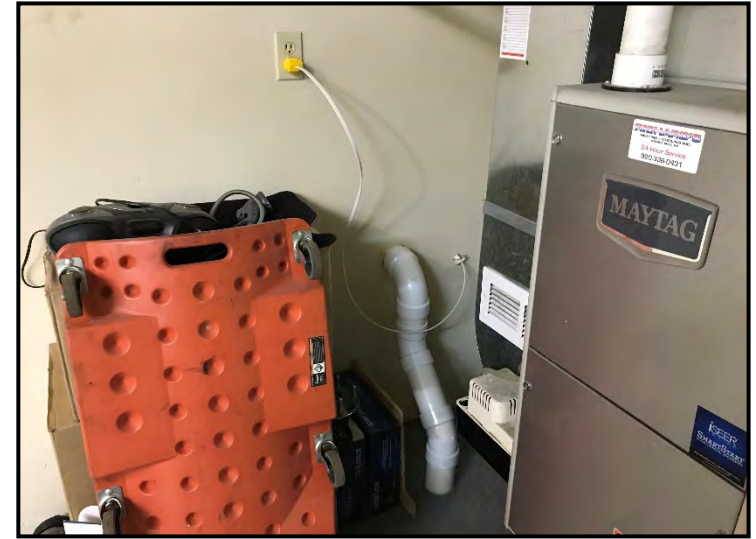
Vacuum point and power source

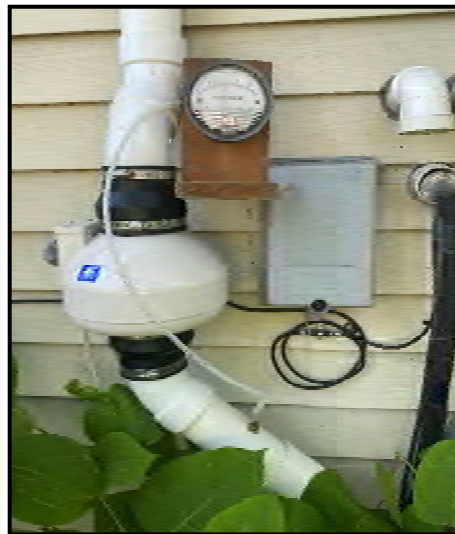
Vacuum gauge

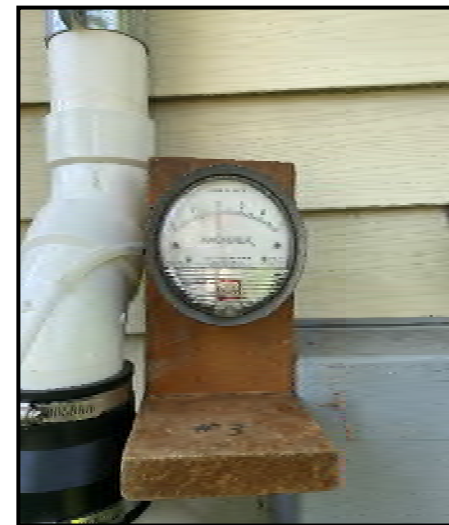
2" of water column

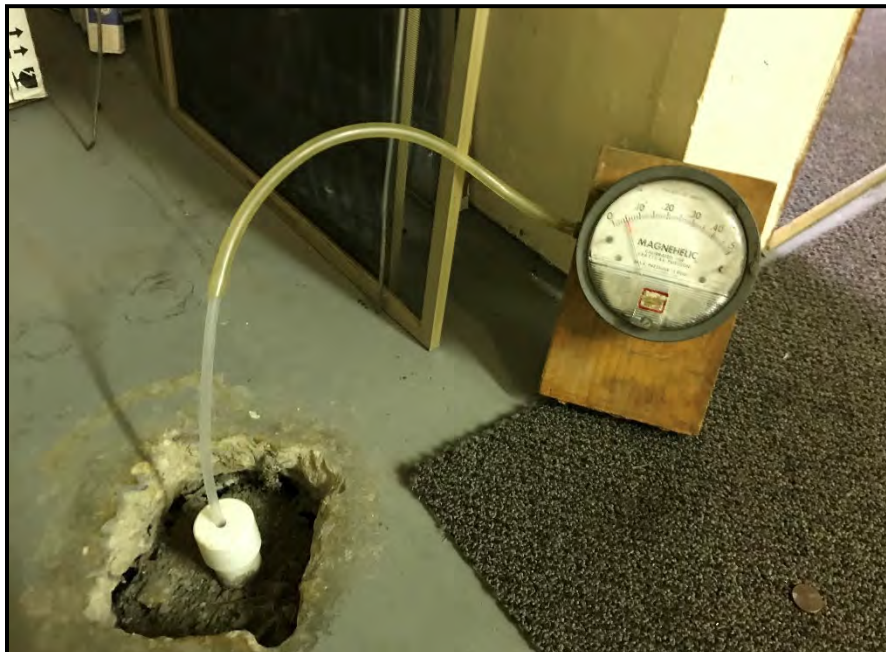
A 0.0-0.5 inches of water Magnehelic vacuum gauge was used to detect sub-slab vacuum from temporary wells TW900 and TW1400 within the building. Low level vacuum (0.05 inches of water) was recorded in TW900, adjacent to the vapor mitigation system, and 0.01 inches of water at TW1400. Photographs of conductivity testing are included in D.3 of the VMS Maintenance Plan.

Vacuum at TW900- 0.05" water

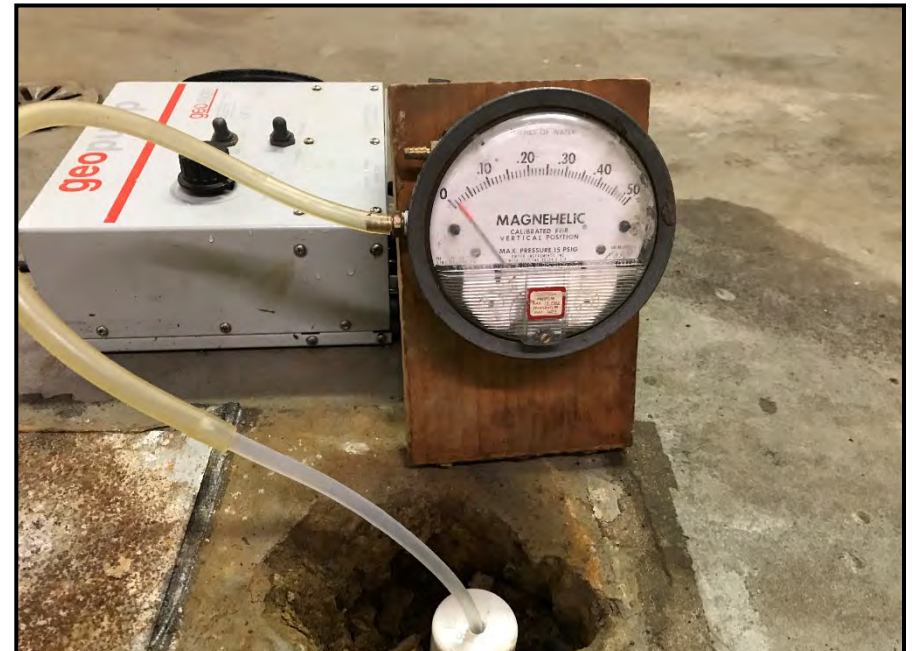
Vacuum at TW1400 - 0.01 " of water

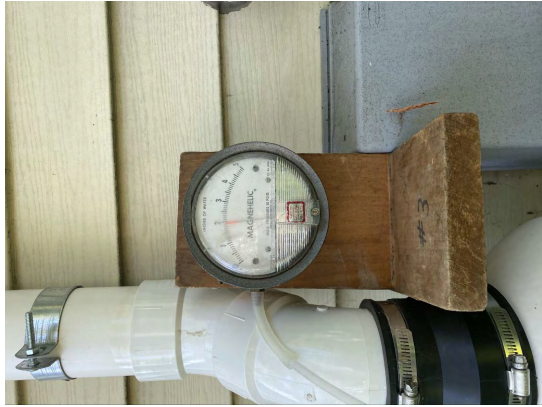
| SYSTEM COMPONENT | | | | Date of Inspection: |
|--|--|---|--|---|
| <p>PHOTO</p> | | | | <p>NOTES: (Record the reading on the gauge. Identify specific building and location description:)</p> <p><input type="checkbox"/> Not Applicable</p> <p>Exterior adjacent to fan. Vacuum = 2" of water</p> |

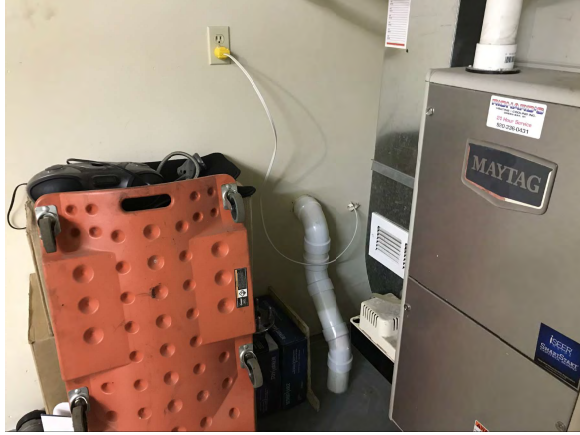
| SYSTEM COMPONENT | | Date of Inspection: | | |
|---|---|---|--|--|
| PHOTO | | <p>NOTES: (Identify specific building and location description:)</p> <p><input type="checkbox"/> Not Applicable</p> <p>Suction point near northwest corner of building</p> | | |
