MEMORANDUM

SUBJECT: Preliminary Site Evaluation (Updated 4/20/2020)

One Hour Martinizing/Jim's Music Site

1233 South Military Road, Green Bay, Wisconsin

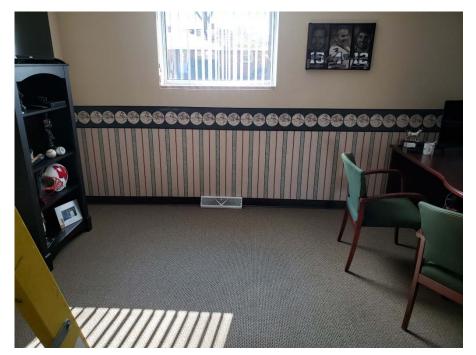
- 1. The air ducts under the floor of the Edward Jones unit 1239 could provide a pathway for vapor migration into the building if they are not well sealed. These appear to be supply ducts, so they would be expected to be under pressure when the furnace is operating. Median indoor air Gasmet PCE concentrations ranged from 0.14 to 0.25 ppm. These concentrations are significantly higher than the March 16, 2020 PCE laboratory result for indoor air sample AA6, reported at 0.043 ppm.

Photo 1: Edward Jones back office wall with floor register (4/2/20; 10:08).

- 1. Consider internally sealing the heating ducts below the floor in the Edward Jones unit (#1239) using a process such as provided by Aeroseal.
- 2. Complete sub-slab vapor mitigation in the buildings with basements will likely not be possible without additional dewatering because the basement floor, at least at the Jim's Annex, appears to be at the water table. Basement floor elevations should be compared to water levels measured in the monitoring wells to confirm that this is the case.

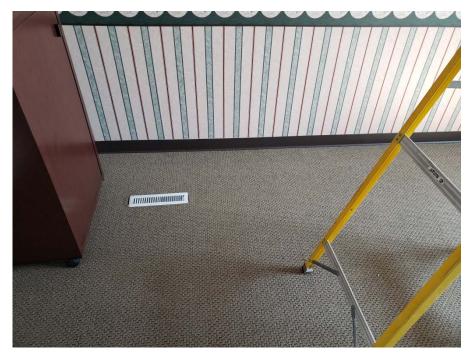
Photo 2: Edward Jones back office with floor register 4/2/20; 10:08).

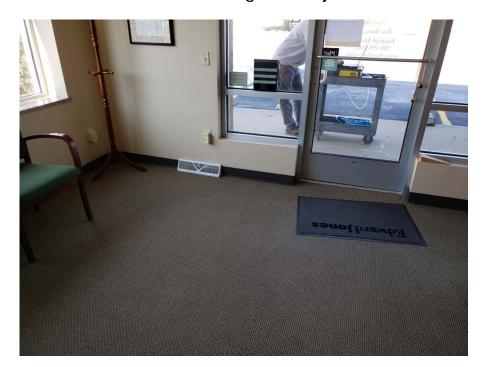
Photo 3: Edward Jones front reception area with floor register (4/2/20; 10:09)

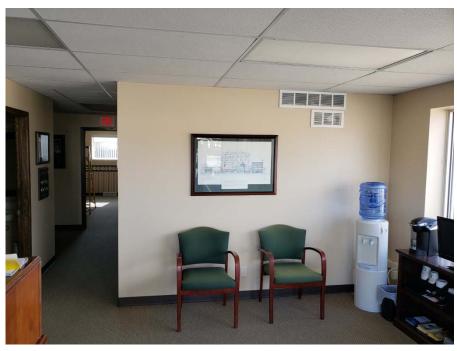
Photo 4: Edward Jones wall registers outside HVAC room 4/2/20; 10:09).

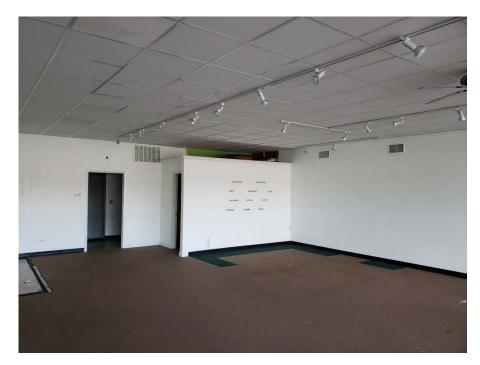
Photo 5: Former Williams Tae Kwon Do (unit 1235) back and south walls with HVAC vents near ceiling (4/2/20; 10:50).

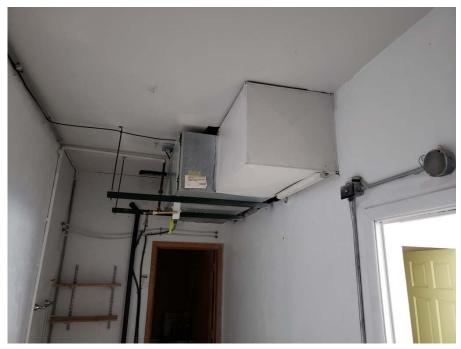
Photo 6: Unit 1235 – HVAC unit in back room. Bathroom is through door below HVAC unit 4/2/20; 10:15).

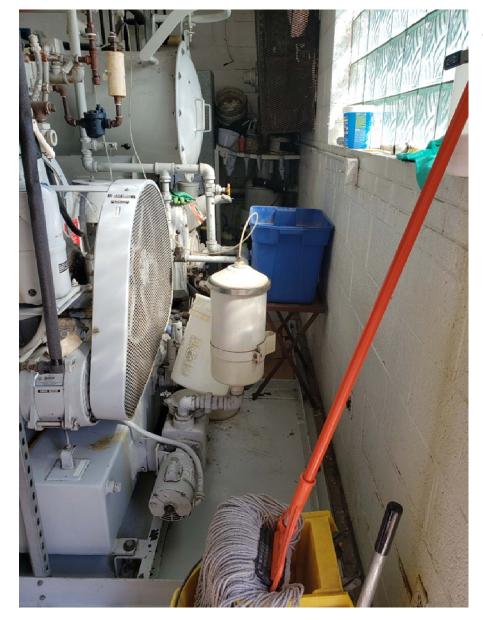
Photo 7: Back of dry cleaning machine in unit 1233 (4/2/20; 11:13).

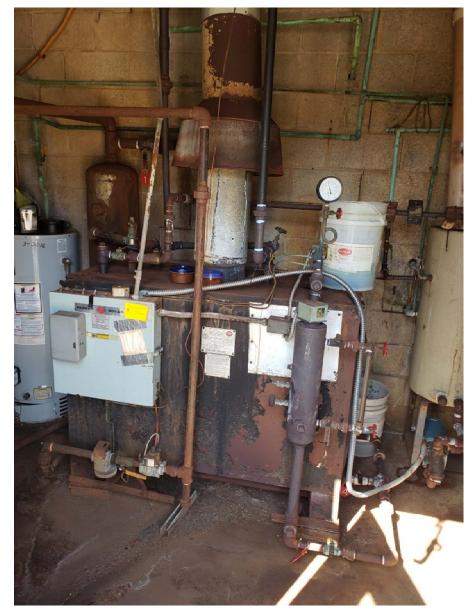
Photo 8: Boiler at back of dry cleaner (unit 1233), 4/2/20; 11:13).

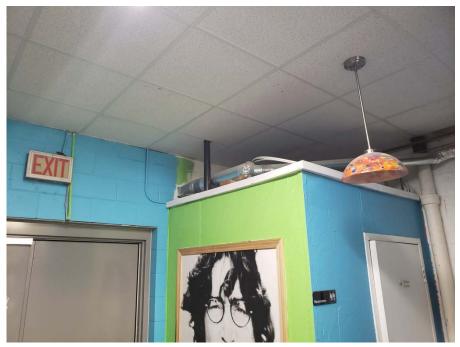
Photo 10: Plumbing vents (black 2" ABS and white 4" cast iron) at rear bathroom, Jim's music (4/2/20; 12:29).

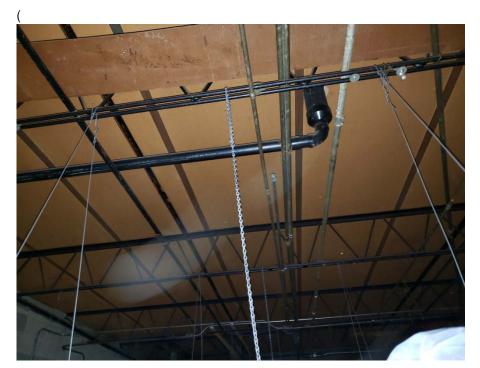
Photo 11: Interior view of plumbing vent with high PID result, Jim's Music (4/2/20; 12:30).

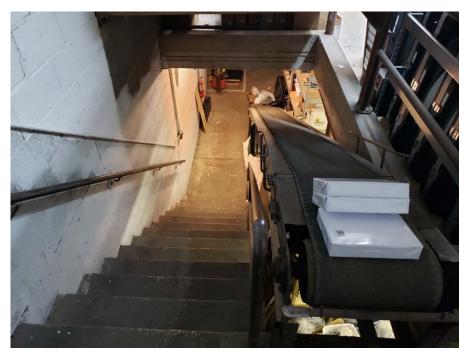
- 5. Neither of the basements in the 1219 or 1231 units are well sealed to prevent migration of vapors from the basements up to the ground floor. The stair opening to the basement of the 1219 building is 6 feet wide and 10.5 feet long and is not equipped with any kind of closure or fire door.

Photo 12: Stair opening to basement, Jim's Music (4/2/20; 12:39)

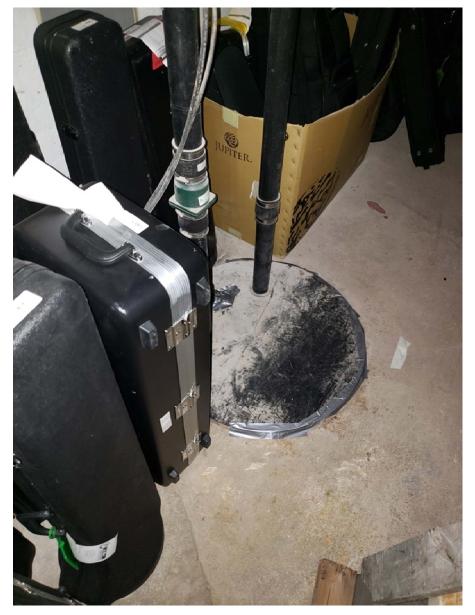
- 6. None of the sump lids appear to be particularly well sealed, although the sumps in the 1231 basement appear to be in worse condition than the 1219 sumps. All of the sumps are relying on duct tape to prevent migration of vapors from the sumps into the basement. Gasmet readings were collected in the air space above the sumps, but no readings were collected within the sumps.

Photo 13: Sump at back wall of Jim's basement adjacent to water and sewer connections to street (4/2/20; 12:34).

- 1. Limit occupancy of the Jim's Annex (unit # 1231) and keep the connecting door closed.
- 2. Thoroughly seal the basement sump covers using methods appropriate for radon mitigation.
- 3. Seal the beam pocket opening in the south wall of the annex basement.
- 4. Repair as necessary, close, and to the extent possible, seal the doors in the stairs leading to the annex basement.
- 5. Monitor the operation and effectiveness of the carbon filtration unit in the showroom.
- 6. Conduct private utility locate to evaluate extent of underground utilities which may act as preferential pathways for contaminant migration.
- 7. Continue to operate the air filtration unit in Jim's Music (unit 1219).

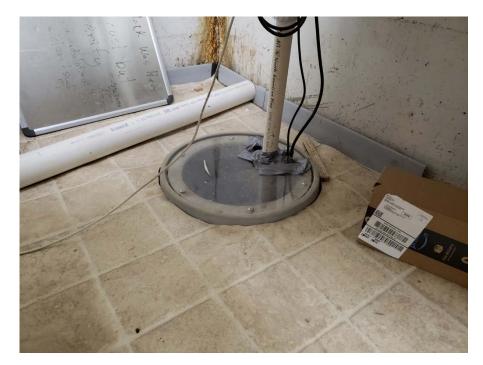
Photo 14: Sump at NW corner of Jim's basement in office area (4/2/20; 12:51).

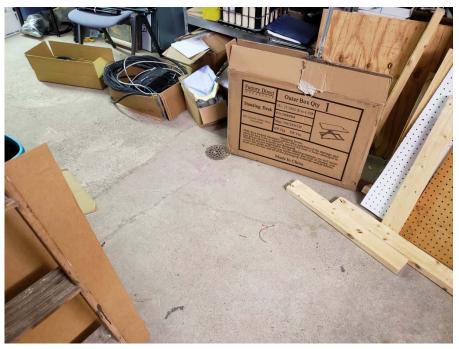
Photo 15: Floor drain in Jim's basement near stairwell (4/2/20; 13:01).

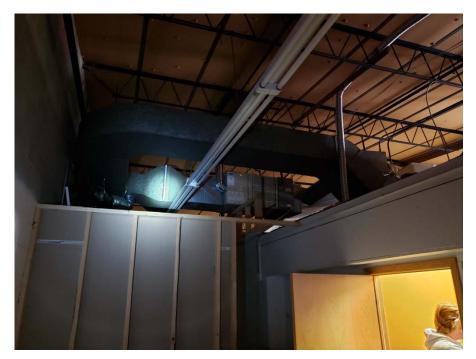
Photo 16: HVAC unit in ceiling of Jim's annex (4/2/20; 13:34).

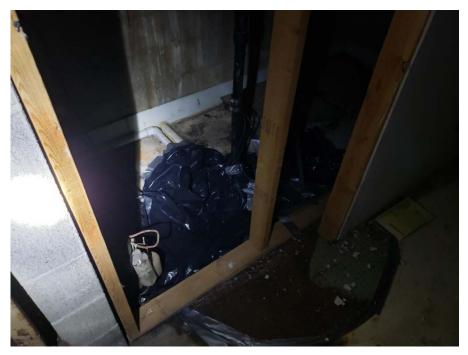
Photo 17: Sump at back wall of Jim's annex (4/2/20; 13:37).

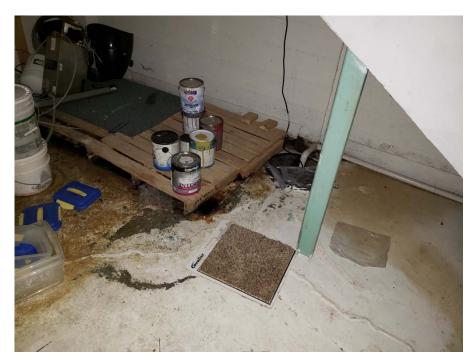
Photo 18: Sump near NE corner of Jim's annex basement (4/2/20; 13:53).

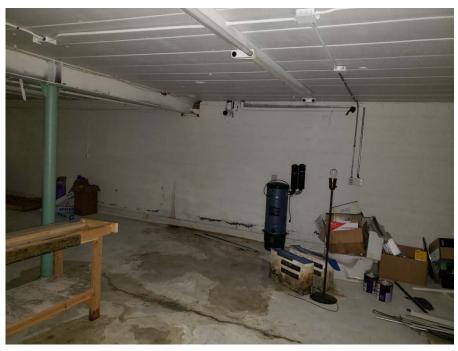
Photo 19: Water on floor in basement of Jim's annex (4/2/20; 13:52)

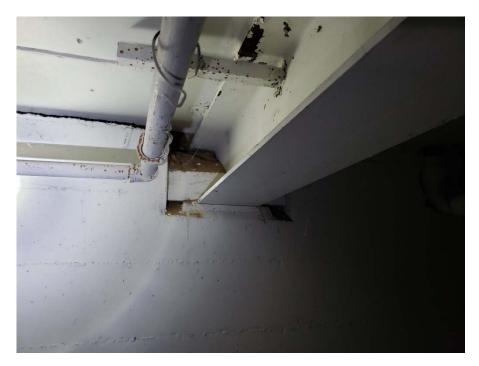
- 7. The basement below the 1231 unit extends only about 2/3 the width of the unit. Based on the high readings obtained at the un-sealed beam pocket in the south basement wall, it appears that PCE vapors are present in the soil directly below the floor slab of the southern 1/3 of Jim's Music annex. The highest Gasmet readings in the annex were located closest to the south wall.

Photo 20: Beam pocket in south wall of Jim's annex basement 4/2/20; 13:53).

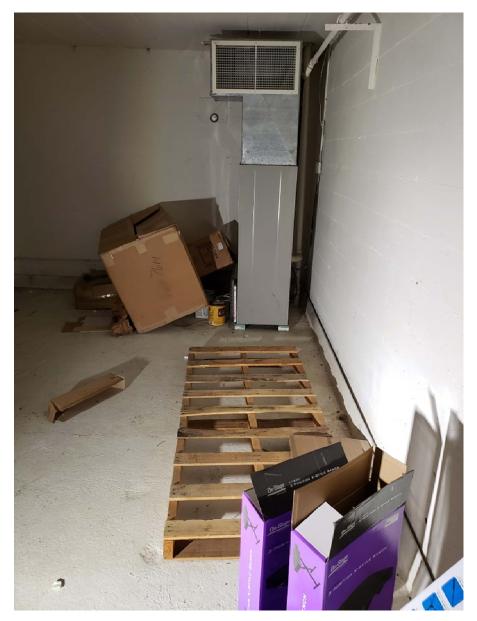
- 8. The basement exhaust fan in 1219 and the heating unit in 1231 may be contributing to negative pressure inside the buildings and may be helping to draw in vapors.
- 9. The ambient temperatures during our inspection were in the mid to upper 50s and the ground was most likely at least partially thawed, so vapor pathways and stack effects were likely different than when the previous sampling was completed in early March 2020.
- 10. The highest PID reading on the roof, by far (over 10,000 ppb), was obtained at a 4-inch plumbing vent on the roof of Jim's Music, unit 1219. This vent appears to originate at the restrooms at the rear of the building and may extend to the sewer in the basement. The source of these vapors was not conclusively identified, but may be related to sump pump discharges to the sanitary sewer in the basement.

Photo 21: Heating unit in Jim's Annex basement (4/2/20; 13:57).

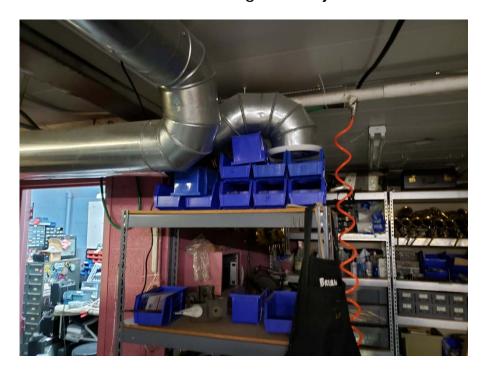
Photo 26: Exhaust fan inlet and ducting in Jim's basement (4/2/20; 15:59).

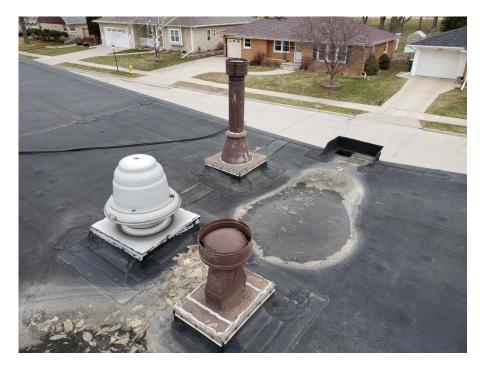
Photo 30: Bathroom fan vents (rusty) and basement exhaust fan (gray) at common wall between 1231 and 1219 units (4/3/20; 14:32).

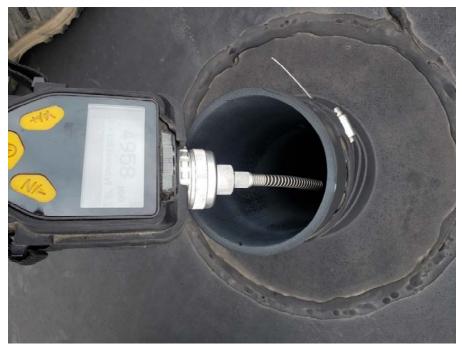
Photo 31: Plumbing vent in roof of 1219 unit with elevated PID reading (4/3/20; 14:36).

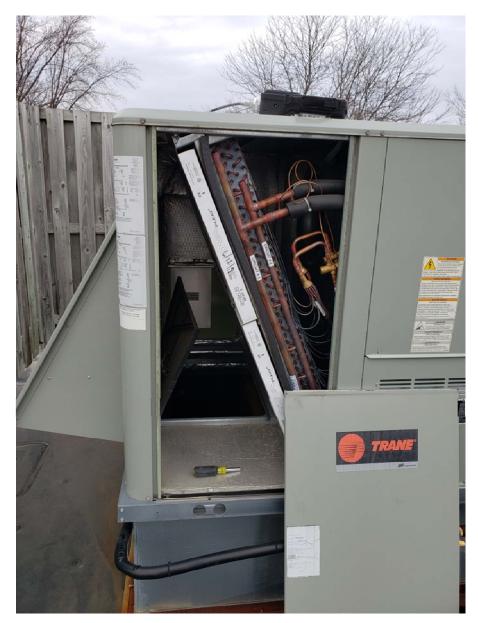
Mr. Oelkers made a more detailed inspection of the roof-top HVAC unit that serves the 1219 space. This unit is a combined heating and air conditioning package with the condenser attached. The unit is equipped with a damper that allows either return air from the building or external air to be drawn through the cooling coils or heater. This unit is the only HVAC appliance observed at the building that can pull outdoor air into the building.

Photo 32: Roof-top HVAC unit at Jim's (unit 1219) showing damper for indoor return air (4/3/20: 14:45).
