Subject: Response to Vapor Mitigation System Documentation and Additional Actions Needed
One Hour Martinizing, 1233 South Military Avenue, City of Green Bay, Wisconsin
BRRTS # 02-05-217270

Interim Action Design Concerns

Photographic Log

Sub-slab Vapor Mitigation System Installation
Innovative Properties
Military Avenue, Green Bay, WI

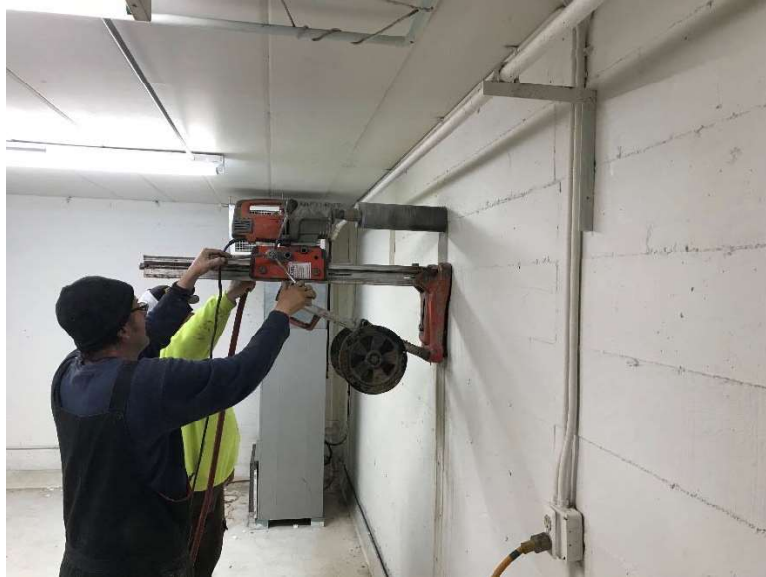
Photo 5. Installation of south basement vacuum extraction points.

- a. Photos 5, 8, 14, 15, and 16 of the June 2020 VMS Report show what appears to be perimeter channel drains and/or a floor-wall joint crack. Some form of testing (e.g. smoke testing, tracer gas testing) should be performed to ensure venting of sumps is not short-circuiting and pulling indoor air into the system. If this is occurring, it could potentially be causing additional negative pressure differential within the basement and exacerbating the vapor intrusion issue.

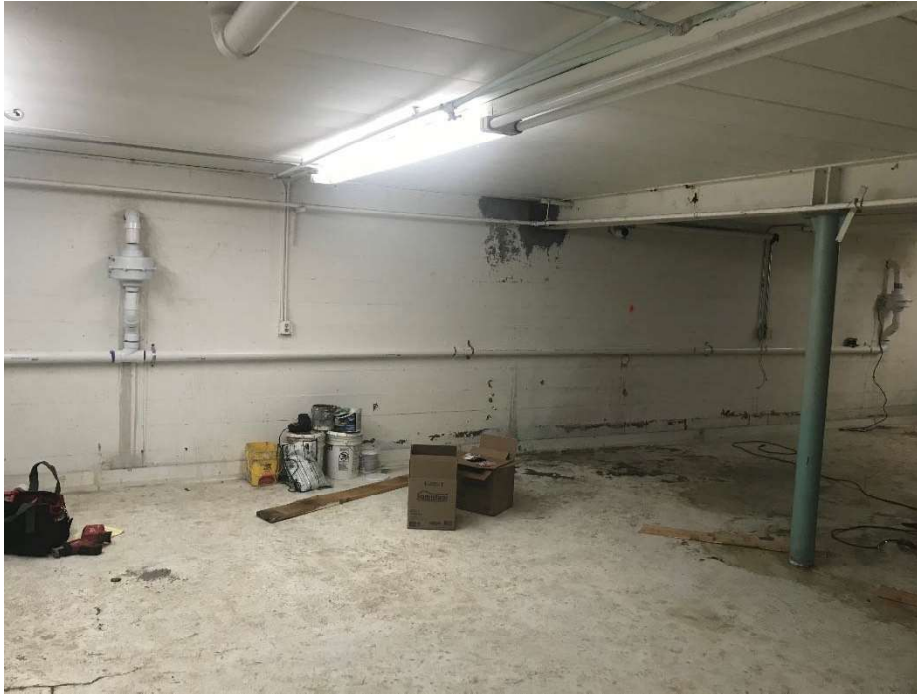
Photo 7. South basement vacuum blowers. Vacuum Blower B4 and B5.

- a. Photos 7 and 13 in the June 2020 VMS Report show piping runs that will likely result in future moisture build-up as there is nowhere for rainwater or condensation to drain and will likely interfere with effectiveness of the VMS in the future.

- a. Photos 7, 9, 12, and 13 of the June 2020 VMS Report show that blowers B1, B2, B3, B4, and B5 are all within the basement (beneath/within conditioned space). These fans should be moved to the exterior or the building.

- a. Photos 7, 9, 12, and 13 of the June 2020 VMS Report show that blowers B1, B2, B3, B4, and B5 have no manometers to monitor system performance. There are vacuum readings listed in Table 1 of the report, however there are no photos of manometer readings. In addition to no manometer, there is no labeling.

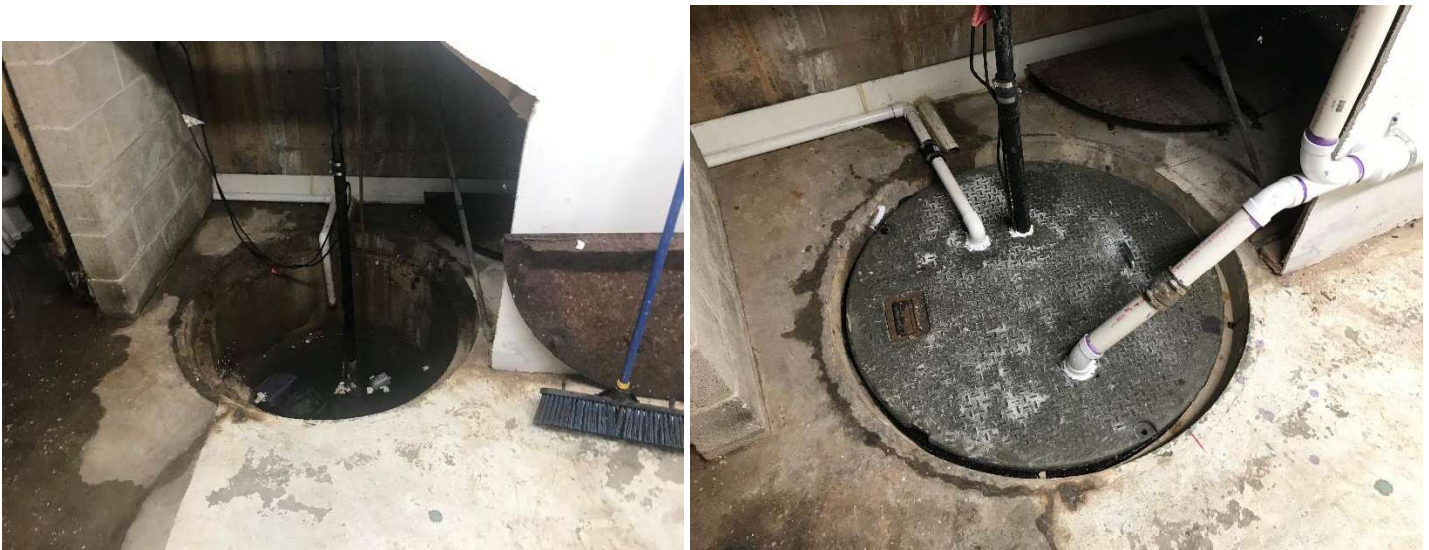
Photo 8. Ejector pit in south basement, Sump S3, before and after sealing.

- a. Photo 8 of the June 2020 VMS Report shows a moisture issue in the basement, which would likely require a trapped drain to be installed on the cover of Sump S3.

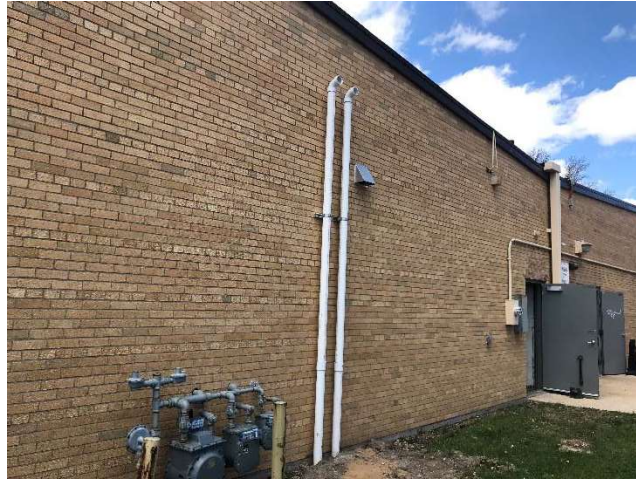
Photo 17. Discharge vents from north basement.

- a. Photos 17 & 18 of the June 2020 VMS Report shows vent exhaust trajectories of 90 degrees.
5. *The point of exhaust shall be not less than 18 inches above a flat roof (ANSI/AARST RMS-LB 7.4.10.c)*

- a. Photo 17 of the June 2020 VMS Report shows vent pipe is not discharging above flat roofline.
6. *Active soil depressurization (ASD) fans shall only be installed in attics, on the exteriors of buildings or in garages that are not beneath conditioned or otherwise occupiable spaces (ANSI/AARST RMS-LB 7.5.3).*

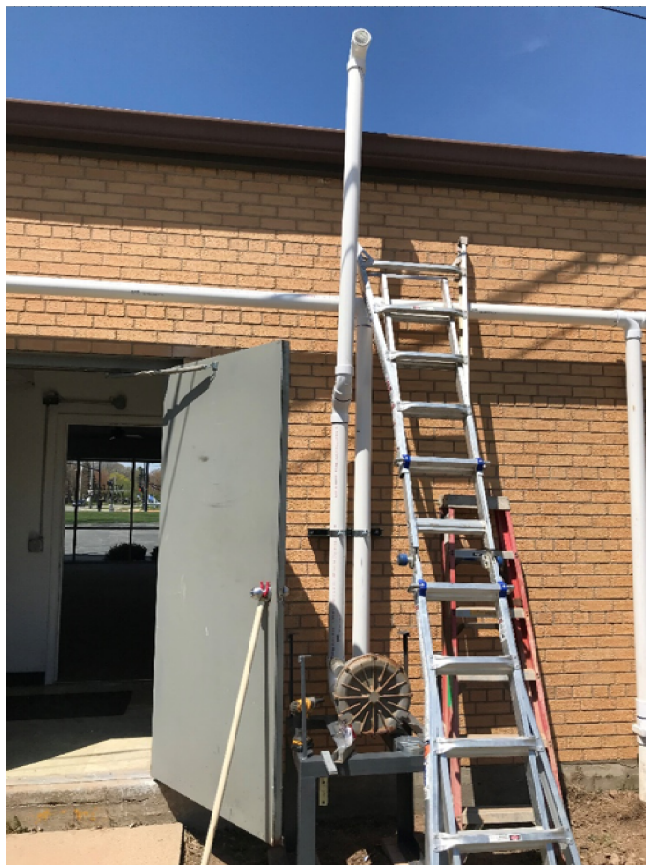
Photo 18. Discharge vent, east wall.

- a. Photo 18 of the June 2020 VMS Report shows a vent pipe that may be less than 4 feet above door.
