Annual Inspection Report – 2013 Barrier Cap Maintenance Plan
Skana Aluminum Co., 2009 Mirro Drive, Manitowoc, WI 54220
VPLE # 06-36-556282
WI DNR Environmental Repair Activity # 02-36-544601
Facility ID # 436106110

Skana Aluminum has performed the required annual Barrier Cap Maintenance Plan inspection of the areas surrounding the 5C section facility and inside of the 5C section of the facility and is posting the results in the attached "Exhibit B".

INSPECTION LOG

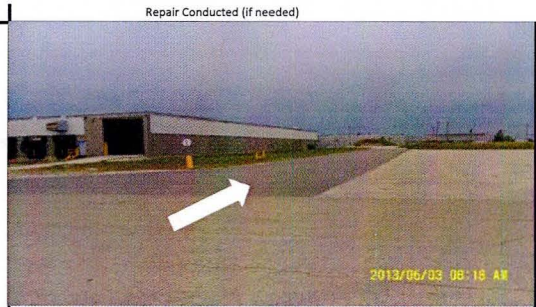
Item No
#1 - East side of 5C Facility

No previous picture
Multiple pot holes,
Asphalt broken up into small pieces
Multiple bad patches

General Area				Condition of Surface		New or Old Condition (location)
Interior/Exterior	Location Marked w/Paint Yes / No	Good	Need Repair	Describe Condition (crack/void/settling, ...)		
Exterior	No	Y	N	Pavement East of 5C - Asphalt		New
Pavement was replaced in Sept. of 2012 - 100 Cu.yds. Soil from under old roadway profiled and disposed of.						
Describe Location: East of 5C Facility						
Recommended Repair: None required at this time.						
Date Repair was Conducted: N/A			Name Documenting Repair Completed: Jay Hetland

NE Asphalt Invoice # 611500-01, PO # 909871
Cardinal Environmental (Removed Soil Profile) PO # 908814
Seiler Soil Removal: 910196

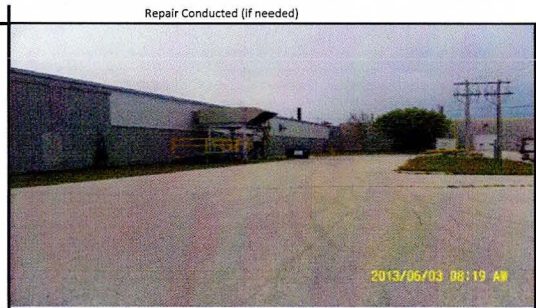
Item No
2 North side of 5C Facility

General Area				Condition of Surface		New or Old Condition (location)
Interior/Exterior	Location Marked w/Paint Yes / No	Good	Need Repair	Describe Condition (crack/void/settling, ...)		
Exterior	No	Y	N	Pavement North of 5C - Asphalt		Old
Pavement in good condition - no potholes or cracks						
Describe Location: North of 5C Facility						
Recommended Repair: None required at this time.						
Date Repair was Conducted: N/A			Name Documenting Repair Completed: Jay Hetland

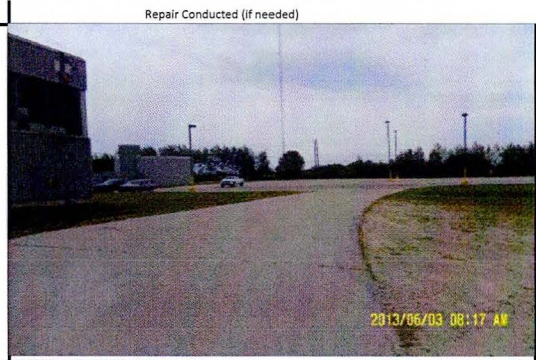
Item No
#3 - South West side of 5C Facility

General Area				Condition of Surface		New or Old Condition (location)
Interior/Exterior	Location Marked w/Paint Yes / No	Good	Need Repair	Describe Condition (crack/void/settling, ...)		
Exterior	No	Y	N	Pavement South West of 5C - Asphalt		Old
Pavement in good condition - no potholes or cracks						
Describe Location: South West of 5C Facility						
Recommended Repair: None required at this time.						
Date Repair was Conducted: N/A			Name Documenting Repair Completed: Jay Hetland

PO # 909871
NE Asphalt Invoice # 611500-01
Cardinal Environmental (Removed Soil Profile) PO #
Seiler Soil Removal:
