Annual Inspection Report – 2014 Barrier Cap Maintenance Plan
Skana Aluminum Co., 2009 Mirro Drive, Manitowoc, WI 54220
VPLE # 06-36-556282
WI DNR Environmental Repair Activity # 02-36-544601
Facility ID # 436106110

INSPECTION LOG

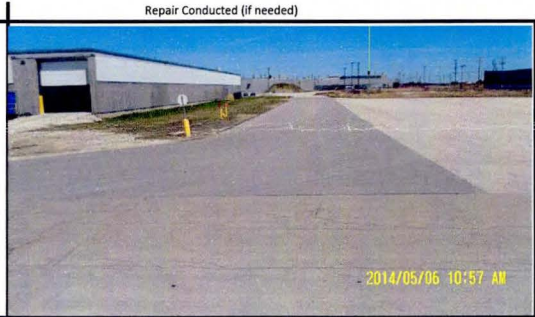
General Area				Condition of Surface		New or Old Condition (location)
Interior/Exterior	Location Marked w/Paint Yes / No	Good	Need Repair	Describe Condition (crack/void/settling, ...)		
Exterior	No	Y	N	Pavement East of 5C - Asphalt		New
Pavement was replaced in Sept. of 2012 - 100 Cu.yds. Soil from under old roadway profiled and disposed of.						
Describe Location: East of 5C Facility						
Recommended Repair: None required at this time.						
Date Repair was Conducted : N/A			Name Documenting Repair Completed: Jay Hetland

Item No
#1 - East side of 5C Facility
No repairs needed

Condition At Time of Inspection
All Good - 2 years old

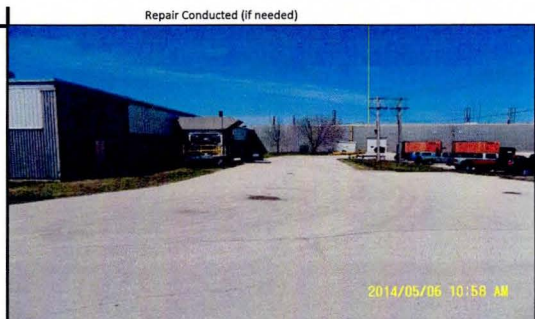
General Area				Condition of Surface		New or Old Condition (location)
Interior/Exterior	Location Marked w/Paint Yes / No	Good	Need Repair	Describe Condition (crack/void/settling, ...)		
Exterior	No	Y	N	Pavement North of 5C - Asphalt		Old
Pavement in good condition - no potholes or cracks						
Describe Location: North of 5C Facility						
Recommended Repair: None required at this time.						
Date Repair was Conducted : N/A			Name Documenting Repair Completed: Jay Hetland

Item No
2 North side of 5C Facility
No repairs needed

Condition At Time of Inspection
All good - no cracks or potholes

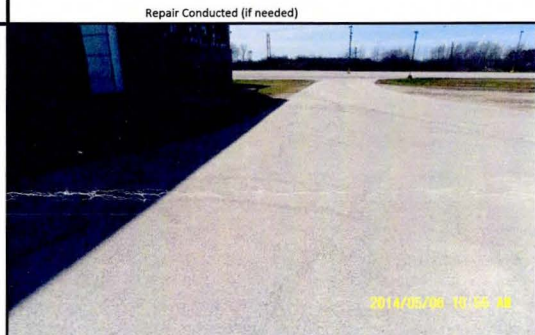
General Area				Condition of Surface		New or Old Condition (location)
Interior/Exterior	Location Marked w/Paint Yes / No	Good	Need Repair	Describe Condition (crack/void/settling, ...)		
Exterior	No	Y	N	Pavement South West of 5C - Asphalt		Old
Pavement in good condition - no potholes or cracks						
Describe Location: South West of 5C Facility						
Recommended Repair: None required at this time.						
Date Repair was Conducted : N/A			Name Documenting Repair Completed: Jay Hetland

Item No
#3 - South West side of 5C Facility
No repairs needed

Condition At Time of Inspection
All good - no cracks or potholes in target area
