Annual Inspection Report – 2015 Barrier Cap Maintenance Plan
Skana Aluminum Co., 2009 Mirro Drive, Manitowoc, WI 54220
VPLE # 06-36-556282
WI DNR Environmental Repair Activity # 02-36-544601
Facility ID # 436106110

INSPECTION LOG

VLPE #06-36-556282
WI DNR Environmental Repair Activity # 02-36-544601/02-36-550138
Facility ID# 436106110

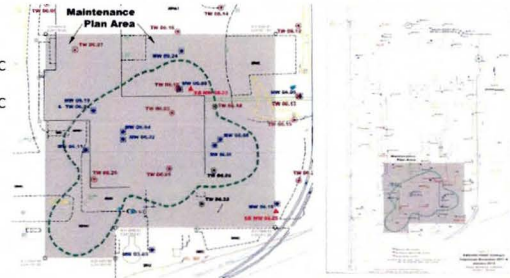
Concrete - Building 5C
Asphalt - Exterior Building 5C

General Area		Condition of Surface		New or Old Condition (location)
Interior/Exterior	Location Marked w/Paint Yes / No	Good	Need Repair	
Exterior	No	Y	N	Pavement East of 5C - Asphalt Pavement was replaced in Sept. of 2012 - 100 Cu.yds. Soil from under old roadway was profiled and disposed of.
Describe Location: East of 5 C Facility				
Recommended Repair: None required at this time.				
Date Repair was Conducted: N/A		Name Documenting Repair Completed: Jay Hetland

General Area		Condition of Surface		New or Old Condition (location)
Interior/Exterior	Location Marked w/Paint Yes / No	Good	Need Repair	
Exterior	No	Y	N	Pavement North of 5C - Asphalt Pavement good - No repairs needed
Describe Location: North of 5C Facility				
Recommended Repair: None required at this time.				
Date Repair was Conducted: N/A		Name Documenting Repair Completed: Jay Hetland

General Area		Condition of Surface		New or Old Condition (location)
Interior/Exterior	Location Marked w/Paint Yes / No	Good	Need Repair	
Exterior	No	Y	N	Pavement South West of 5C - Asphalt South side pavement replaced Oct. 2015 By N.E. Asphalt - Asphalt ground off & relaid -No soil removed - only minor grading.
Describe Location: South West of 5C Facility				
Recommended Repair: None required at this time.				
Date Repair was Conducted: Oct. 2015		Name Documenting Repair Completed: Jay Hetland

General Area		Condition of Surface		New or Old Condition (location)
Interior/Exterior	Location Marked w/Paint Yes / No	Good	Need Repair	
Interior	No	Y	N	Concrete floor in 5C Facility Pavement in good condition - no excavations or cracks
Describe Location: Inside of 5C Facility East half				
Recommended Repair: None required at this time.				
Date Repair was Conducted: N/A		Name Documenting Repair Completed: Jay Hetland

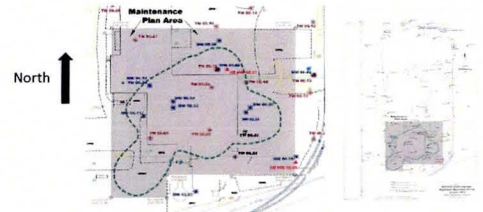
Concrete - Building 5C
Asphalt - Exterior Building 5C

Item No	Condition At Time of Inspection	Repair Conducted (if needed)
<p>#1 - East side of 5C Facility</p> <p>No repairs needed</p> <p>If subcontractor used for repairs (attach Invoice) WI DNR Approval Required (attach Approval Letter)</p>	<p>All Good- 3 years old</p>	
<p># 2 North side of 5C Facility</p> <p>No repairs needed</p> <p>If subcontractor used for repairs (attach Invoice) WI DNR Approval Required (attach Approval Letter)</p>	<p>All good - no cracks or potholes</p>	
<p>#3 - South West side of 5C Facility</p> <p>No repairs needed</p> <p>If subcontractor used for repairs (attach Invoice) WI DNR Approval Required (attach Approval Letter)</p>	<p>All good - no cracks or potholes in target area.</p> <p>Note: Roadway along South Side of building completely replaced - Asphalt surface ground off & Relaid, only minor grading of base gravel.</p>	
<p>#4 - Interior Floor of 5C Facility</p> <p>No repairs needed.</p> <p>If subcontractor used for repairs (attach Invoice) WI DNR Approval Required (attach Approval Letter)</p>	<p>No previous picture</p>	<p>No picture taken Machines and stock inhibit any composite picture</p>
