Site Investigation

April 2010

Prepared For City of Chilton 42 School Street Chilton, WI 53014

Former Larsons Dry Cleaners Site Property Located at 317 East Main Street Chilton, Wisconsin

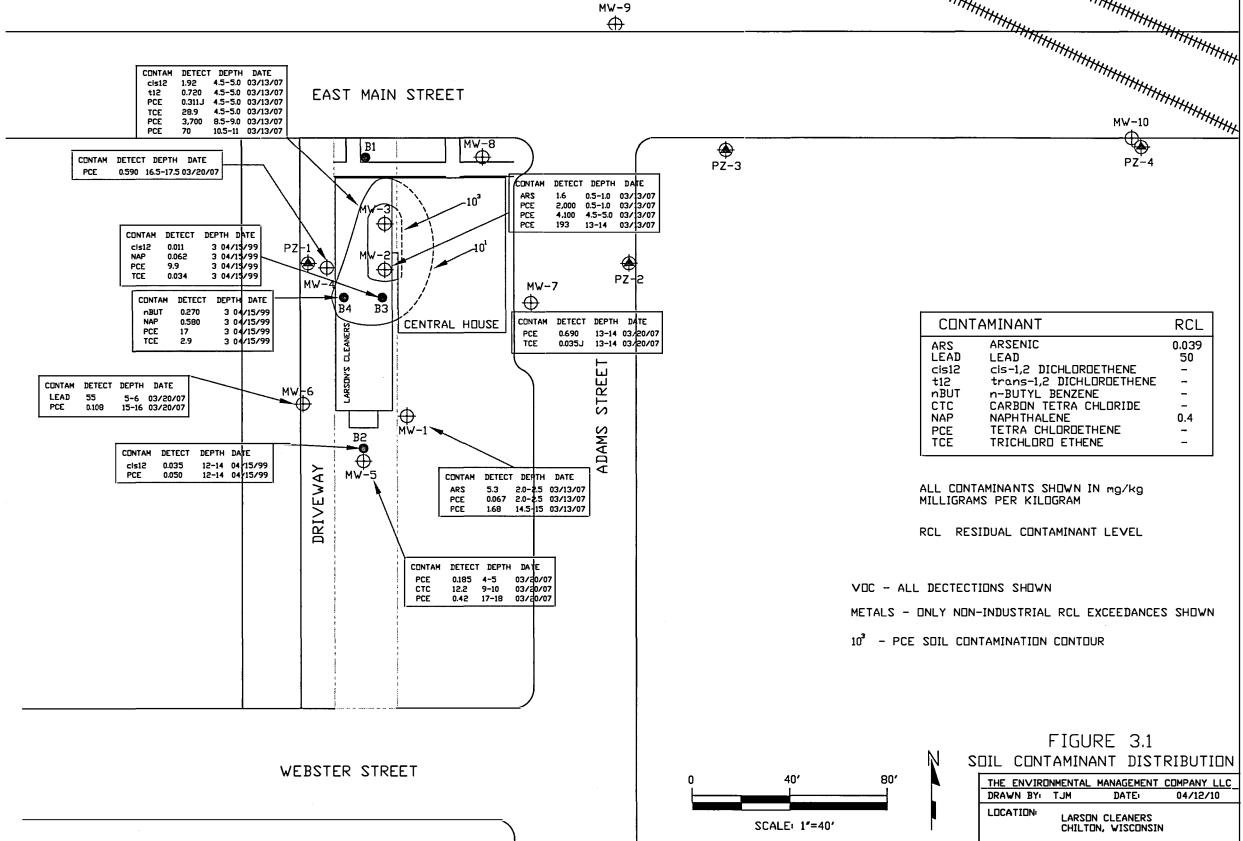
The distribution of soil contamination in the subsurface at the site and in the surrounding area is contained in Tables 1 through 3 and is shown on Figure 3.1. The figure shows all detections of soil VOC contamination, and RCRA metals contaminants detected above Direct Contact - Non-Industrial Residual Contaminant Levels (DC-NI RCL). No detections of PAH compounds above RCL for protection of groundwater or DC-NI were reported in the seven (7) soil samples analyzed for PAH compounds.

Results of the VOC analyses of soil samples indicate the area in which monitoring well MW-2 is located, which was reported to be the location of the former dry cleaning machine, is the source area of chlorinated VOC subsurface contamination. The highest levels of PCE were detected in samples collected from 0.5 feet to 1.0 feet bgs (2,000 mg/kg) and 4.5 to 5.0 feet bgs (4,100 mg/kg). The level of PCE in the soil sample collected from 13 to 14 feet bgs decreased to 193 mg/kg. PCE levels in soil samples collected from boring MW-3, north of MW-2, showed a concentration of the solvent in the sample collected from 8.5 feet to 9.0 feet bgs (3,700 mg/kg), and much lower levels above, at 4.5 to 5 feet bgs (0.311^J mg/kg) and below, at 10.5 to 11 feet bgs (70 mg/kg).

This distribution of PCE soil contamination indicates dry cleaning fluid was discharged on the ground surface near MW-2 and migrated downward through the silty clay residual soil and northward toward MW-3. The bulk of the contaminant mass remains in the silty clay (upper 10 feet of soil) in this relatively small source area.

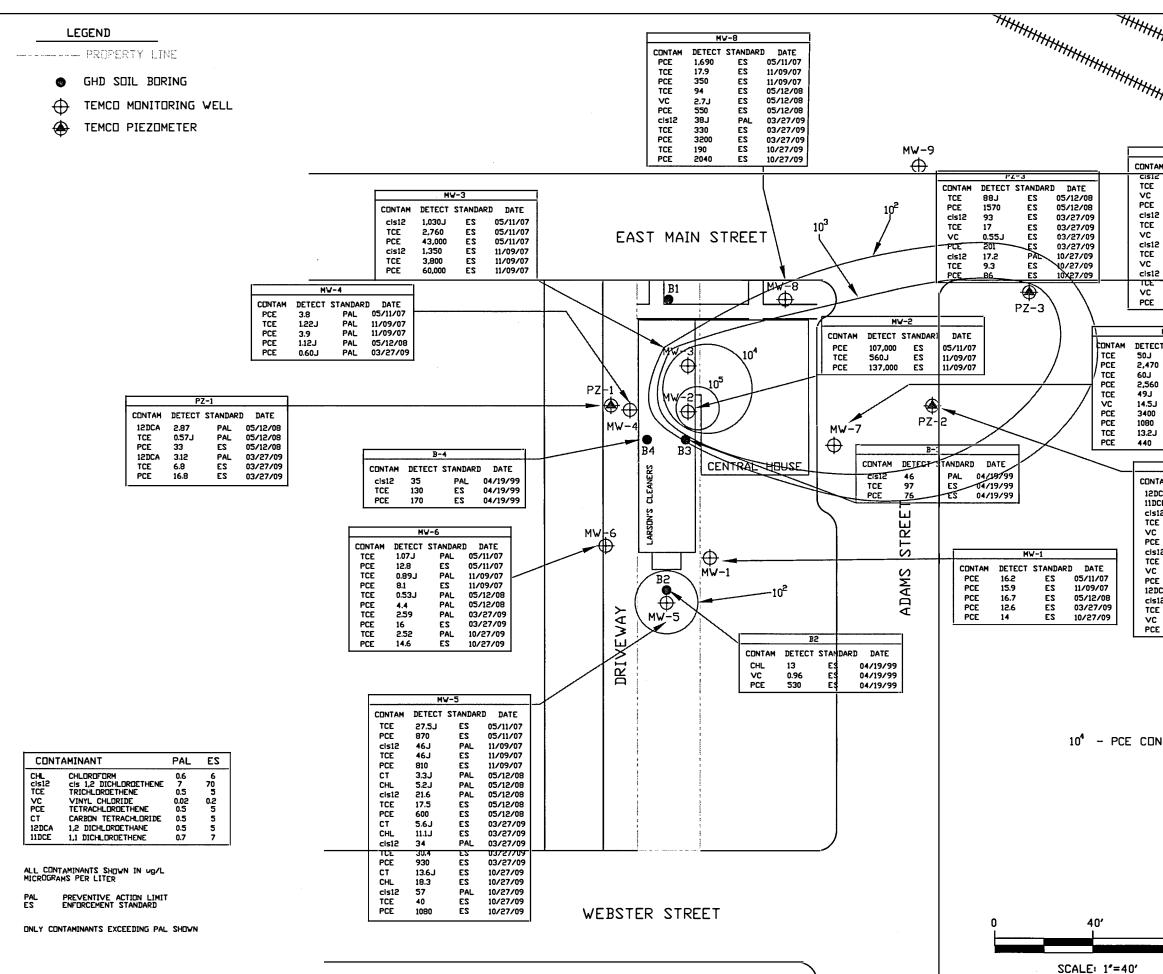
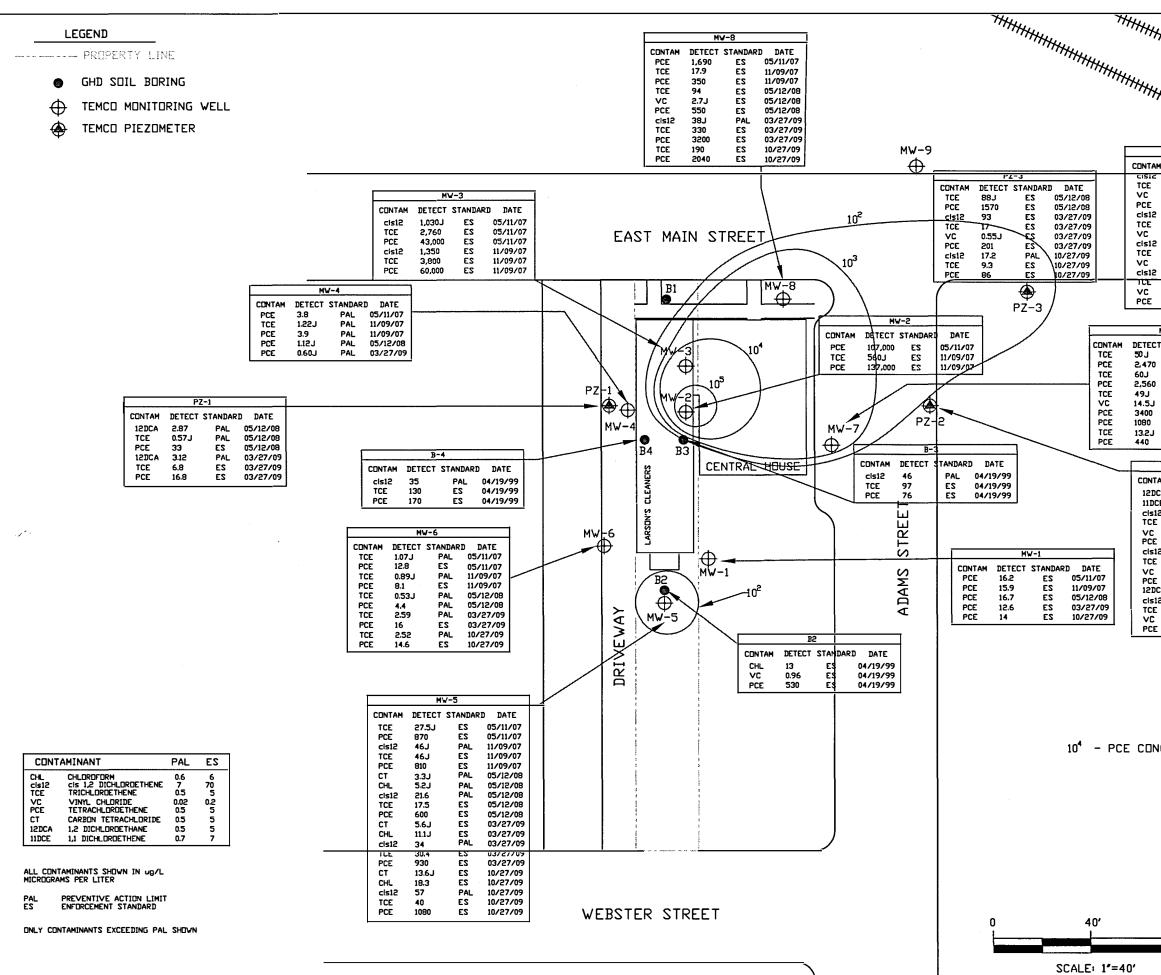
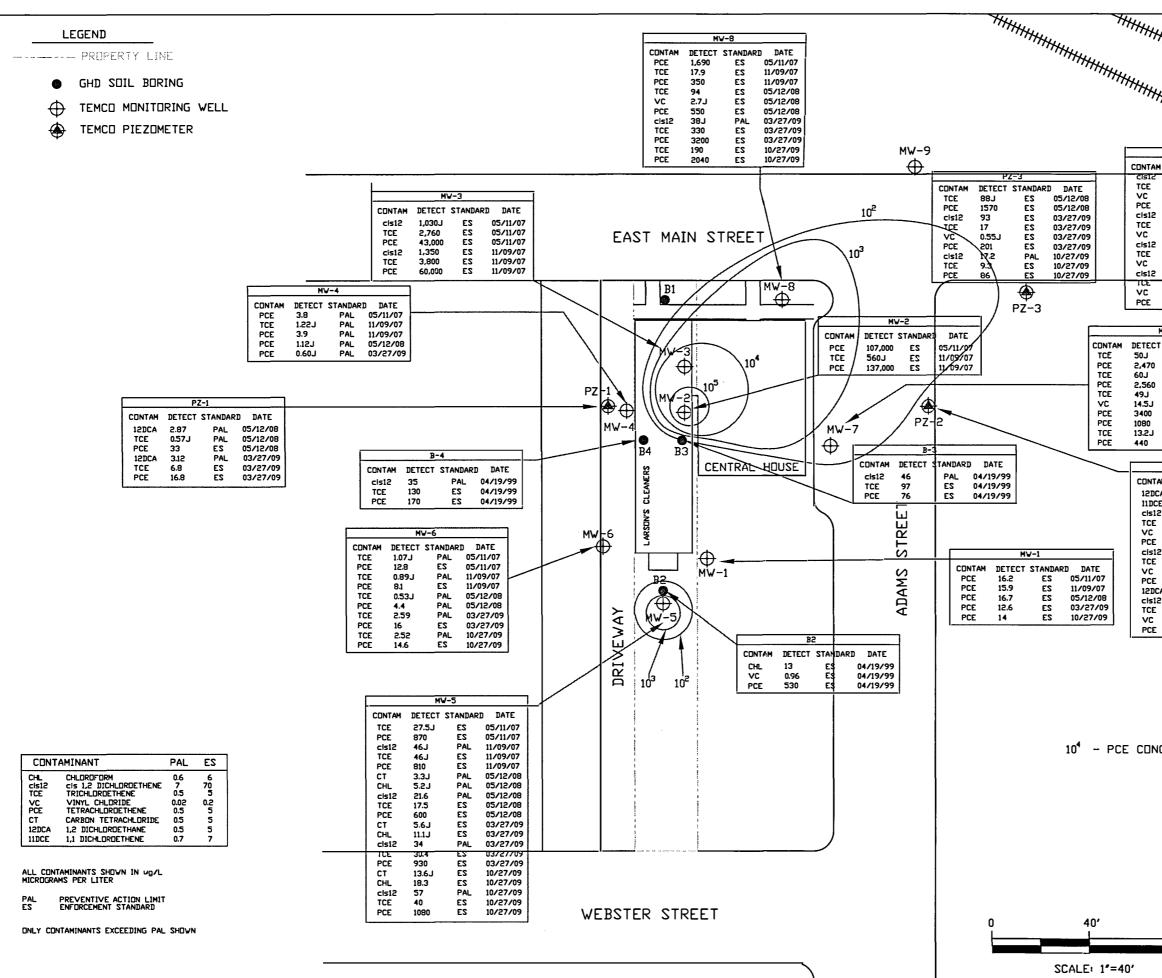
The distribution of VOC groundwater contamination at the site and surrounding area is shown on Figures 4.1 through 4.3. These figures also show PCE concentration contours for the three (3) most recent monitoring events.

Review of the groundwater VOC contaminant distribution data (Table 4 and Figures 4.1, 4.2, and 4.3) indicates PCE is the dominant chlorinated VOC component of groundwater contamination in the source area and in the downgradient plume. Except at the fringes of the groundwater contaminant plume, PCE levels are one (1) to three (3) orders of magnitude higher than levels of individual chlorinated VOC daughter compounds. Considering that dry cleaning operations at the site began 60+ years ago, breakdown of PCE in the subsurface is apparently occurring at relatively slow rates.

The location and shape of the groundwater contaminant plume are consistent with the east-northeast direction of groundwater flow measured consistently through the five (5) monitoring events completed. PCE levels in groundwater exceed 10⁵ ug/l in the source area and decrease to levels between the PAL and ES in groundwater samples collected from the farthest downgradient monitoring well/piezometer pair (MW-10 and PZ-4). At least one (1) additional monitoring well/piezometer pair will need to be installed east of MW-10/PZ-4 to define the downgradient edge of the groundwater contaminant plume.

Complete characterization of the level and extent of groundwater VOC contamination sourced from the site will require installation of additional downgradient monitoring wells, and piezometers screened at depths greater than 40 feet bgs.

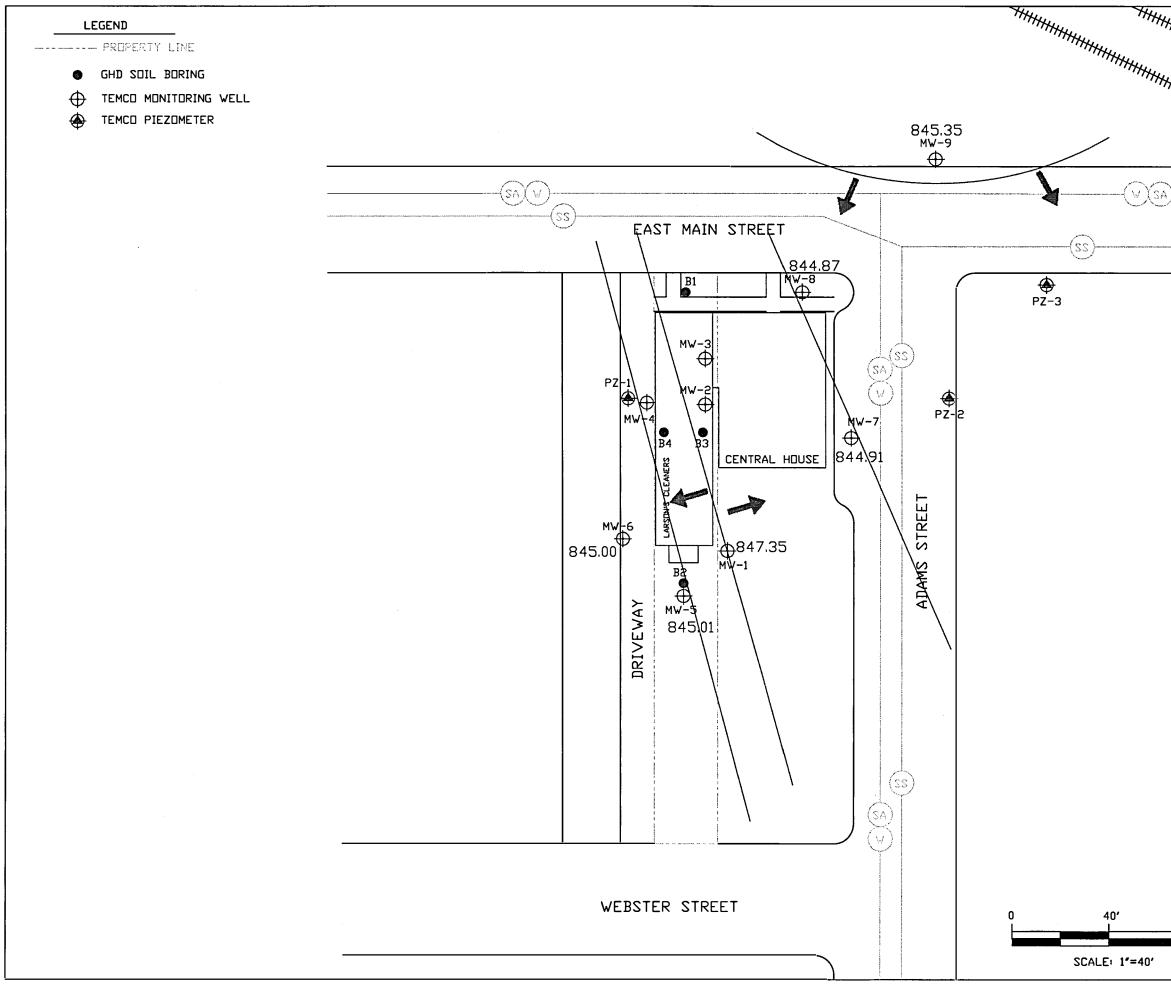
844.65^{MW-10} PZ-4 FIGURE 5.5.1 GROUNDWATER TABLE ELEVATION N CONTOURS: OCTOBER 27, 2009 80' THE ENVIRONMENTAL MANAGEMENT COMPANY LLC DRAWN BY: TJM DATE: 04/12/10 LOCATION LARSON CLEANERS CHILTON, WISCONSIN

The groundwater elevation data (Table 5) collected from the ten (10) monitoring wells (MW-1 through MW-10) during the five (5) monitoring events completed show a consistent direction of groundwater flow from the source area on the site to the east-northeast. Two (2) anomalous conditions appear on the groundwater elevation/flow direction figures for the water table monitoring wells (5.1, 5.2, 5.3.1, 5.4.1, and 5.5.1):

- An apparent groundwater divide is present just west of the source area on the site. The divide trends consistently north-northwest/south-southeast, and appears to shift slightly in the east-west direction over time.
- The groundwater elevation in monitoring well MW-9 is frequently higher than a consistent easterly direction of groundwater flow would predict.
