### SCS ENGINEERS

May 23, 2014 File No. 25213180.07

Subject: Vapor Mitigation Summary for Central House Building Larson Cleaners Project, Chilton, Wisconsin WDNR Purchase Order #NMD00000758 BRRTS #02-08-221491

# Post Mitigation Report For: Central House/Cullen Property, 321 E. Main St., Chilton, WI

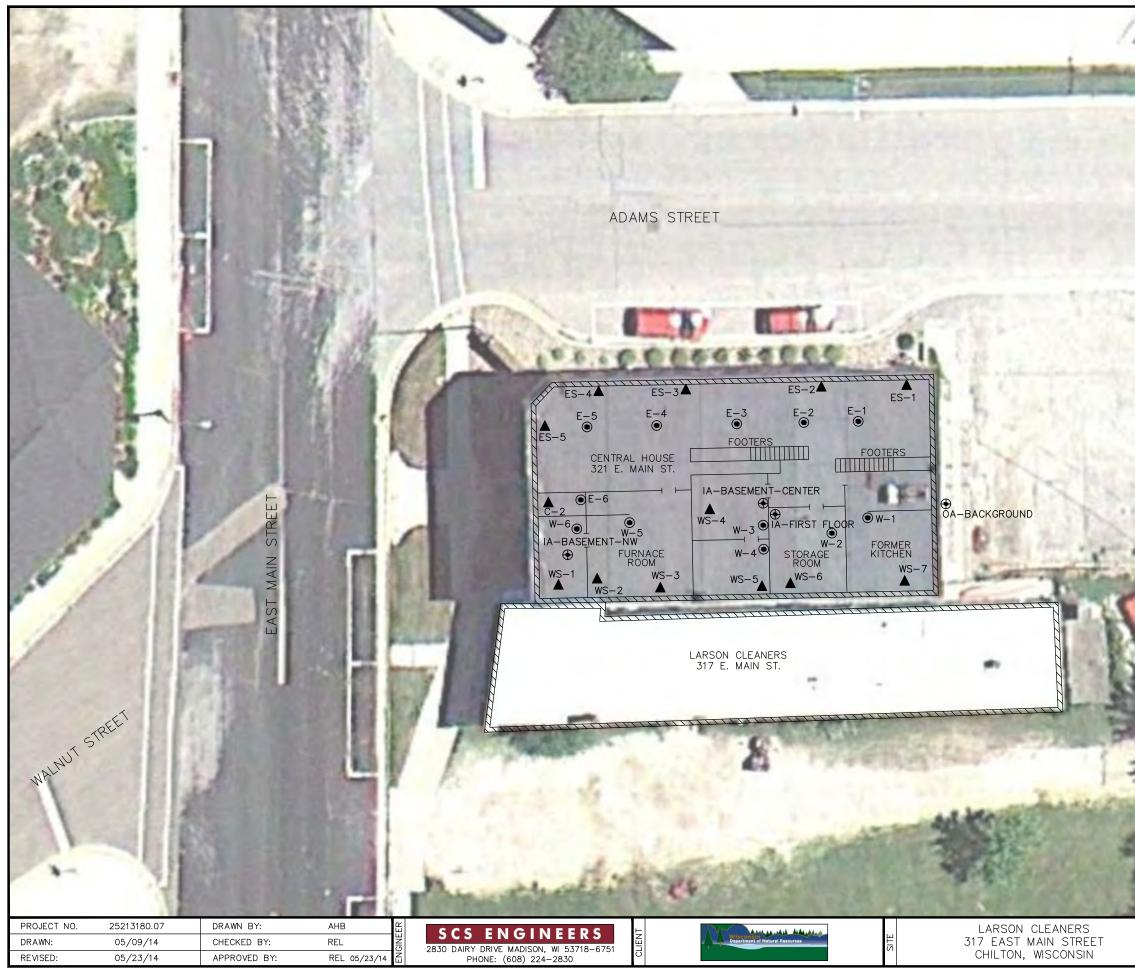
The SSDS was installed by Acura Services, LLC (Acura) in April 2014 and included installation of 12 pickup points through the floor slab, associated piping, and blowers. Following system start-up, Acura conducted sub-slab vacuum testing which verified successful depressurization of the sub-slab. Pickup and vacuum observations points are shown on **Figure 1**.

SCS conducted post-mitigation ambient air sampling for the Central House building on May 12 and 13, 2014. The purpose of the sampling was to assess the effectiveness of the SSDS system. SCS collected two samples from the basement, one from the first floor, and one outside of the building (background). Sample locations are shown on **Figure 1**.

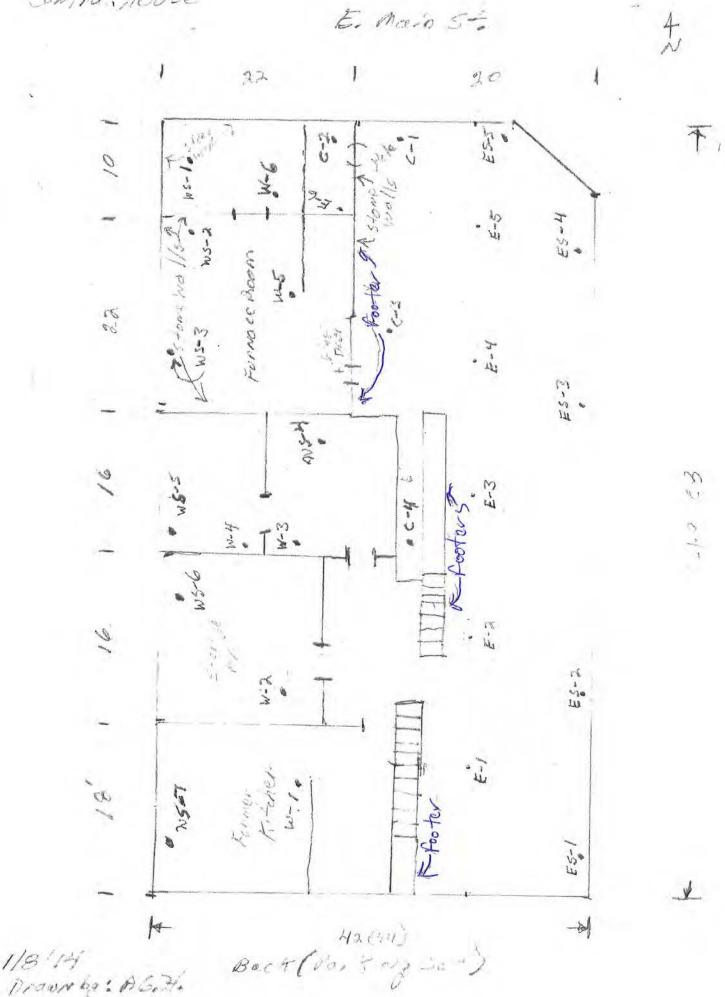
**Results:** See the drawing for approximate location of the test holes. All results below are from testing done April 10, 2014 after the system(s) were started up. (Note: See the drawing for approximate location of the pickup points. Pickup points are labeled E-1 thru E-6 for those on the east side of the building and W-1 thru W-6 for those on the west side of the building.)

Test holes are designated W-S (west sample point); C-S (central sample point); or E-S (east sample point).

E-S-1, minus 0.110; E-S-2, minus 0.095; E-S-3 minus 0.091; E-S-4 minus 0.011; E-S-5 minus 0.013;

C-S-1, minus 0.030; C-S-2 minus 0.037; C-S-3 minus 0.226 (after valve installed and adjusted minus 0.033); C-S-4 minus 0.204'

W-S-1 minus 0.647; W-S-2 minus 0.008; W-S-3 minus 0.018; W-S-4 minus 0.046 (with valve adjusted minus 0.056); W-S-5 minus 0.333 (with valve adjusted minus 0.053); W-S-6 minus .008 (with valve adjusted minus 0.011); W-S-7 minus 0.013 (with valve adjusted minus 0.021);

The manometer readings indicate that the slab in the basement has been successfully depressurized.

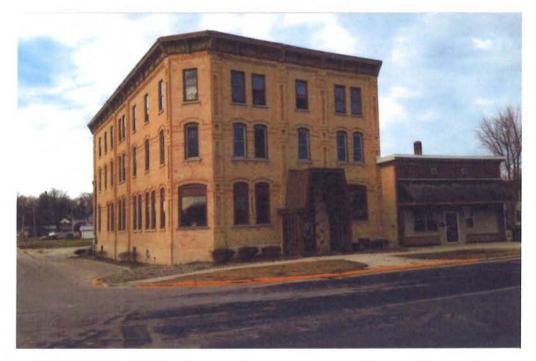
Photo 1: Central House building

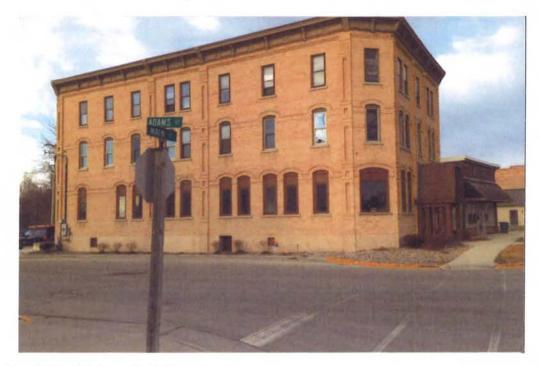
**Photo 2:** Central House building

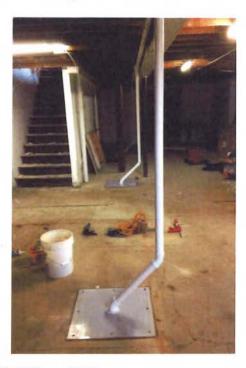
**Photo 3:** Pick-up points E-1, E-2, and E-3

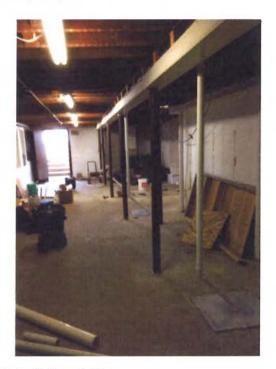
Photo 4: Pick-up points E-3, E-2, and E-1

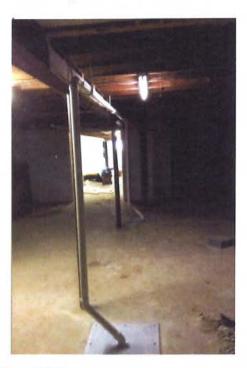
**Photo 5:** Pick-up points E-5 and E-4

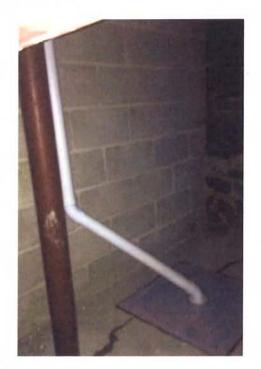
Photo 6: Pick-up point E-6

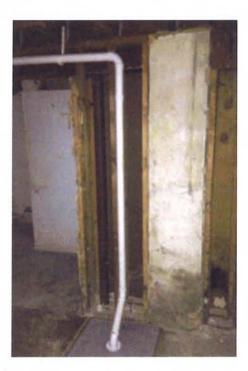
Photo 8: Pick-up point W-1

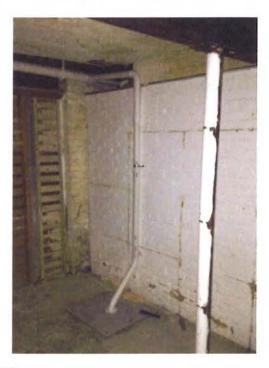
**Photo 9:** Pick-up point W-2

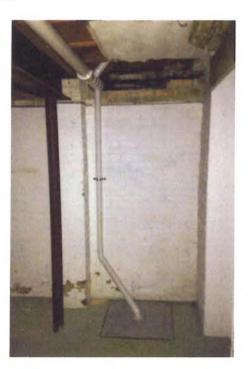
Photo 10: Pick-up point W-3

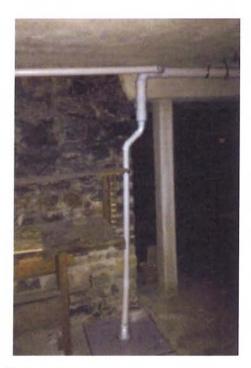
Photo 12: Pick-up point W-5

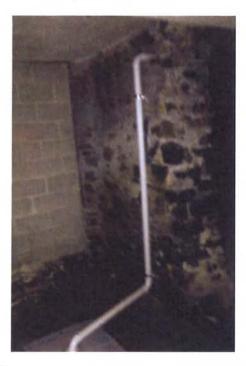
Photo 13: Pick-up point W-6

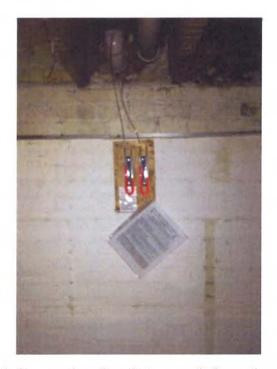
Manometers were installed on each three inch header. The manometer on the East Header pipe connecting five (5) pickup points read 1.8 inches of water column. The manometer on the West Header pipe connecting seven (7) pickup points read 1.5 inches of water column. The air flow is estimated to be 84 cfm on the discharge of the West and 60 cfm on the East discharge.

Photo 14: Manometers, label, operation & maintenance information, and warranty information

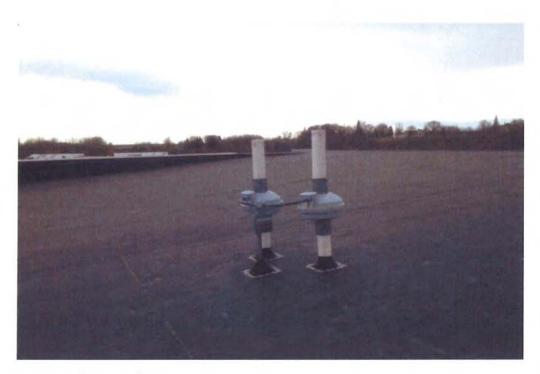
The building has a flat roof and the attic space is limited. Due to limited access and difficulty of potentially servicing the fans if installed in the attic the fans were mounted above the roof. There's a hatch with easy access to the roof on the third story of the building.

Photo 15: Fans above roof
