Phase IV Environmental
Site AssessmentPetroleum Impacted Soil Removal
and Disposal Monitoring Services

Thomas Service Station Property STH 77, STA. 329+10 to 330+70 Montreal, Iron County, Wisconsin WISDOT Project No. 9250-09-70

August 29, 1997

Giles Project No. 1E-9703039

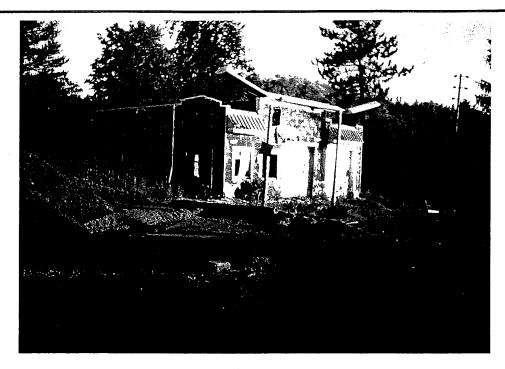
Photograph #1: View of the former Thomas service station (facing southwest).

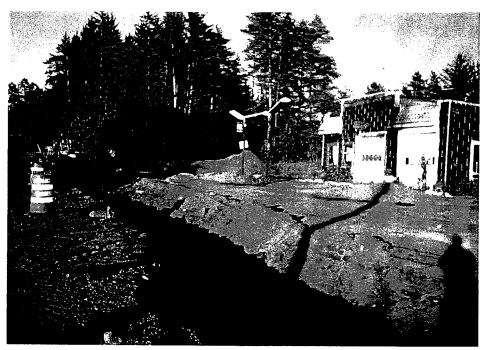
Photograph #2: View of the former Thomas service station with the installed storm sewer (facing southeast).

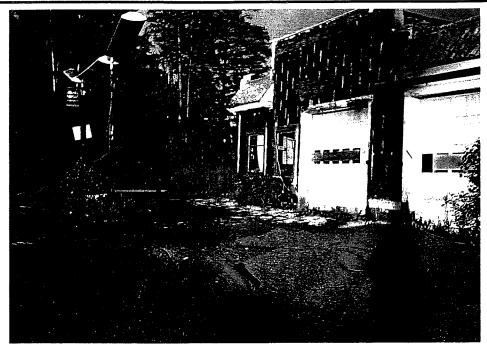
Photograph #3: A closer view of the former Thomas service station with the pump island (facing southeast).

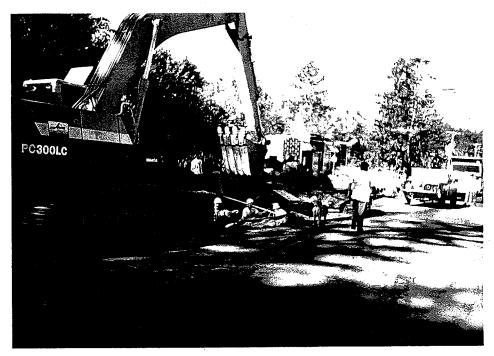
Photograph #4: View of the excavation and transportation equipment.

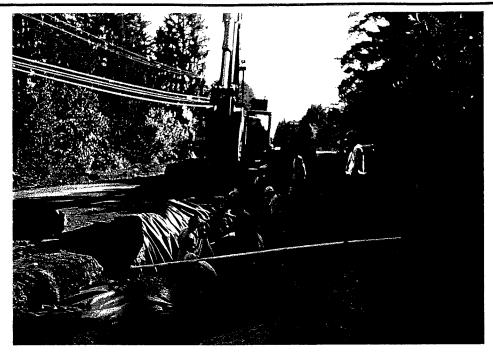
Photograph #5: View of storm sewer installation activities (facing northeast).

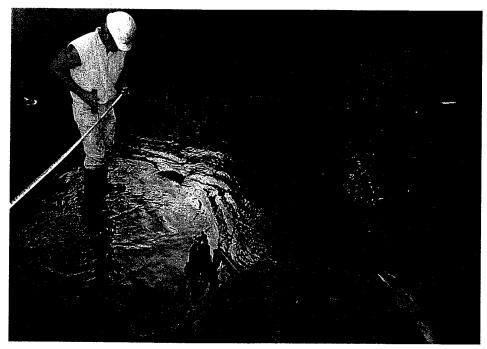
Photograph #6: View of dewatering activities in installing the storm sewer.

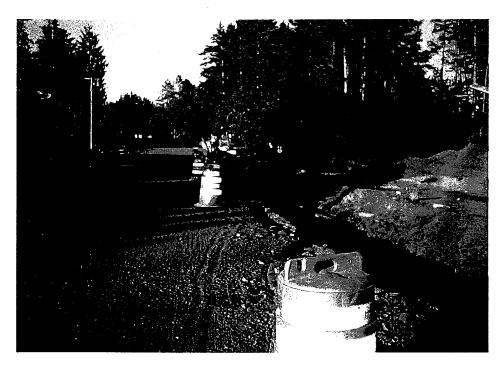
Photograph #8: View of the installed storm sewer (facing southeast).
