**BROWNFIELDS ENVIRONMENTAL ASSESSMENT
PHASE 1 UPDATE**

FORMER P. & G. SCHOOL BUS SERVICE .

6815 West Mill Road
Milwaukee, Wisconsin 53218
October 14, 1998

Binyoti F. Amungwafor

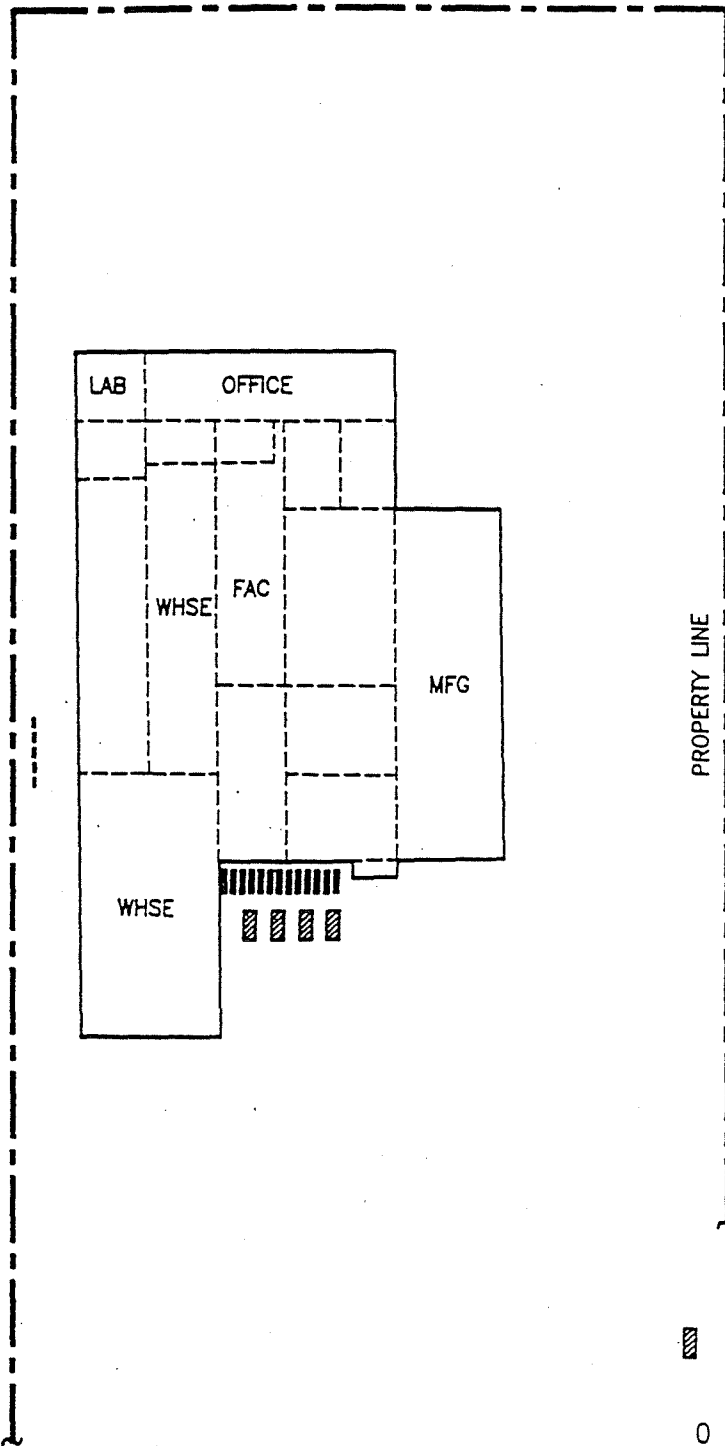
Former Underground Tanks

During tank excavation and removal, measurable concentrations of solvents were identified in the native soil and fill surrounding the tanks, and in water associated with the fill. A variety of activities, some of which are ongoing, were initiated to remediate the identified contamination.
