**Remediation & Redevelopment
 Continuing Obligation Review**

BRRTS ID No. 02-68-245535 _____

Site Name: Distinctive Cleaners

| Site Address 13855 W North Ave (13925 W North Ave) | City Brookfield | ZIP Code 53045 |

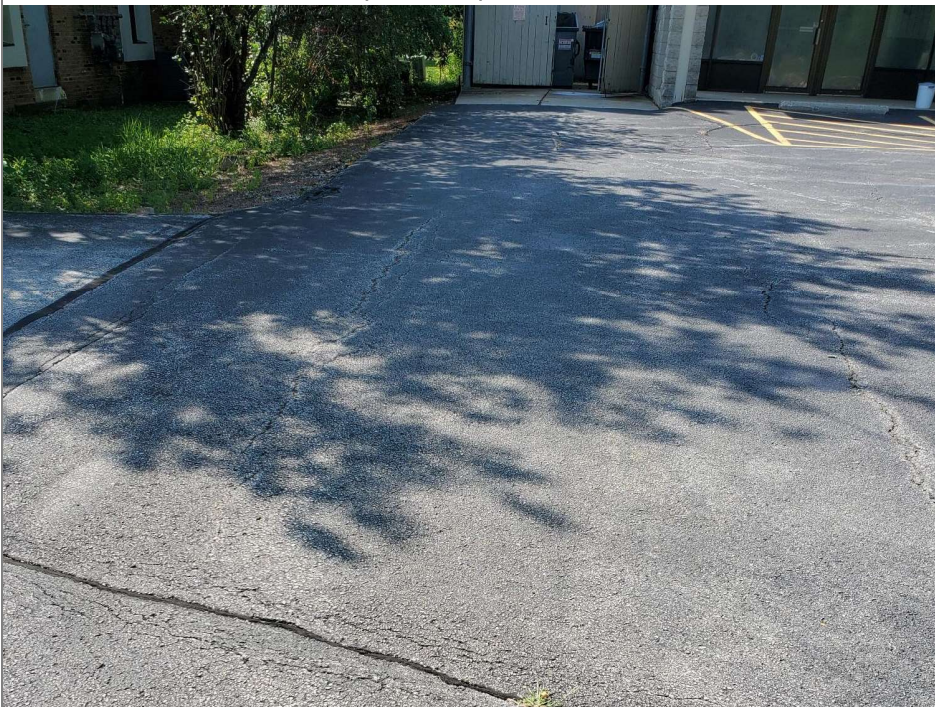
Title: East end of parking lot

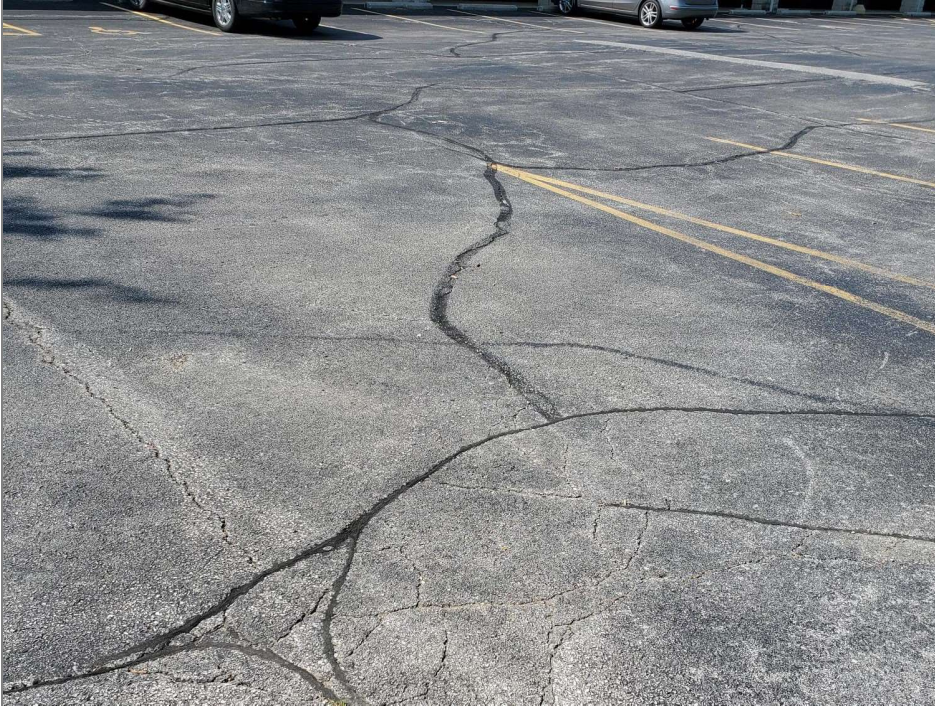
Title: Parking lot

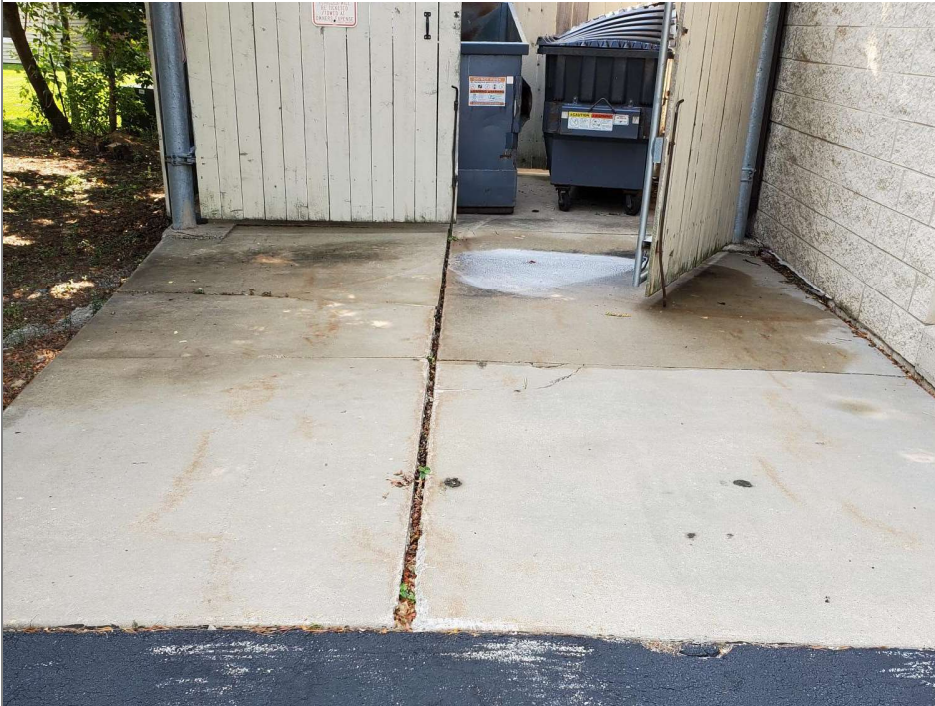
Concrete pads are starting to separate, gravel behind dumpster areas starting to get thin. Both areas may need maintenance soon.

Title: Dumpster area surface, east side of lot

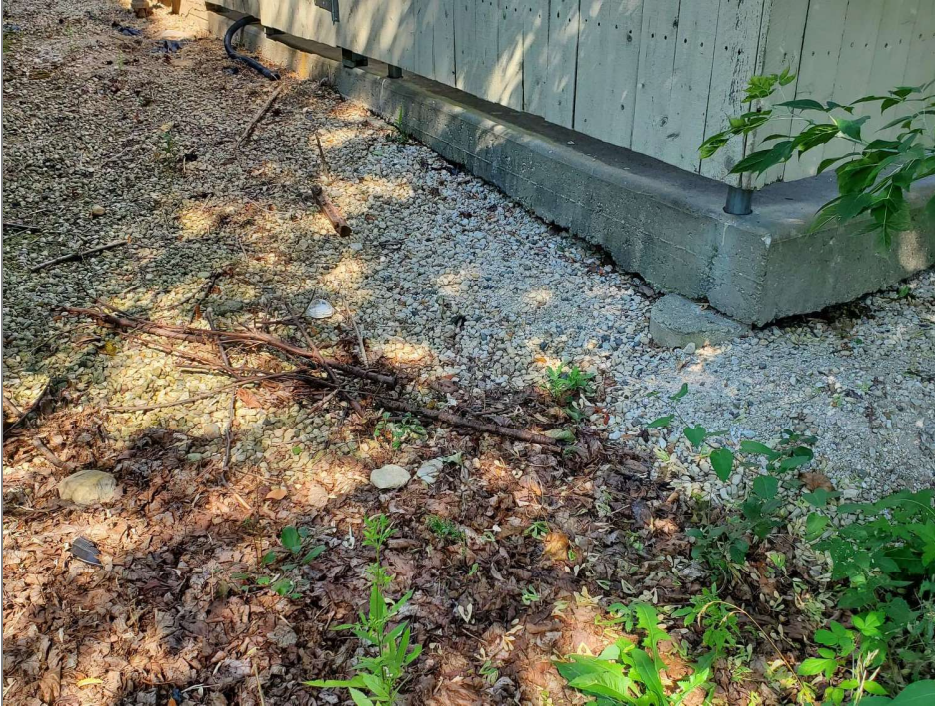
Title: Landscaped area behind dumpsters

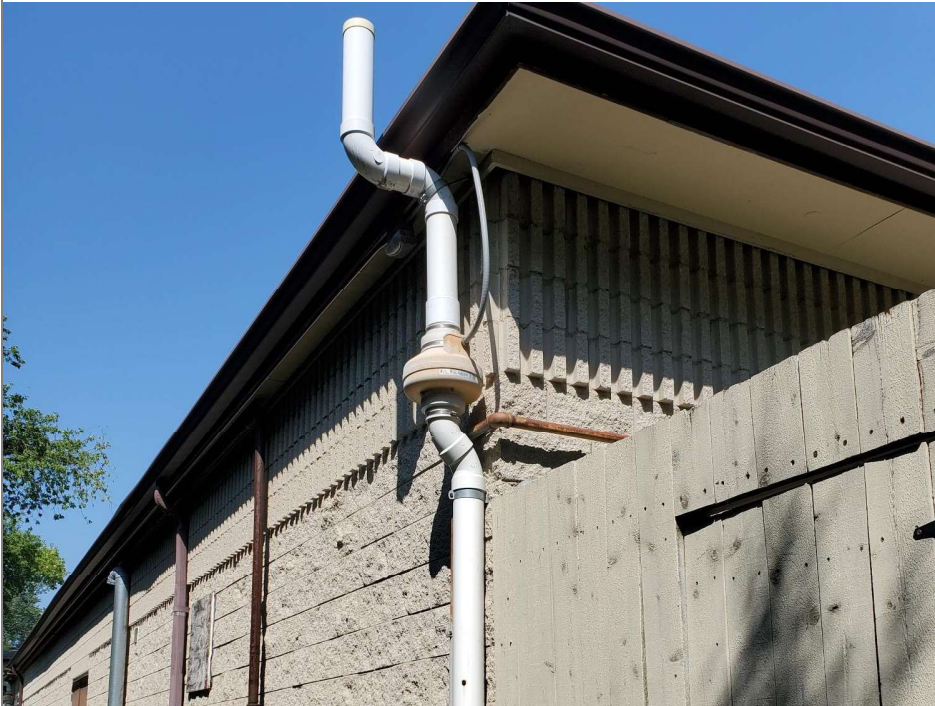
Title: Mitigation fan - southeast corner of building

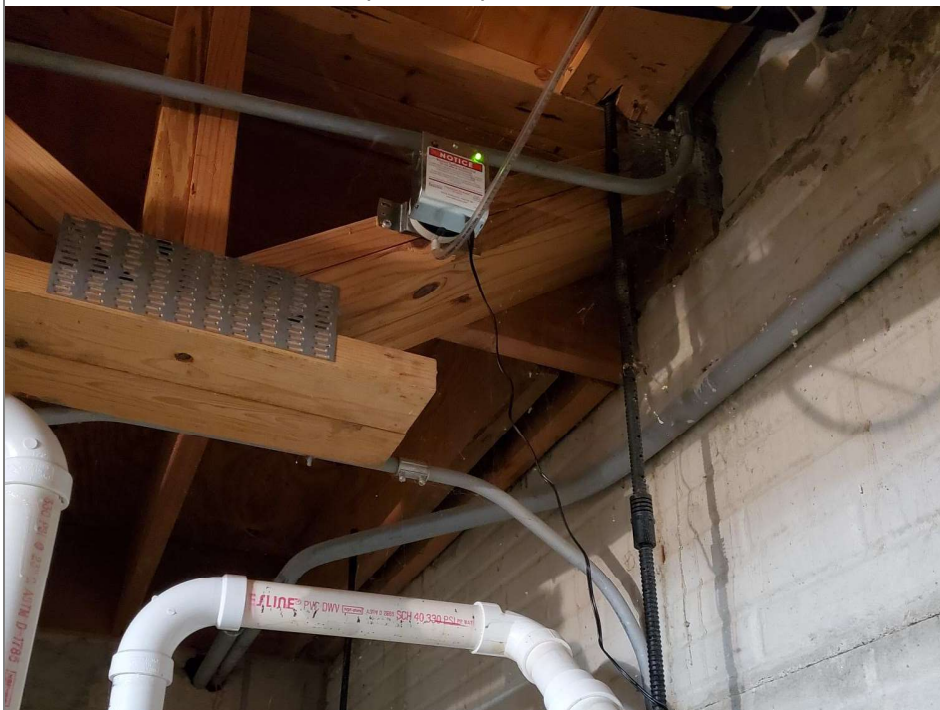
Title: Sample mitigation fan alarm

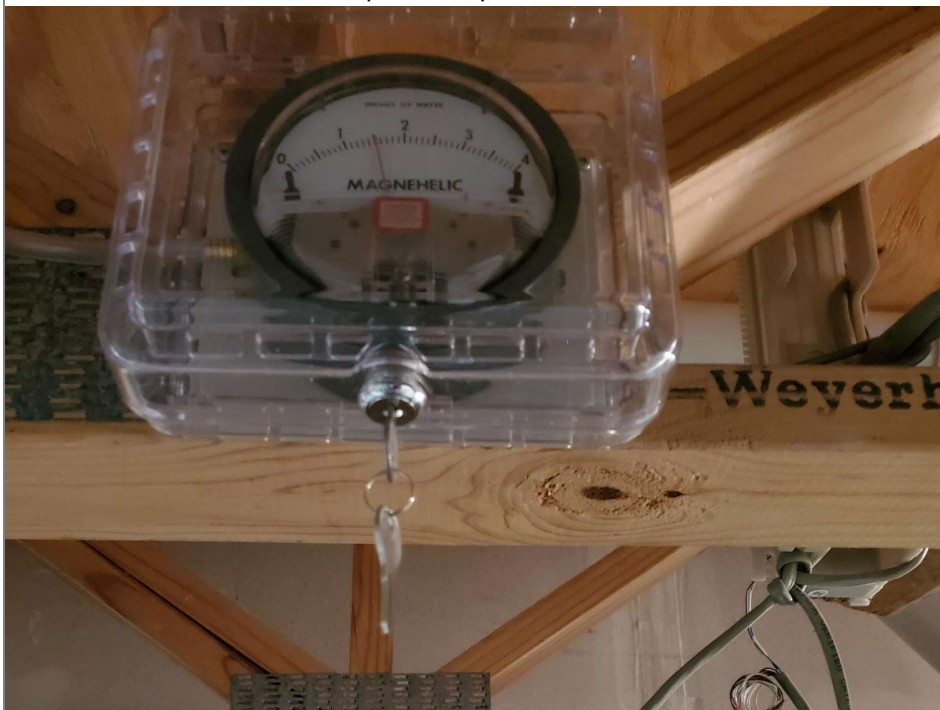
Title: Sample pressure gauge

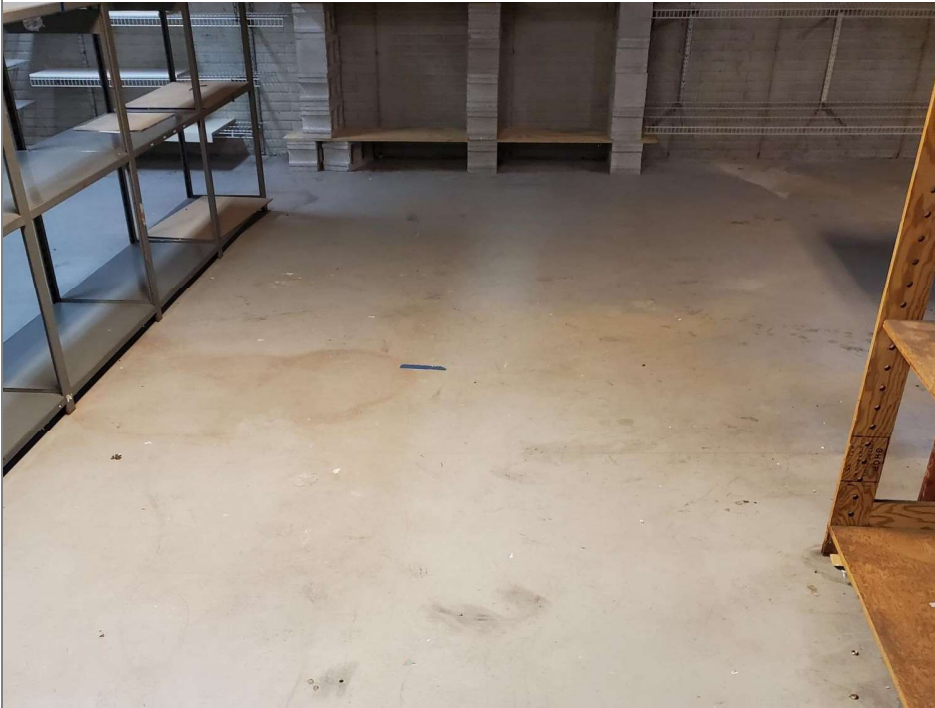
Title: Basement floor - east end of building

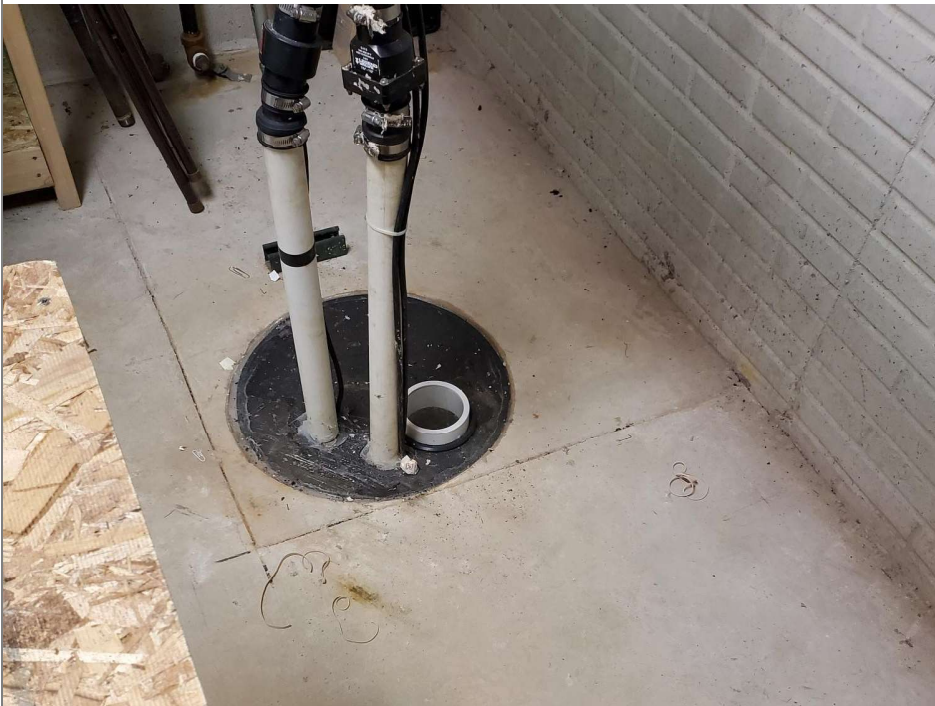
Title: Sealed sump

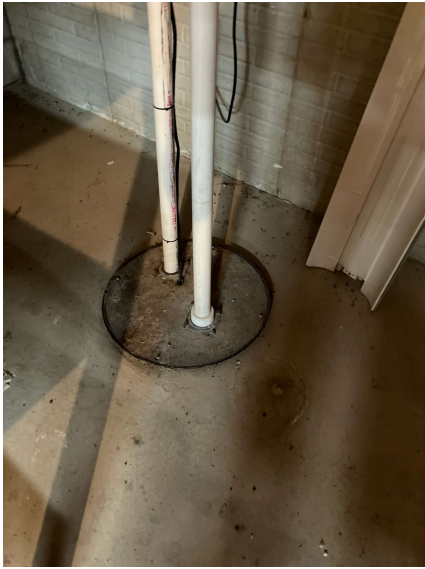
Description: Typical sealed sump

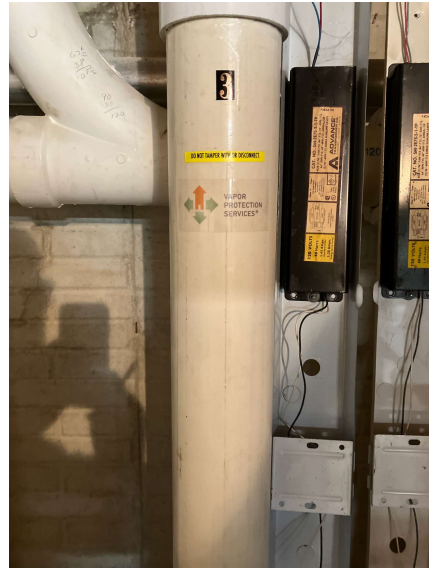
Description: Pipe with labelling

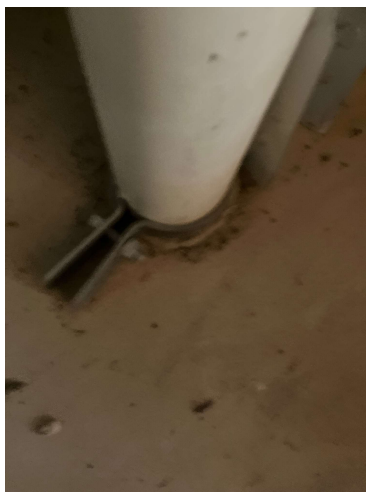
Description: Typical seal at floor

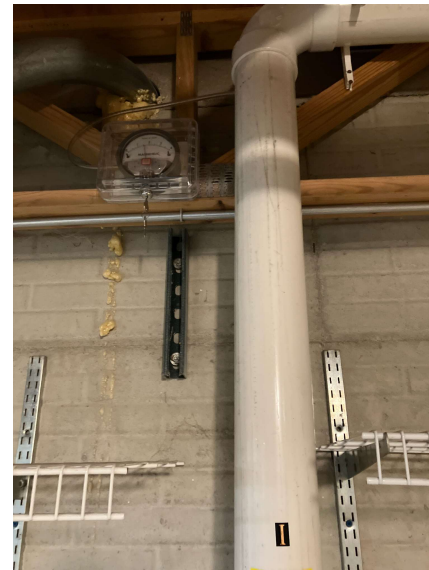
Description: Typical gauge
