Supplemental Checklist for Vapor Mitigation Continuing Obligations

BRRTS Site Name Distinctive Cleaners Activity Number 02-68-245535

System Address(es) 13855 W North Avenue, Brookfield Current Site Use(s): Vacant office/retail

Inspected By: R. Hoverman/P. Grittner Date 8/24/2023

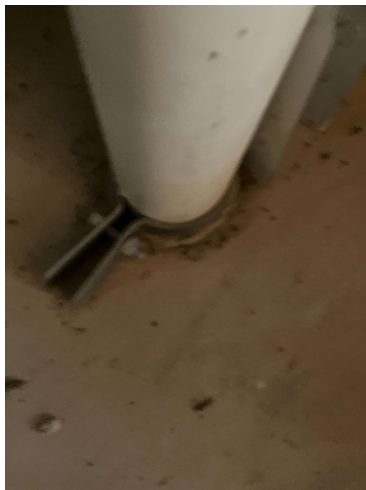
Description: Typical seal at floor

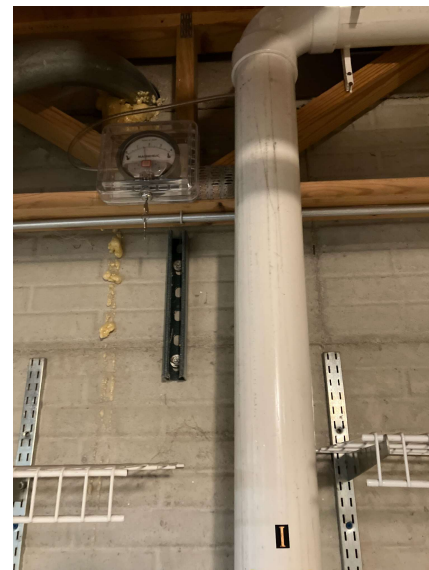
Description: Typical gauge
