From: Grittner, Paul V - DNR
Sent: Thursday, September 28, 2023 3:56 PM
To: Frank Damato
Subject: Inspection forms - 13855 W North Ave.

Thank-you for providing documentation that inspections of the vapor mitigation system and cap at the Distinctive Cleaners site (13855 W North Avenue, BRRTS # 02-68-245535) have been completed. Please remember to conduct these inspections at least once a year, complete repairs on the system and cap as needed, and keep a copy of the maintenance plans and all completed inspection forms on the property.

Activity (Site) Name BRRTS No. 02-68-245535
DISTINCTIVE CLEANERS

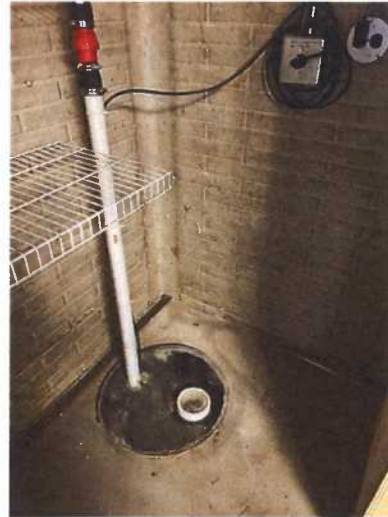
Sump Crock 1

No visible defects in the Lid and Lid seal and View Port seal in good condition. All discharge lines in good condition with no sign of damage. Photo taken on 9/27/23

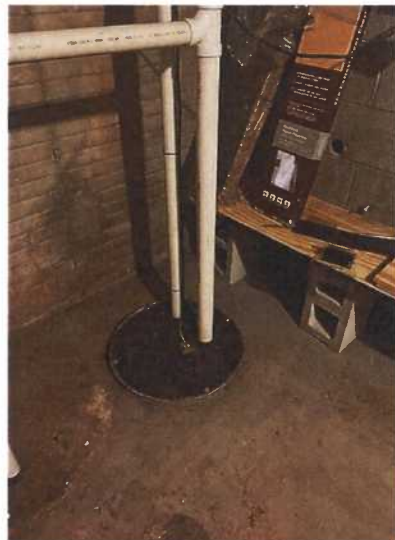
Sump Crock 2

No visible defects in the Lid and Lid seal and View Port seal in good condition. All discharge lines in good condition with no sign of damage. Photo taken on 9/27/23

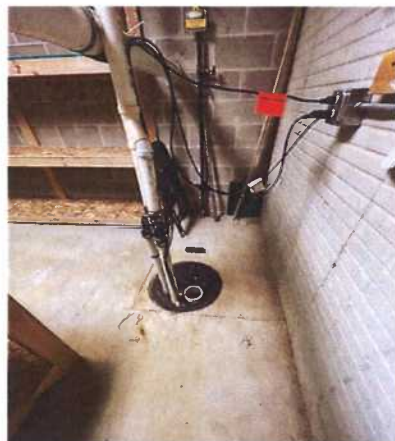
Sump Crock 3

No visible defects in the Lid and Lid seal and View Port seal in good condition. All discharge lines in good condition with no sign of damage. Photo taken on 9/27/23

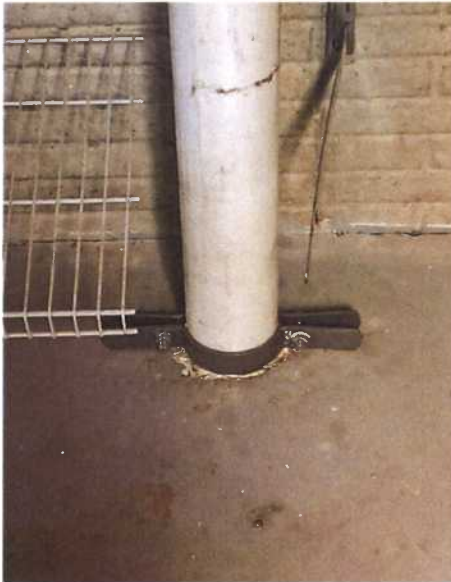
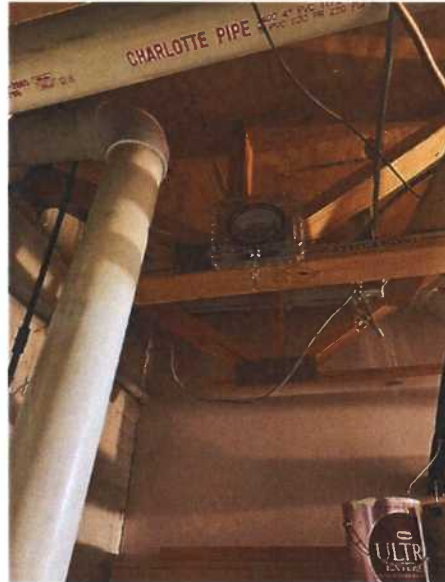
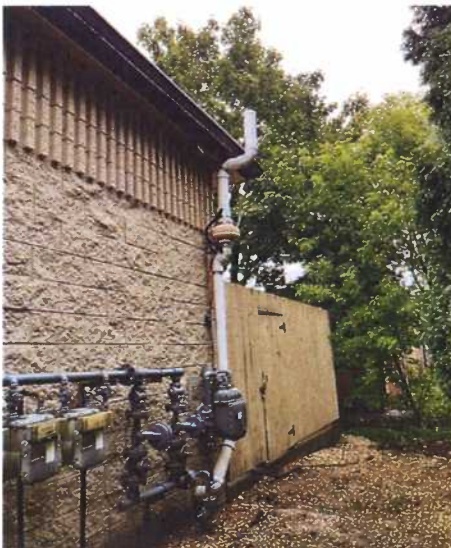
Mitigation Vacuum System 1

All extraction points were checked and shown to be sealed. Fan is operational and the alarm indication light was observed to be green. Vacuum gauge at the time of inspection read 1.6. Exterior exhaust vent was observed to be free of any debris.

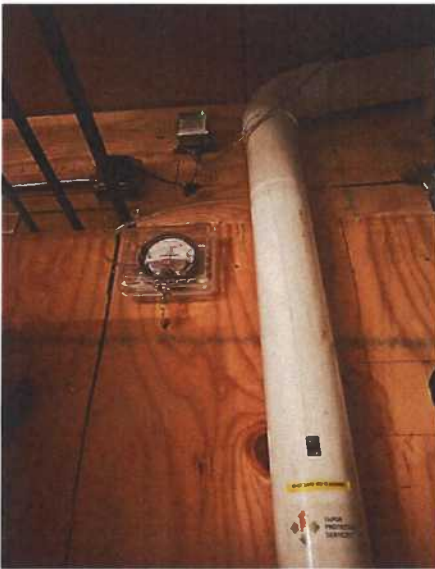
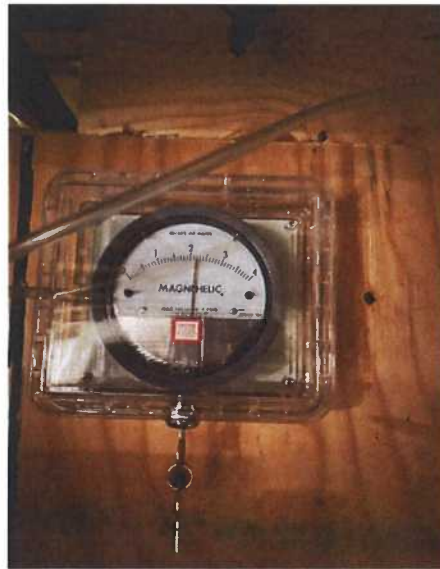
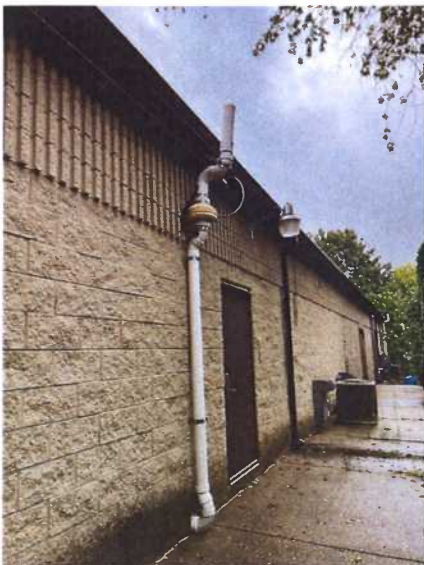
Mitigation Vacuum System 2

All extraction points were checked and shown to be sealed. Fan is operational and the alarm indication light was observed to be green. Vacuum gauge at the time of inspection read 2.2. Exterior exhaust vent was observed to be free of an debris. Inspection was conducted on 9/27/23.

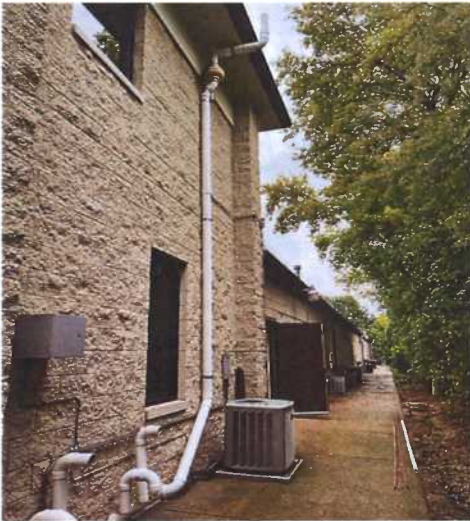
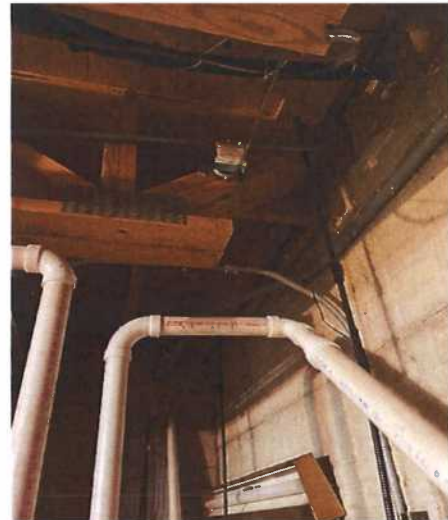
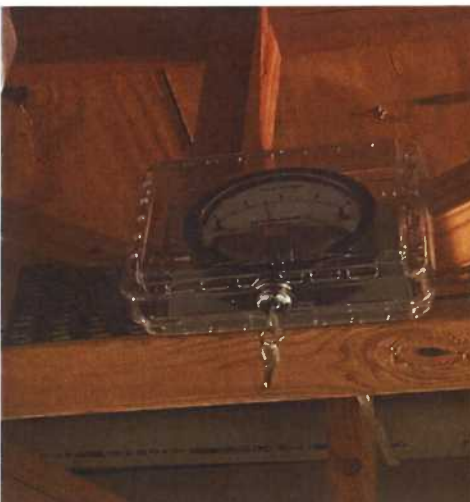
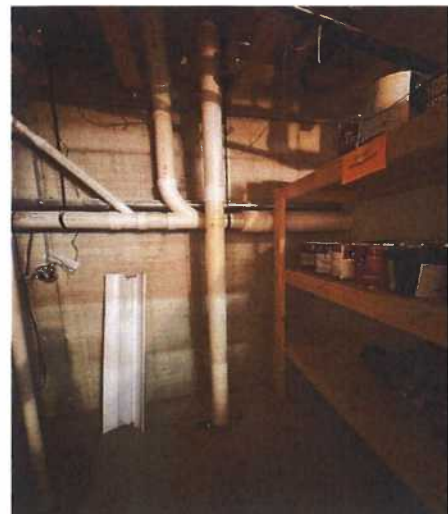
Mitigation Vacuum System 3

All extraction points were checked and shown to be sealed. Fan is operational and the alarm indication light was observed to be green. Vacuum gauge at the time of inspection read 1.5. Exterior exhaust vent was observed to be free of any debris. Inspection was conducted on 9/27/23.

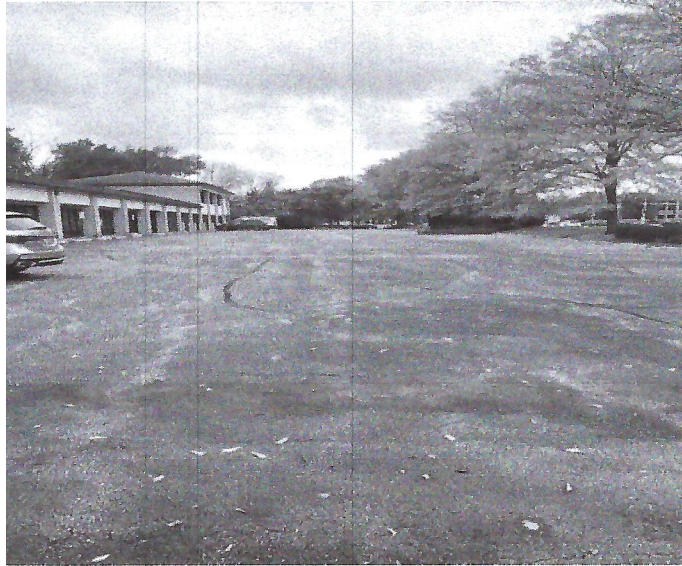
Photo 1 Looking west at existing asphalt cover between the existing building and W. North Ave. Pavement appears to be in good condition with no signs of deterioration or exposed soil.

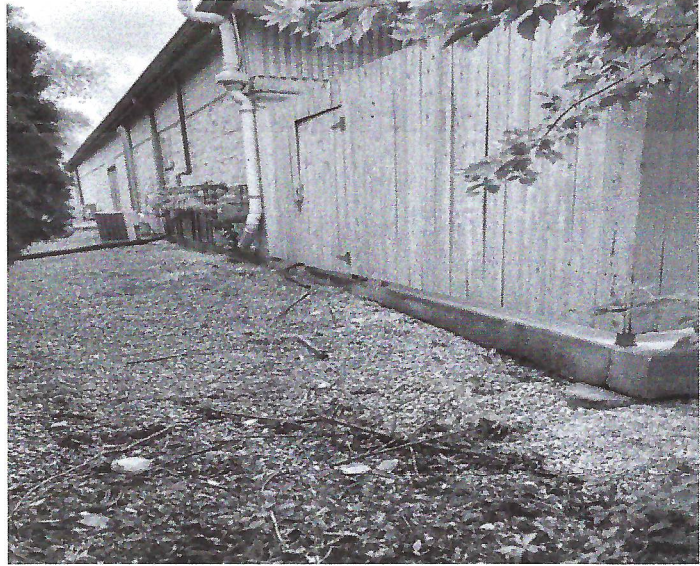
Photo 2 Looking west at the Southeast corner of building at 13855 W. North Ave. all soil shown to be covered by existing dumpster/generator concrete slab and gravel landscaping.

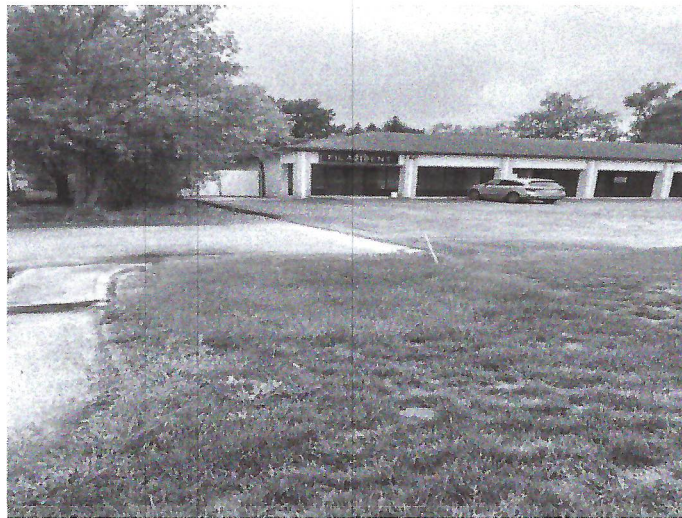
Photo 3. Looking south at existing asphalt pavement. Pavement appears to be in good condition with sign of deterioration or exposed soil.

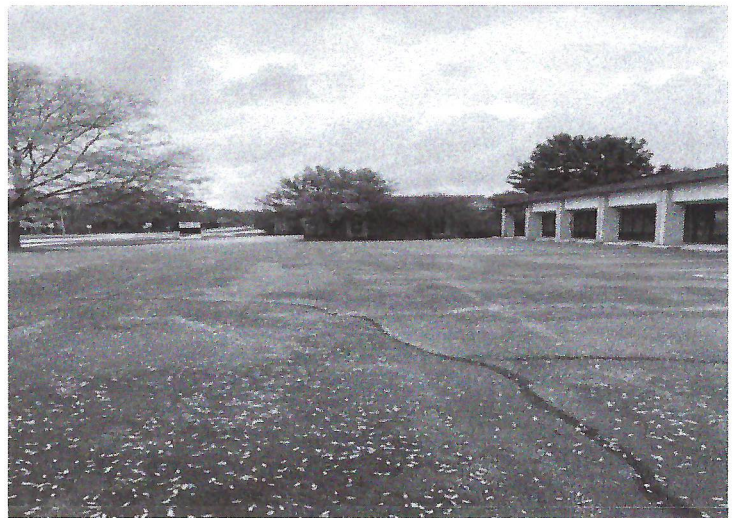
Photo 4. Looking east at existing asphalt pavement. Pavement appears to be in good condition with sign of deterioration or exposed soil.
