Subject: Review of Site Investigation Report for the Former Trent Tube Property  
2811 Church Street, East Troy, Wisconsin BRRTS #02-65-245827

The Department of Natural Resources (Department) reviewed the "Site Investigation Report" (Report) for the Former Trent Tube Property in East Troy, Wisconsin (Property). The Report was prepared on your behalf by GZA GeoEnvironmental Inc. (GZA) and submitted to the Department on EnPro Holdings, Inc.'s (EnPro) behalf on December 7, 2022. A Wis. Admin Code ch. NR 749 review fee was included with the submittal. The nature of the Report and the complexity of the varied environmental conditions at the Property necessitated an extended review time.

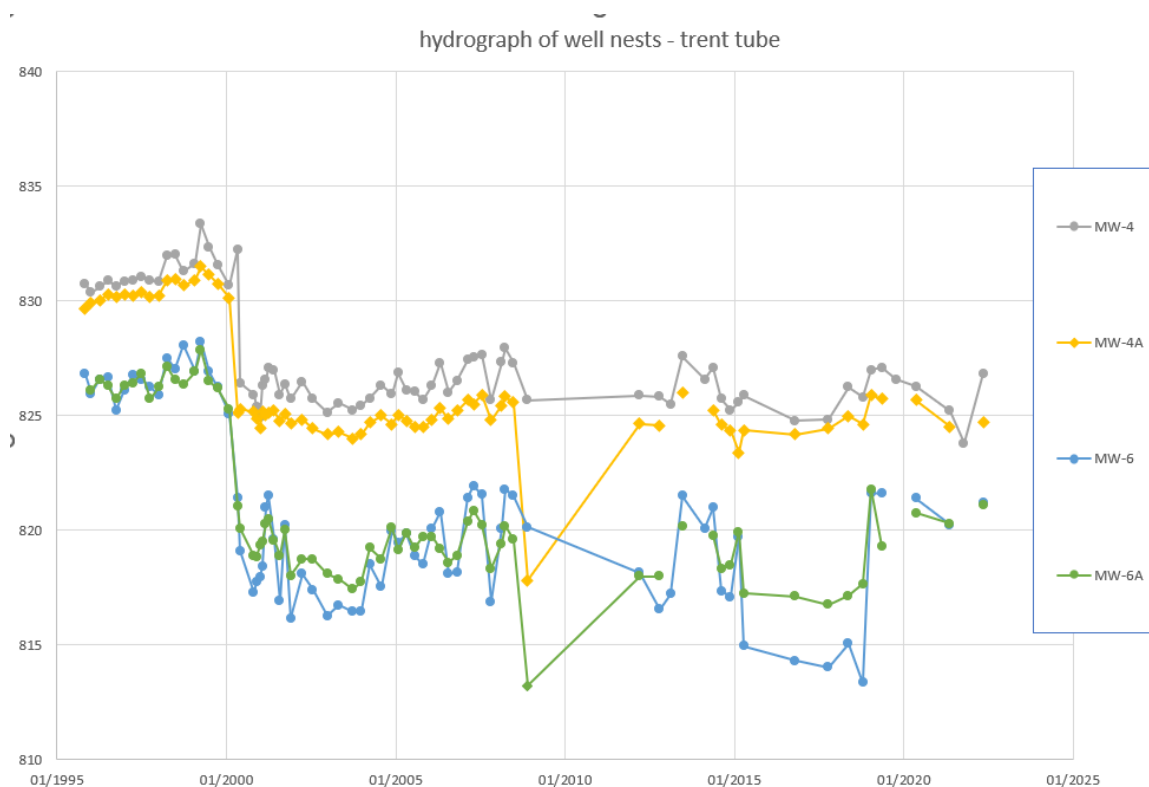
The discussion of vertical gradient on is oversimplified. The discussion should not be limited to the last five events. An analysis of the nearly 30-year record should show that the MW-6 nest has variable gradient direction, whereas the MW-4 well nest has consistent downward gradients.

The downward gradient at the MW-4 nest, which is less than 100 feet from Honey Creek, does not support the conceptual model of an aquitard and complete hydraulic capture of contaminated groundwater by Honey Creek.

- Better characterization of the presumed aquitard.
- Better evaluation of vertical gradients and contaminant migration at depth.
- Consistent downward gradients at well nest MW-4.
- Potential presence of DNAPL at the site.
- Multiple source areas over a 13+ acre site.
