From: [Hnat, John J - DNR](#)
To: [DOT Hazmat Unit](#)
Subject: RE: Notice of Contamination
Date: Wednesday, July 29, 2020 7:17:00 AM
Attachments: [20200720_11_Closure_Final_OHM108.pdf](#)

The purpose of this email is to provide notification that residual soil and groundwater contamination exists under South 108th Street, West Allis, WI right-of-way west of the following properties:

One Hour Martinizing
2262 South 108th Street

July 20, 2020

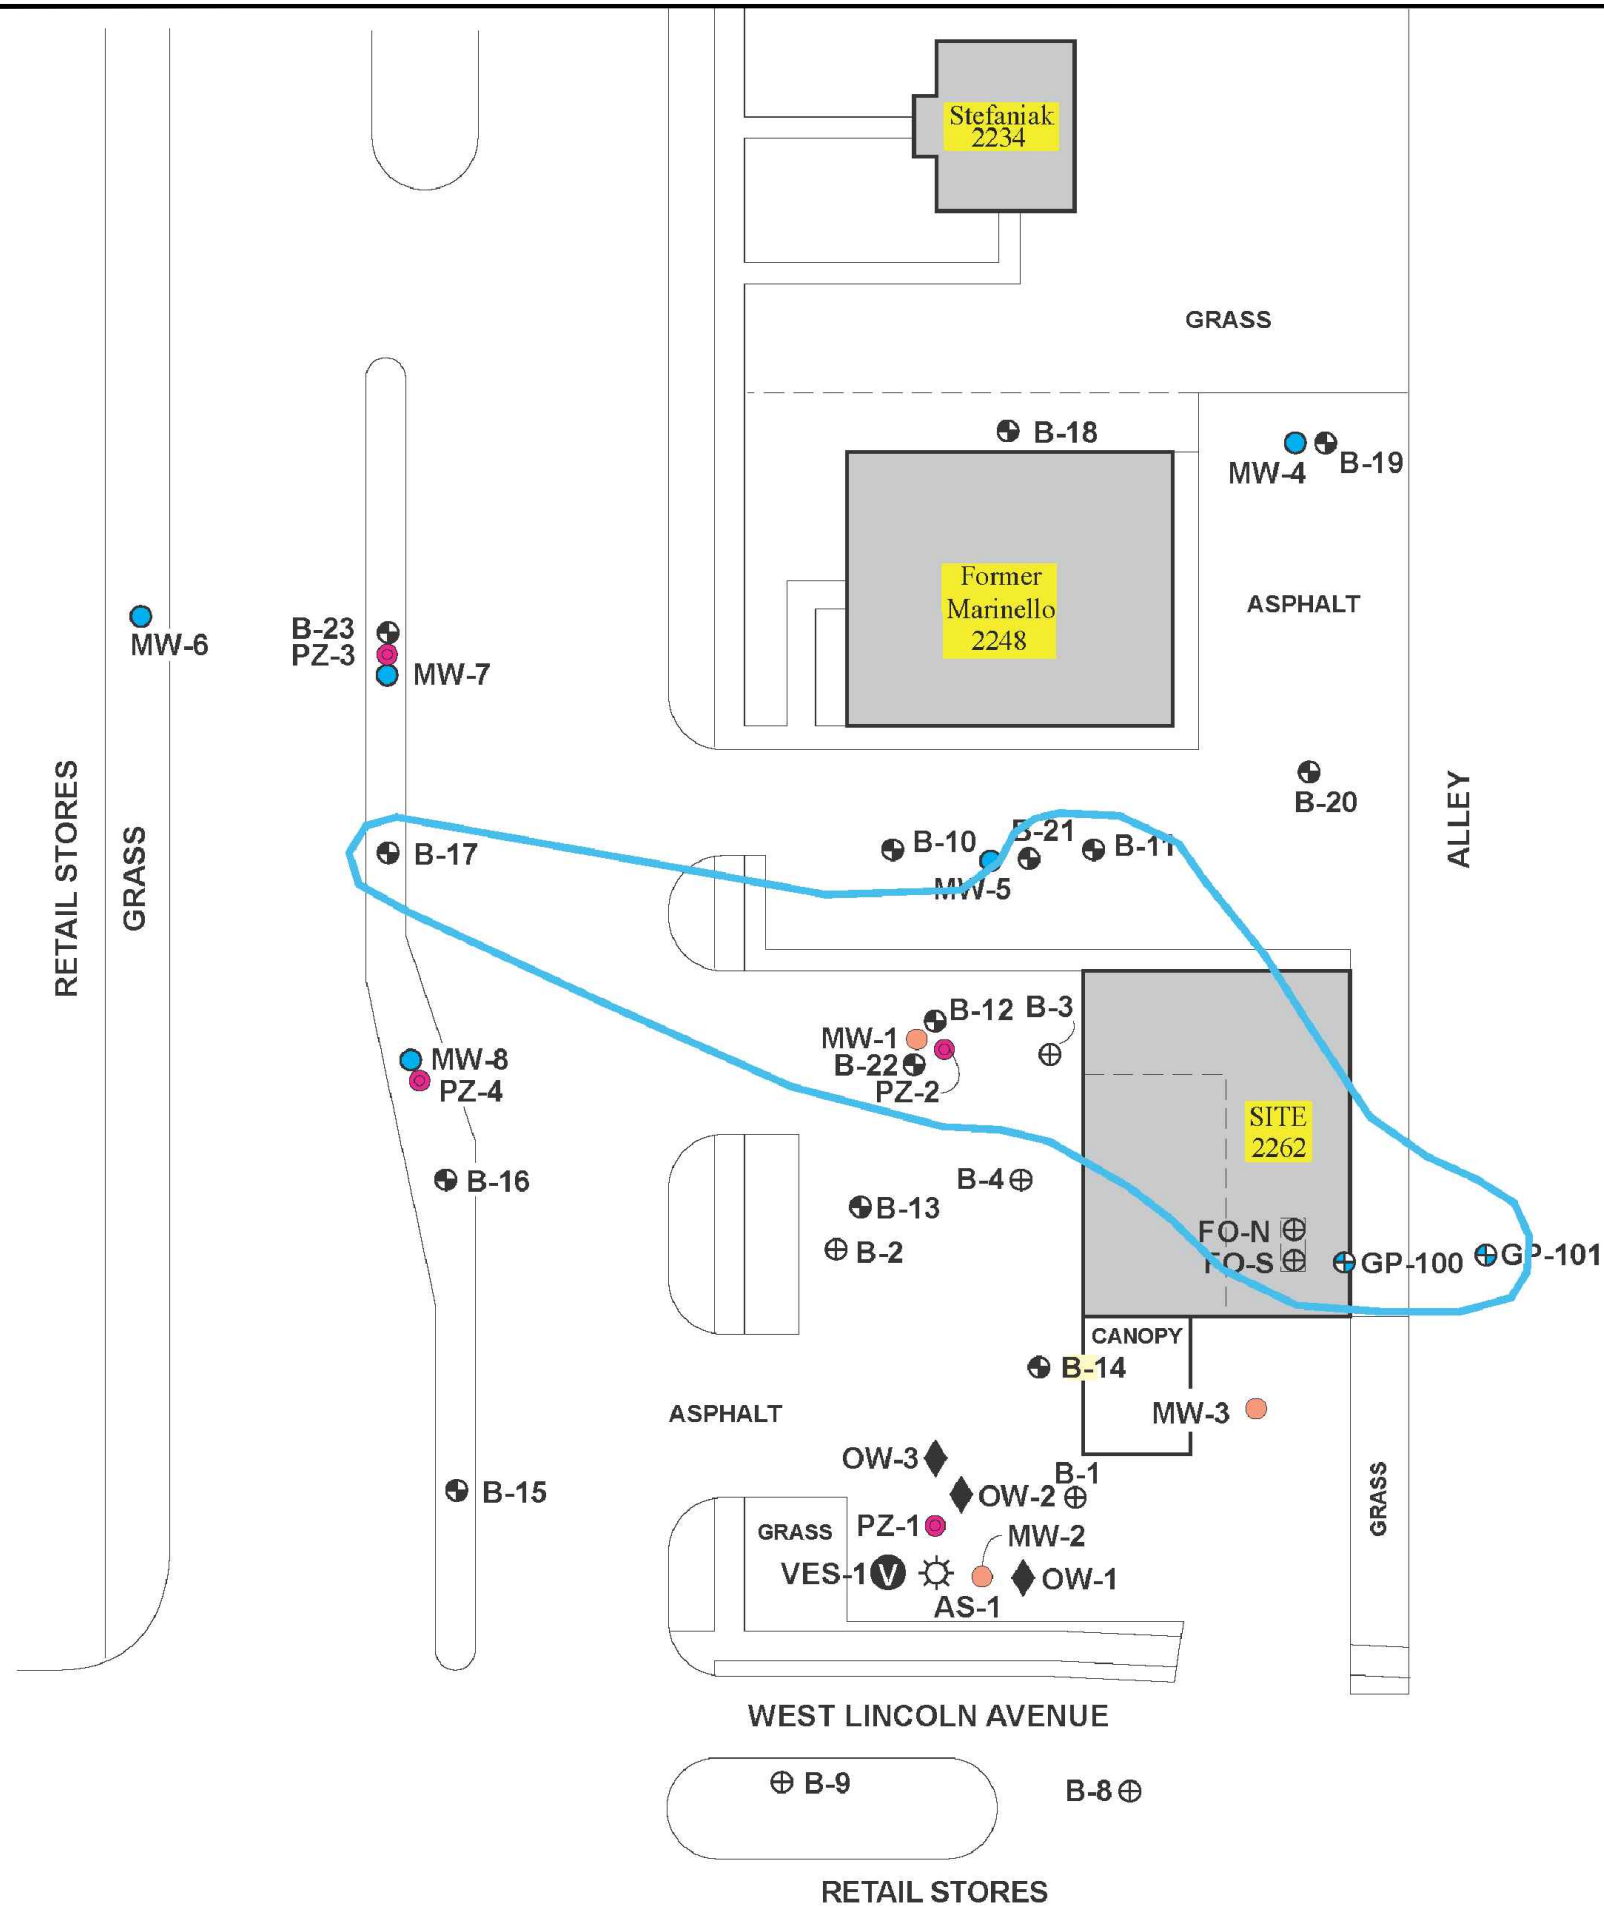
RESIDUAL SOIL CONTAMINATION

Soil contamination remains at the locations as indicated on the **attached map Residual Soil Contamination Map, Figure B.2.b, dated 5/19/20**. If soil in the specific locations described above is excavated in the future, the property owner or right-of-way holder at the time of excavation must sample and analyze the excavated soil to determine if contamination remains. If sampling confirms that contamination is present, the property owner or right-of-way holder at the time of excavation will need to determine whether the material is considered solid or hazardous waste and ensure that any storage, treatment or disposal is in compliance with applicable standards and rules. Contaminated soil may be managed in accordance with ch. NR 718, Wis. Adm. Code, with prior DNR approval. This continuing obligation also applies to the owner of 2230 South 108th Street, Milwaukee, Wisconsin, 2248 South 108th Street, Milwaukee, Wisconsin, the City of West Allis Right-of-Way, and WisDOT 108th Street Right-of-Way.

In addition, all current and future owners and occupants of the property and right-of-way holders need to be aware that excavation of the contaminated soil may pose an inhalation or other direct contact hazard and as a result special precautions may need to be taken to prevent a direct contact health threat to humans.

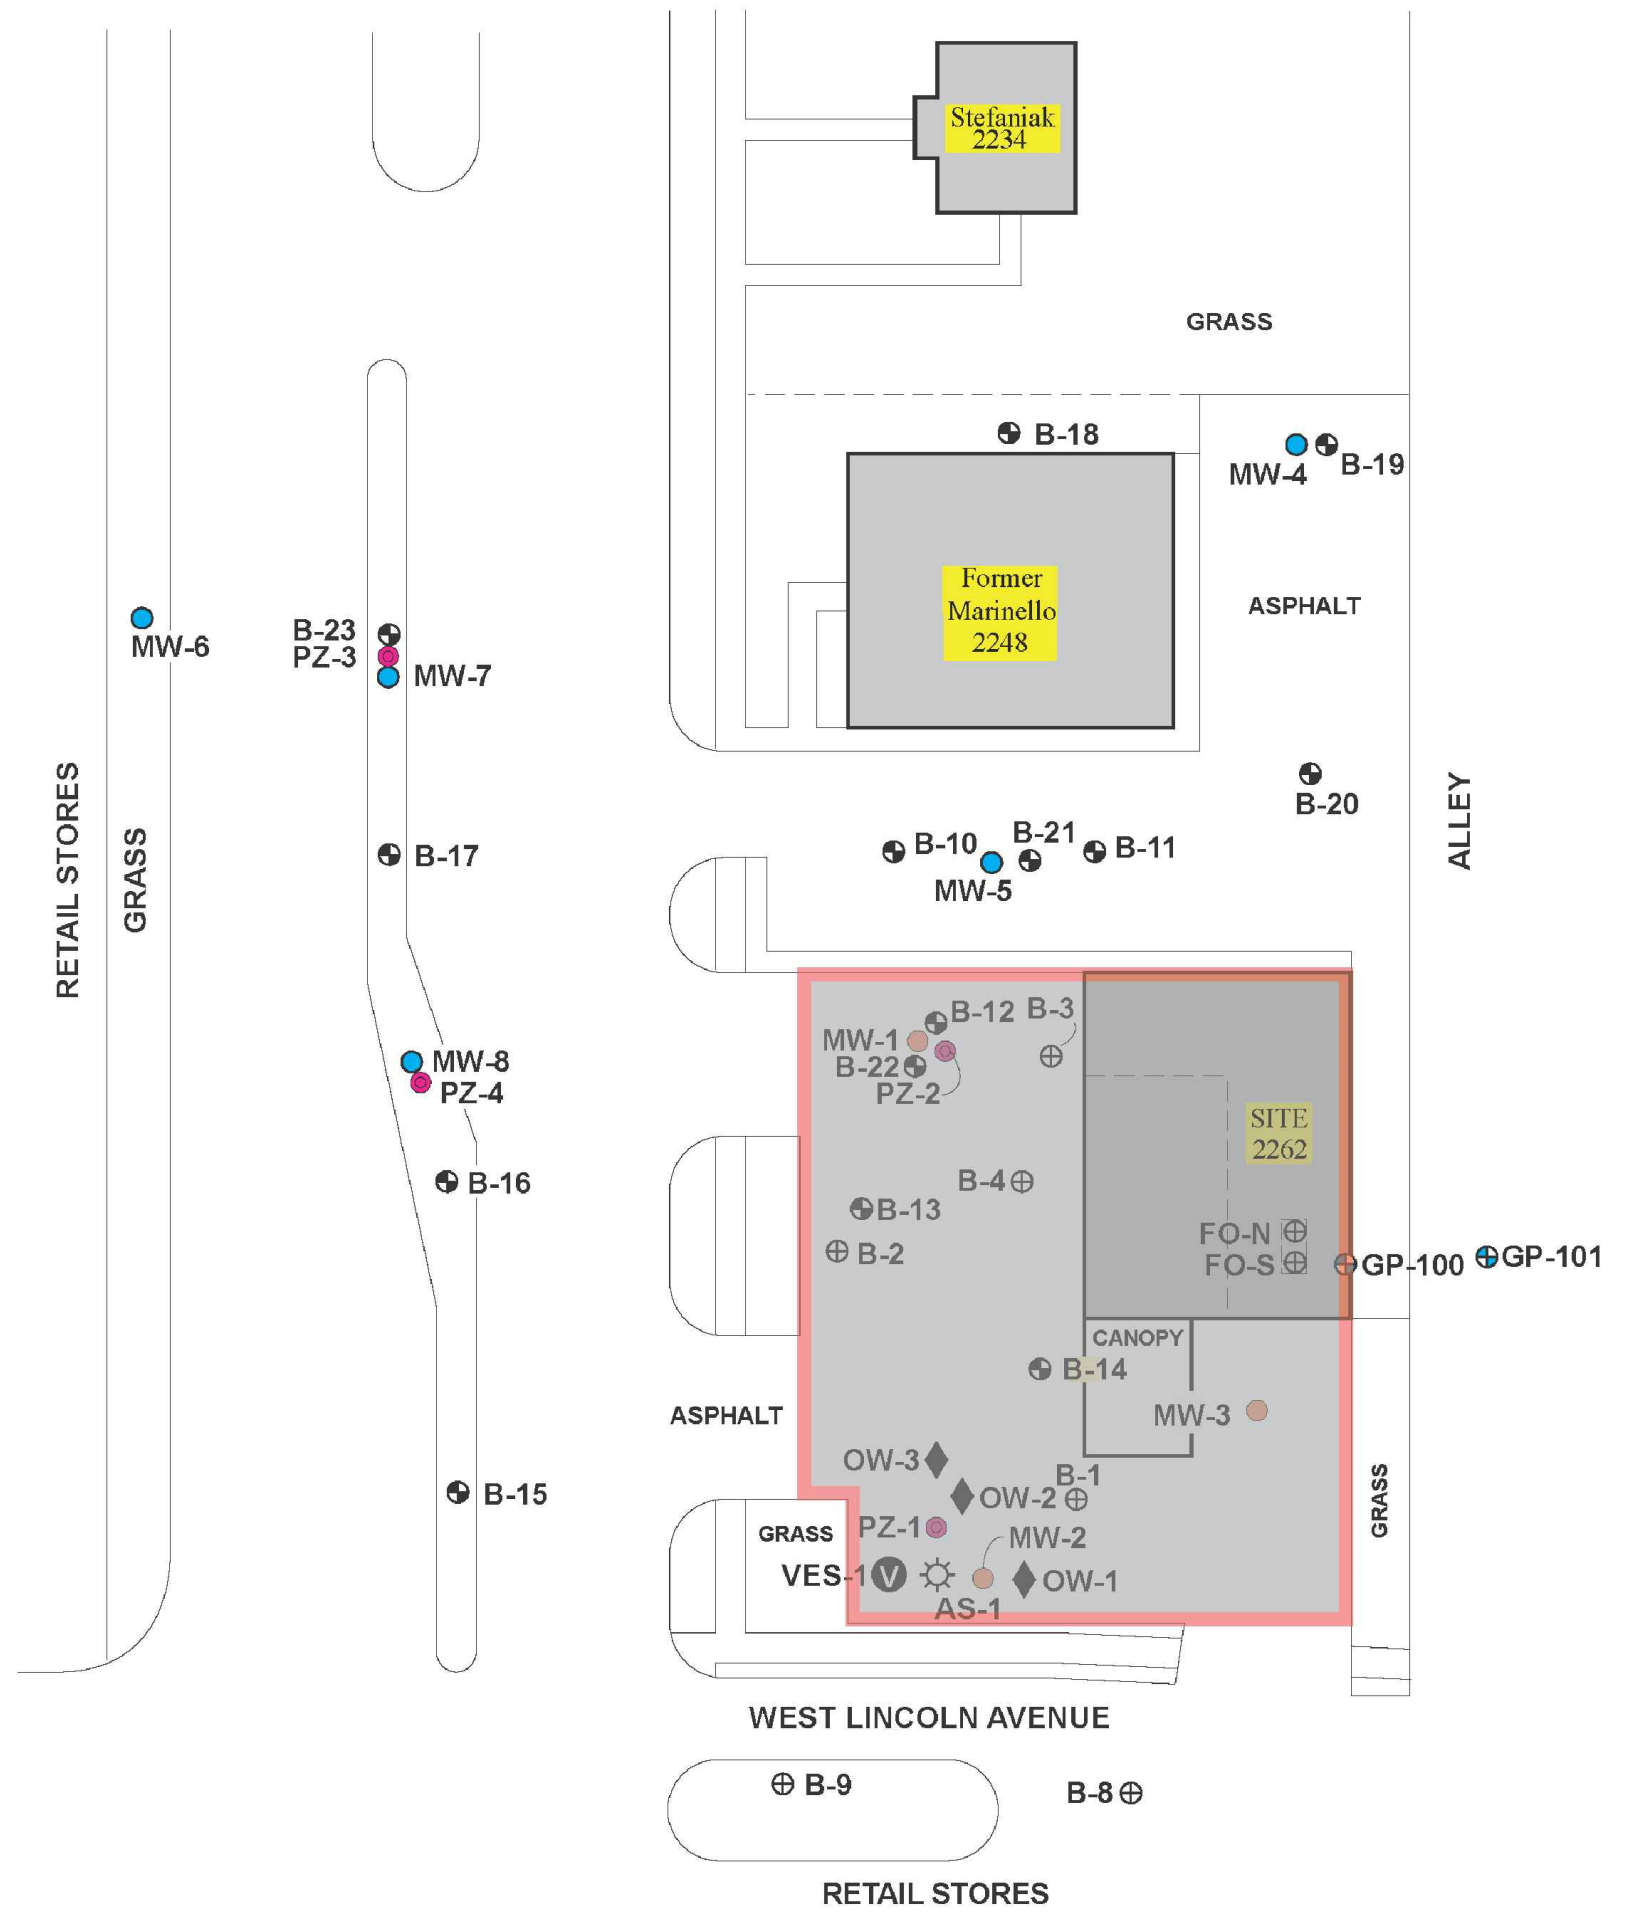
ENGINEERED CAP AREA	
OHM - Lincoln 2262 South 108th Street West Allis, Wisconsin

The pavement and building foundation that exists in the location shown on the **attached map Engineered Cap, Figure D.2, dated 5/19/20**, shall be maintained in compliance with the **attached maintenance plan** in order to minimize the infiltration of water and prevent additional groundwater contamination that would violate the groundwater quality standards in ch. NR140, Wis. Adm. Code.

The following activities are prohibited on any portion of the property where an asphalt/concrete parking lot and building foundation cap is required as depicted on the attached **Figure D.2**, unless prior written approval has been obtained from the WDNR: 1) removal of the existing barrier; 2) replacement with another barrier; 3) excavating or grading of the land surface; 4) filling on capped or paved areas; 5) plowing for agricultural cultivation; or 6) construction or placement of a building or other structure.

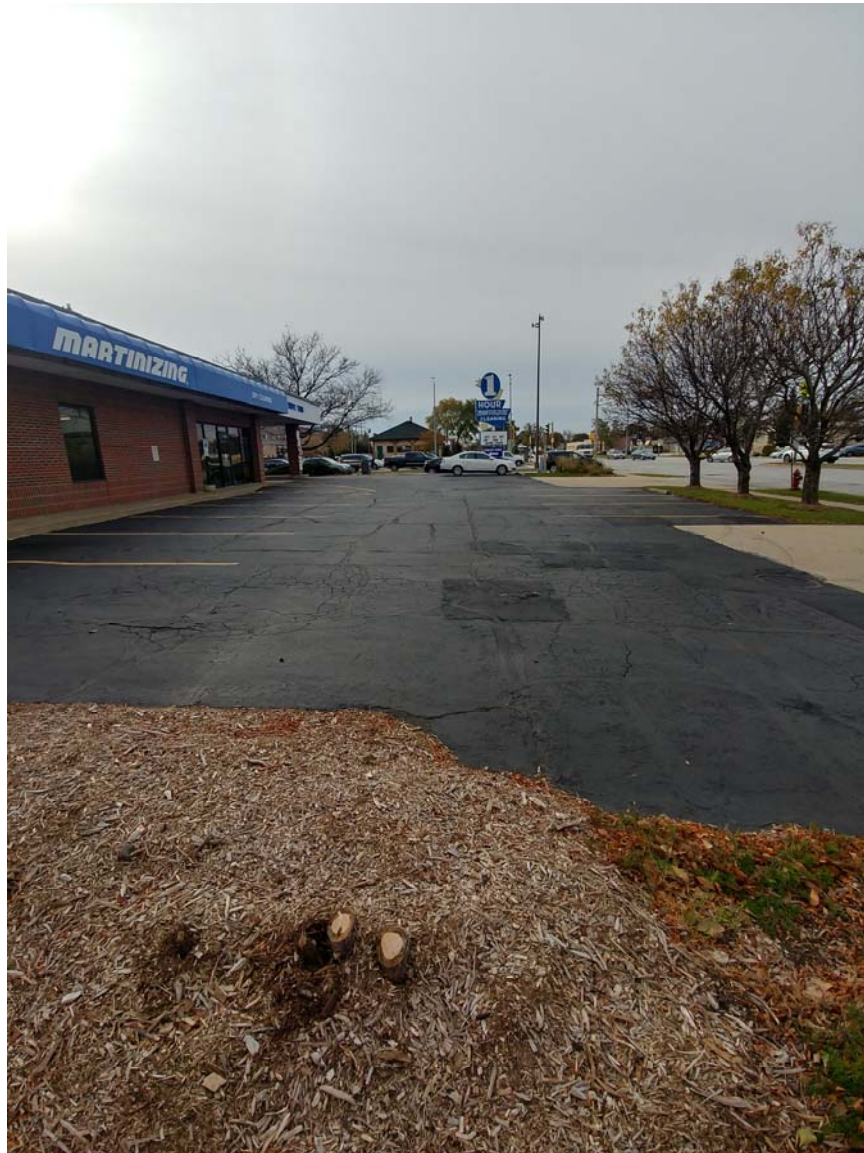
Overview of asphalt/concrete cap – facing south

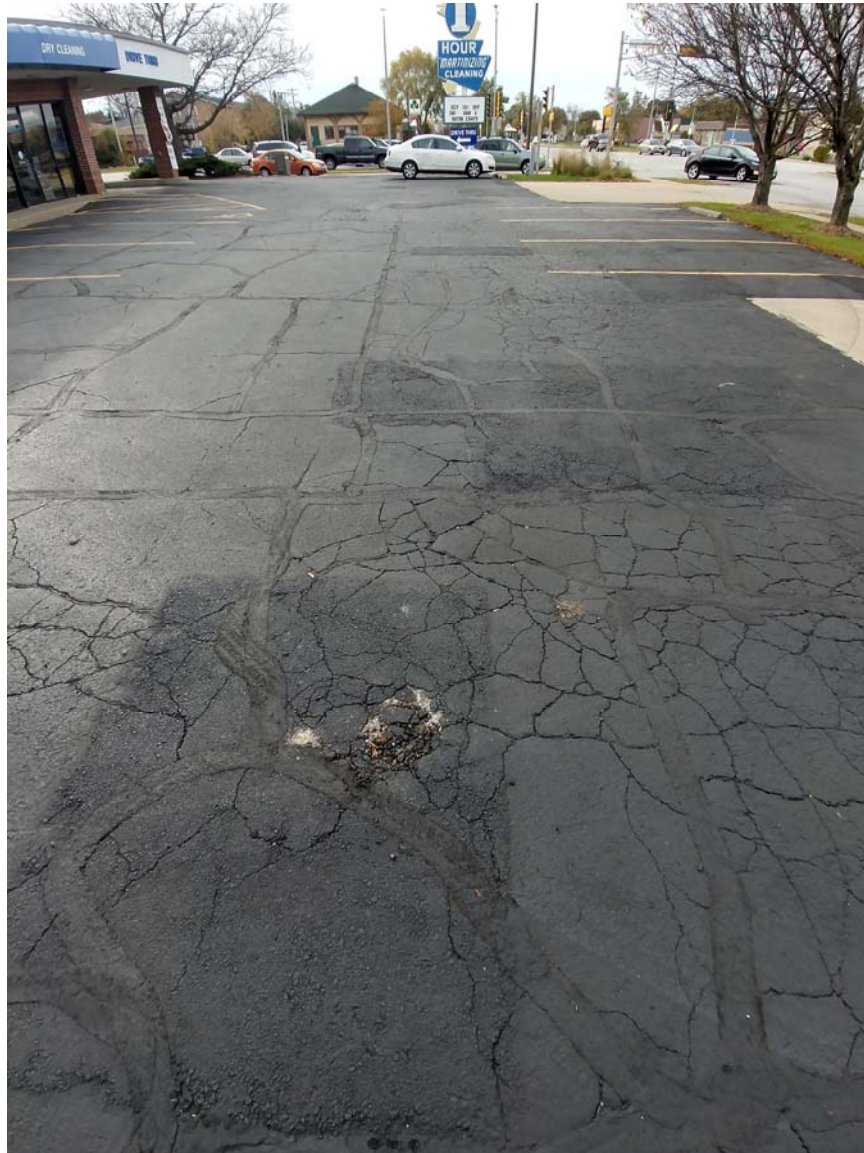
Asphalt condition in northern part of site – facing south

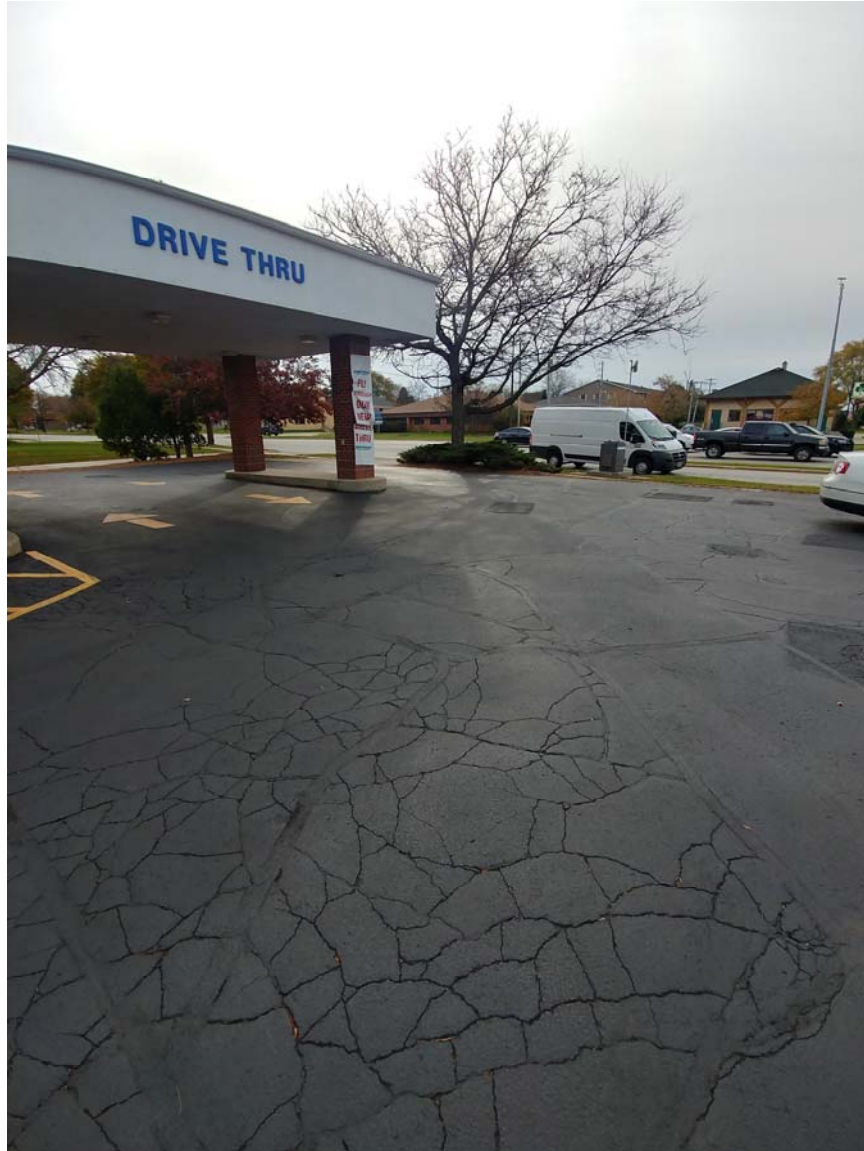
Asphalt condition in southern part of site – facing southeast

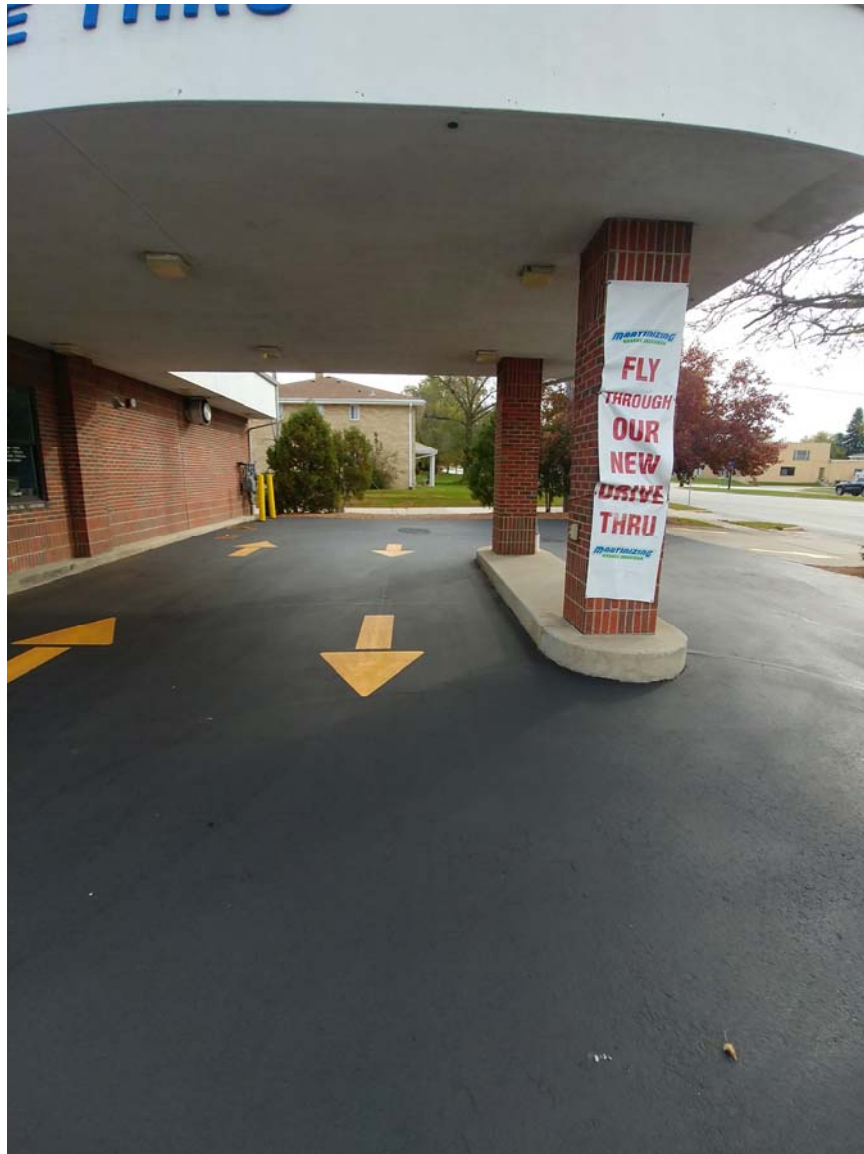
Overview of cap in drive-through area – facing east

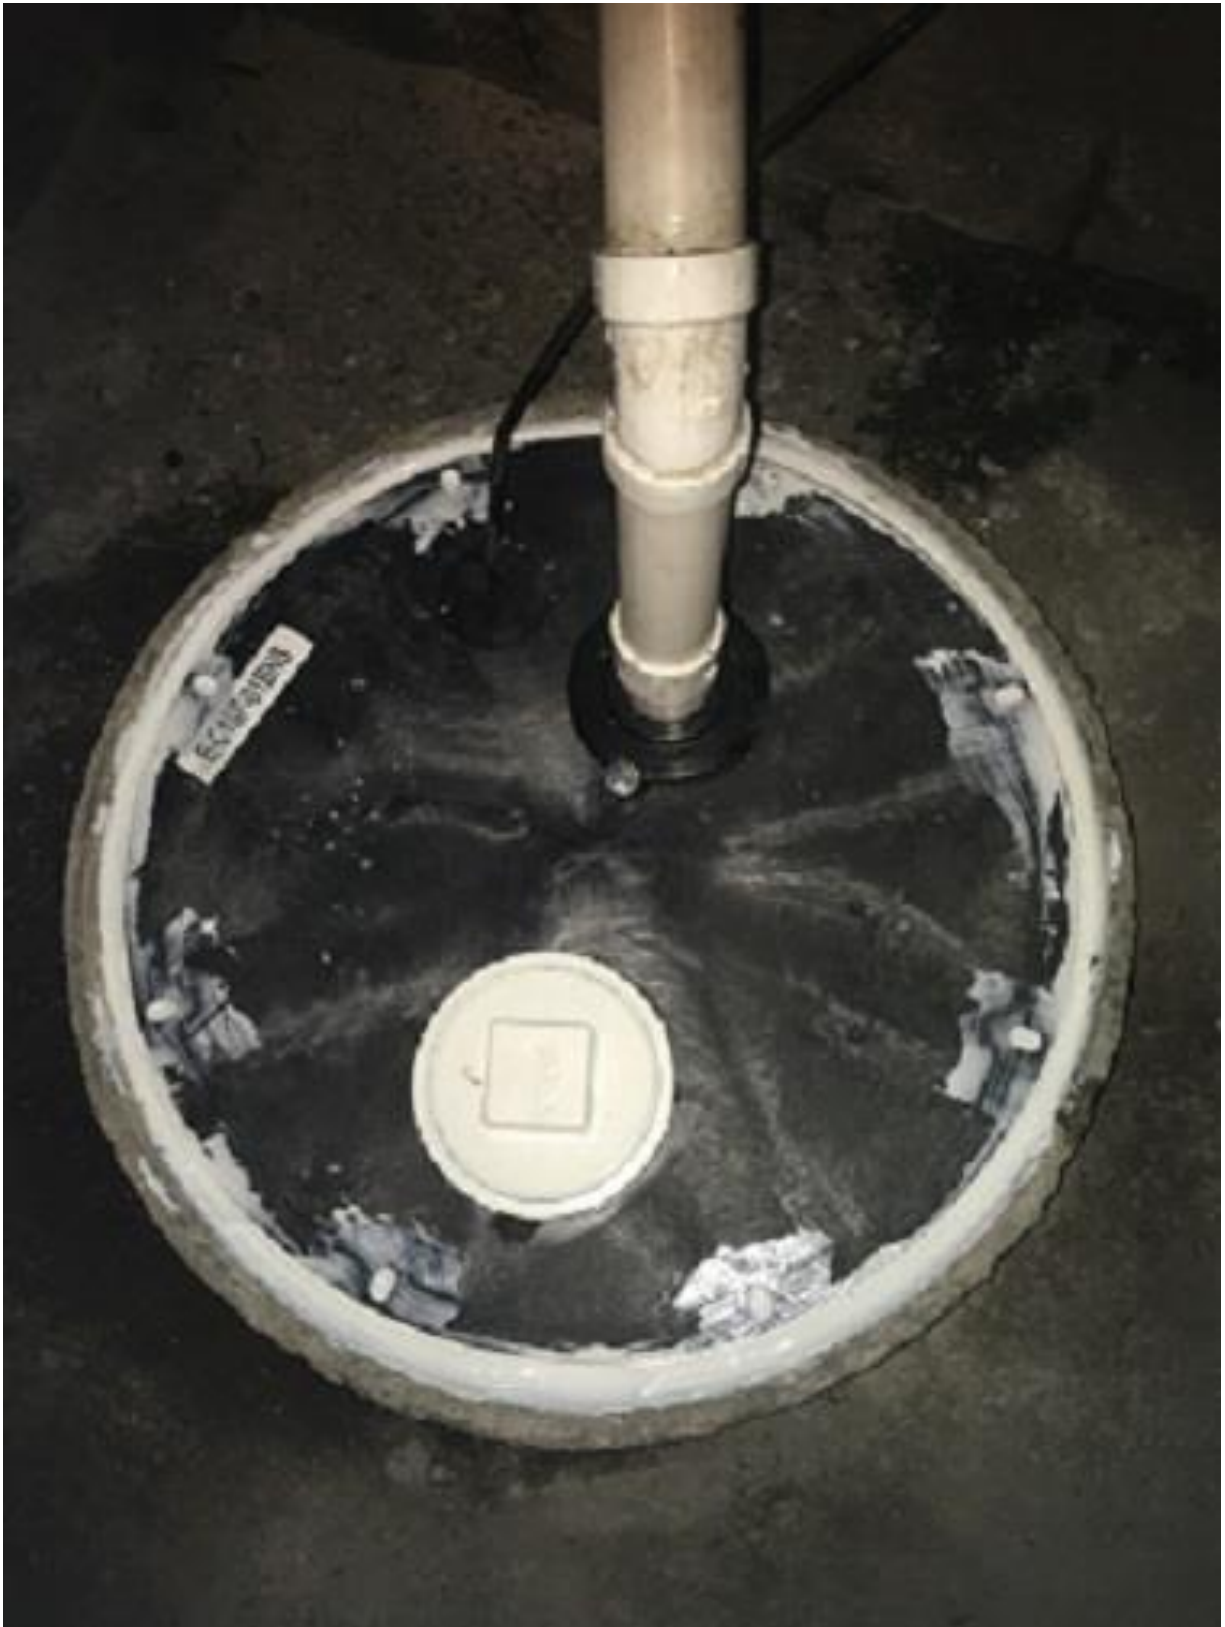
Photo #1: New vapor-tight basement sump lid with threaded plug to allow access for collecting samples.

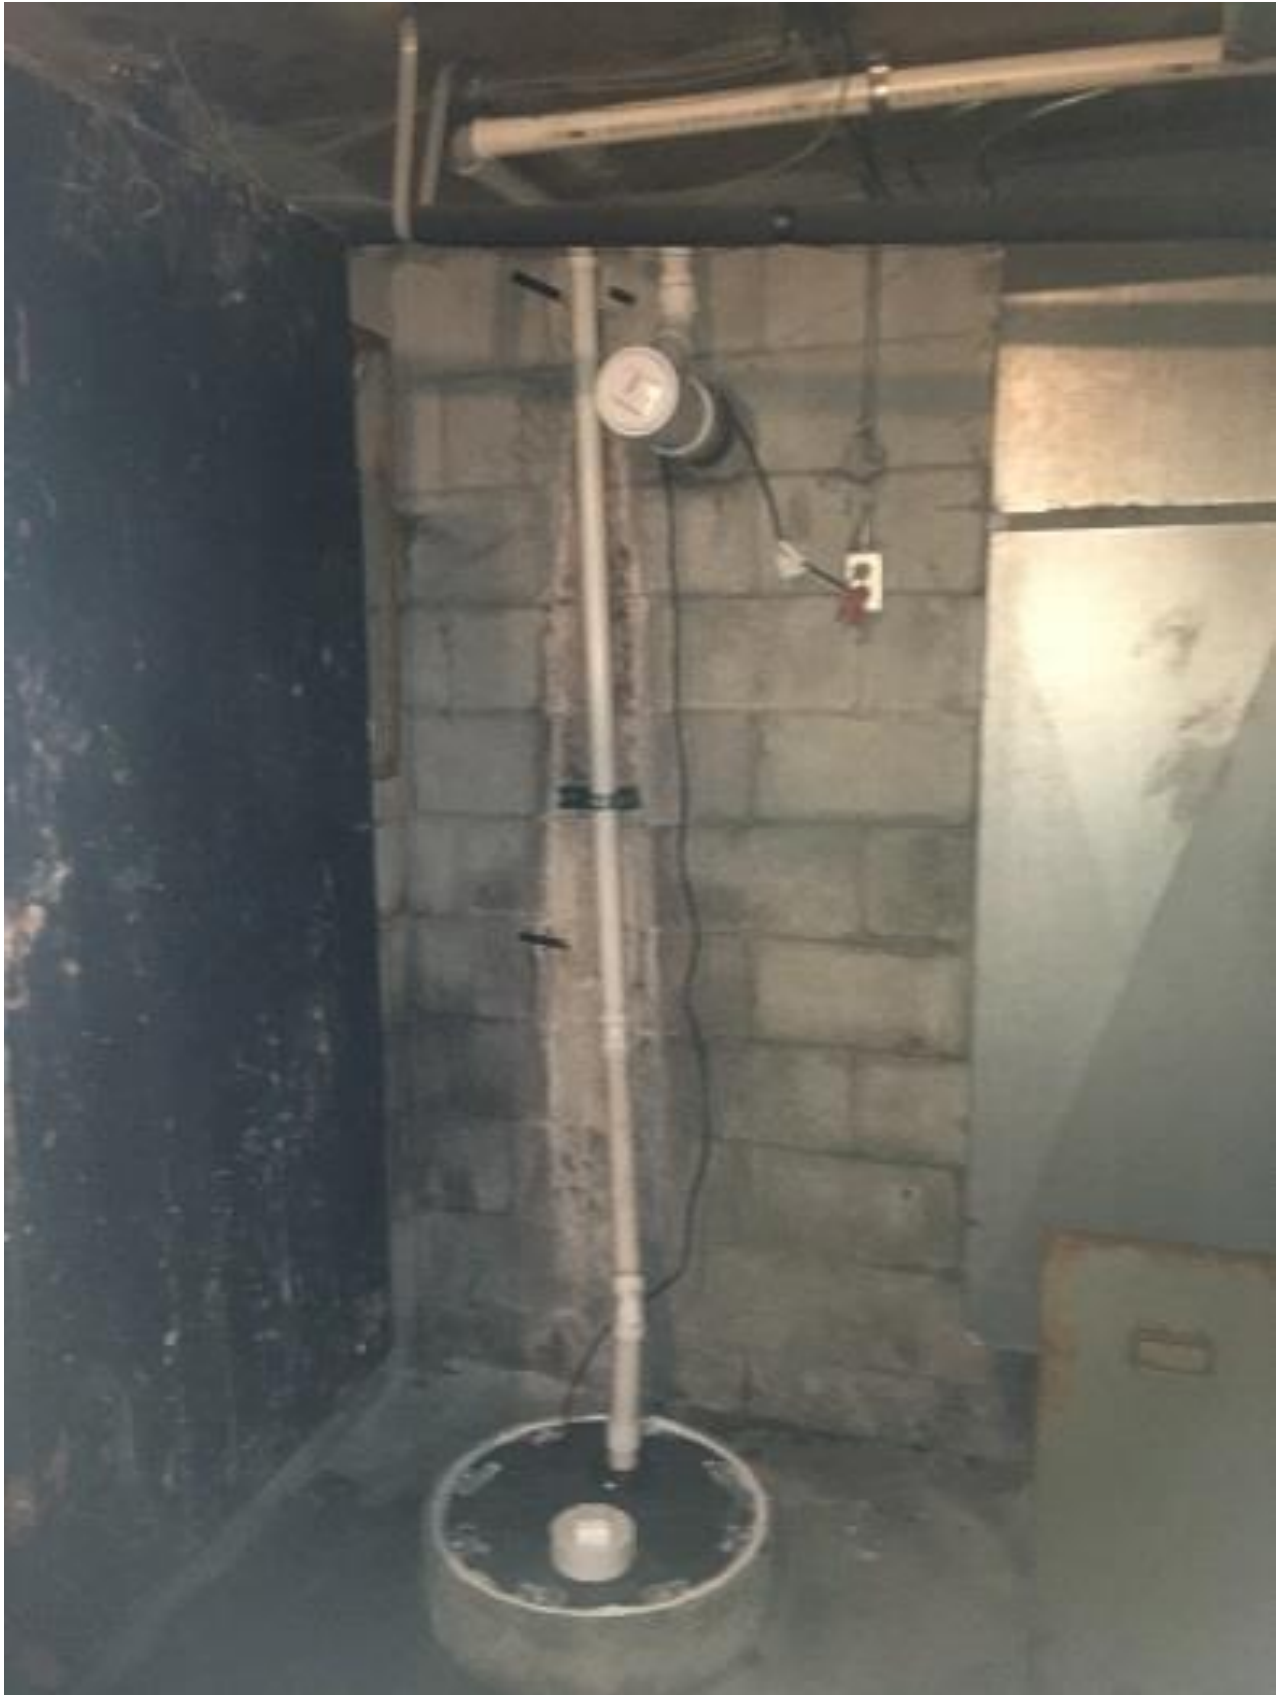
Photo #2: Basement sump and piping. Sump discharge has been disconnected from the storm sewer lateral seen adjacent right of the sump riser.

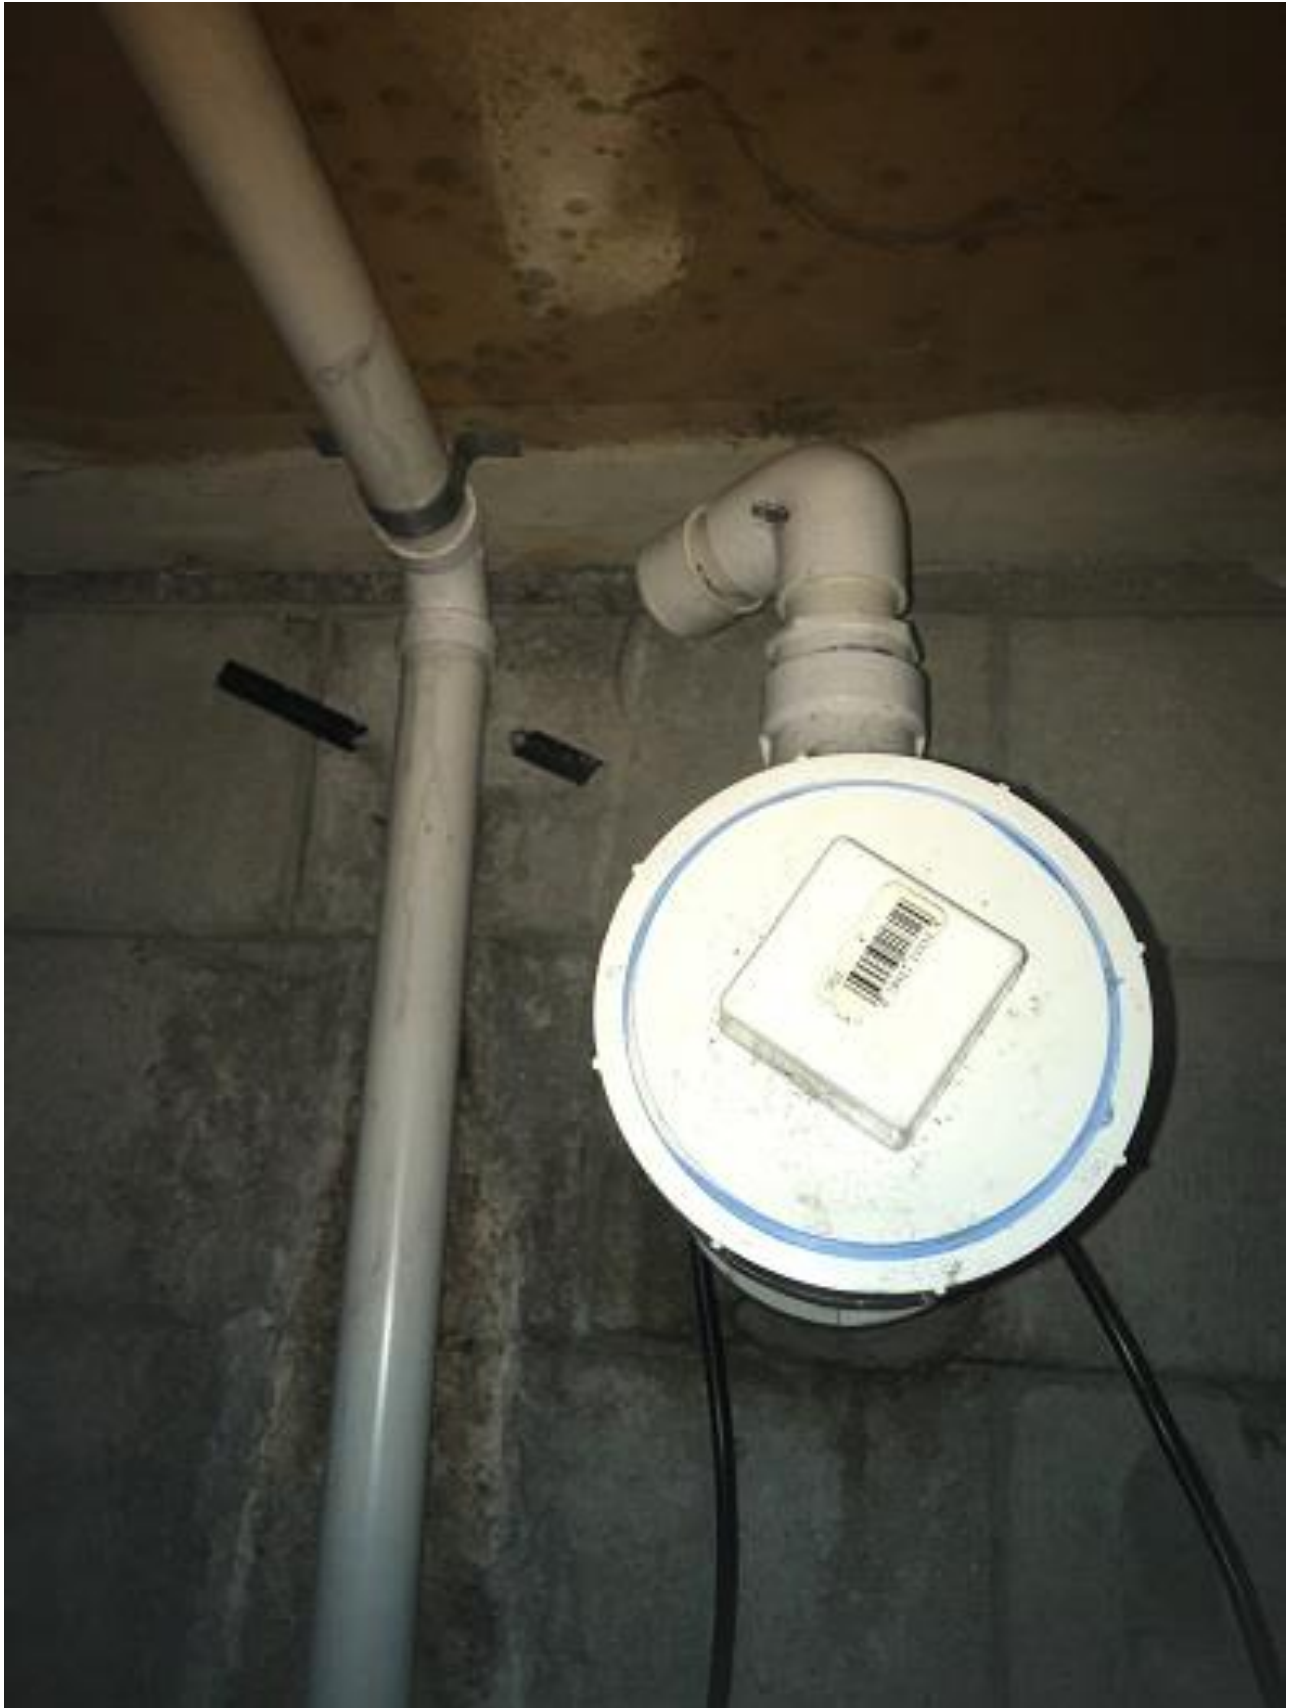
Photo #3: Close up showing that the sump discharge piping has been disconnected from the storm sewer lateral. The PVC elbow that formerly conveyed the sump discharge into the storm sewer lateral has been capped.

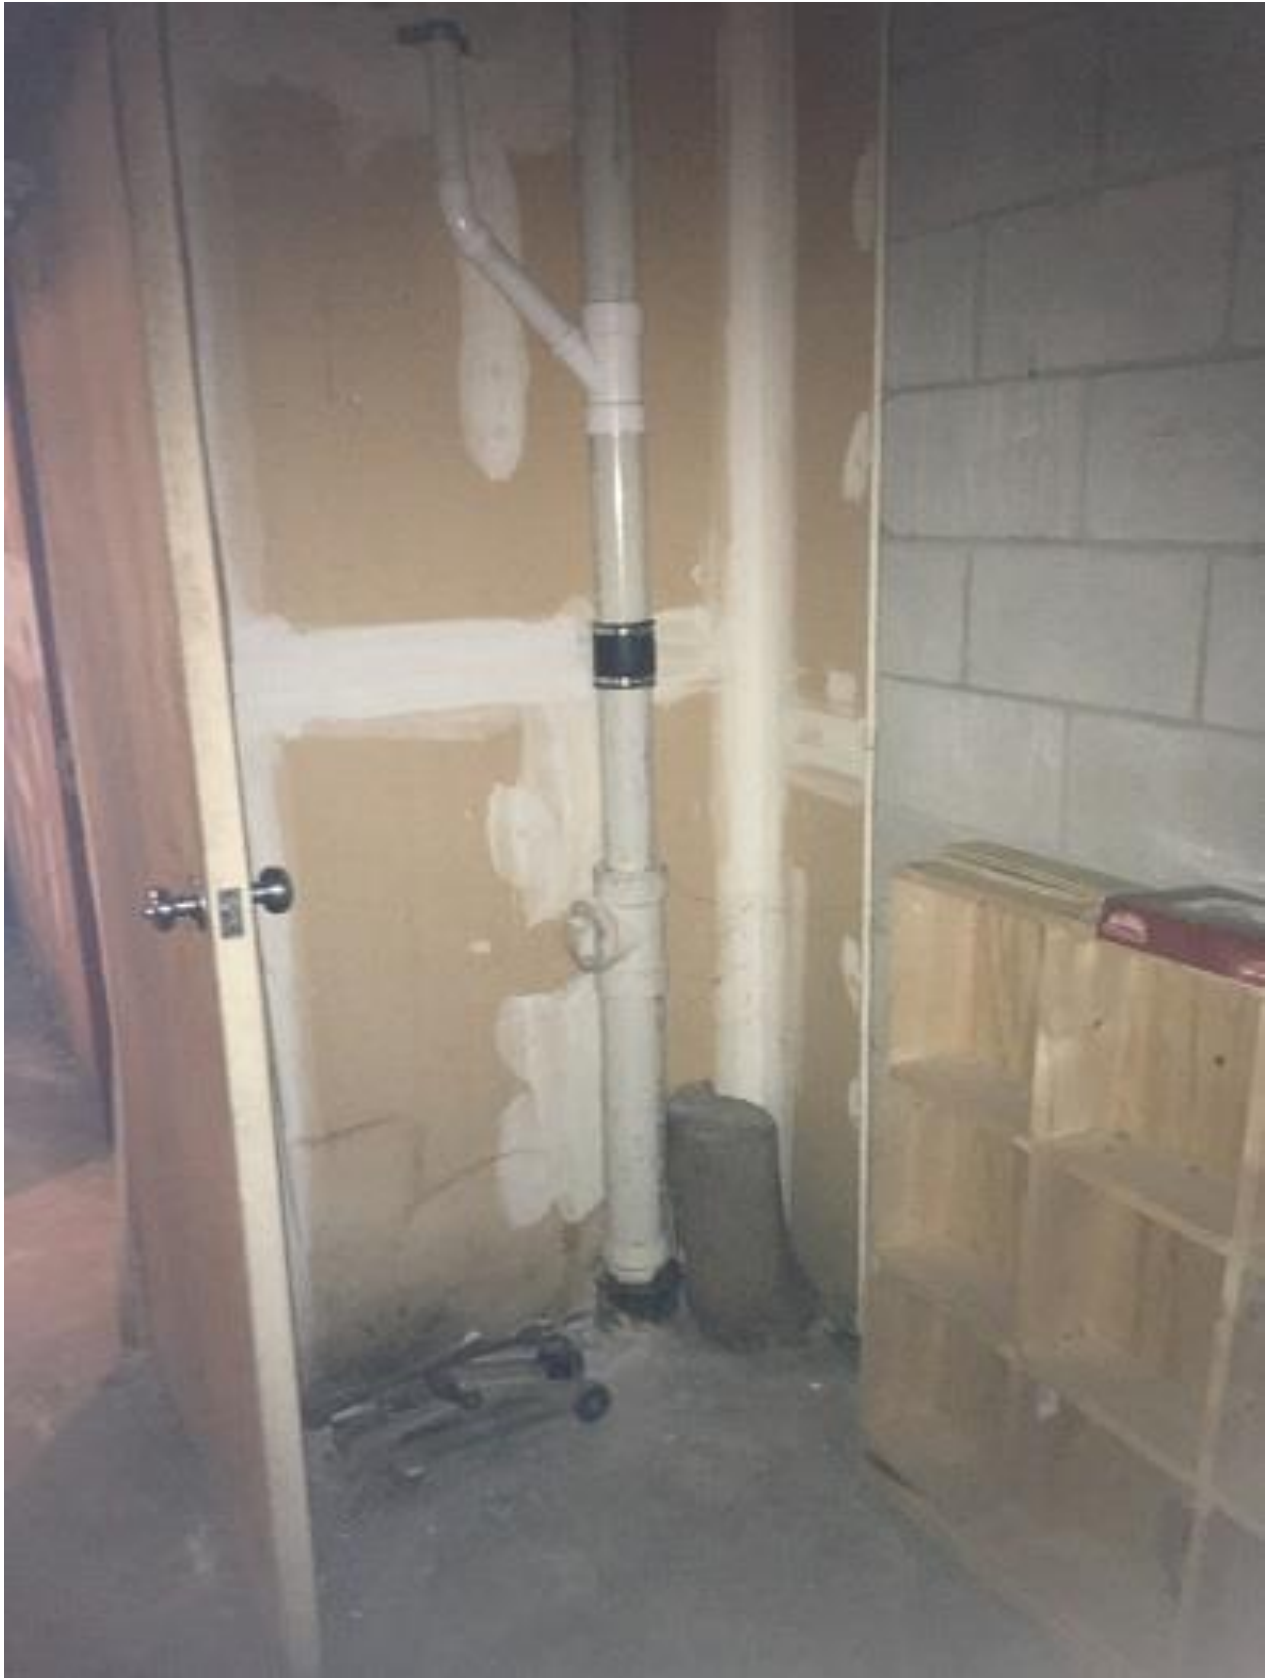
Photo #4: New sump discharge piping has been connected to a sanitary sewer lateral located just outside of the basement utility room.
