BRRTS Number: 02-16-246715

Reviewer: Erin Endsley
 Site Name: Slop Oil Manifold

Review Date: 7/22/13
 Region: NOR

Address/ City/Zip Code: 2407 Stinson Ave, Superior, WI, 54880

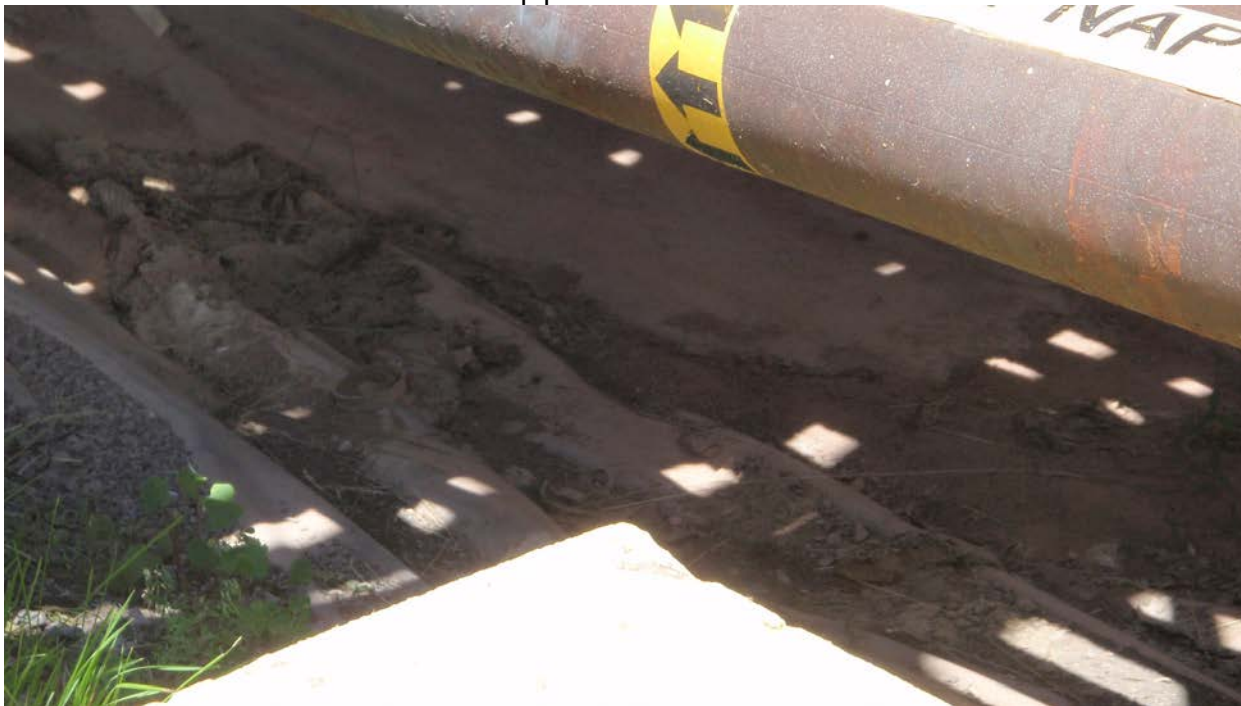
The following photos illustrate the cap at this site, which consists of a 60-mil HDPE liner. This site also has a structure impediment, due to the extensive piping associated with the manifold and pipe rack. The liner appears to be in good shape, with good seals where it meets existing piping or other structures. It is also sealed along the perimeter where it meets the concrete.

Photo 1 – west side of liner underneath pipe rack

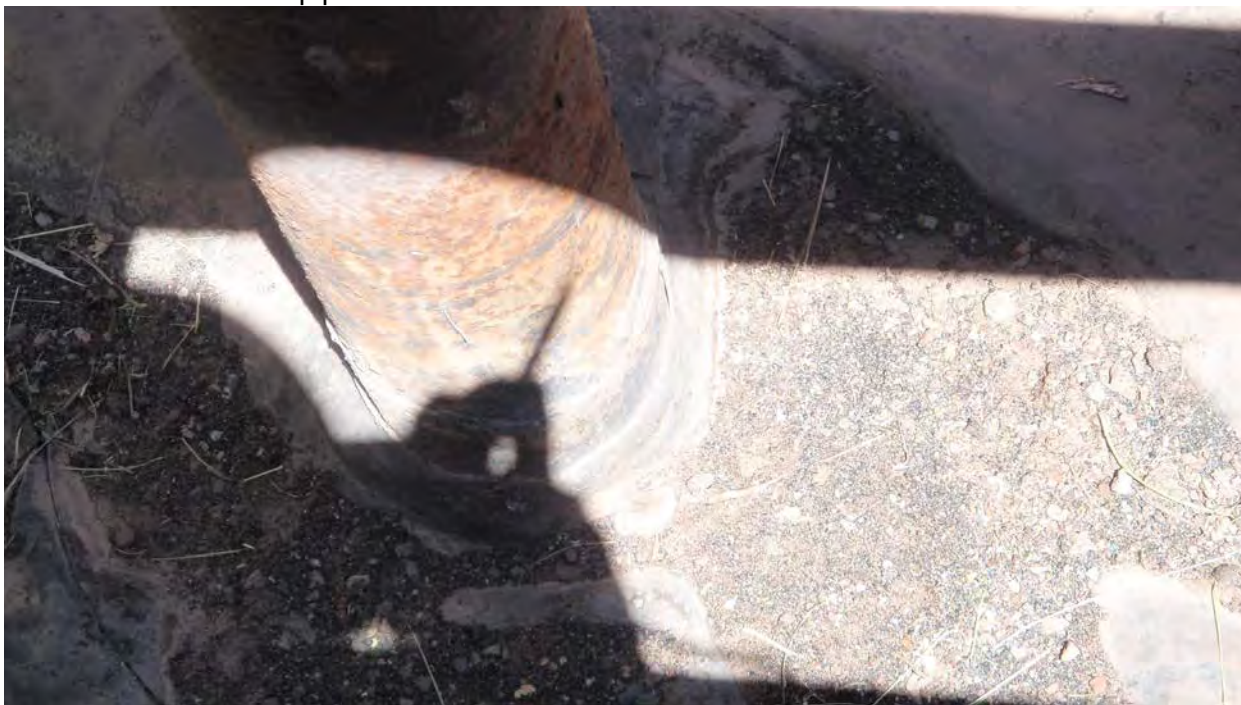
Photo 2 – seal around pipe

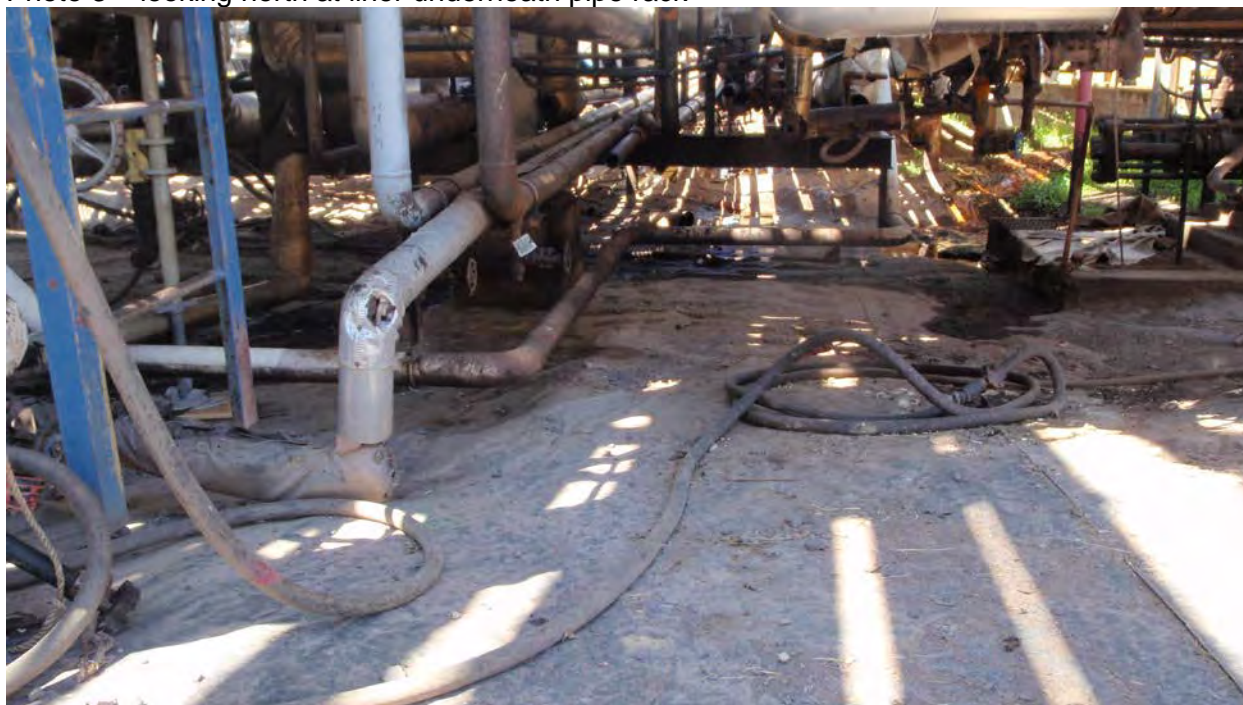
Photo 3 – looking north at liner underneath pipe rack
