**BRRTS ID No. 02-30-261259**

Site Name: Glenwood Dry Cleaners

Site Address 2713 18th St	City Kenosha	ZIP Code 53140
County Parcel Identification Number (PIN) 07-222-24-125-043	FID Number 230107240

**Remediation & Redevelopment  
Continuing Obligation Review**

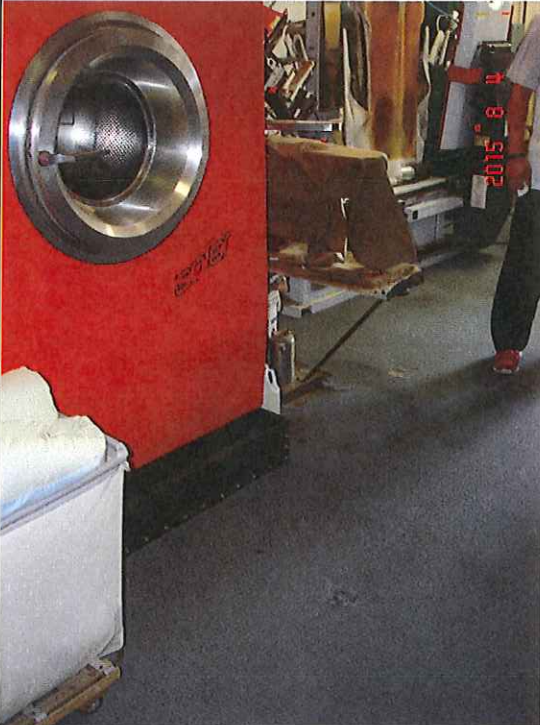
Title: Photo facing southeast towards dry cleaning machine with containment beneath it. Floor in excellent condition, with small sealed holes in the carpeting where boreholes had been drilled.

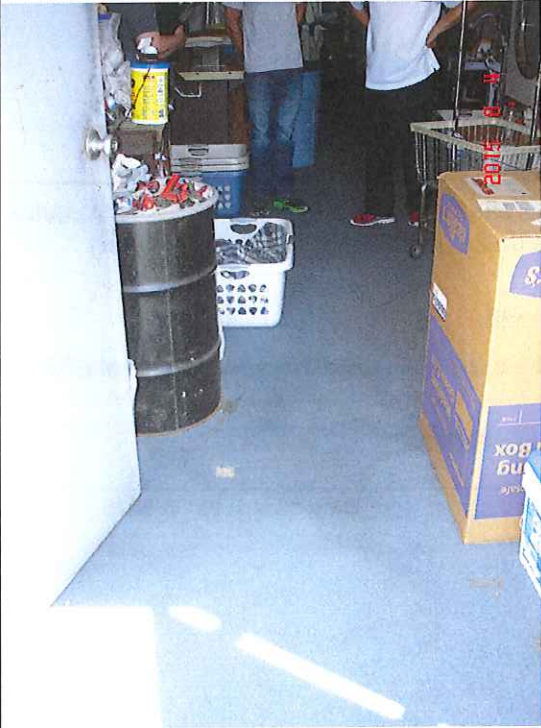
Title: Photo facing north from back door. Carpeted floor, cap over contaminated soil, in excellent condition. Small hole in the carpet is where a borehole had been drilled and then sealed.

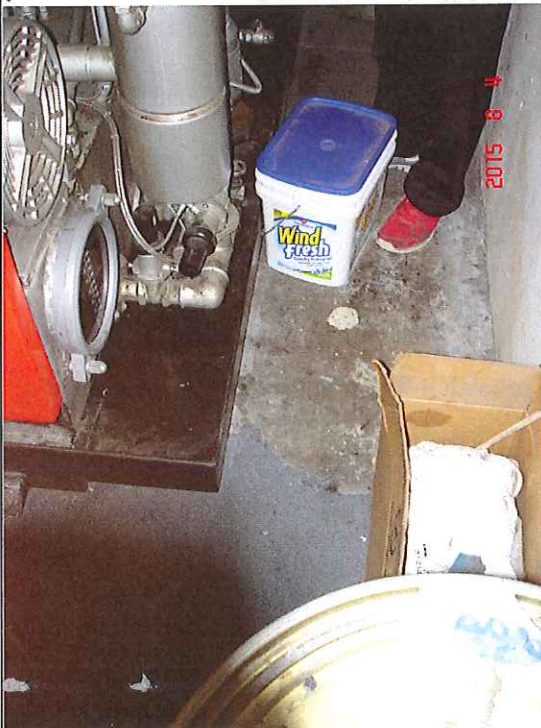
Title: View of containment under dry cleaning machine, back of machine, and sealed borehole (along the east wall of the facility).
