Subject: ZYDUCK RESIDENCE. FID# 241722800

RE: Heating oil spill, 4905 South 34th Street, Greenfield

Re: Site Investigation of a Home Heating Oil Release to the Environment

SUBSURFACE INVESTIGATION
JOSEPHINE ZYDUCK PROPERTY
GREENFIELD, WISCONSIN
January 1994

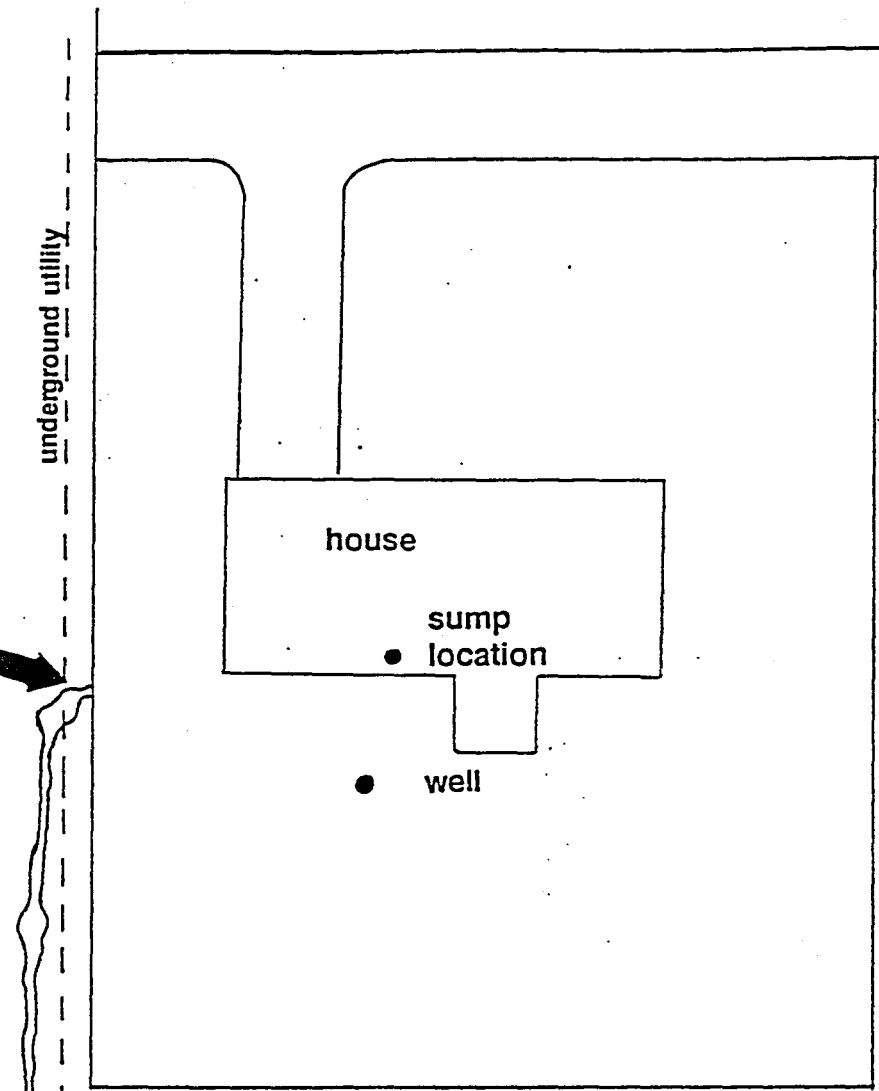
FIGURE 2
LOCATION OF FUEL OIL SPILL
Josephine Zyduck Property
Greenfield, Wisconsin

The only underground utilities in the vicinity of the property are for water, sanitary sewer, and gas; some of these utilities are located as shown in Figure 2. A well, which was at one time the source of potable water for the residence, remains in place on the property and west of the residence, but is reported to be used only for watering the lawn and garden at this time. Mrs. Zyduck reported that no sign of oil was observed in the well water at any time. No stressed vegetation was observed in the area on the western side of the property at the time of the initial survey, which would have been watered with well water. No sign of stressed vegetation was observed anywhere on the property in July 1993 nor were there any signs of leakage or spills of oil, including none which could have occurred while the basement oil tank was being filled.

Stressed vegetation was noted in the property to the north, as shown in Figure 2, currently part of the Greenfield Middle School grounds. It consisted of a strip, running west from the point of discharge of the sump pump line to a point about 200 feet further west, meandering along a line between 2 and 15 feet north of the property line. The strip ranges in width from less than 1-foot at the drain pipe to about 2-1/2 feet. The widest section, an area approximately 5 feet by 16 feet, was located immediately north and west of the point of discharge.

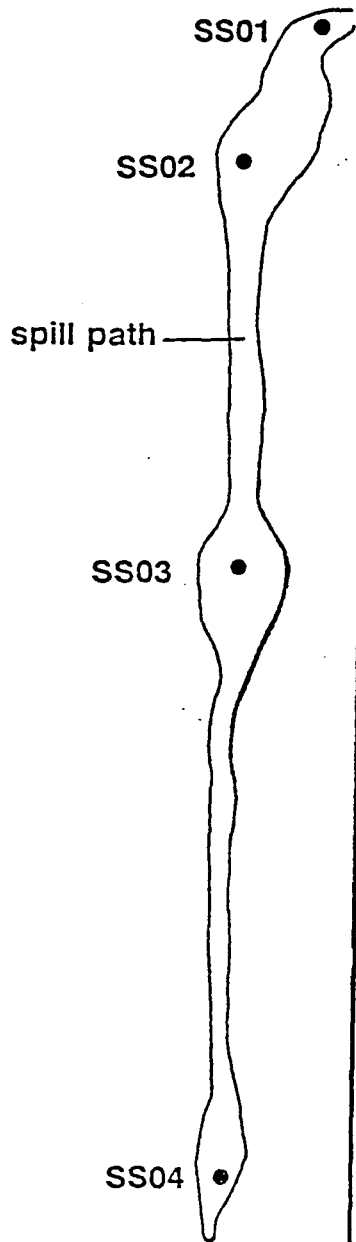
Sampling of the potentially contaminated soils was conducted on December 7, 1993. No snow had yet covered the ground, and the drainage path along which the contamination flowed was readily apparent on the property immediately north of the Zyduck residence. Stressed or dead vegetation (grass) was observed and assumed to indicate the areal extent of petroleum migration. Accordingly, samples were collected from the observed area of stressed or dead vegetation.

During sampling of the soils, it was noted that the soil is silty clay, dark brown to black in color indicating a relatively high level of organic matter in the top 12 to 18 inches. The soil, as would be expected in winter, was very wet and near or at saturation below 12 inches deep. It is likely that further migration of fuel oil contaminants will be very limited, and that the organic complex of the soil will attenuate residual fuel oil in the soil. It is probable that degradation has begun with the contaminants as we have seen the veritable non-detection of DRO at sample location SS04, an area that was near the far extent of fuel migration (across the ground surface) and was initially of sufficient concentration to kill the grass.
