**From:** Byers, Harris <Harris.Byers@stantec.com>  
**Sent:** Wednesday, May 20, 2020 1:08 PM  
**To:** Van Der Kloot, James; Beggs, Tauren R - DNR; Adam Tegen  
**Subject:** Supplemental UST Assessment - 1512 Washington Street  
**Attachments:** UST Assessment.pdf

May 18, 2020  
File: 193706270

**Reference: Supplemental Underground Storage Tank Assessment**  
**Former Mirro Facility**  
**1512 Washington Street**  
**Manitowoc, Wisconsin**  
**BRRTS ID: 03-36-274209 (Closed LUST)**  
**USEPA ACRES ID: 169132**

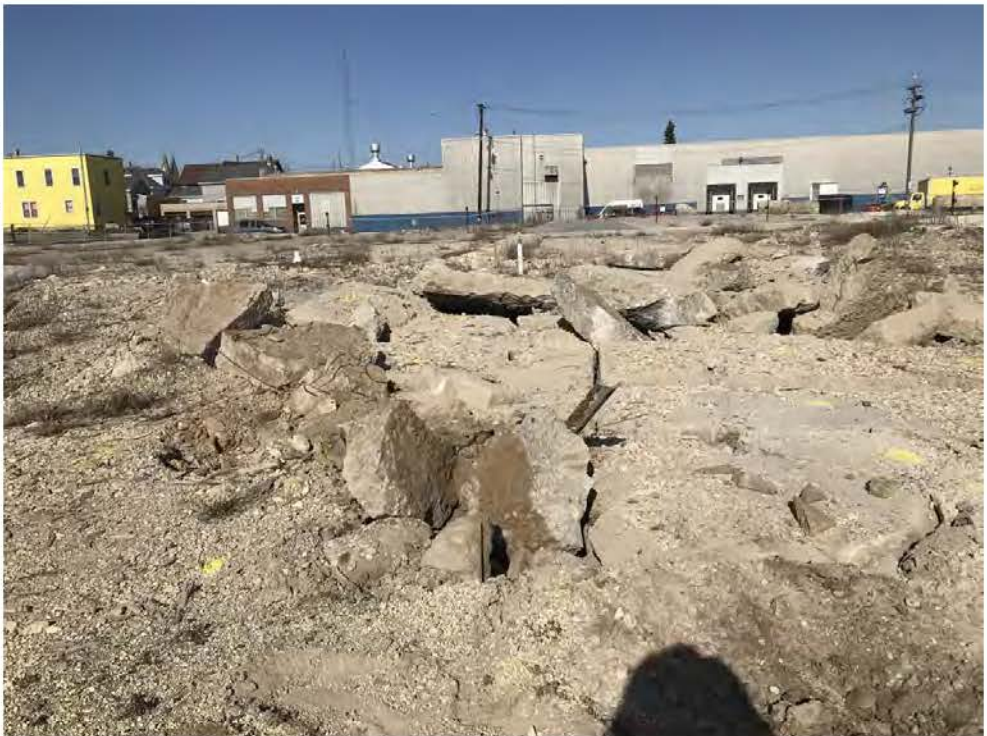
<b>Photo Location:</b> East of UST 3			
<b>Direction:</b> Looking west			
<b>Survey Date:</b> 5/13/2020			
<b>Comments:</b> Broken concrete prior to removal over UST 3 and UST 4; monitoring well MW-25 is visible.			
<b>Photograph ID:</b> 4

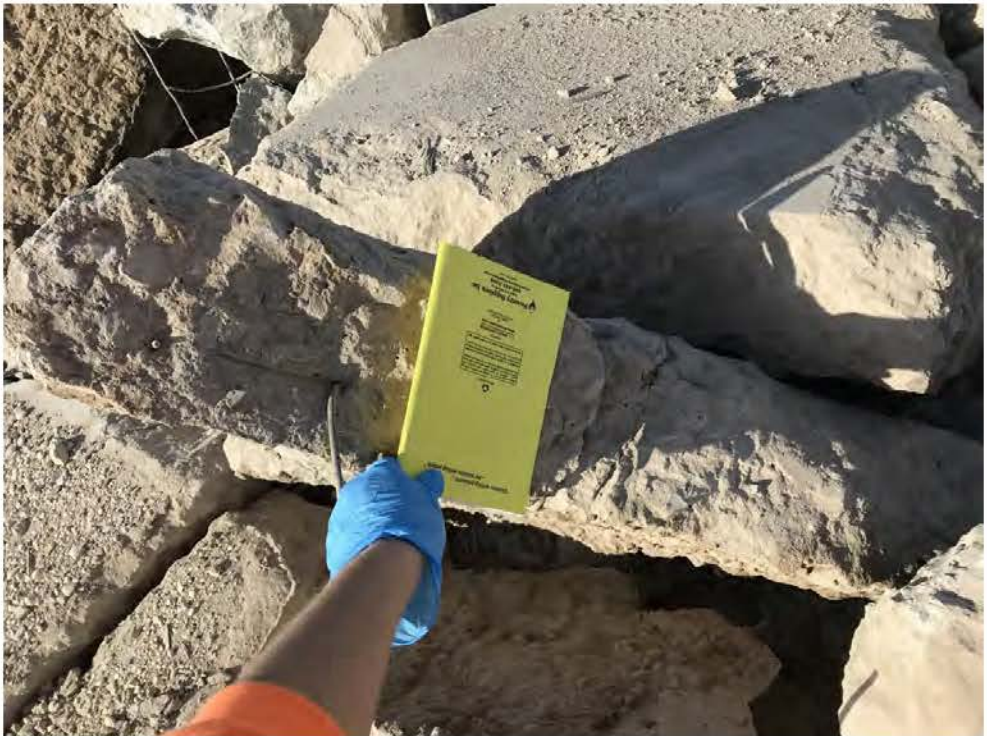
<b>Photo Location:</b> Tank bed surface			
<b>Direction:</b>			
<b>Survey Date:</b> 5/13/2020			
<b>Comments:</b> The thickness of the concrete was between six and eight inches (field notebook pictured is seven inches tall); wire "pencil rod" reinforcement is also visible.

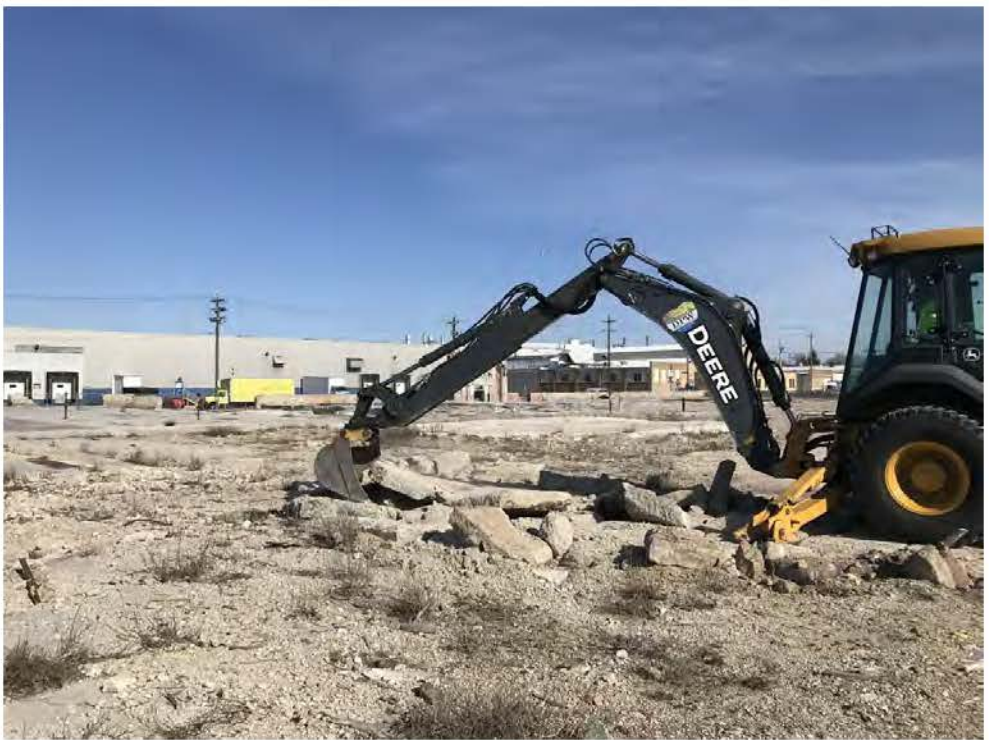
<b>Photo Location:</b> South of tank bed			
<b>Direction:</b> Looking northwest			
<b>Survey Date:</b> 5/13/2020			
<b>Comments:</b> Removing the concrete pieces using an excavator.			
<b>Photograph ID:</b> 6

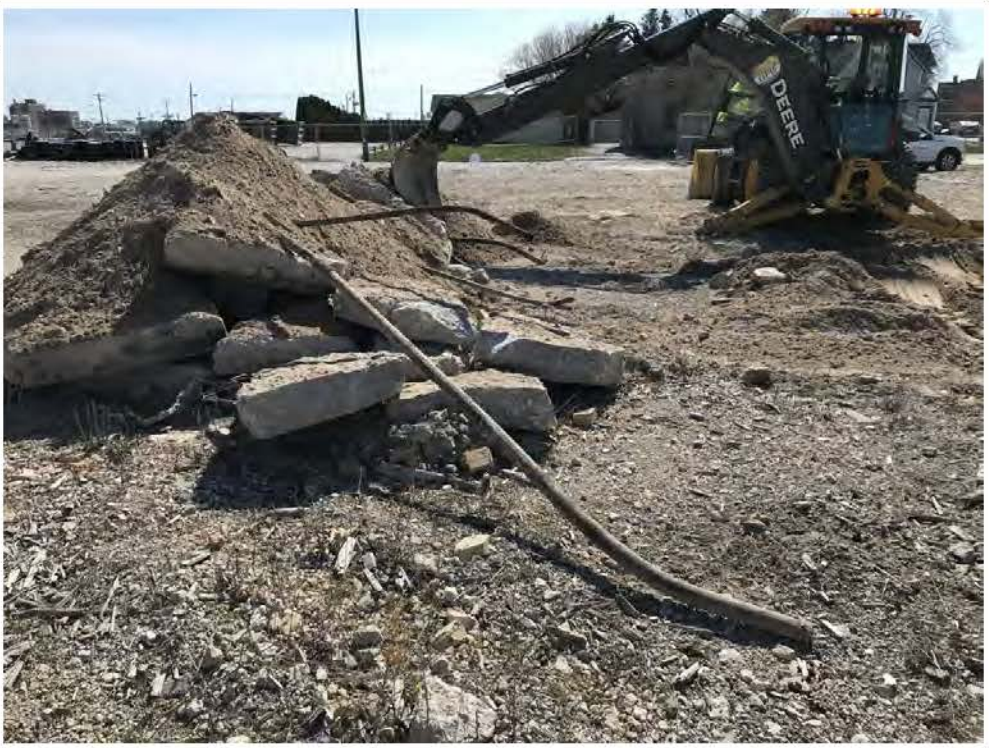
<b>Photo Location:</b> North of tank bed			
<b>Direction:</b> Looking east			
<b>Survey Date:</b> 5/13/2020			
<b>Comments:</b> Broken concrete, fill piping and fill sand taken out of the excavation in the vicinity of UST 3 and UST 4.

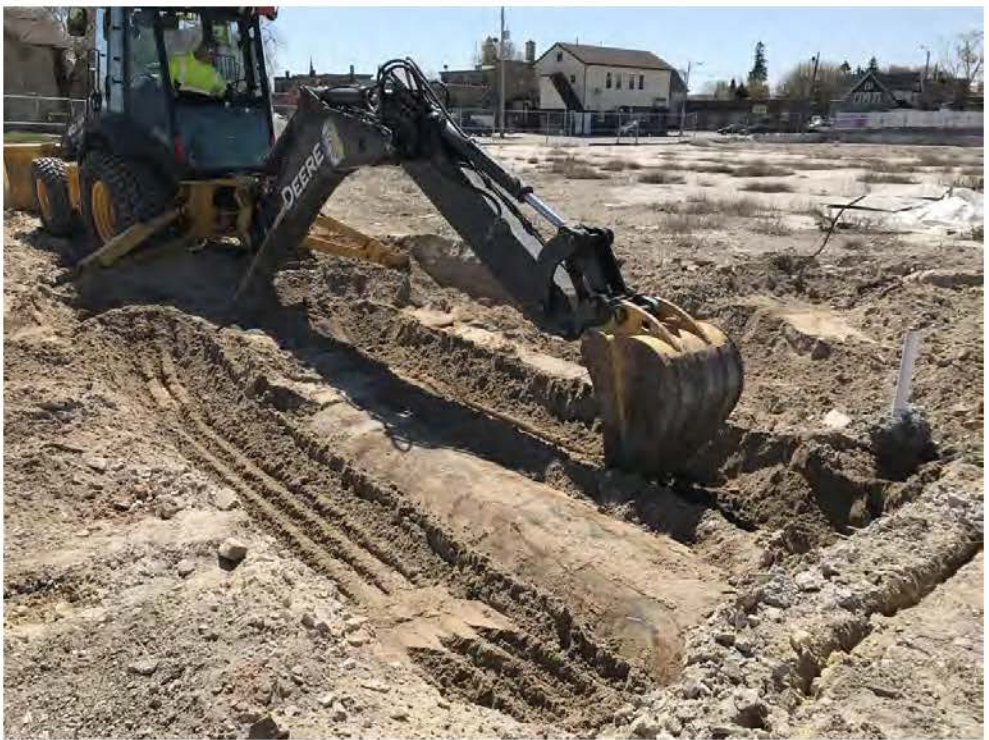
<b>Photo Location:</b> Northwest corner of tank bed			
<b>Direction:</b> Looking southeast			
<b>Survey Date:</b> 5/13/2020			
<b>Comments:</b> Exposing the surface of UST 4 (foreground) and UST 3.			
<b>Photograph ID:</b> 8

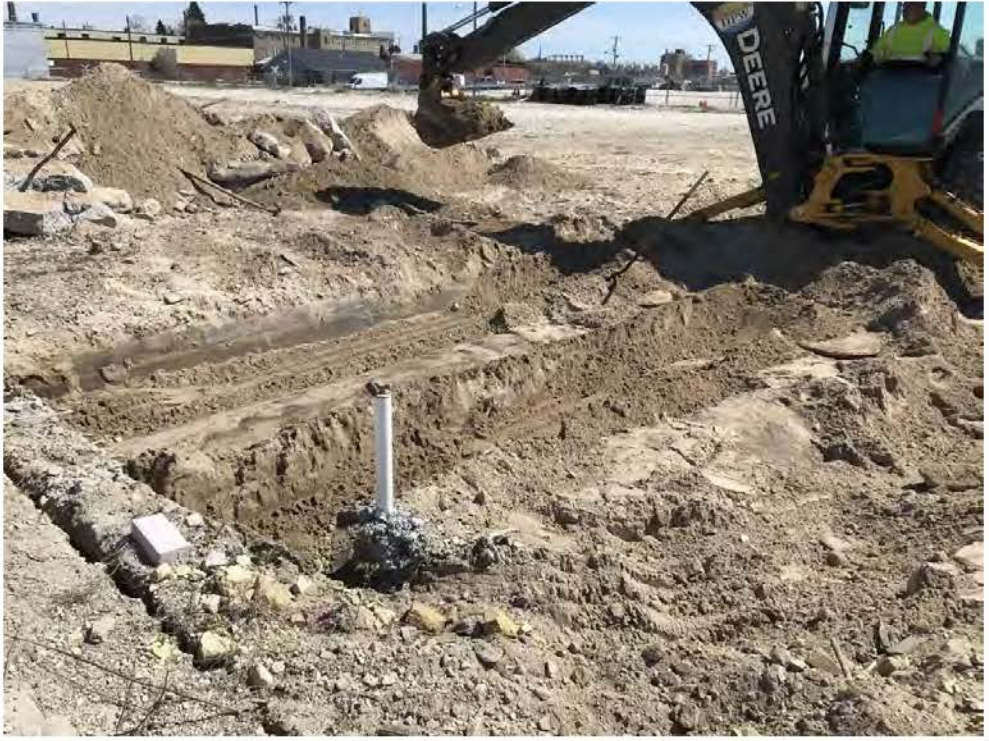
<b>Photo Location:</b> Southwest corner of tank bed			
<b>Direction:</b> Looking northeast			
<b>Survey Date:</b> 5/13/2020			
<b>Comments:</b> Exposing the surface of UST 3 (foreground) and UST 4; MW-25 is visible, and was installed through the western end of UST 3.

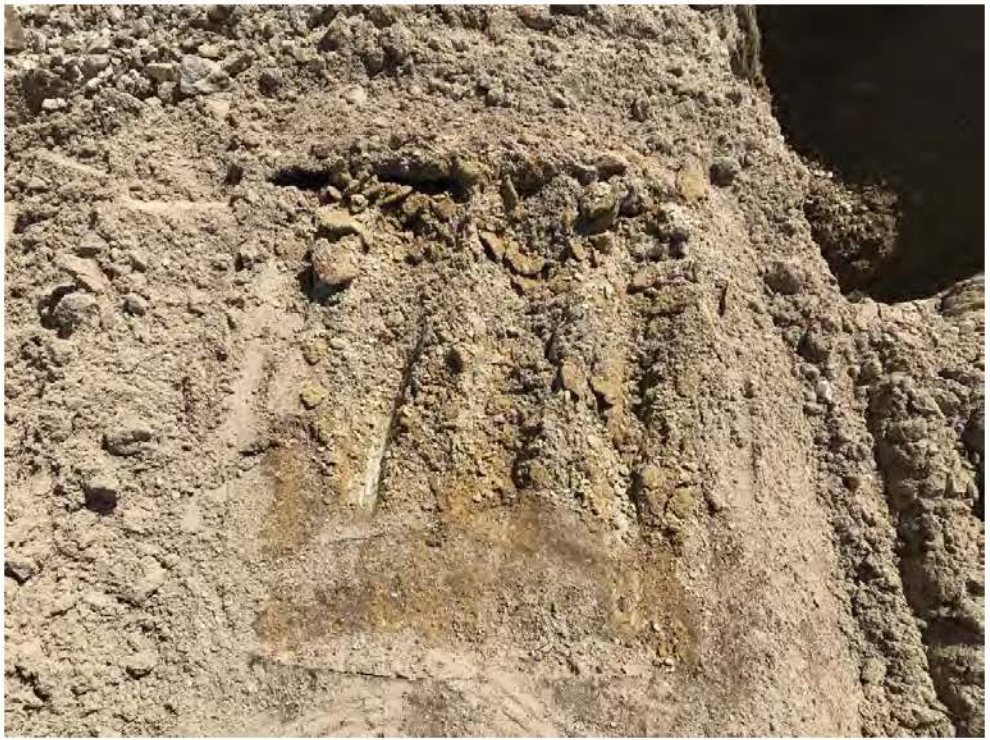
Tank Contents. An approximate 1.5-foot square tack-welded cutout was removed from the top of UST 4 by the excavator. The tank appeared to be filled with inert concrete or cement, which is consistent with UST abandonment records prepared in 2001.

<b>Photo Location:</b> Cut-out from UST 4			
<b>Direction:</b>			
<b>Survey Date:</b> 5/13/2020			
<b>Comments:</b> The contents of the tank exposed after removing the 1.5-foot square plate; the tank abandonment contents were observed to be concrete or cement.			
<b>Photograph ID:</b> 12

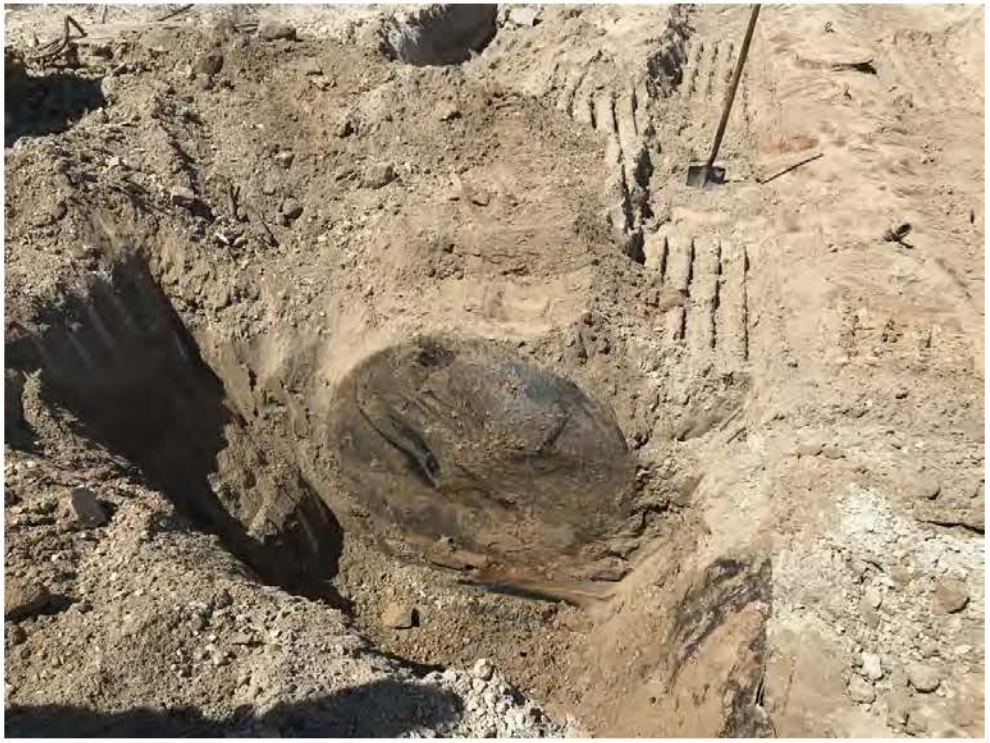
<b>Photo Location:</b> East of UST 3			
<b>Direction:</b> Looking southwest			
<b>Survey Date:</b> 5/13/2020			
<b>Comments:</b> The eastern end of UST 3. A small area of black staining was observed at the bottom of the excavation beneath a small hole in the side of the tank; while exposing the side of UST 3, the western end of UST 2 was discovered (bottom-right corner of the photograph).

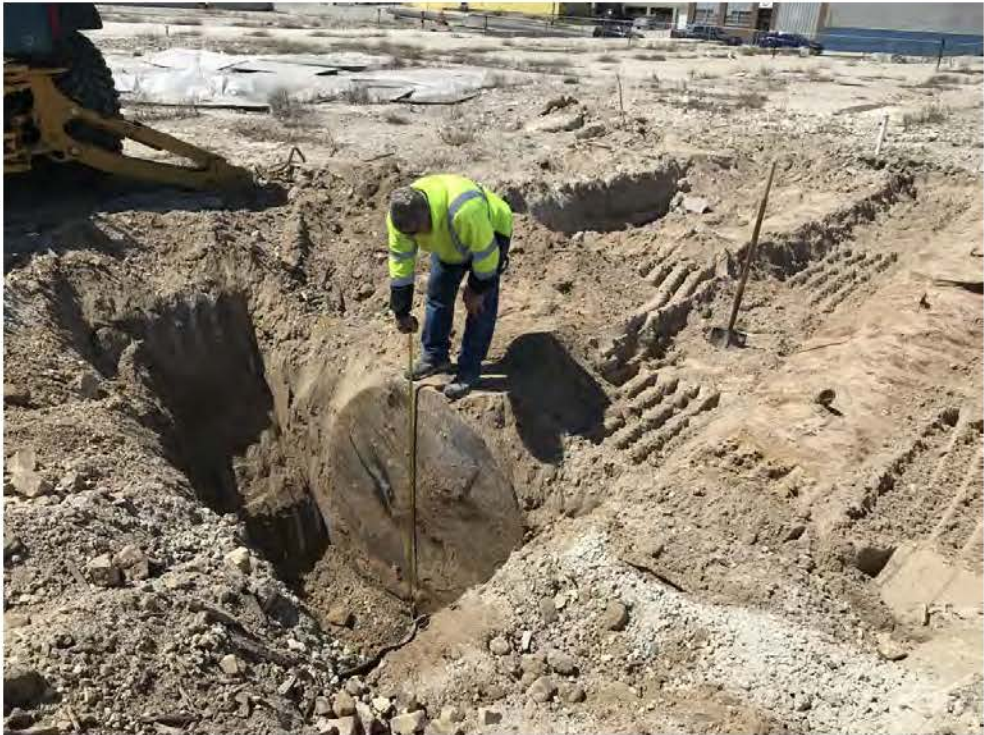
All three tanks encountered (UST 2, UST 3, and UST 4) were approximately five feet in diameter and 30 feet long, corresponding to each having an approximate 4,406-gallon capacity, which is consistent with tank sizes listed in UST abandonment documentation prepared in 2001. Further information for each tank is provided below.

<b>Photo Location:</b> East of UST 4	
<b>Direction:</b> Looking southwest	
<b>Survey Date:</b> 5/13/2020	
<b>Comments:</b> Measuring the diameter of UST 3; each of the tanks revealed was five feet in diameter and 30 feet long.

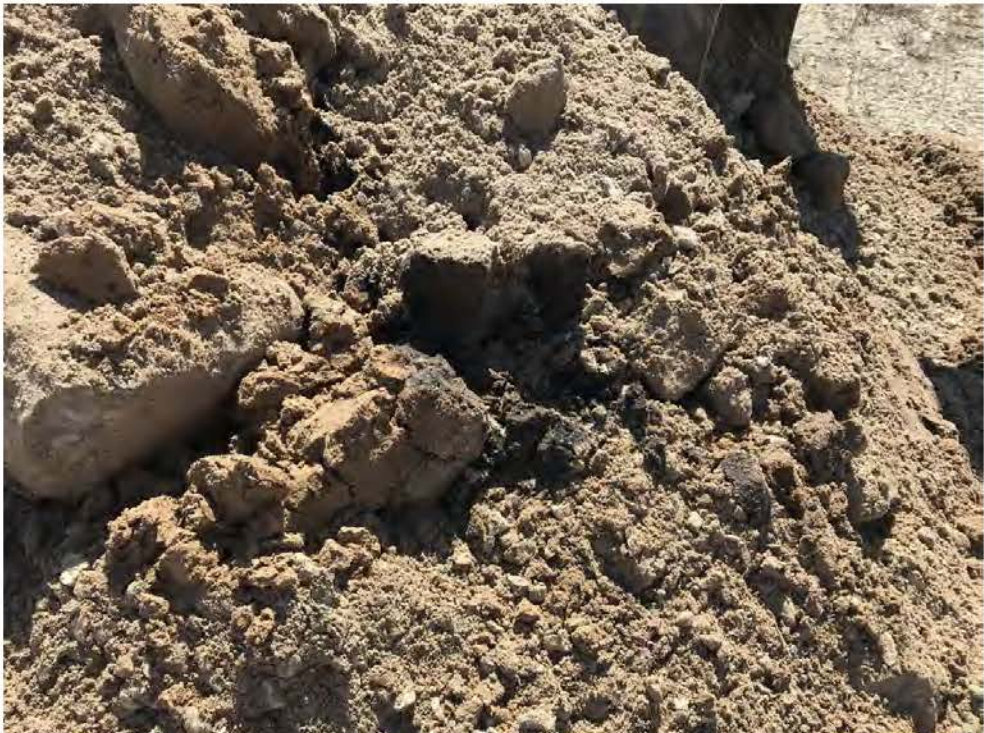
Somewhat consistent with observations made at the time of UST closure, a very small quantity of soil with a weathered petroleum-like odor was encountered near the bottom of the east end of UST 3. Petroleum impacted soils were not removed as part of this assessment. Medium-grained sandy fill removed to expose the surface of UST 3 was used to backfill the excavation.

<b>Photo Location:</b> Temporary soil stockpile from UST 3	
<b>Direction:</b>	
<b>Survey Date:</b> 5/13/2020	
<b>Comments:</b> Black staining noted in soil during the last bucket excavated east of UST 3; the impacted soil was immediately placed back into the bottom of the excavation from where it came from, and backfilled with visually/olfactory unimpacted soil.

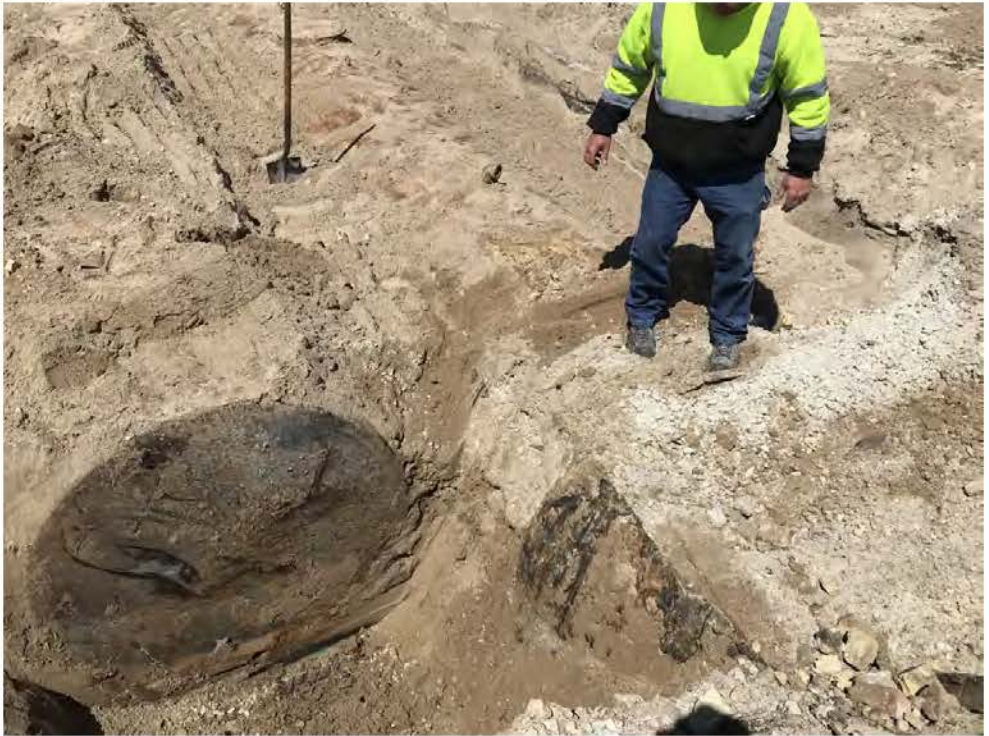
<b>Photo Location:</b> East of UST 3			
<b>Direction:</b> Looking northwest			
<b>Survey Date:</b> 5/13/2020			
<b>Comments:</b> Three tanks visible from the former location of UST 1; UST 3 (left), UST 4 (top-right), and UST 2 (bottom-left). City employee is standing in the approximate two-foot space between UST 4 and UST 2.			
<b>Photograph ID:</b> 16

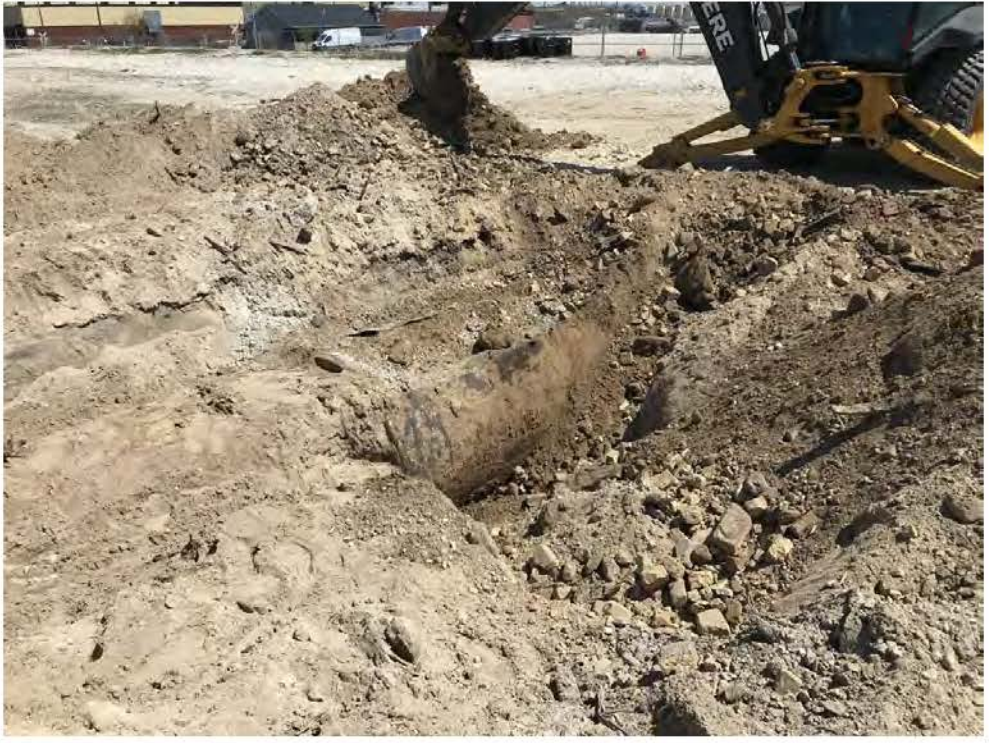
Tank Contents. The tank appeared to be backfilled with general site fill (brick, debris) and trace amounts of imported gravel. It is unclear whether this is the same material that the tank was originally abandoned with, or if the tank was intended for removal in 2003, but for one reason or another was replaced back into the excavation and filled with general site debris.

<b>Photo Location:</b> South of UST 3			
<b>Direction:</b> Looking northeast			
<b>Survey Date:</b> 5/13/2020			
<b>Comments:</b> Further excavation to reveal UST 2; the top of the tank was removed, and appeared to be backfilled with general site fill.

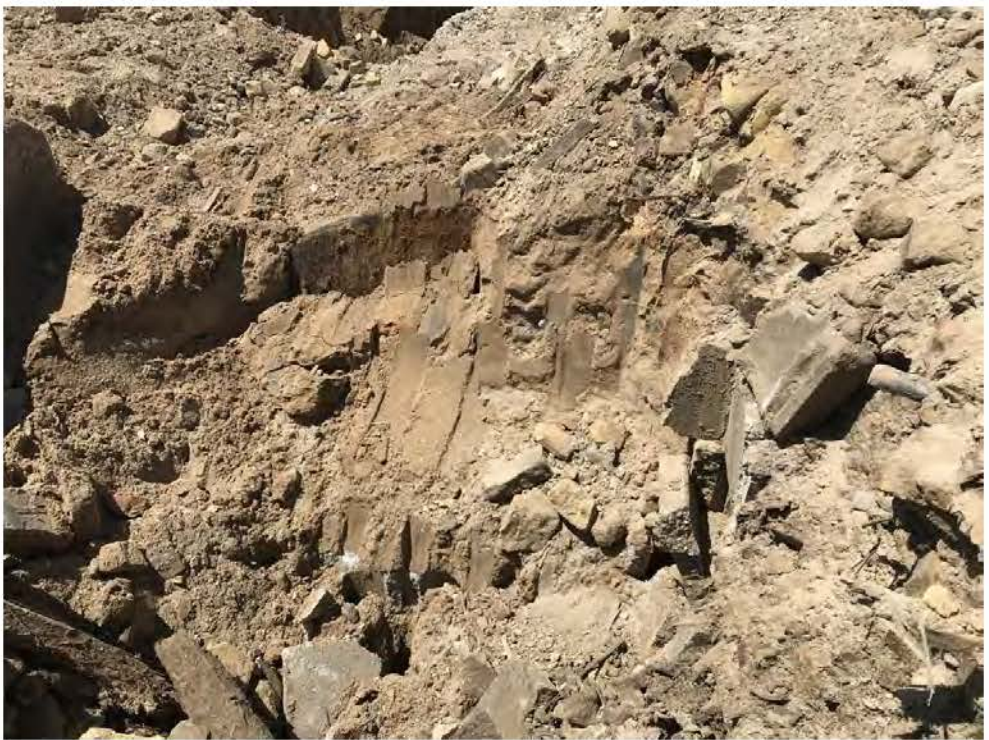
<b>Photo Location:</b> East end of tank bed			
<b>Direction:</b> Looking west			
<b>Survey Date:</b> 5/13/2020			
<b>Comments:</b> The eastern end of UST 2, as seen from directly east of UST 2.			
<b>Photograph ID:</b> 22

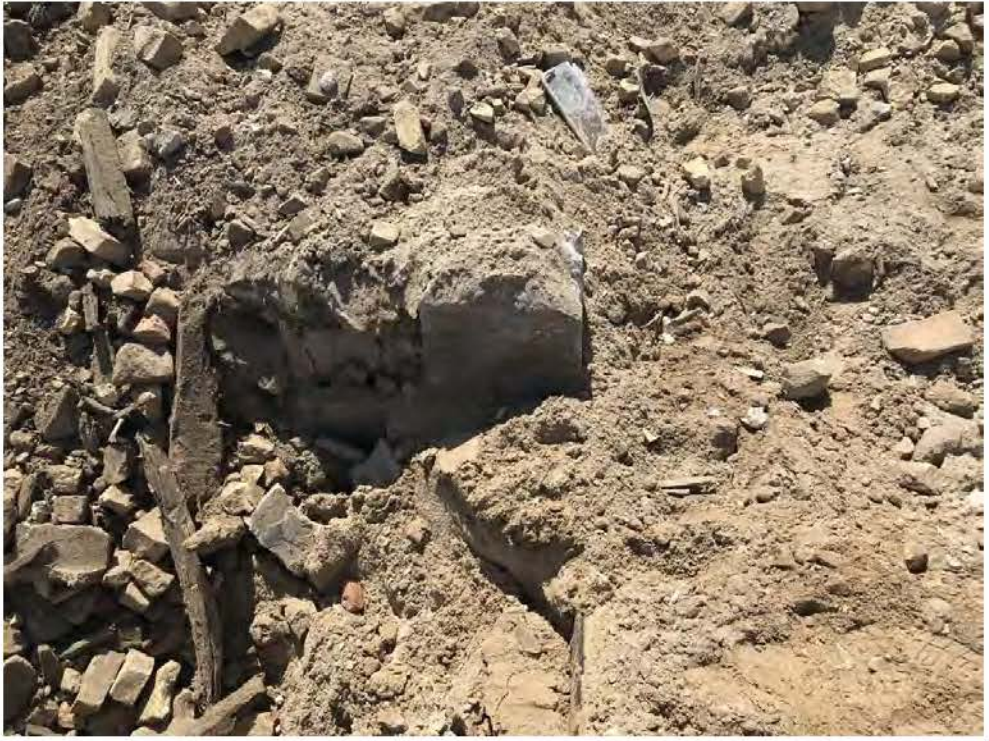
<b>Photo Location:</b> East end of tank bed			
<b>Direction:</b> Looking south			
<b>Survey Date:</b> 5/13/2020			
<b>Comments:</b> The eastern end of UST 2 (rusted metal face shown near bottom center of the photograph), and the opening cut into the north-south running wall just east (left) of it.

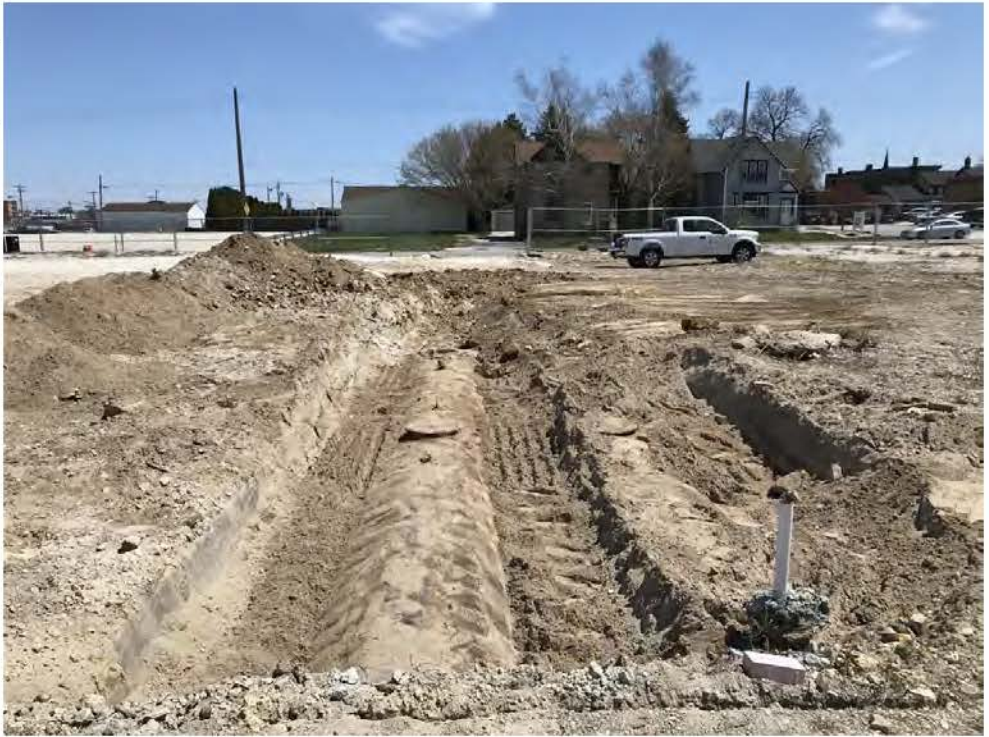
<b>Photo Location:</b> West end of tank bed	
<b>Direction:</b> Looking east	
<b>Survey Date:</b> 5/13/2020	
<b>Comments:</b> Tank bed after being filled in to a minimum of three feet below grade for safety.

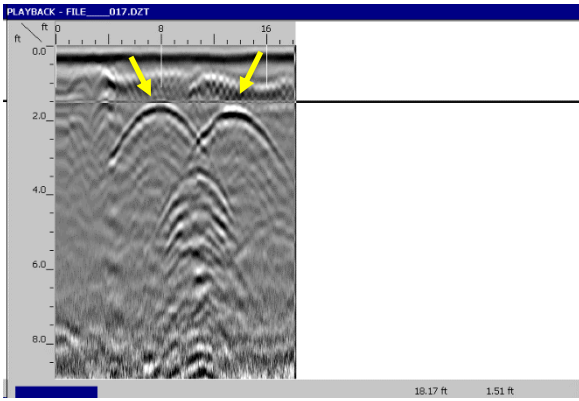
GPR Data Screenshot- 2 suspected UST's represented by the yellow arrows. The depth of the suspected tanks is approximately 1.5' deep.

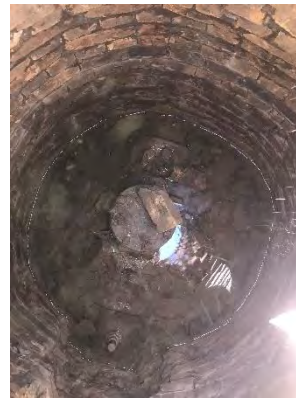
Site Photo- Inside of unknown manhole.

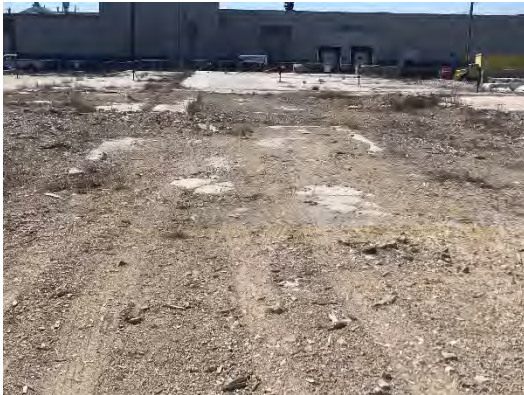
Site Photo- Tank Extents represented by yellow paint.

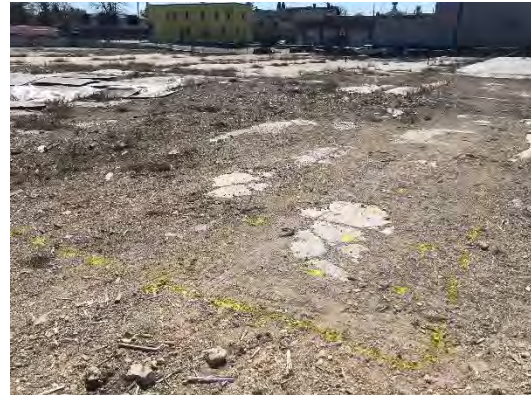
Site Photo- Tank Extents represented by yellow paint.
