**BRRTS Number:** 02-46-279670

**Remediation & Redevelopment  
 Continuing Obligation Review**

Reviewer: John Feeney & Lee Delcore  
 Site Name: OHM Butler, Inc.

Address/ City/Zip Code: 108 E Freistadt Rd, Mequon, WI 53092

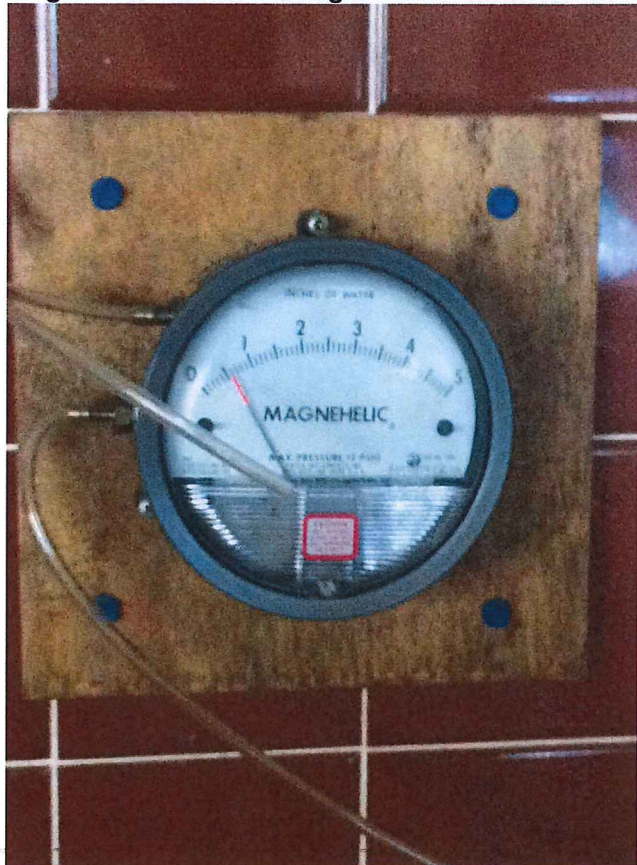
Magnehelic Meter Reading at ~6 inches of Water

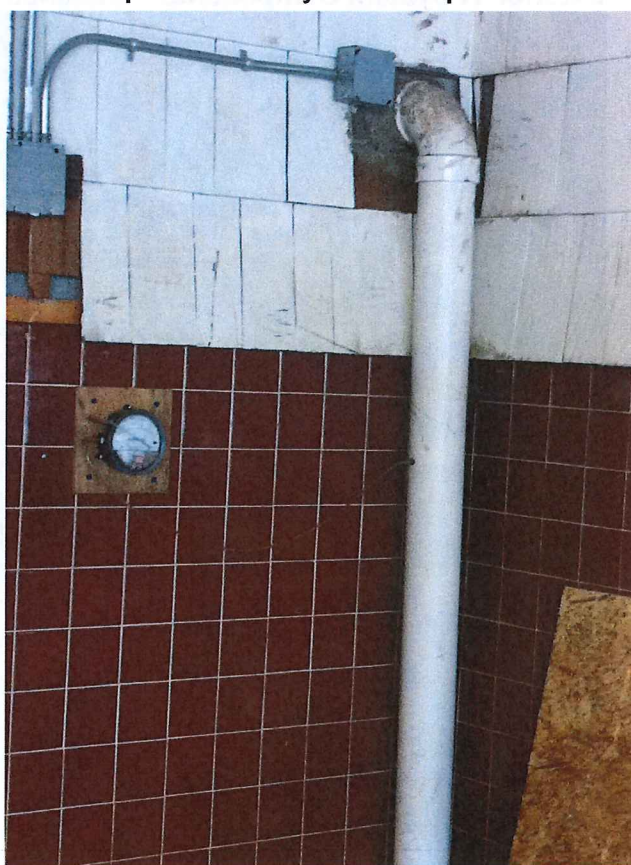
Close-up of Internal System Components

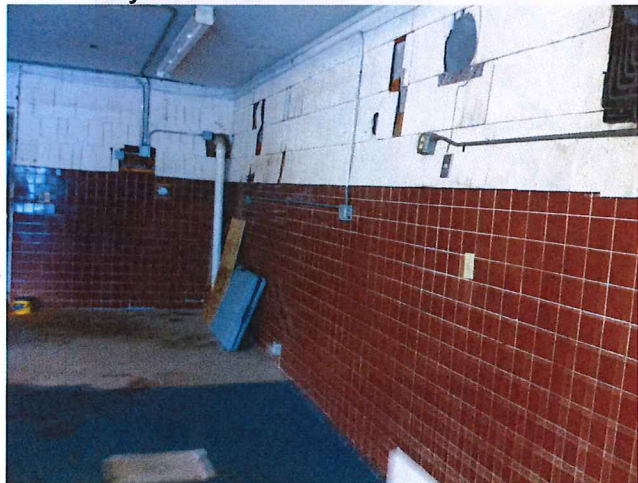
Internal System from S to N

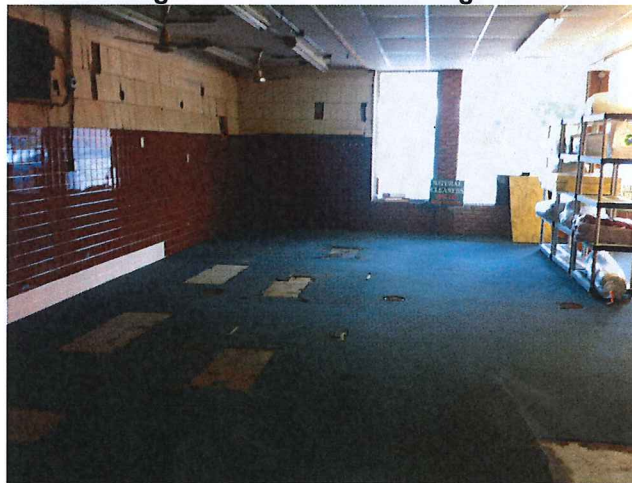
3 Monitoring Well Covers in Building from N to S

Lee and I inspected the site and observed what looks to be monitoring well covers inside the building. Those are covers for the former infiltration gallery. I called Rich Gnat at KPRG, He said that those were all properly abandoned by filling them with grout. He said that they left the covers in place.

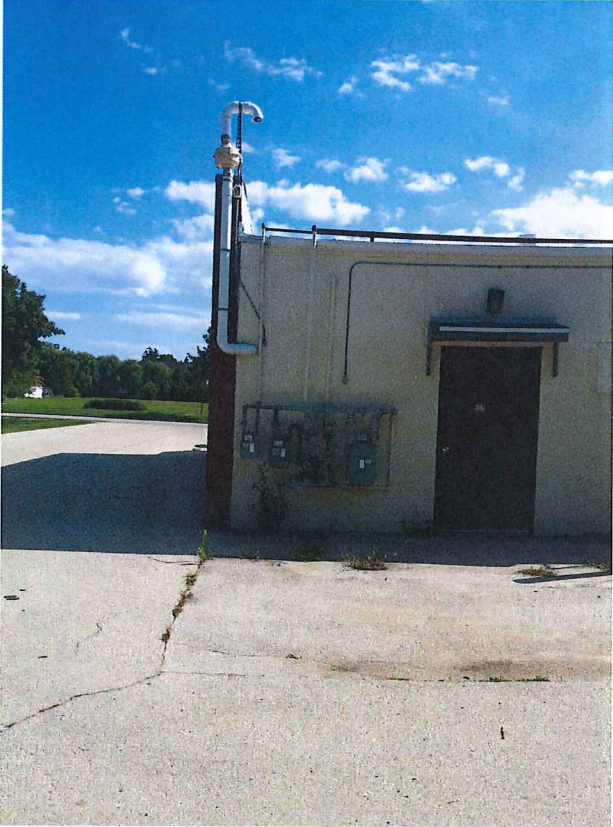
Exterior VI System Components – Distance

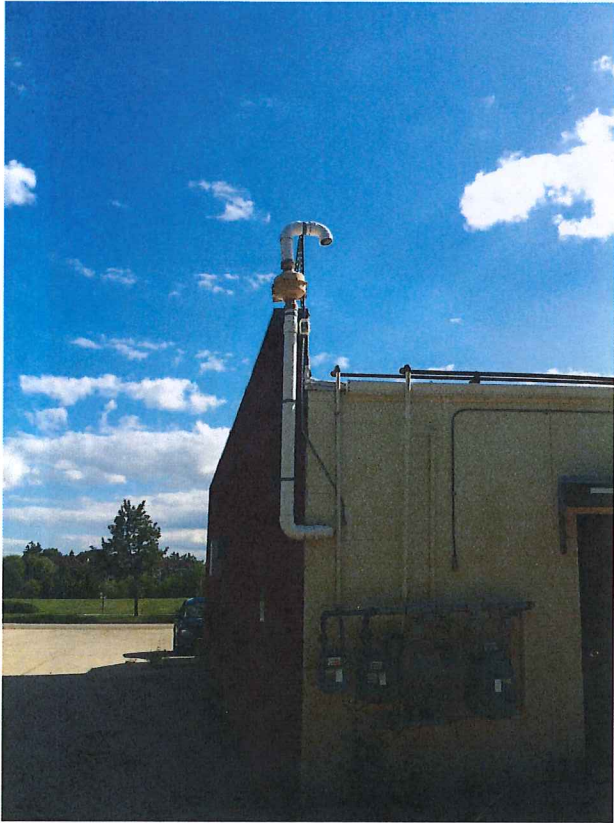
Exterior System Components – Close-Up

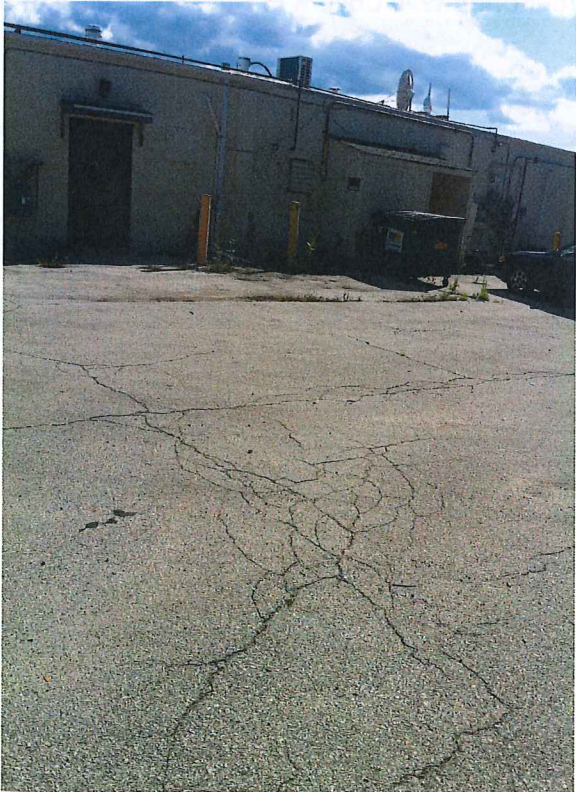
Asphalt Condition on N Side of Building

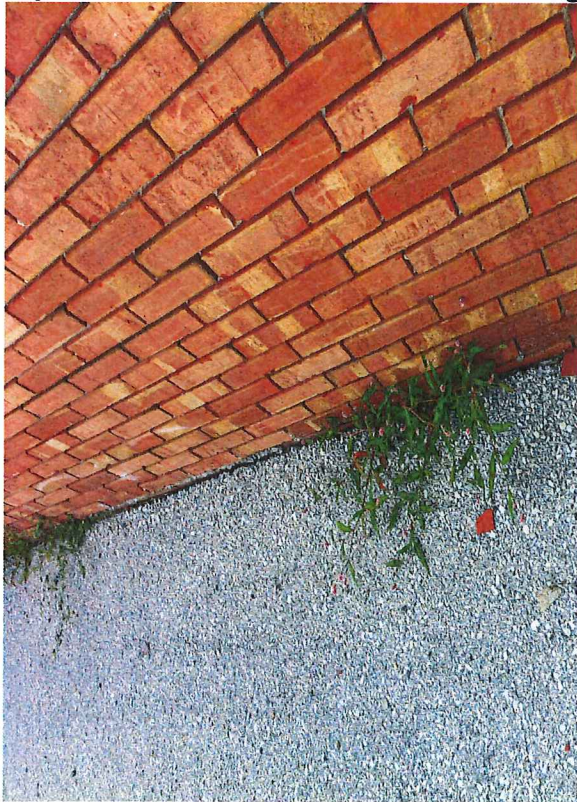
Separation Crack on East Side of Building

Describe any site-specific requirements that the site owner and/or responsible party needed to address.  
Will suggest filling separation crack between east building wall and asphalt drive

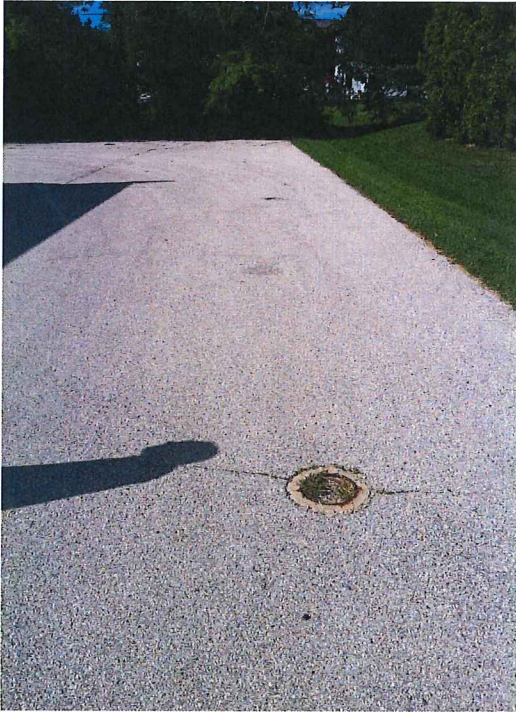
MW-4 Abandonment Scar

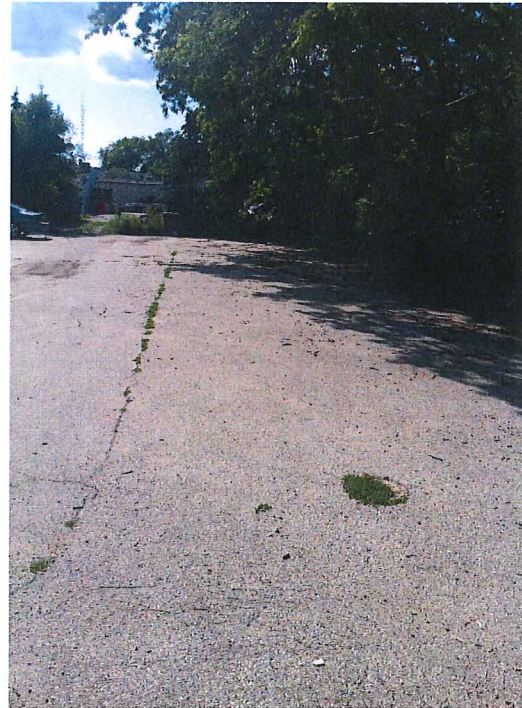
MW-3 Abandonment Scar

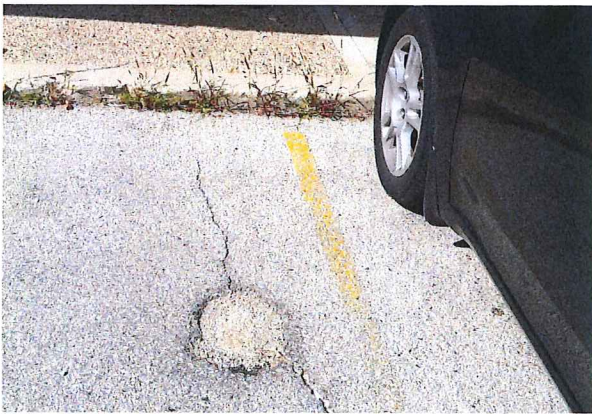
SB-7 Abandonment Scar

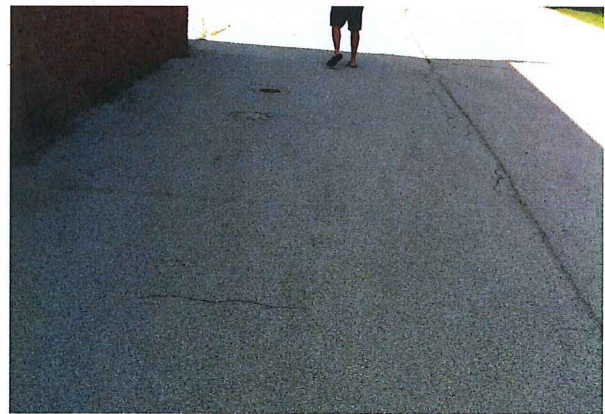
MW-5 Abandonment Scar

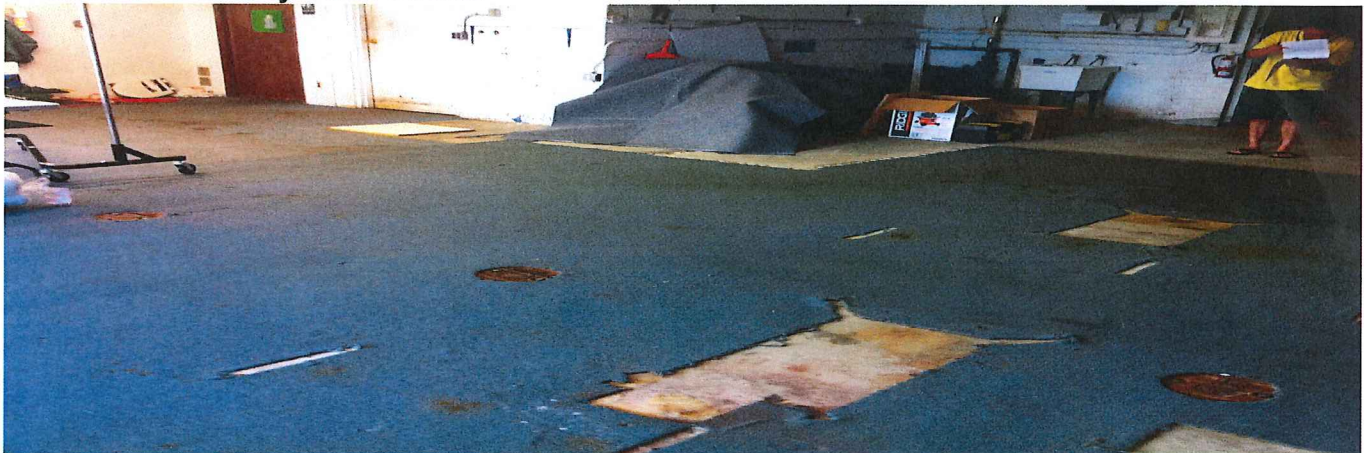
3 "Infiltration Gallery" Well Covers
