**Remediation & Redevelopment
 Continuing Obligation Review**

BRRTS ID No. 02-68-280310 _____

Site Name: Quick Cleaners (Former)

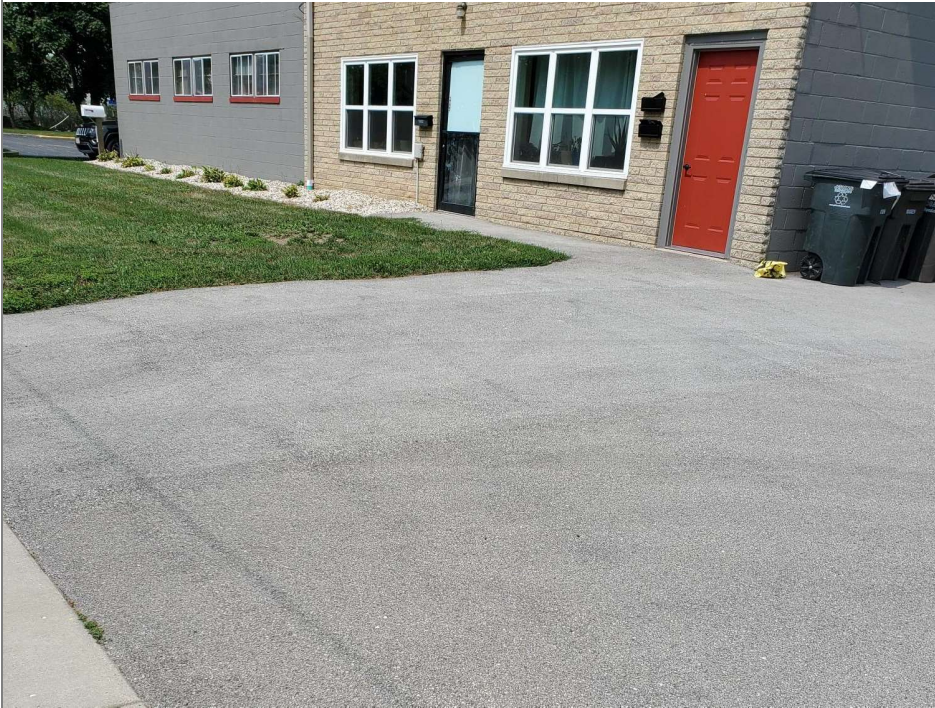
Title: South side pavement

Yes – Explain: improvements made to pavement on south and east sides of building

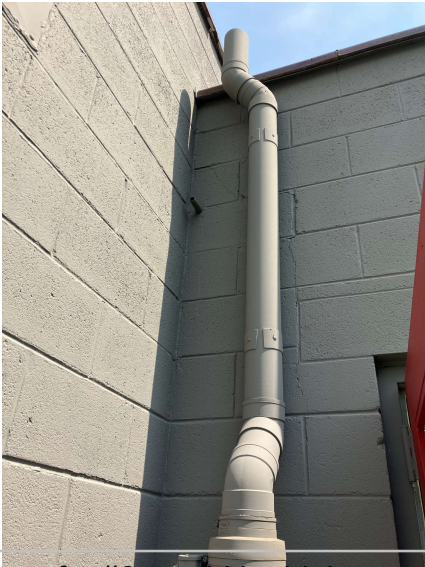
<p>Description: fan#2, could be higher</p>	<p>Description:</p>
<p>Description:</p>	<p>Description:</p>
