Supplemental Checklist for Vapor Mitigation Continuing Obligations

BRRTS Site Name Quick Cleaners Activity Number 02-68-280310
System Address(es) 530 S Franklin, Oconomowoc Current Site Use(s): Com and Res 2nd floor
Inspected By: R. Hoverman/P. Grittner Date 2023/08/18
Owner Contact*: Joe Jursenas - Mojo Franklin St LLC Phone: (262) 751-4707 Ok for text messages
Email Address: jjursenas@briohn.com
Occupant Contact*: _____ Phone: _____ Ok for text messages
Email Address: _____

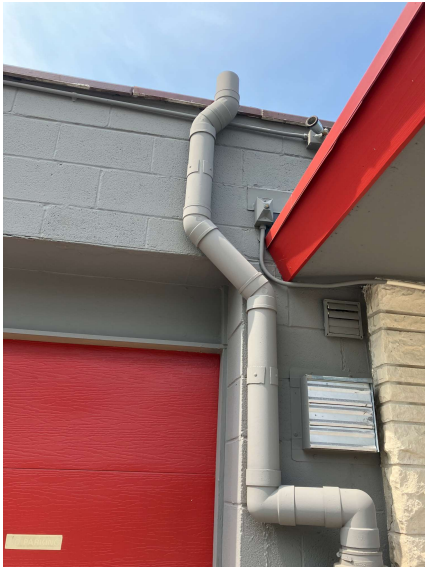
Description: East fan #1

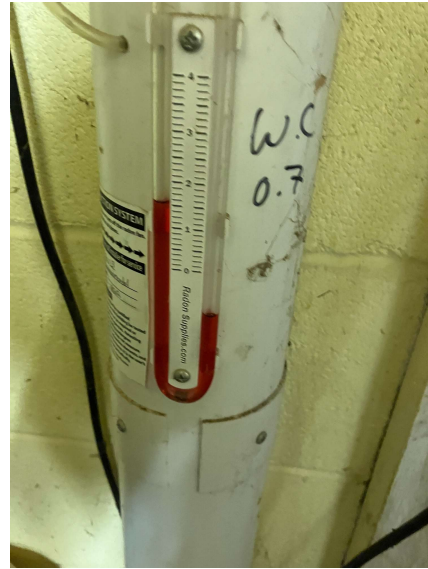
A pressure monitor is present, operating, and is accessible. Y N (active systems only, e.g., U-Tube manometer, cylinder, or gauge.) Pressure Reading: 1.6/1.5 in h2o

Description: Fan #1 pressure

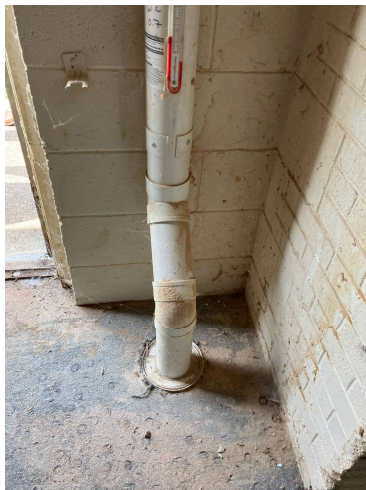
Description: W. fan #2 floor penetration

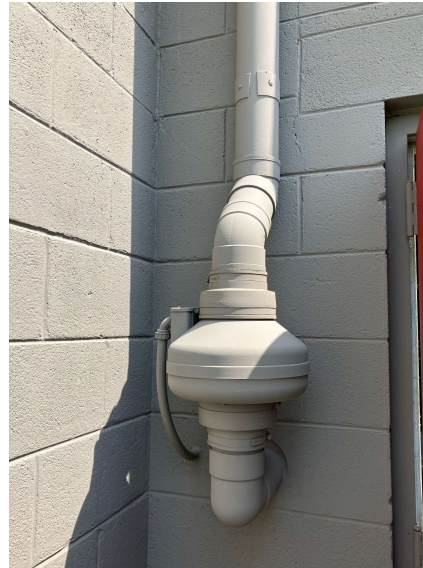
Description: West fan #2

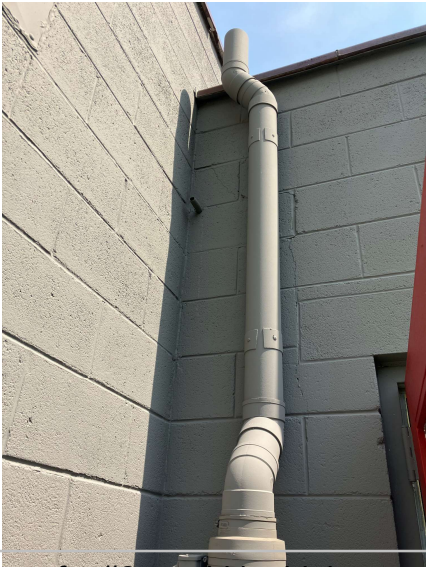
<p>Description: fan#2, could be higher</p>	<p>Description:</p>
<p>Description:</p>	<p>Description:</p>
