August 21, 2009

KPRG Project No. 10009

**AS-BUILT REPORT FOR DERF REMEDIAL ACTION
FORMER BASK DRY CLEANERS
WESTBROOK SHOPPING CENTER
WAUKESHA, WISCONSIN**

**BRRTS # 02-68-297669
FID # 268188800**

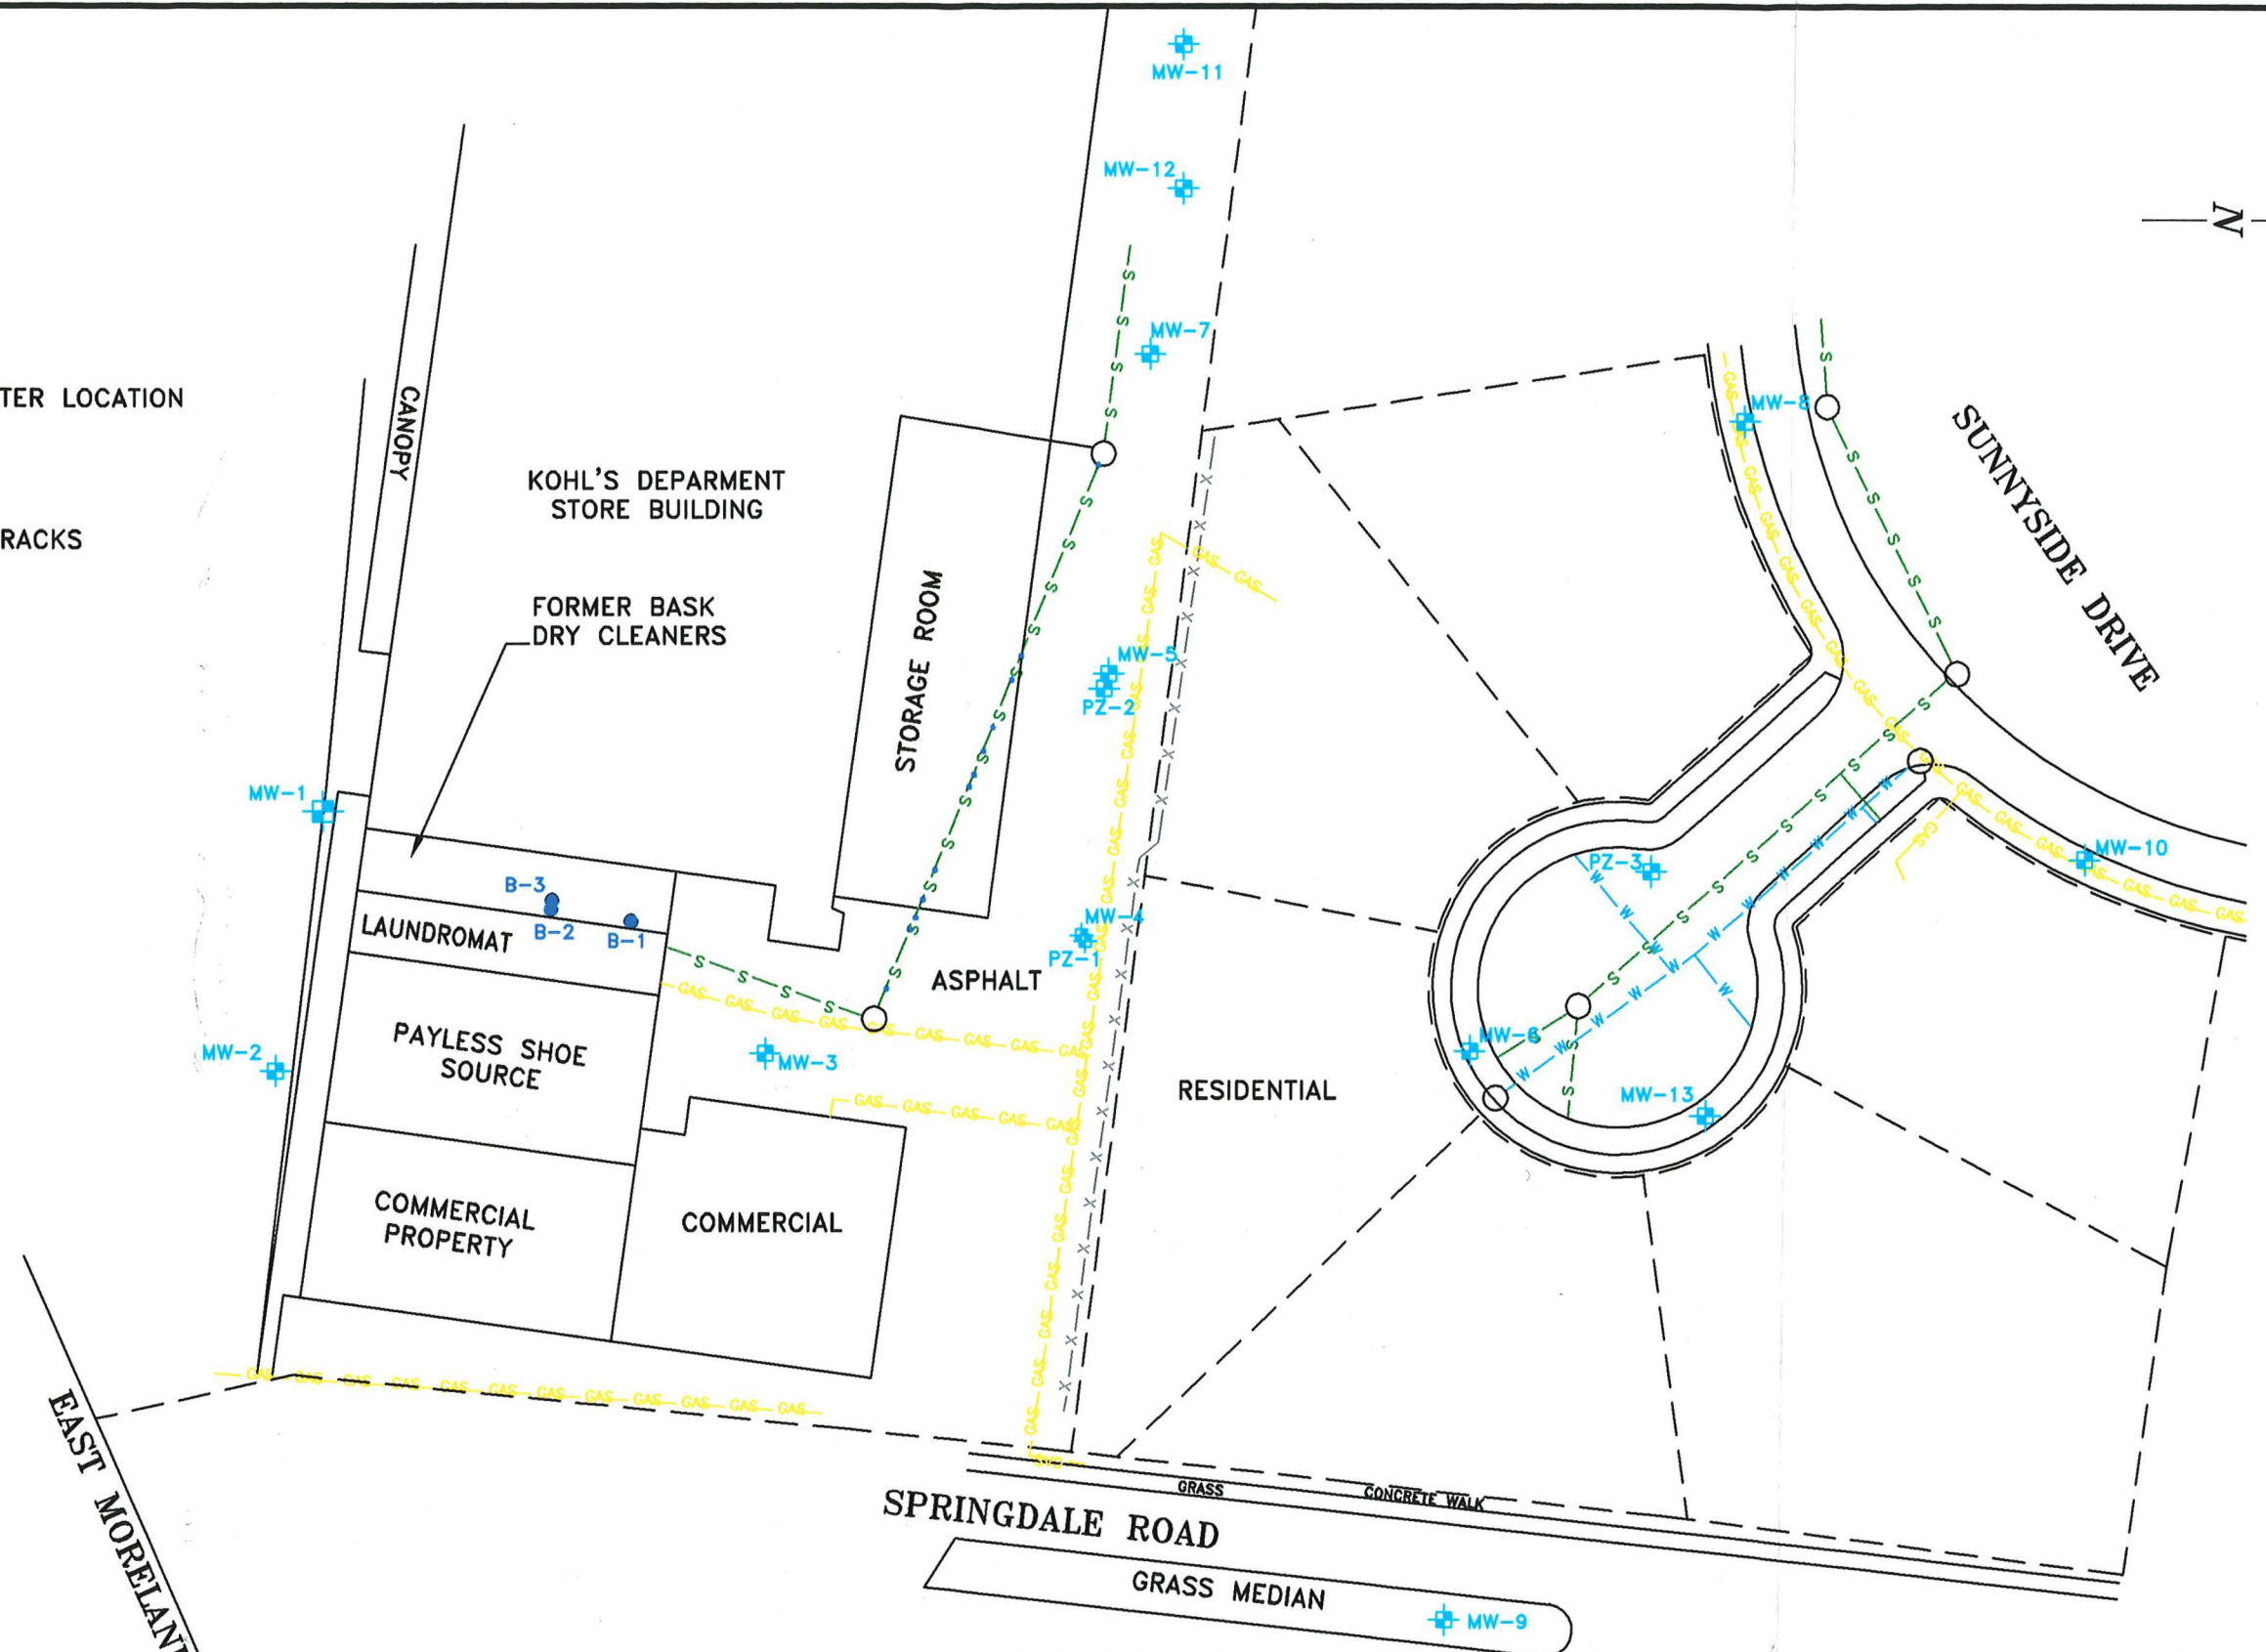
FORMER BASK CLEANERS	
Wide Joints/Cracks in Sewer Line Westbrook Shopping Center	
Scale: SEE BARSCALE	Date: August 17, 2009
KPRG Project No. 10009	FIGURE 1

The initial site investigation work performed for this site included a camera survey of the main sanitary sewer line on the north side of the property. The lateral from the former dry cleaner suite discharged into this main line. Any fluids that may have included residual PCE that entered the main sewer line may have leaked through the noted cracks. As shown on Figure 1, the camera inspection identified 11 separate cracks or wide sewer joints within the main line. This was identified as a potential source of impacts.

To address this issue, KPRG obtained competitive bids from sewer rehabilitation contractors to repair the main sewer line. Visu-Sewer, Inc. Trenchless Solutions of Pewaukee, Wisconsin was selected to perform this work. All work was performed in late evening and night hours as not to impact ongoing use of building restroom facilities such as at the Kohl's Department Store (Kohl's). The following sewer repair was completed:

- The subject line was pressure washed with water. At that point, an inverted, resin-impregnated liner was placed into the sewer and rolled out using pressurized air until the liner day-lighted at the west manhole.

- The liner was then fully inflated within the sewer.
- Once inflated, pressurized steam was introduced to activate and cure the resin. This process continued until a temperature of greater than 200 °F was achieved and held for over 1 hour. At that point the steam pressurization was stopped.

- Each end of the pipe was then trimmed and a robotic unit was introduced into the pipe to cut openings for the laterals which enter the main sewer. Work was completed on July 1, 2009 at approximately 6 am.

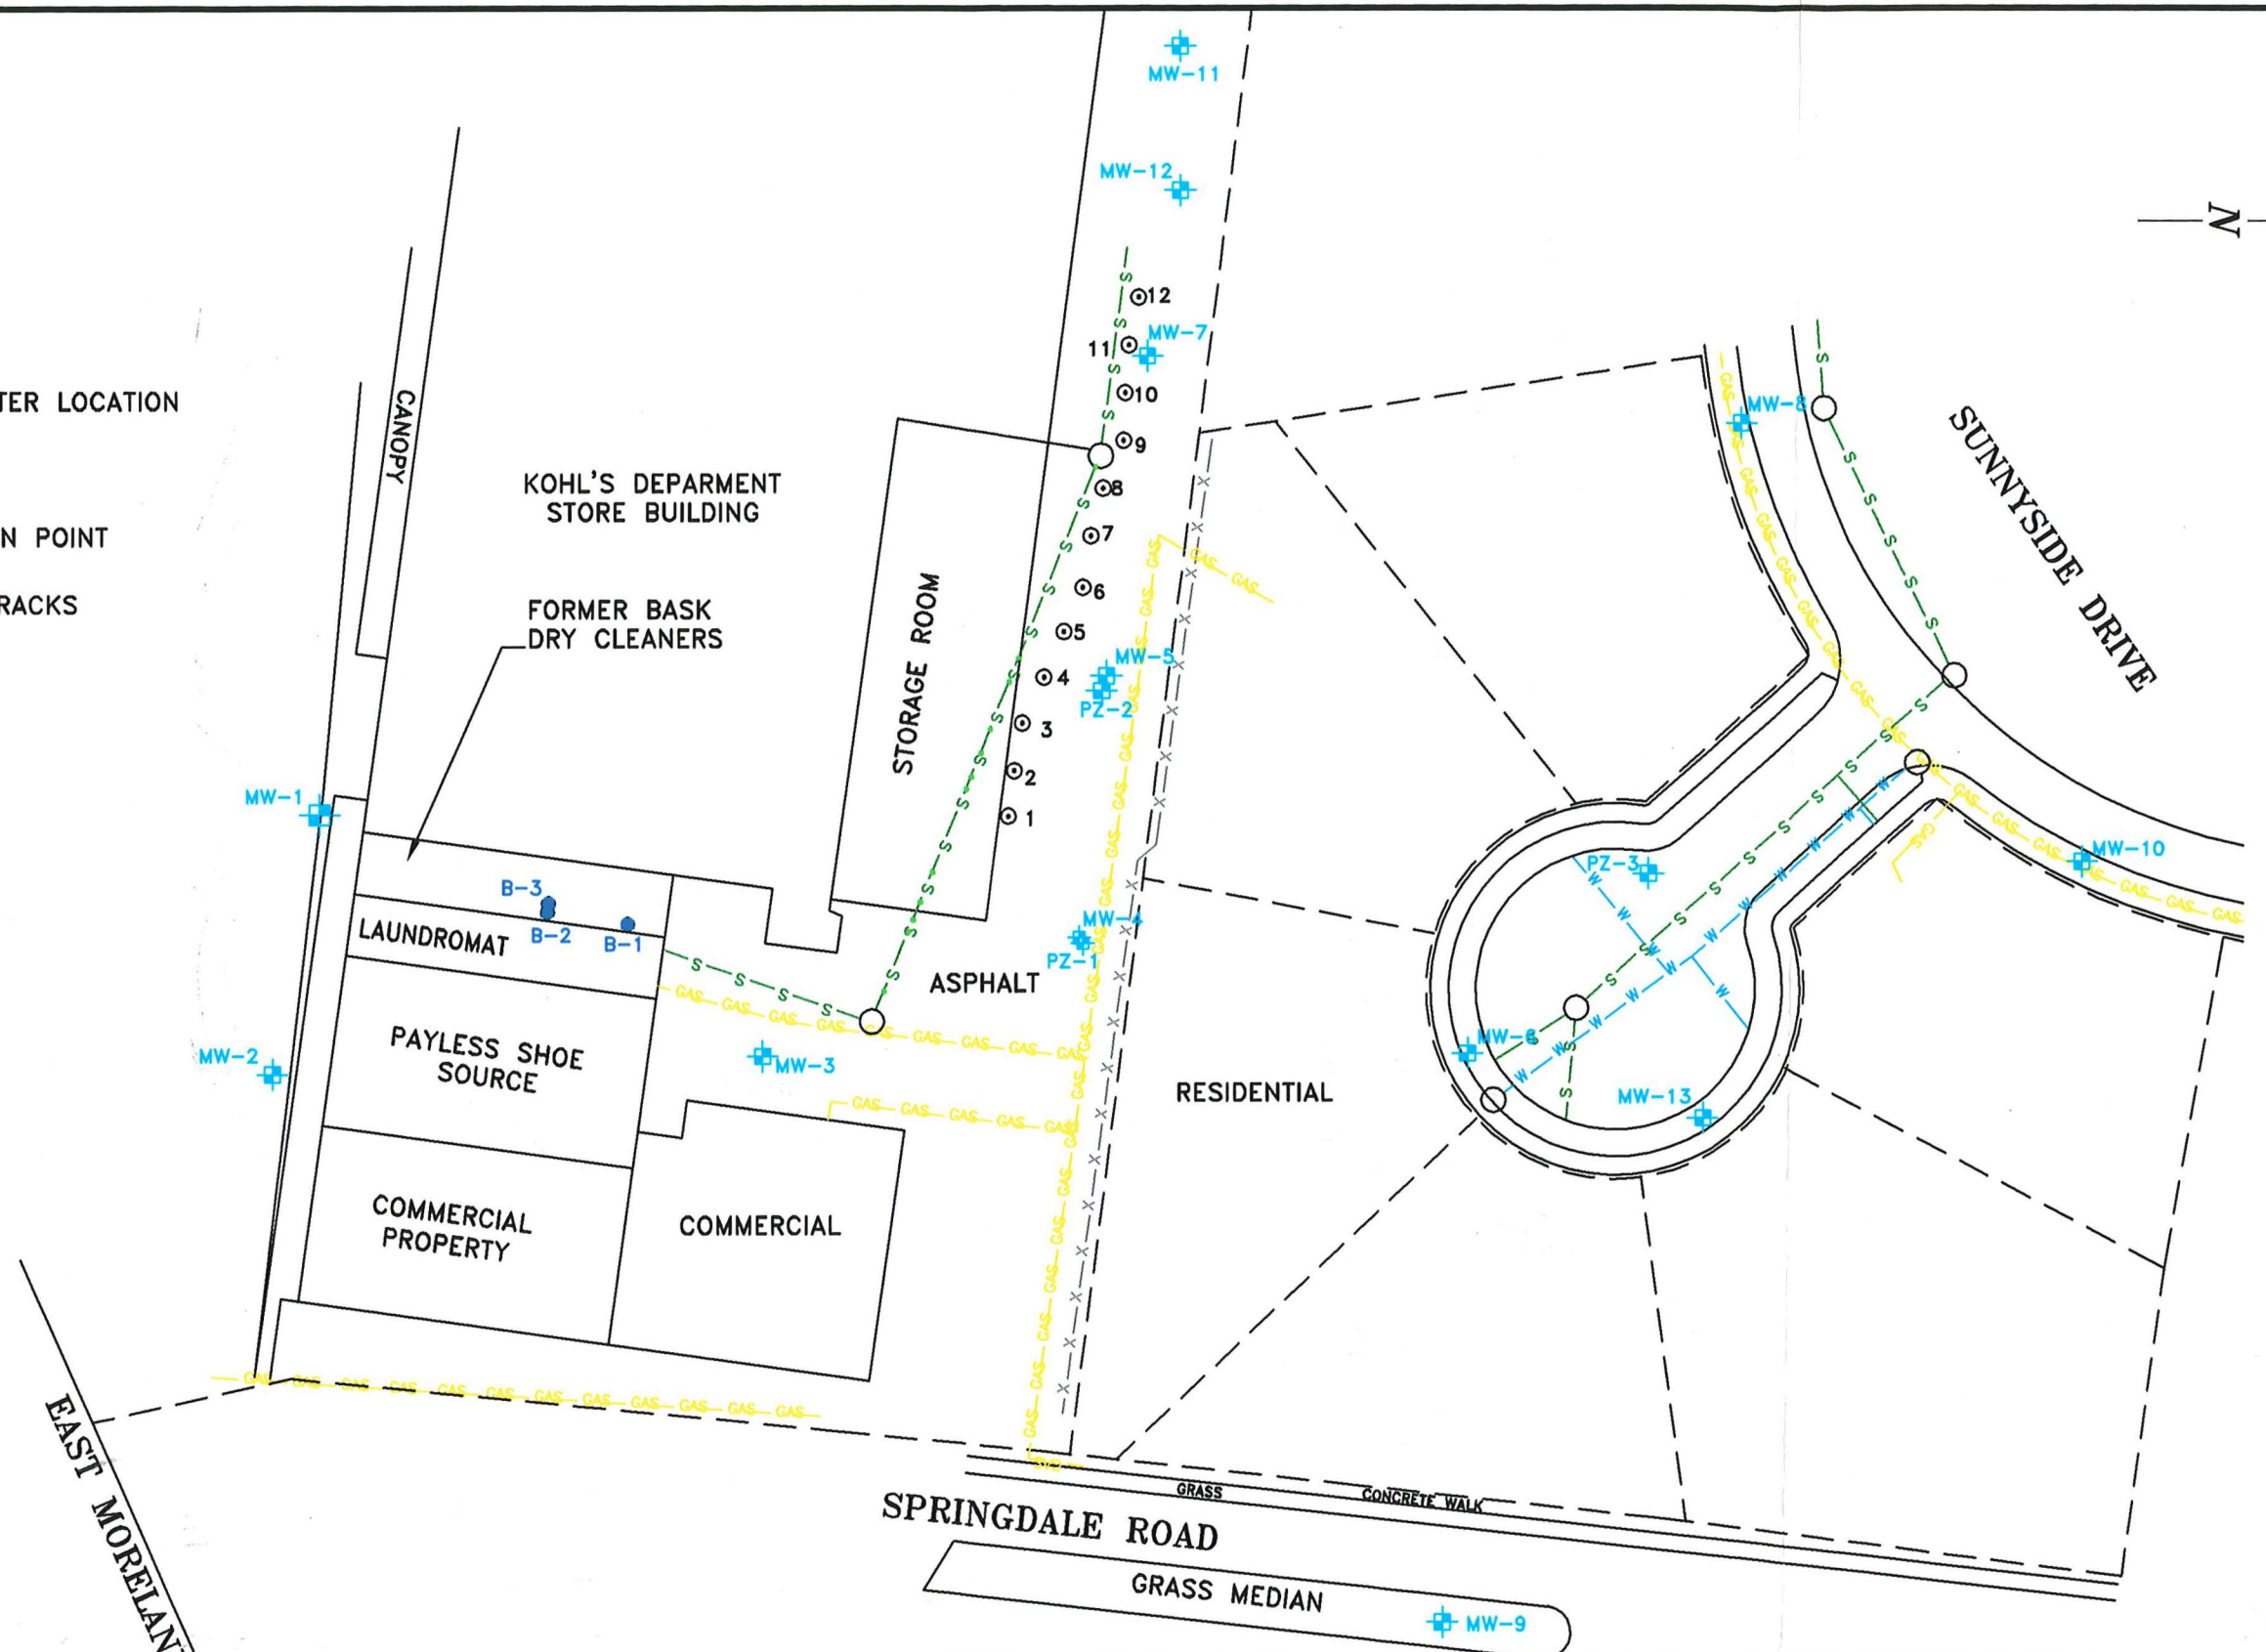
The HRC injection was performed from July 10 through July 15, 2009. A total of 12 injection points were used (the proposal specified 10 injection points, however, based on the layout of the site in the field and the actual well locations, the injection line was extended by one point in both directions). The trace of the injection line is provided on Figure 2. It is noted that the points on the northwest side of the injection line were moved slightly north of the initial proposed locations. This was due to the presence of an outside semi-trailer, converted to a storage unit, which is being used by Kohl's for inventory as well as utility lines previously unknown. After inspection of the unit by Kohl's logistics personnel, it was determined that if the trailer was to be moved, it would probably be severely damaged and would at that point be unusable in the future. It was decided to relocate the affected points slightly to the north to preclude incurring substantial costs for replacing the storage unit if damaged. The relocation of the points will not impact the overall effectiveness of the remedy.

- The sequence of injection by point number (see Figure 2) was 1, 6, 4, 2, 5, 3, 7, 9, 12, 11, 8 and 10.
- Total injectate mass of approximately 45,485 pounds was introduced into the subsurface.
- Upon completion of injection work, the points were properly abandoned with bentonite chips and patched at the surface with asphalt.

It was noted during individual injections that the adjoining point was being influenced (points were spaced approximately 15 feet apart). This field observation suggests that sufficient radius of injection influence was occurring laterally within the formation. Photodocumentation of the work is provided in Appendix B.
