December 1, 2017

**Re: Response to WDNR Questions Regarding the Supplemental Site Investigation Report  
Former Hoffman's Valet Cleaners  
7215 W. Center Street  
Wauwatosa, Wisconsin 53210  
BRRTS# 02-41-307576  
FID# 241083150**

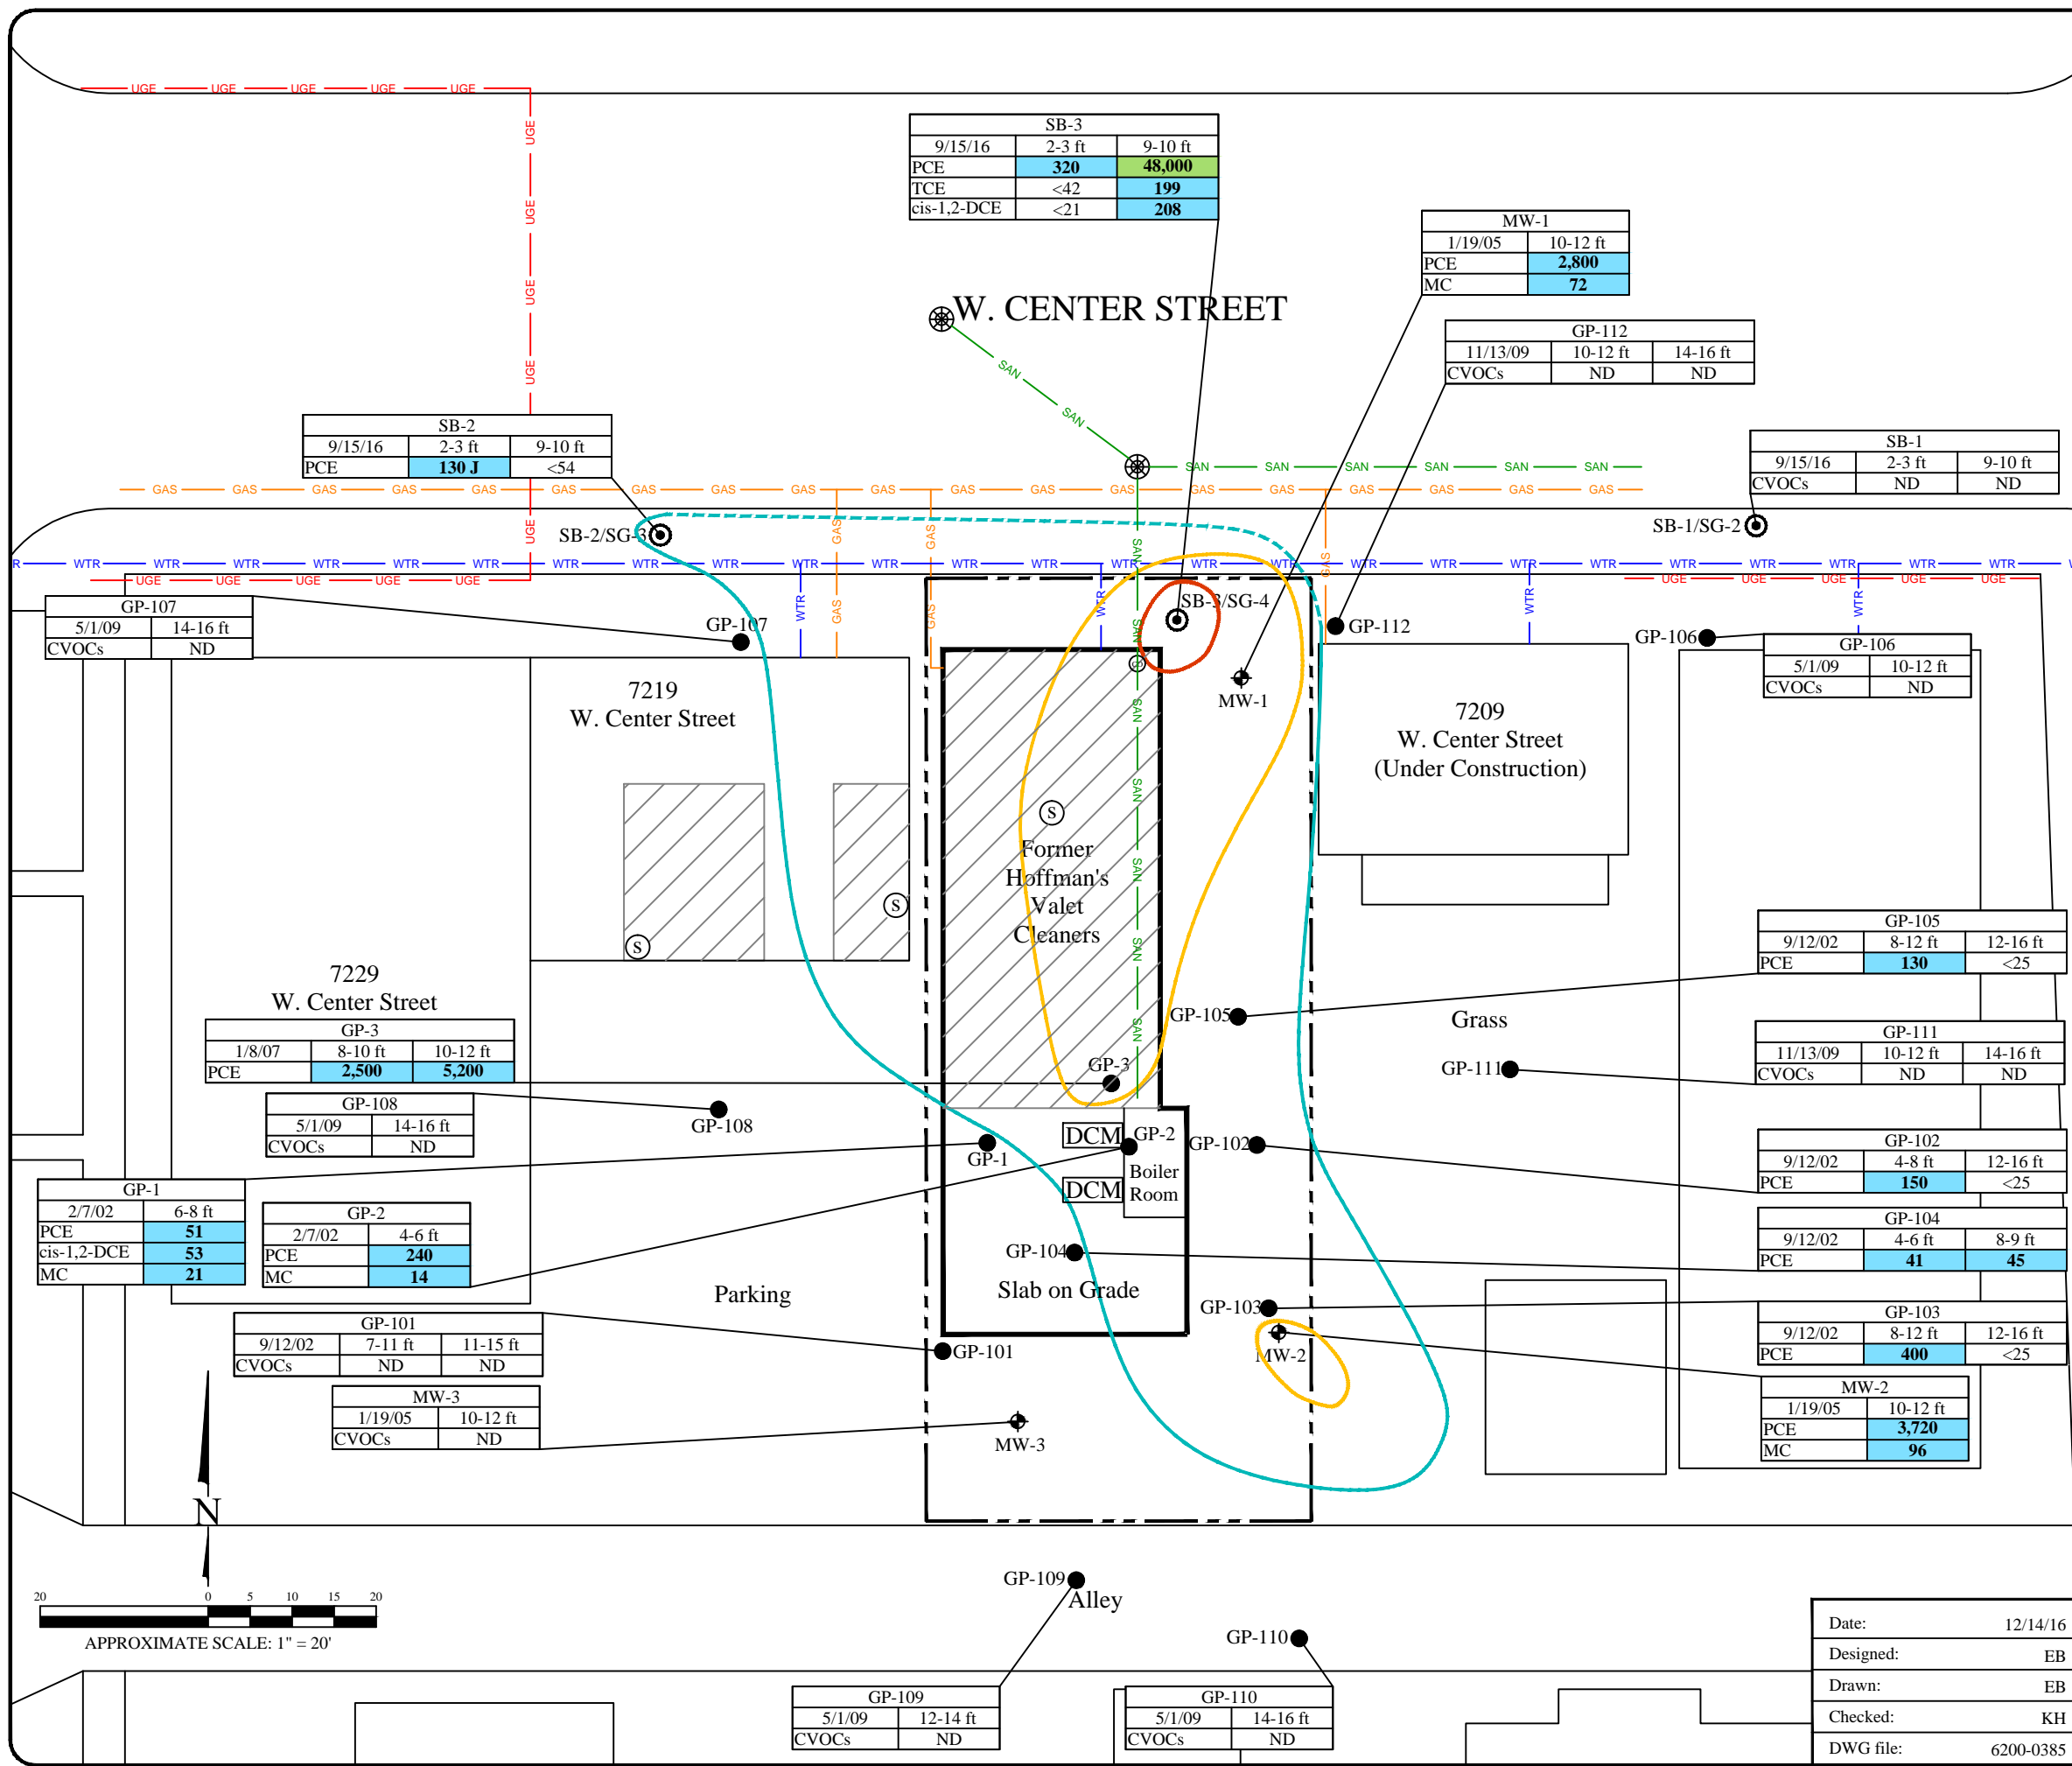
### SOIL SAMPLE ANALYTICAL RESULTS

**1.b.** We understand your question relates to the potential for direct contact exposure within the upper 4 feet of soil. We do not believe that there are direct contact issues in soil at the locations you reference. It appears that the main source of release (source area) is a leaky sanitary sewer lateral near SB-3/SG-4) and potentially some releases on the floor near the dry cleaning machine located on the first floor (GP-3). It is likely that wash water would have been used to clean up any spills, and the PCE contaminated wash water likely entered the sanitary sewer system upon disposal down sinks, the toilet, or floor drain in the basement. Impacts near the source are deeper than 4-feet as indicated in the soil results (**Table 2 in Attachment 2**) and the various figures in **Attachment 1**.

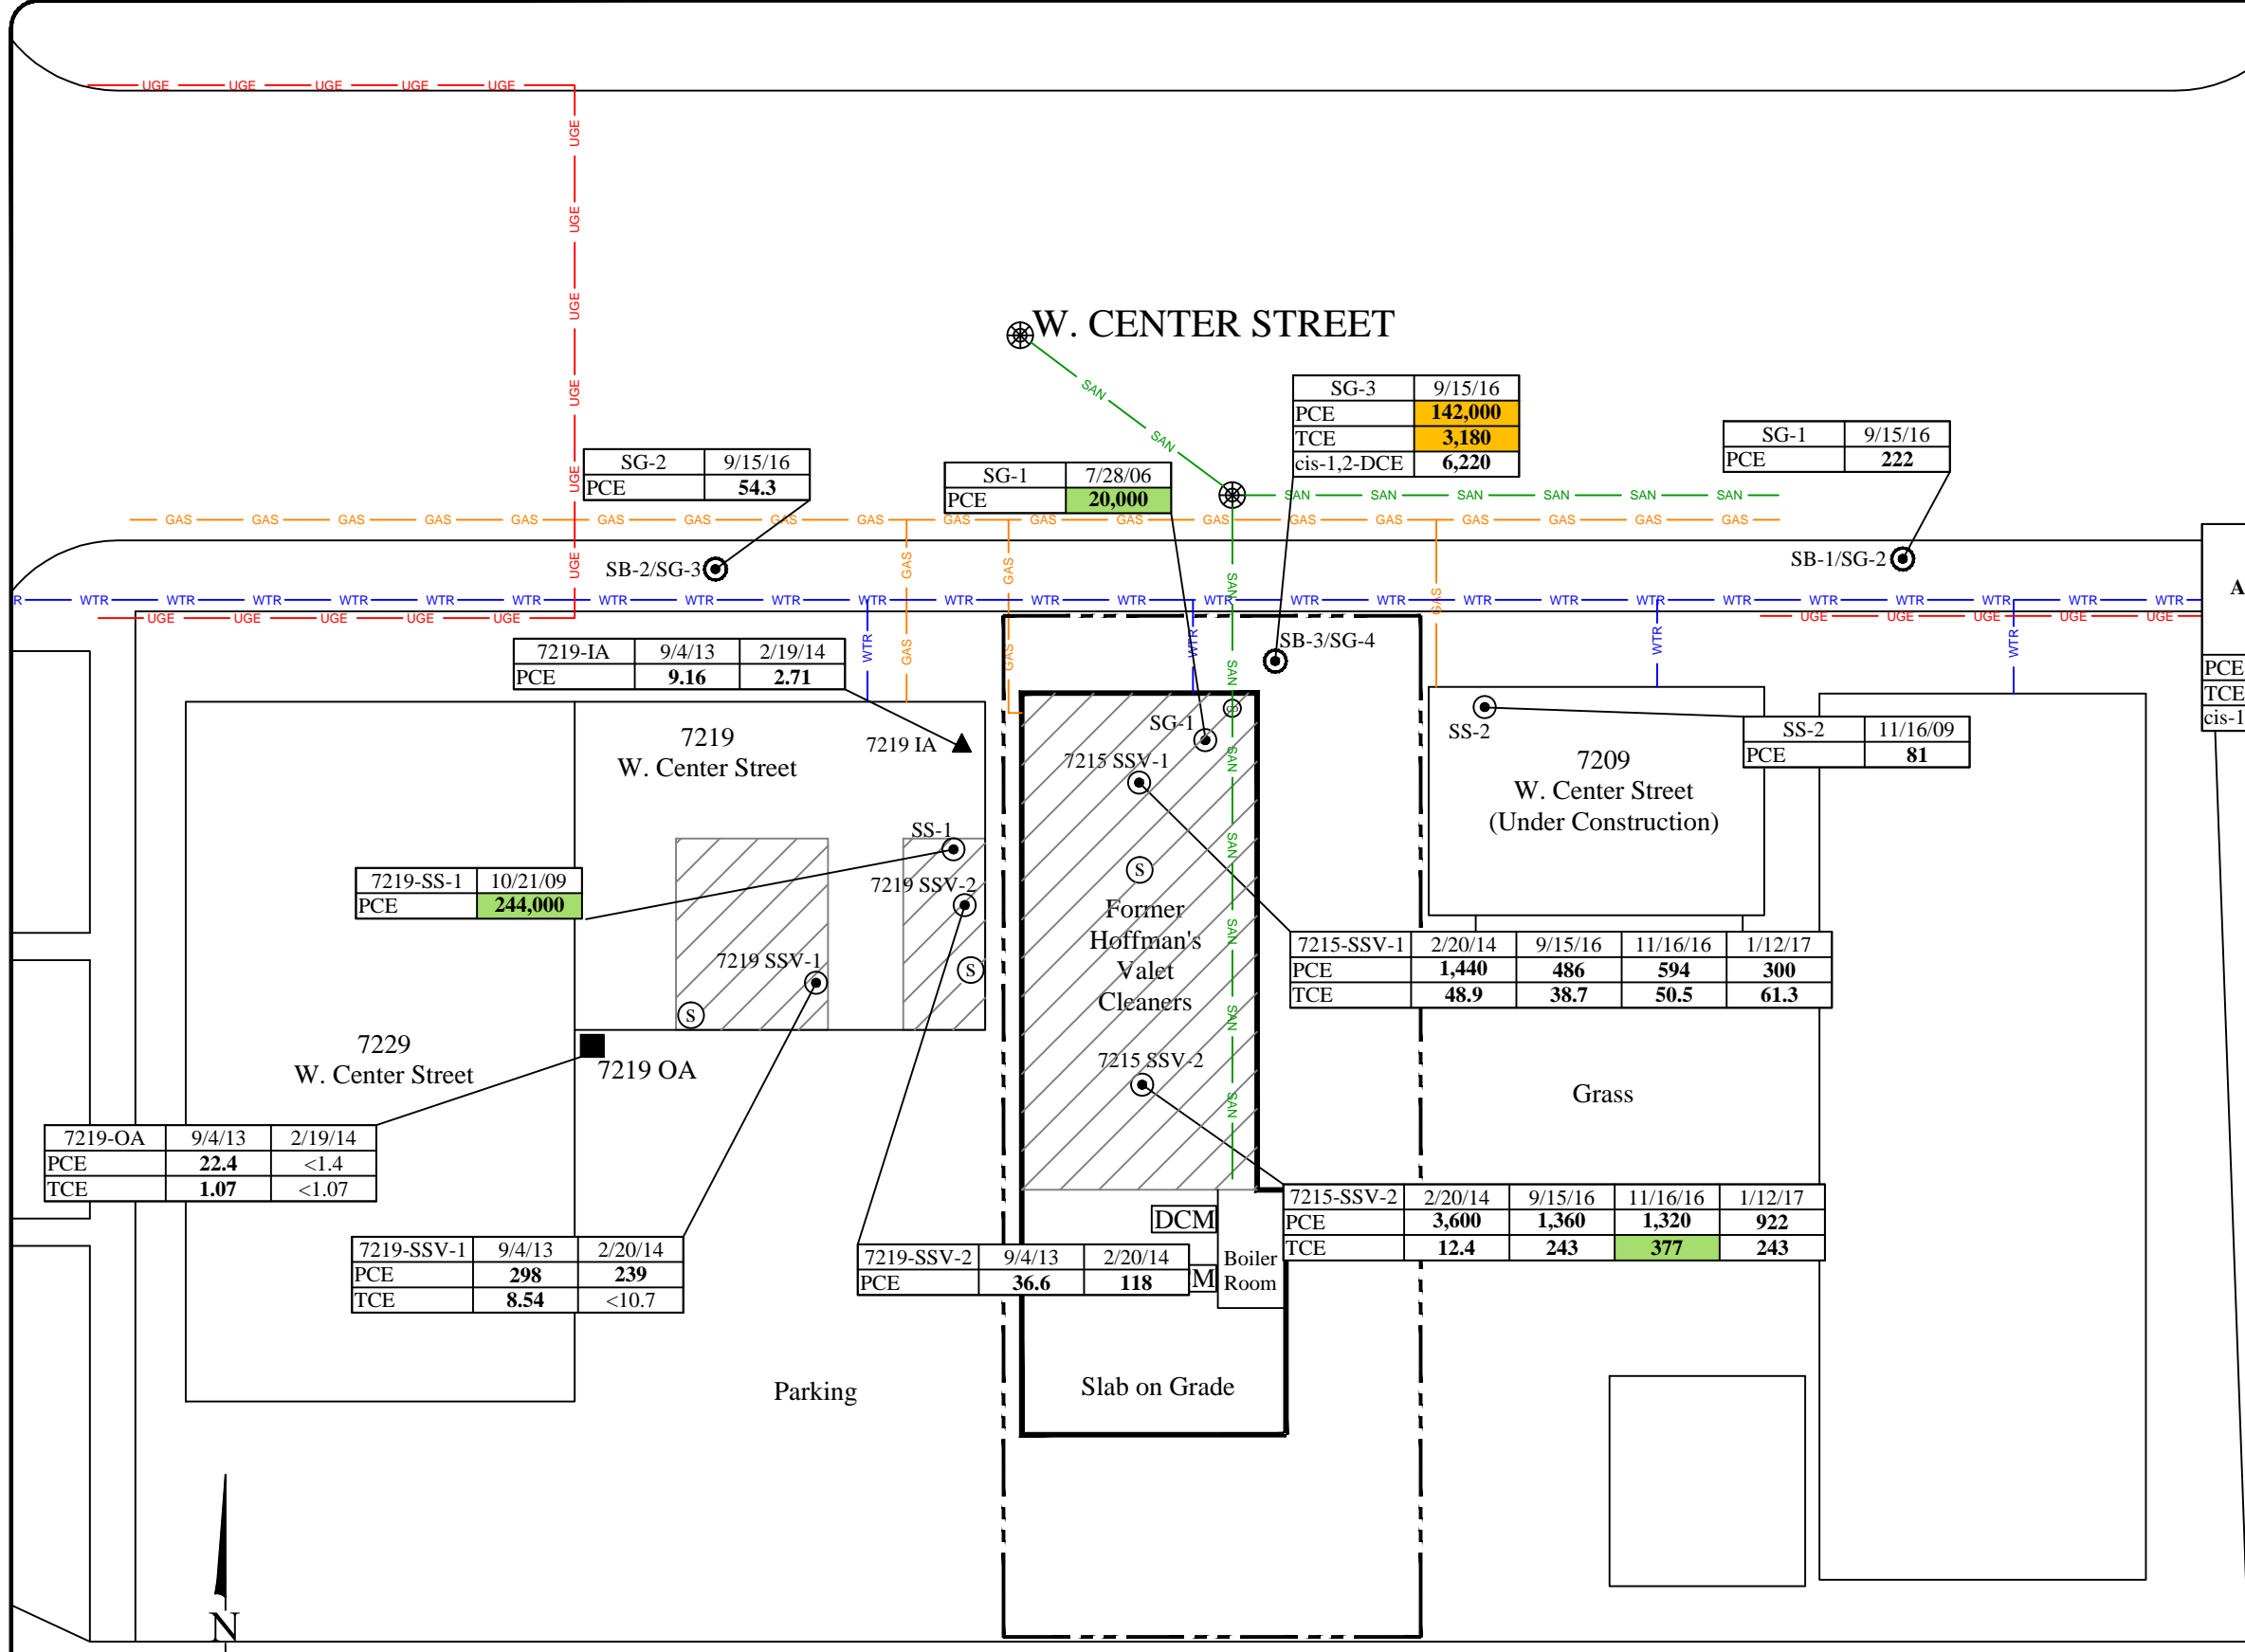
### SOIL GAS AND VAPOR INTRUSION ASSESSMENT RESULTS

**3.a.** Vapor samples were collected from near the water main both east and west of the site for subsurface vapor screening purposes as shown on **Figures 2, 5, 7, and 8**. An additional vapor sample was collected near where the sanitary lateral enters the site building. Soil samples were also collected at all of these locations. As shown on attached **Figure 8**, the natural gas service is located at 3.6 feet below ground surface (bgs) and the storm sewer service is 4.8 feet bgs. As shown on **Figure 9**, these two utilities would be expected to be located above the sand seams identified near MW-1. The water service and sanitary sewer lateral are located at a depth of 7.0 feet and 9.0 feet bgs, respectively. These two utilities were suspected as potential vapor migration pathways. All utilities are located above the water table, which exists at this location in the clayey soil at a depth of approximately 14 feet bgs, and as such the utilities are not expected to be conduits for the migration of groundwater impacts.

**3.b.** We have concluded that the vapor pathway to 7219 is not complete. This conclusion is based on the results of two rounds of sub-slab sampling and paired indoor air sampling at this property. The results indicate that there are no VOC concentrations in indoor air that exceed vapor action levels, and there were no sub-slab VOC concentrations detected that exceed vapor risk levels. Sub-slab samples from SSV-2 were collected on the east side of the basement closest to the property boundary with Hoffman's. In addition, a vapor sample from along utility lines on the north front of the building had only minimal detections of VOC's, while soil samples collected by Arcadis both on the north and south sides of the 7219 building did not have detected VOC's which validates this conclusion.

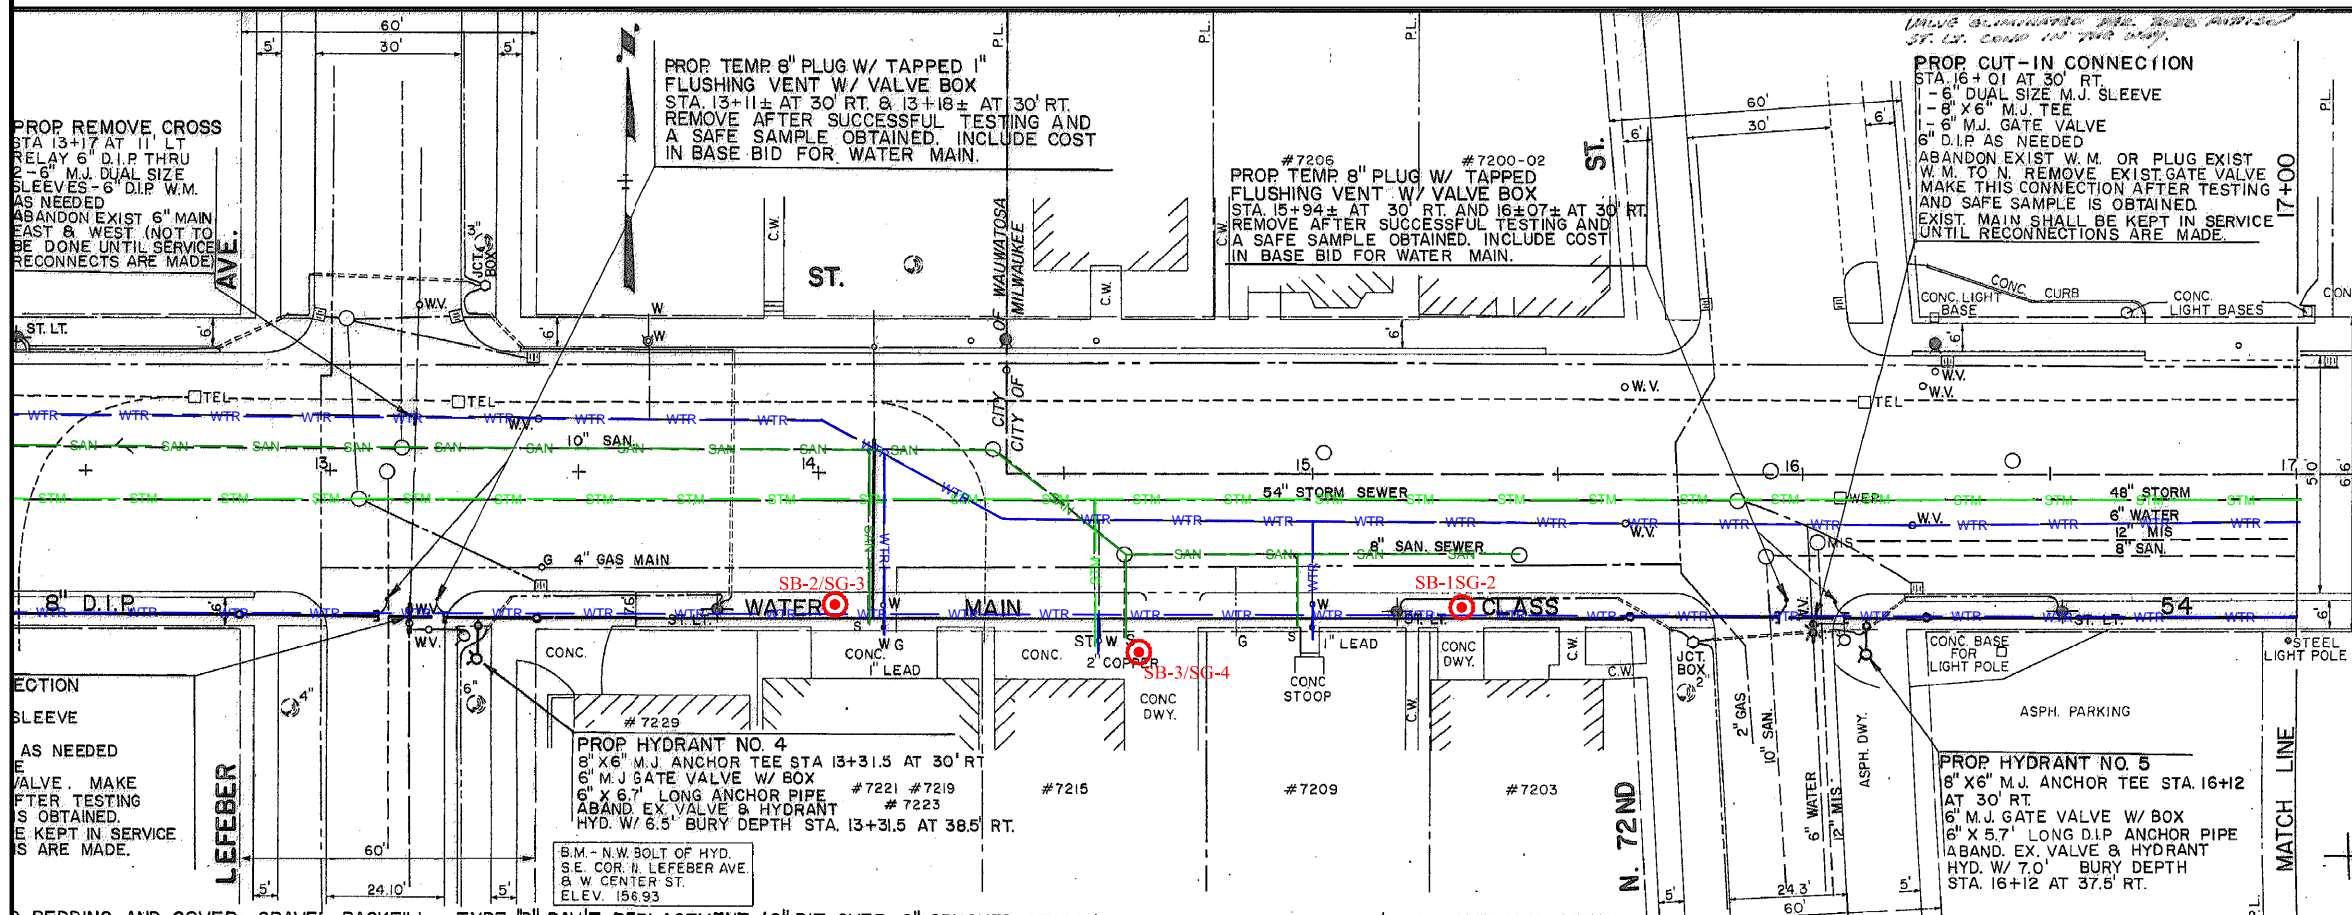
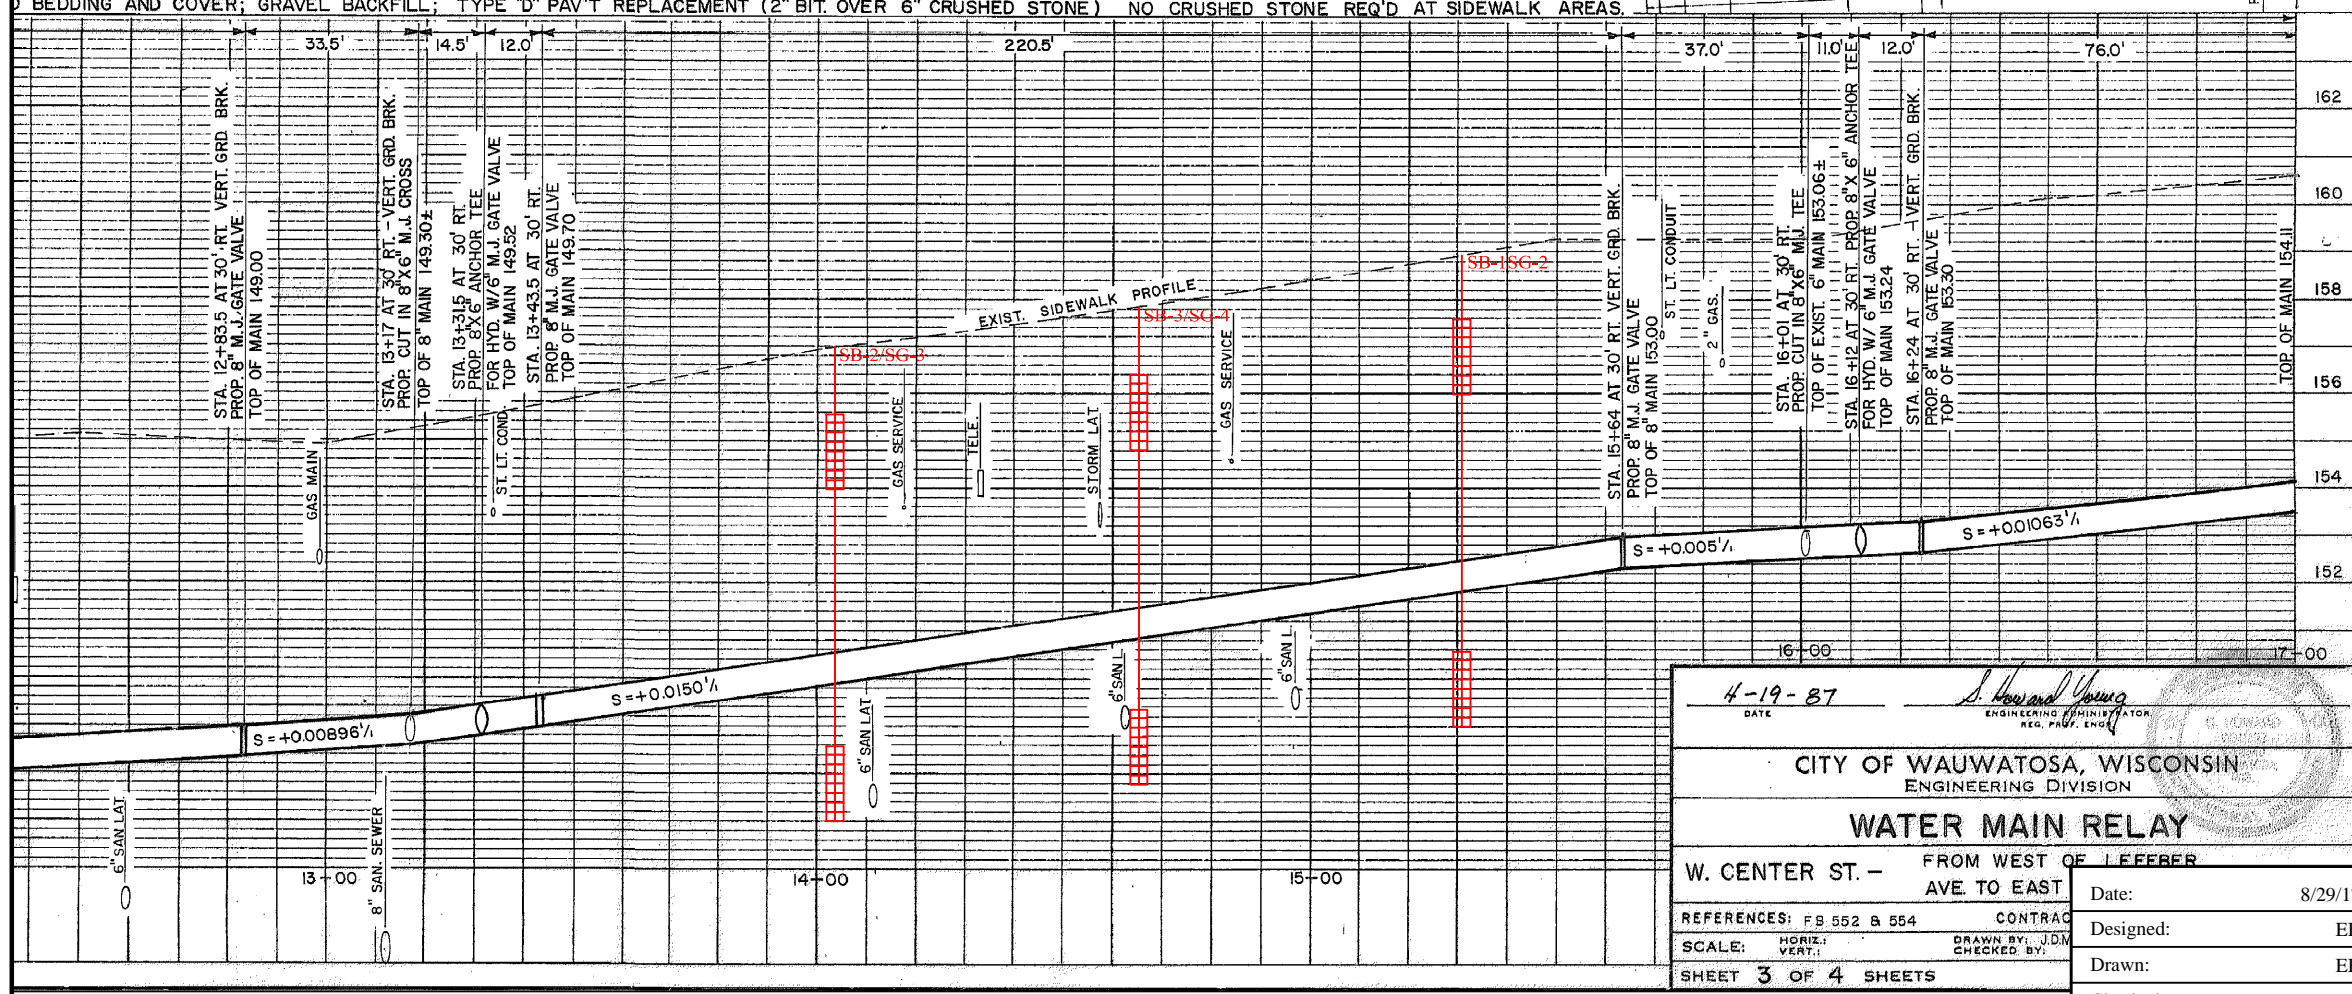
CITY UTILITY LAYOUT

Vapor samples and soil samples were collected by EnviroForensics at the locations and depths shown on the utility drawing, **Figure 8**. The samples were collected from locations along the water service line extending east and west in front of neighboring properties. As can be seen on the soil boring logs previously provided for SB-1, SB-2, and SB-3, soil encountered was silty clay with the exception of a sand layer that was encountered in SB-1 at a depth of 9-10 feet bgs, which was the maximum depth of the boring. Vapor sampling points having a 6-inch long screen were set in sand filter pack from 8-10 feet bgs. The remaining upper eight feet of borehole was sealed with bentonite. This would have put the sample interval within one foot of the water main invert. SB-3/SG-4, was located near the water main, and also in close proximity to the sanitary lateral entering the building. As seen on **Figure 8**, high concentrations of PCE were detected in soil and vapor at this location. However, soil and vapor concentrations were very low at both SB-1 and SB-2. This indicates that the water main did not act as a conduit for vapor migration.

Due to the high concentrations of PCE vapor detected at the sanitary sewer lateral, there may be a potential for the sanitary sewer lateral to transmit these vapors to the main located in Center Street and then migrate to adjacent properties through conveyance to the sanitary laterals entering these buildings. However, past sub-slab sampling in the residence to the east, and the commercial property to the west did not exhibit vapors at concentrations exceeding risk levels, with the exception of a one-time detection of PCE vapor at the property to the west (7219) by Arcadis in 2009. This exception is discussed in 3.b. and 3.c. below. In addition, we would expect sub-slab vapor at the dry cleaner to be the greatest since it is the source of the impacts detected, and that vapor concentrations would decrease in directions away from the source. Sub-slab vapors beneath the dry cleaning building have been below current vapor risk screening levels (VRSL's).

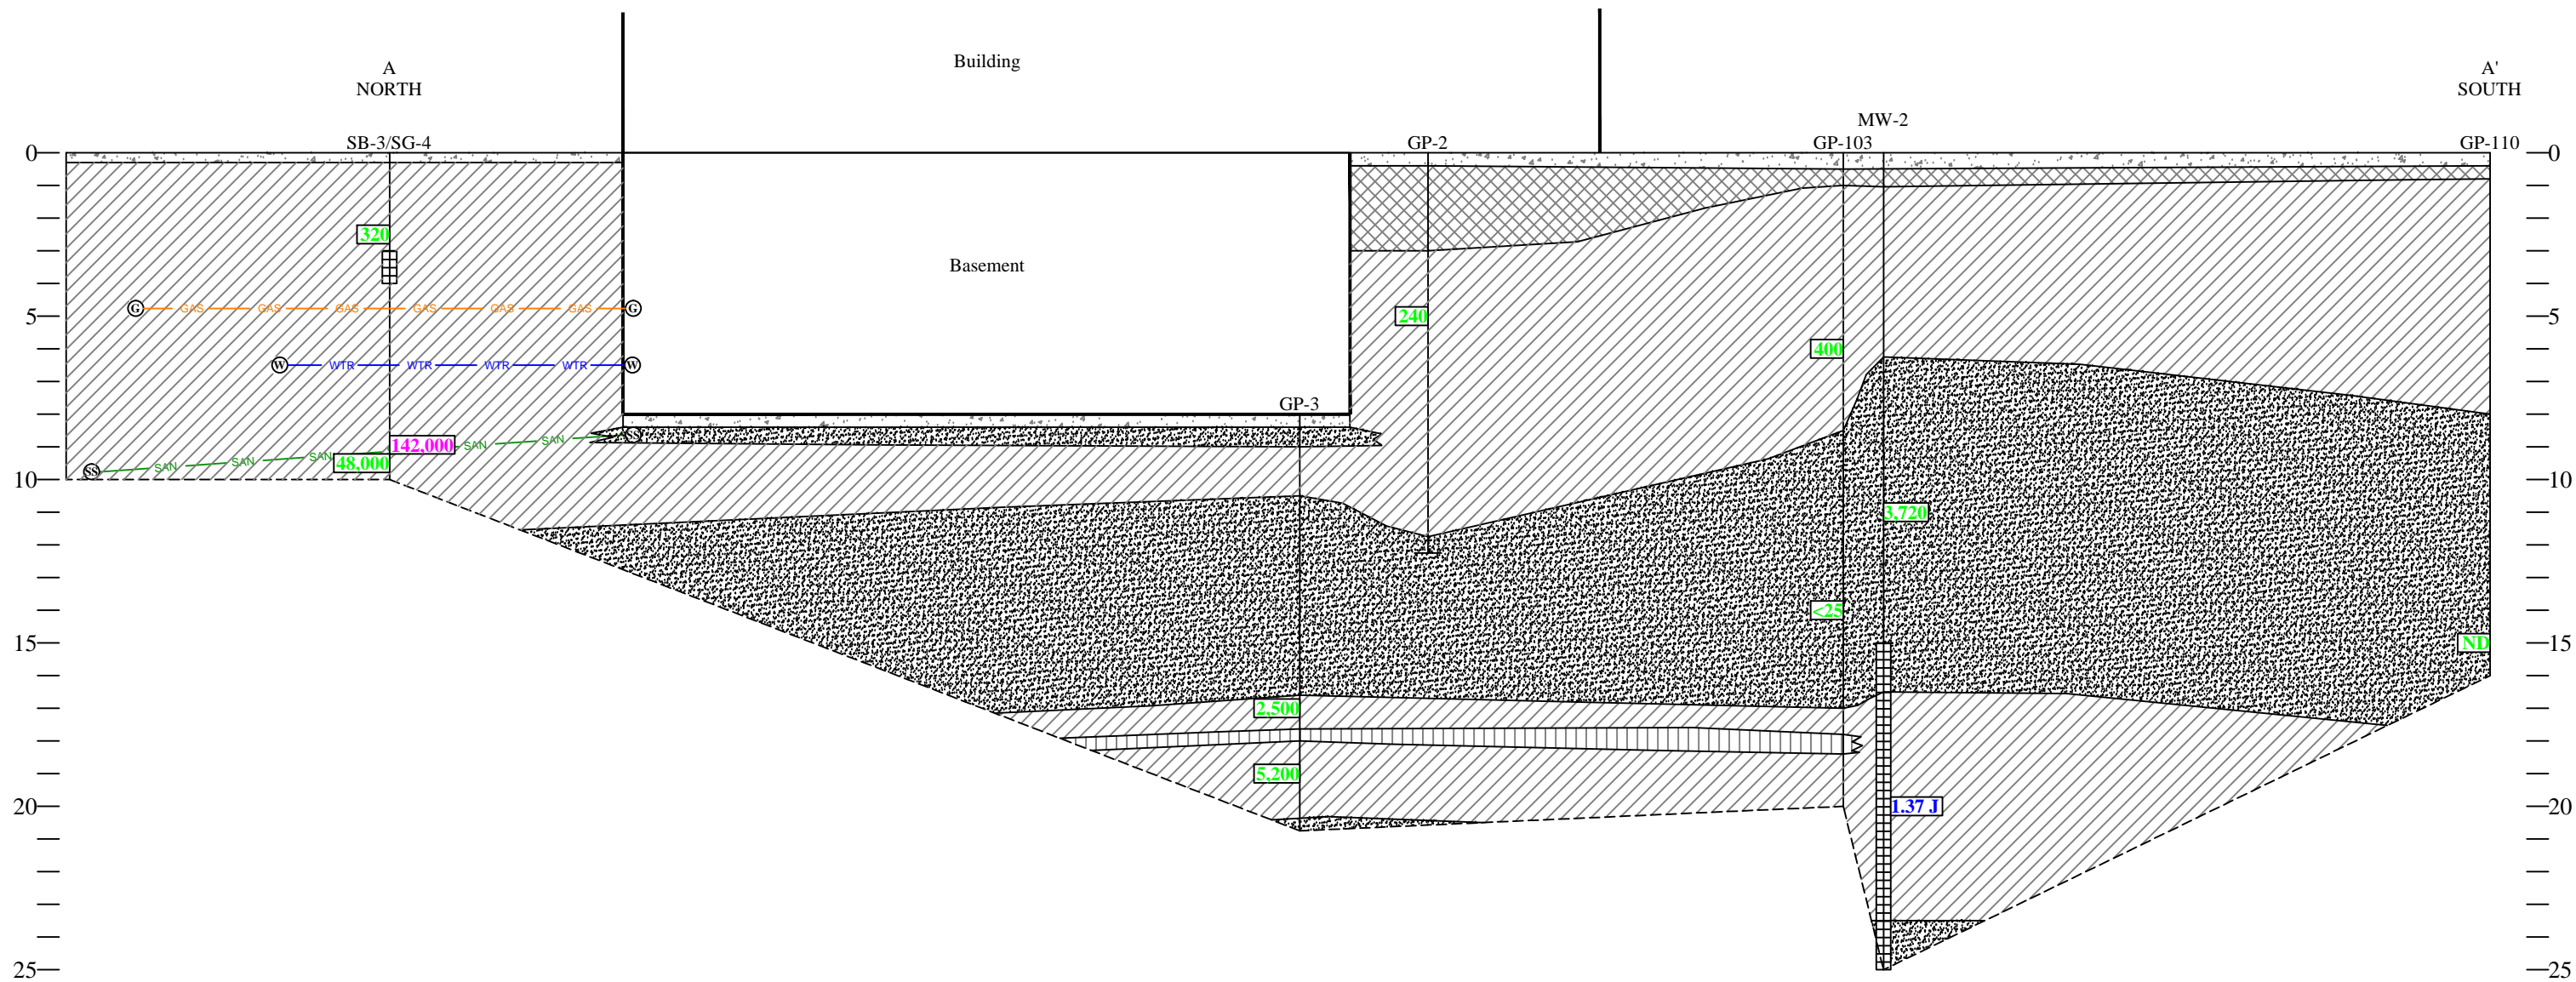
**CROSS SECTION  
A-A'**

New geologic cross-sections have been prepared by Enviroforensics (**Figures 9, 10, and 11** in **Attachment 1**) according to the transects presented on **Figure 2**. As can be seen on **Figure 9**, the sanitary lateral is buried within a sand lense. The sand lense is continuous laterally from MW-2 to MW-1, but appears to pinch out near MW-1. The sand layer may have acted as a conduit for contaminant diffusion laterally to the south. Being near the lateral, soil samples collected from the 10-12 foot depth in MW-1 have contained elevated concentrations of CVOC's. Impacts at the same depth have been detected at MW-2, which is located to the south of MW-1. It is likely that contaminants have migrated laterally along the sand/clay interface which exists at a depth of approximately 12 feet.
