**RE: Final Incident Response Report  
Mercury Release-May 23, 2000  
Ansul's Stanton Street Plant**

## INCIDENT RESPONSE REPORT FOR ANSUL

**RE: FINAL SUMMARY REPORT  
MERCURY RELEASE-MAY 23, 2000  
ANSUL'S STANTON STREET PLANT**

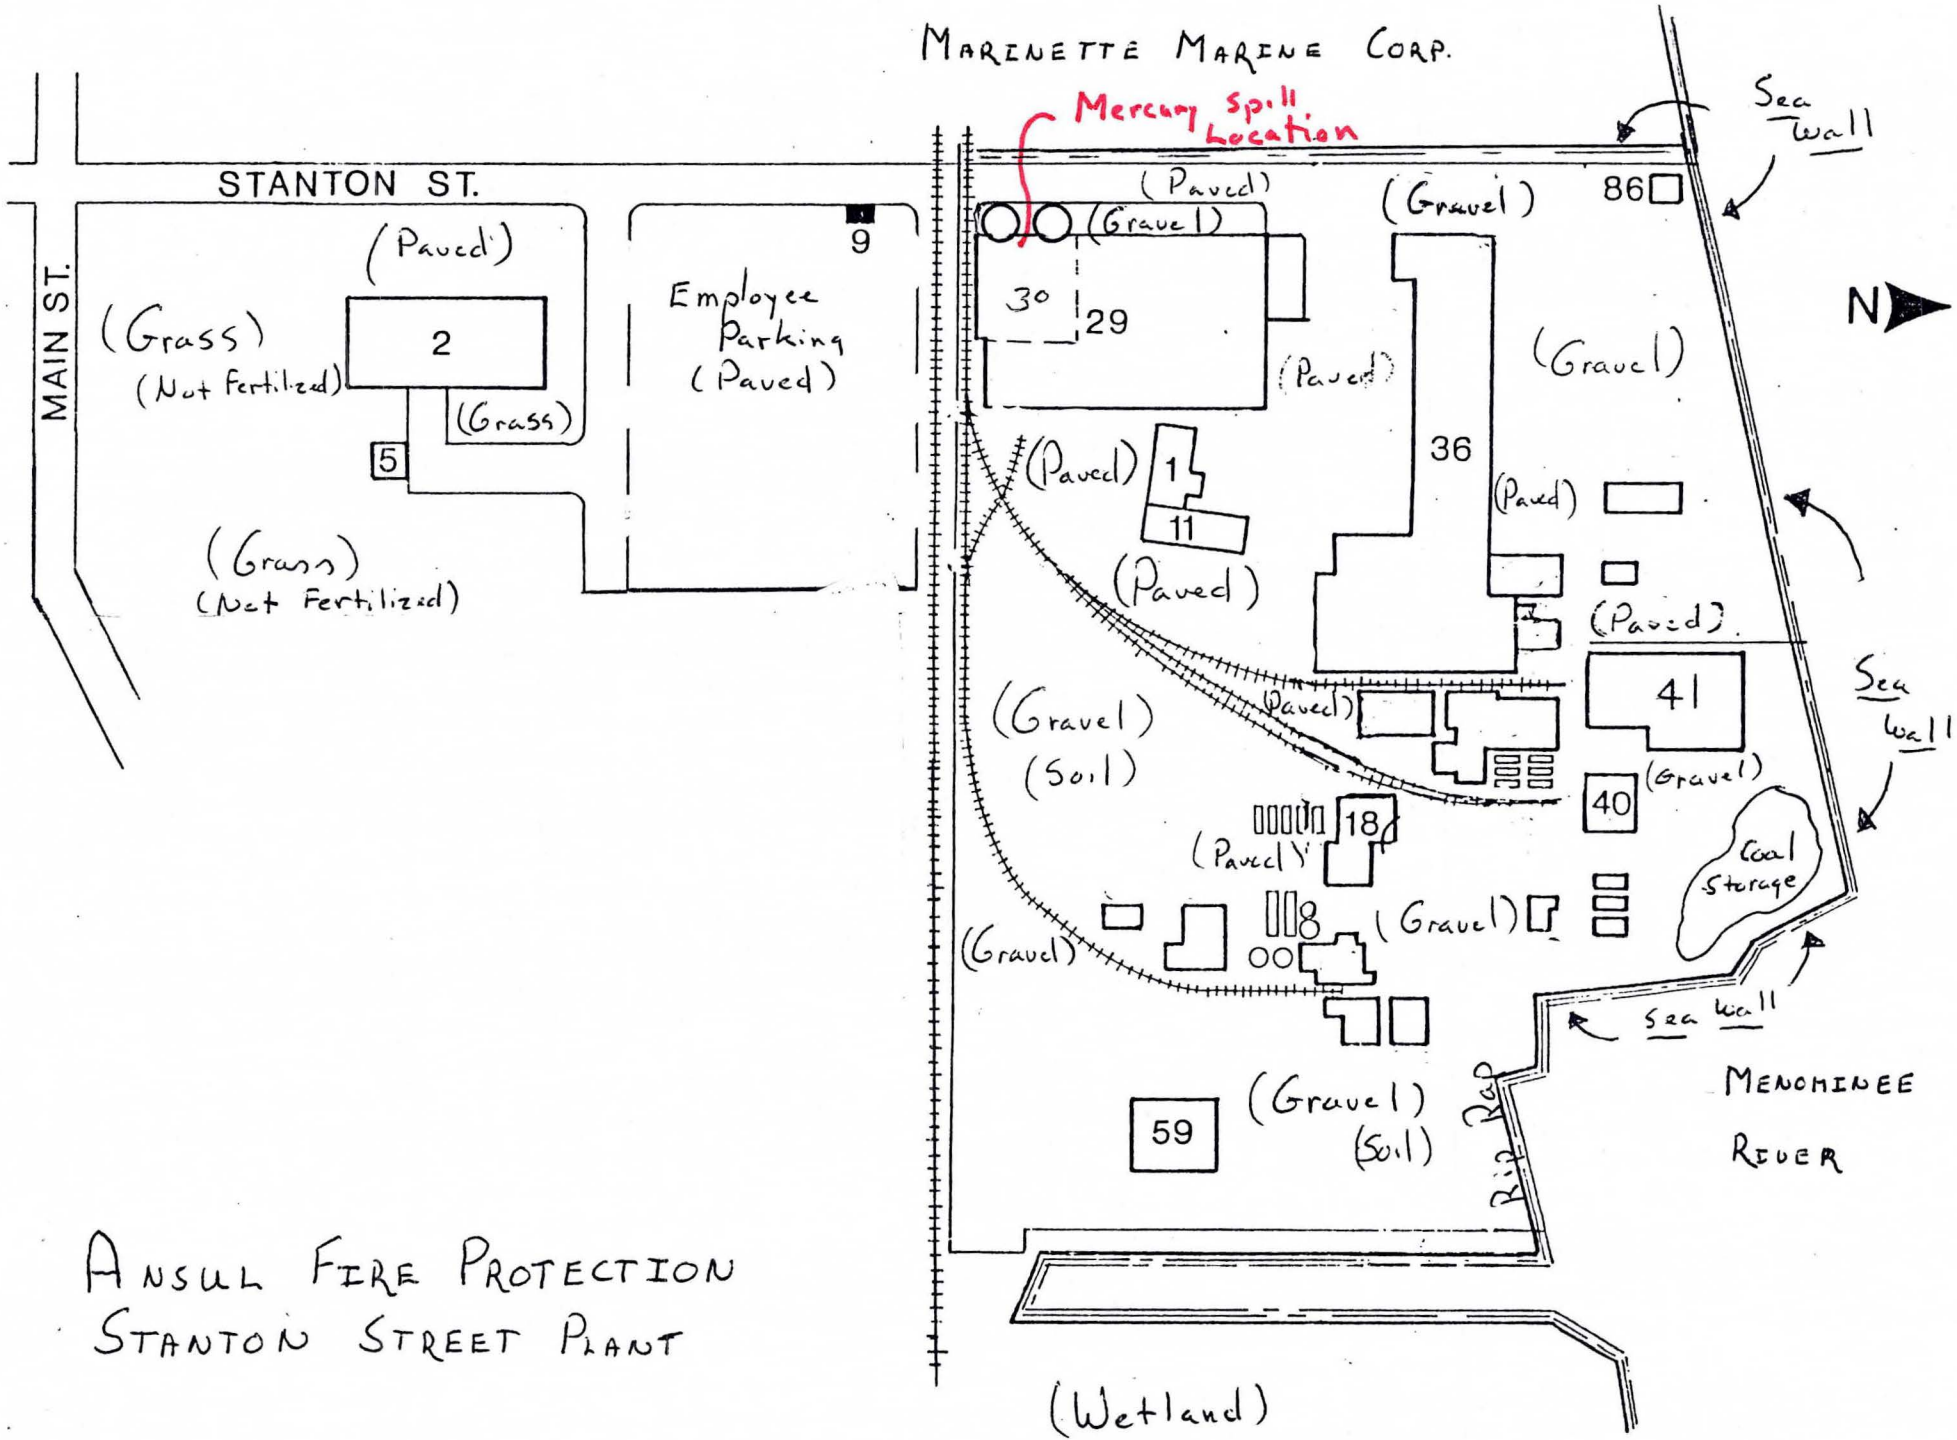
Mercury Spill Location

The spill was discovered at approximately 8 AM on May 23, 2000 in Bldg. 30 at the Stanton Street address. I have attached a map of the site showing the location of the spill.
