TS-AMD-86710-31 June 1986

AERIAL PHOTOGRAPHIC ANALYSIS OF THE WAUSAU WATER SUPPLY Wausau, Wisconsin

This report presents the results of analysis of historical and current aerial photographs of municipal well sites in Wausau, Wisconsin. Municipal wells #3, #4, and #6 are under study by the U.S. Environmental Protection Agency's Region 5 Office to determine possible sources of water contamination. This report documents physical conditions and activity within the study area that are potential sources of the contamination. Three selected dates of black-and-white and color photographs acquired over an 18-year period (1968-1986) are the source data for the analysis.

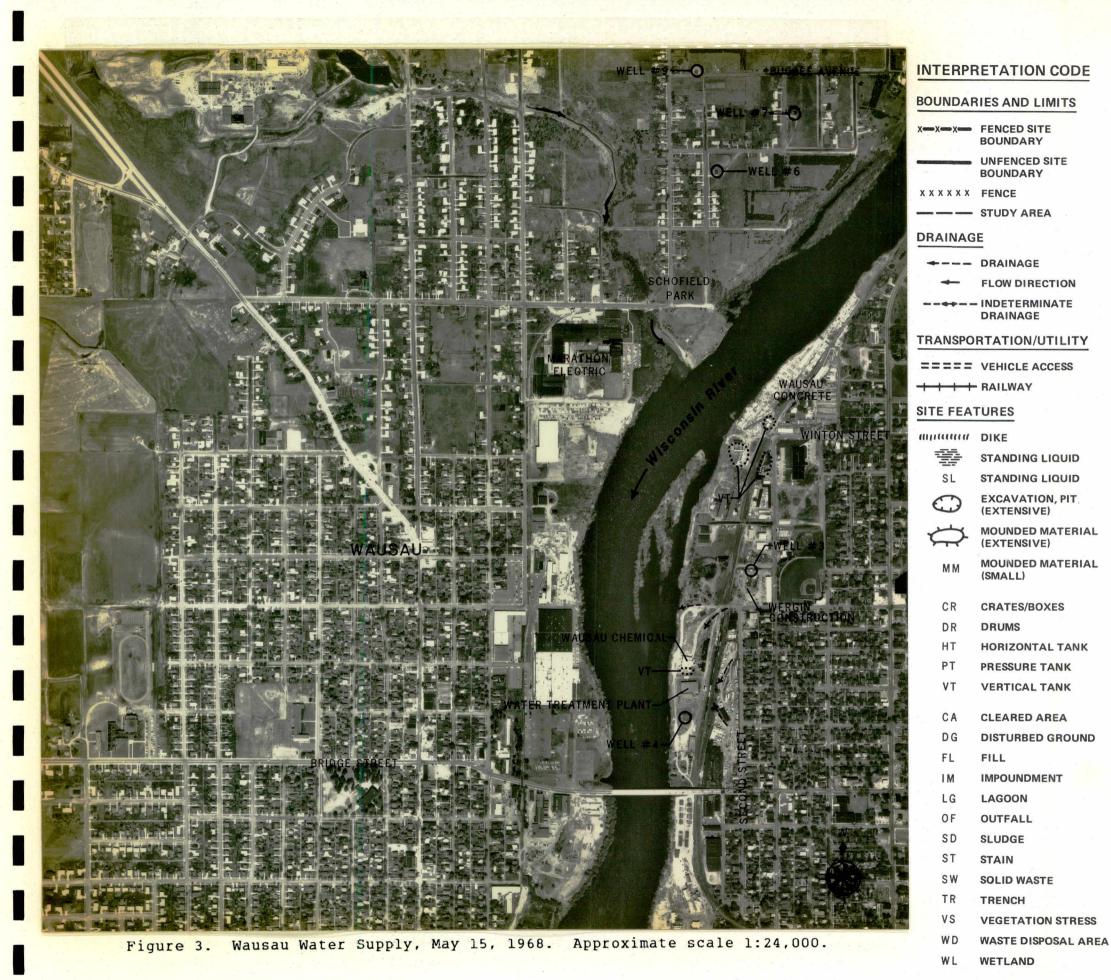
The 1968 photograph (Figure 3) shows the locations of five wells in the Wausau water supply system. The wells #3 and #4 are situated in industrial and commercial sections of the city of Wausau next to the railroad line. There are several bulk storage tank facilities in this section of the city. Three storage tank areas are at the east end of Winton Street. Municipal well #3 is next to open storage yards of the Wergin Construction facility. Municipal well #4 is approximately 400 feet south of a bulk storage tank area of the Wausau Chemical Company. The small scale of the photograph prevents observing details around these tanks.

Municipal well #6 is on the western side of the Wisconsin River. The well location is adjacent to a residential area. There are no visible industrial facilities nearby and no visible evidence of waste disposal activity.

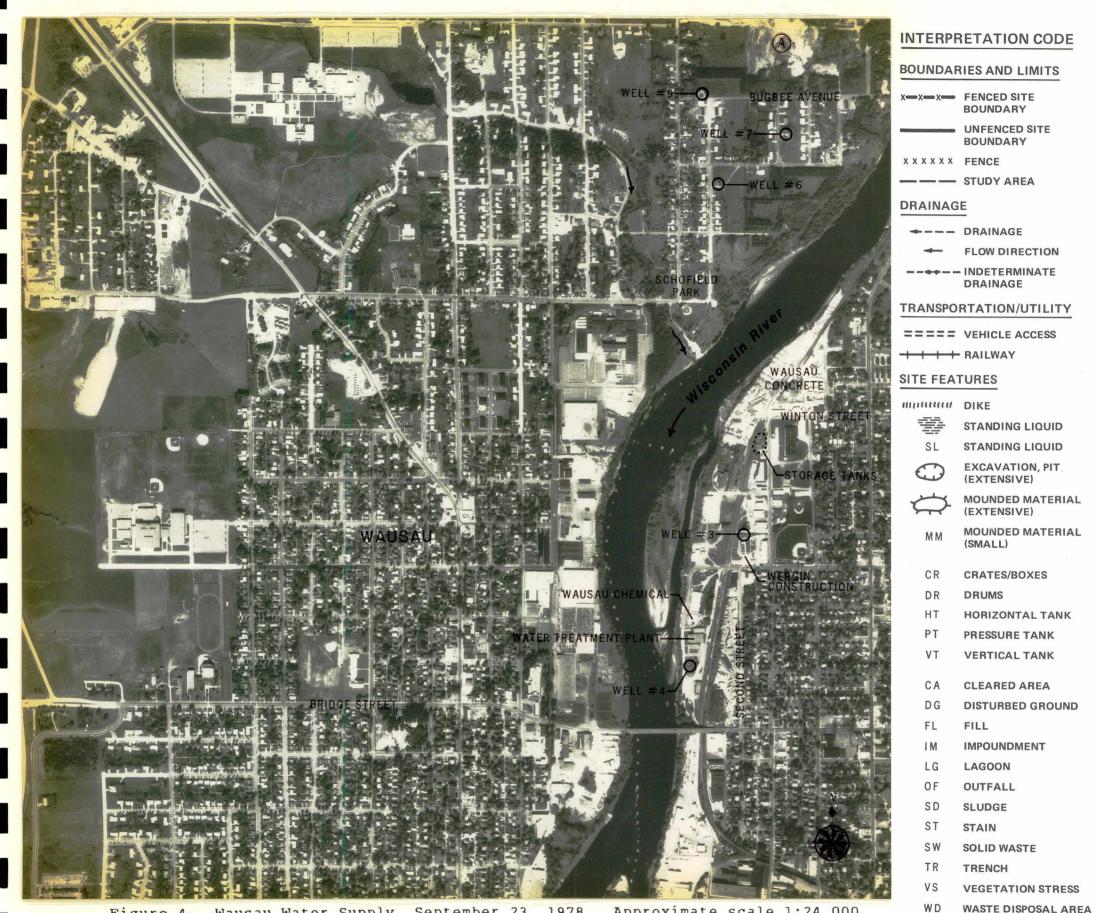
Wausau Water Supply, September 23, 1978. Approximate scale 1:24,000. Figure 4.

The 1978 photograph (Figure 4) reveals the locations of municipal wells #3, #4, and #6. Two bulk storage tank facilities observed on the 1968 photograph (Figure 4) at the east end of Winton Street are dismantled. The storage area associated with the Wausau Chemical facility is not clearly seen due to the small scale and poor quality of the photograph. No indications of leakage or spillage from these bulk storage tanks are visible.

Ground scars (annotation A) are visible in an area north of Bugbee Avenue adjacent to the well field of municipal wells #6, #7, and #9. The massive earthmoving activity is soil borrowing and/or a sand and gravel operation. Large mounds of sand and gravel are nearby. There is no visible indication of dumping solid or liquid waste and/or landfilling action at this excavation site.

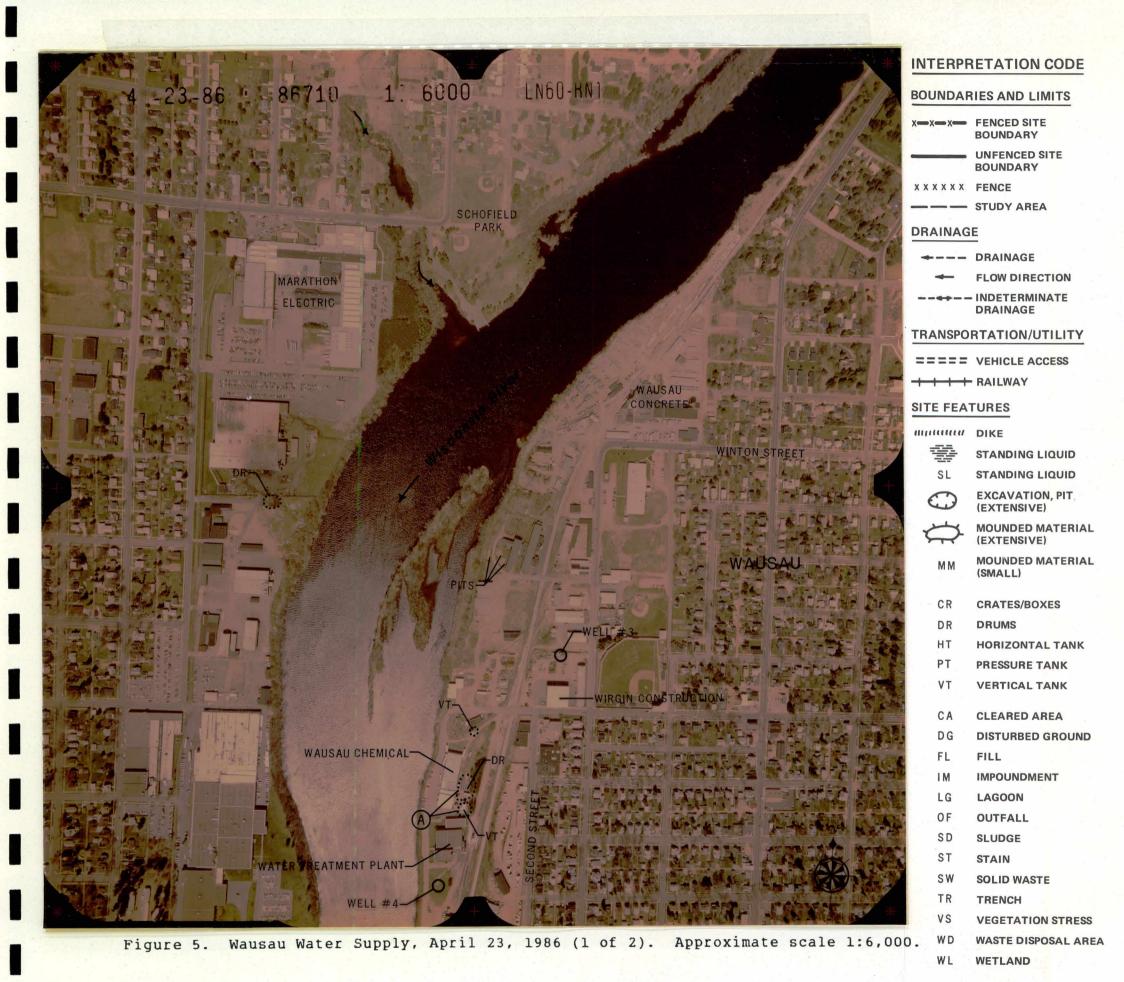
The 1986 photographs (Figures 5,6,7) show the land on which the municipal wells #3 and #4 are located remains an industrial and commercial section of Wausau. Two bulk storage tank areas observed on the 1978 photograph (Figure 4) are absent; however, the storage tank area (Annotation A) associated with the Wausau Chemical facility is present. This storage area has 11 vertical and 1 horizontal uncontained bulk storage tanks and is on the southeast corner of the property. There is a large open storage area with stacks of 55-gallon drums standing on the bare ground that also lack secondary containment. Spillage or leakage of the liquids in these tanks and/or drums could infiltrate into the soil and threaten the groundwater supply. Municipal well #3 is nearest to this Wausau Chemical storage area.

The municipal well #4 is adjacent to a storage yard of the Wergin Construction facility. No storage tanks or drums are discernible around this well.

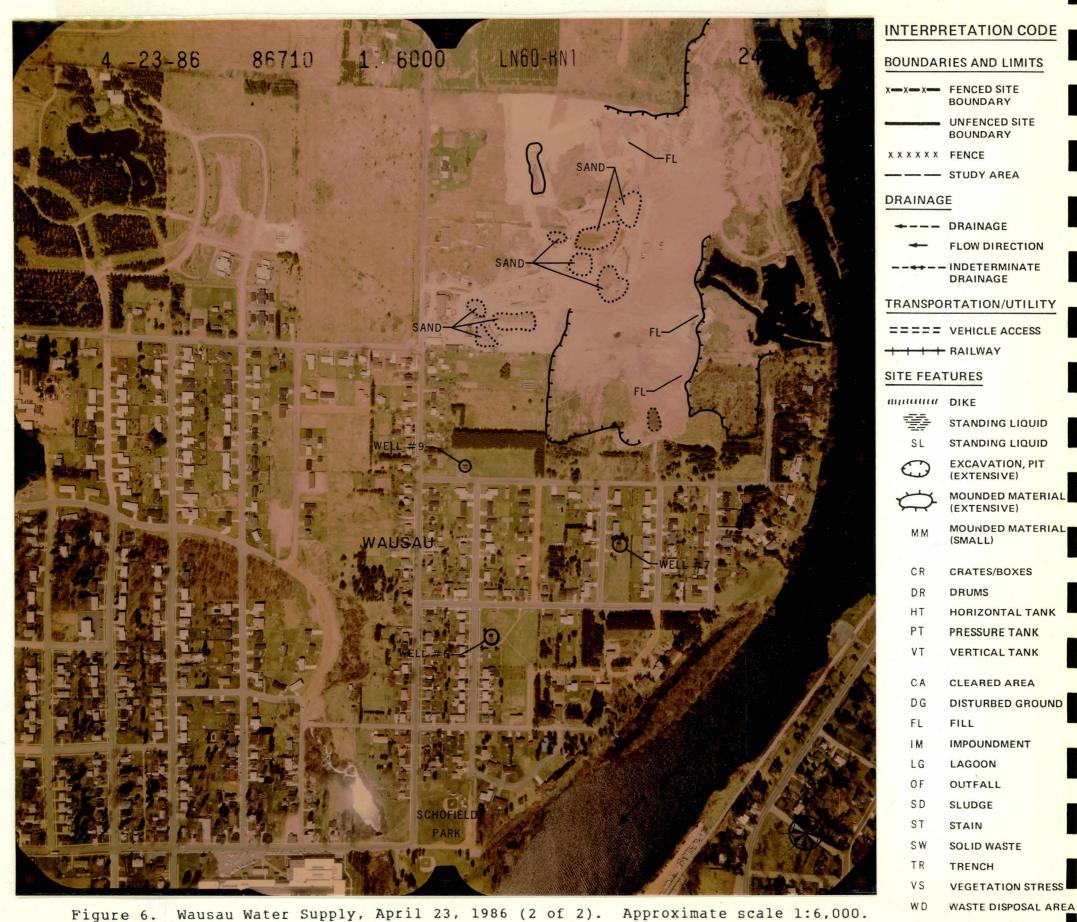
On the west side of the Wisconsin River are municipal wells #6, #7, and #9 (Figure 6). Potential impact to this well field is a landfilling effort north of Bugbee Avenue at sand and gravel pits. These sand and gravel pits were described on the 1978 photograph and portions of the pits have since been partially covered with fill material. The terrain of this landfill has been recontoured with what appears to be construction rubble and fill. No solid or liquid waste dumping activity is visible and there is no visible evidence of leachate seepage or vegetation stress in this area.
