SUPERFUND PRELIMINARY CLOSEOUT REPORT

Better Brite Superfund Site De Pere, Brown County, Wisconsin

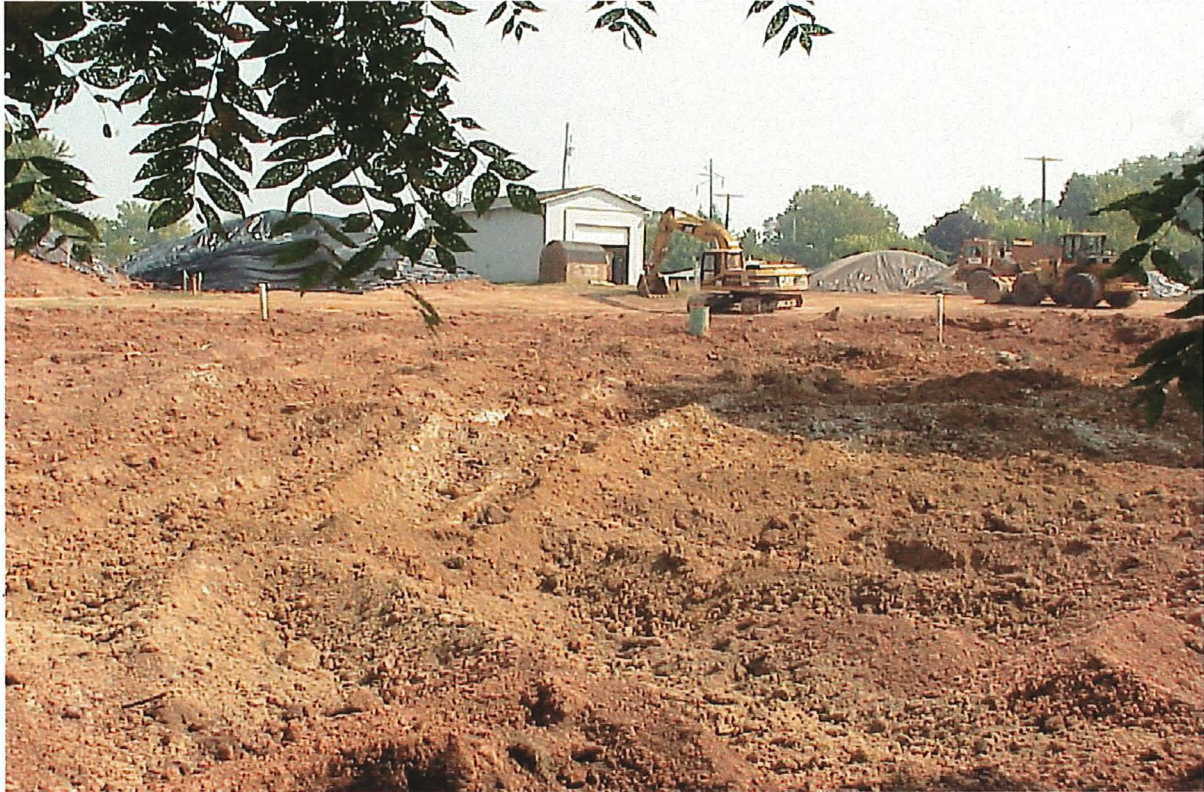
Excavated area at Chrome Shop looking northeast from southwest property corner. Treated soil in foreground (Quad. 2) prior to stockpiling.

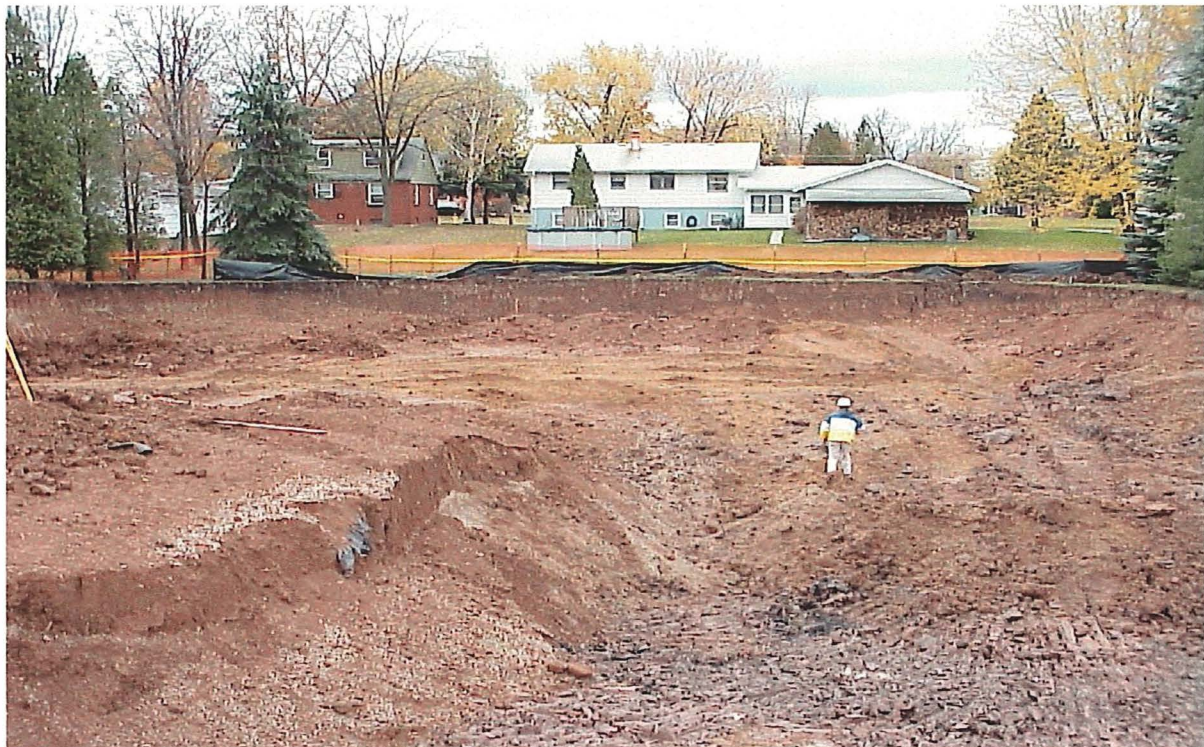
Chrome Shop excavation nearing completion. Quadrants 1, 2, and 3 partially backfilled. Quadrant 4 excavated to depth. Gravel sump area installed by the EPA in the early 1990s visible on left.

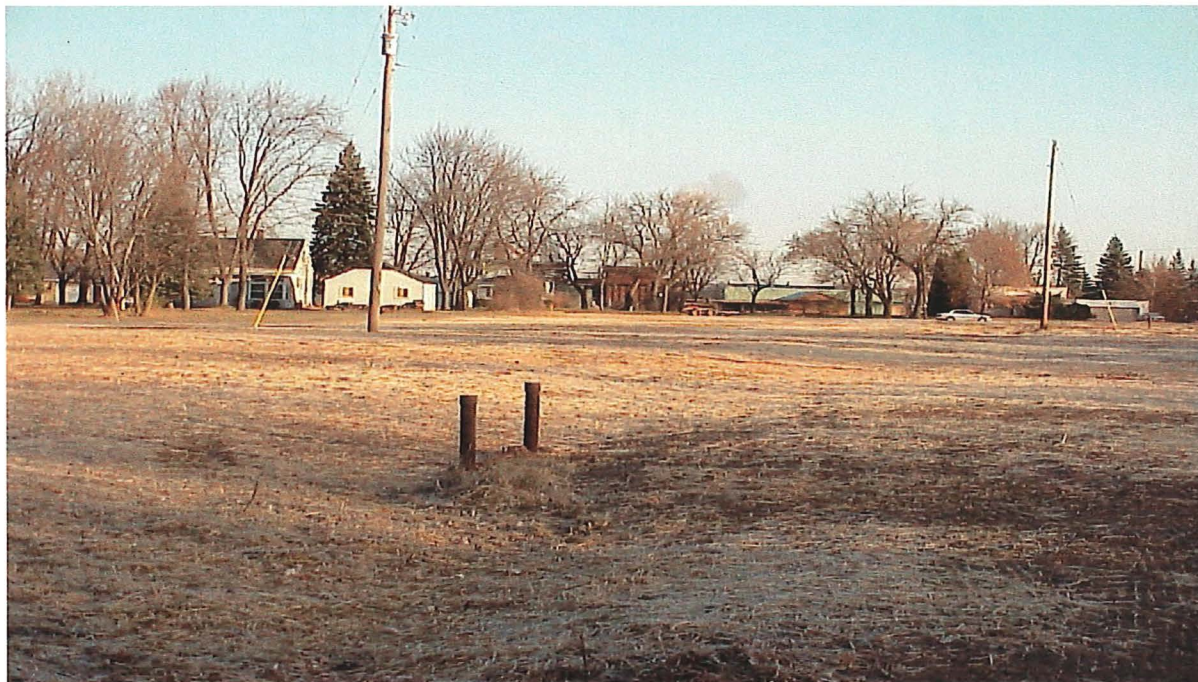
Work was completed at the Chrome Shop at the time of the pre-final inspection. The final grade, seeding and mulching of the site was adequate. No further work is necessary at the Chrome Shop. Replacement of the monitoring wells removed during the remedial action is tentatively scheduled for the winter of 1999-2000.

Final grade at Chrome Shop looking north from MW-107.

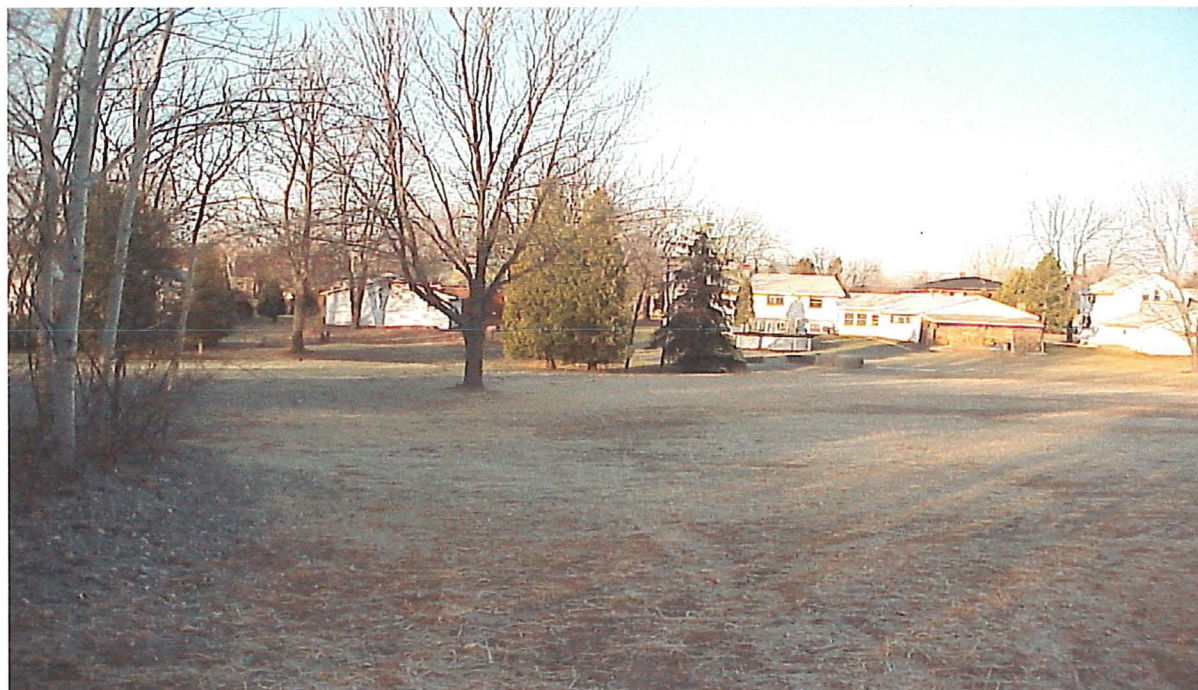
Final grade at Chrome Shop looking west from MW-107.

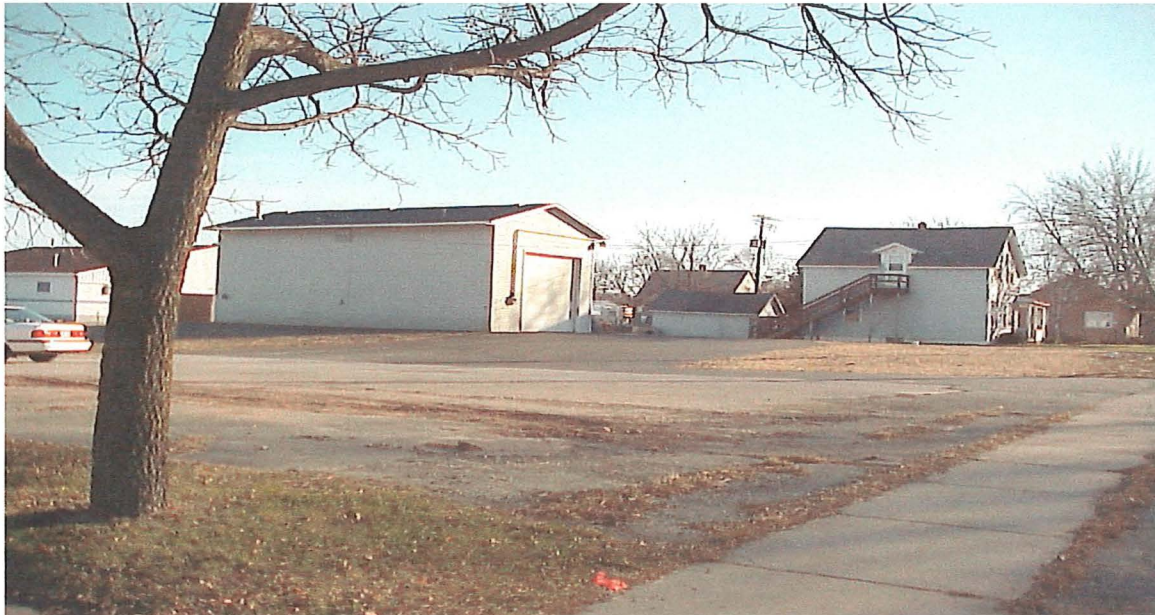
The treatment system building and the water treatment equipment installation were complete at the time of the pre-final inspection. The foundation drains were installed and the majority of the utility installation was completed. The following items that required completion were noted during the pre-final inspection of the Zinc Shop site:

Relocated treatment building at Zinc Shop.

- Repair a broken potable water supply line.
- Repair the foundation drain line from the treatment building to the residence.
- Sawcut the foundation slab around the exterior of the treatment building flush with the exterior building wall.

- Repair the joint between the base plate and the concrete foundation to minimize leakage of rainwater into the building.
- Repair the concrete floor of the treatment building to eliminate areas of puddling.

- Landscape around building and in area of the foundation drain water lines where settling has occurred.
- Complete the grading, topsoil replacement, and seeding surrounding the treatment building.

- Install the blacktop apron to the overhead door.
- Replace the 90 angle on the discharge of the filter press to a 45 to increase the efficiency of the discharge.

- Install a moisture sensor connected to the auto dialer.
- Install and test a new auto dialer system.
