UNITED STATES ENVIRONMENTAL PROTECTION AGENCY  
REGION 5  
77 WEST JACKSON BOULEVARD  
CHICAGO, IL 60604-3590

Re: Better Brite

**DATE:** December 15, 2010

**SUBJECT:** Further evaluation of effectiveness of soil stabilization and potential for off-site migration of chromium contaminated groundwater at the Better Brite, Chrome Shop

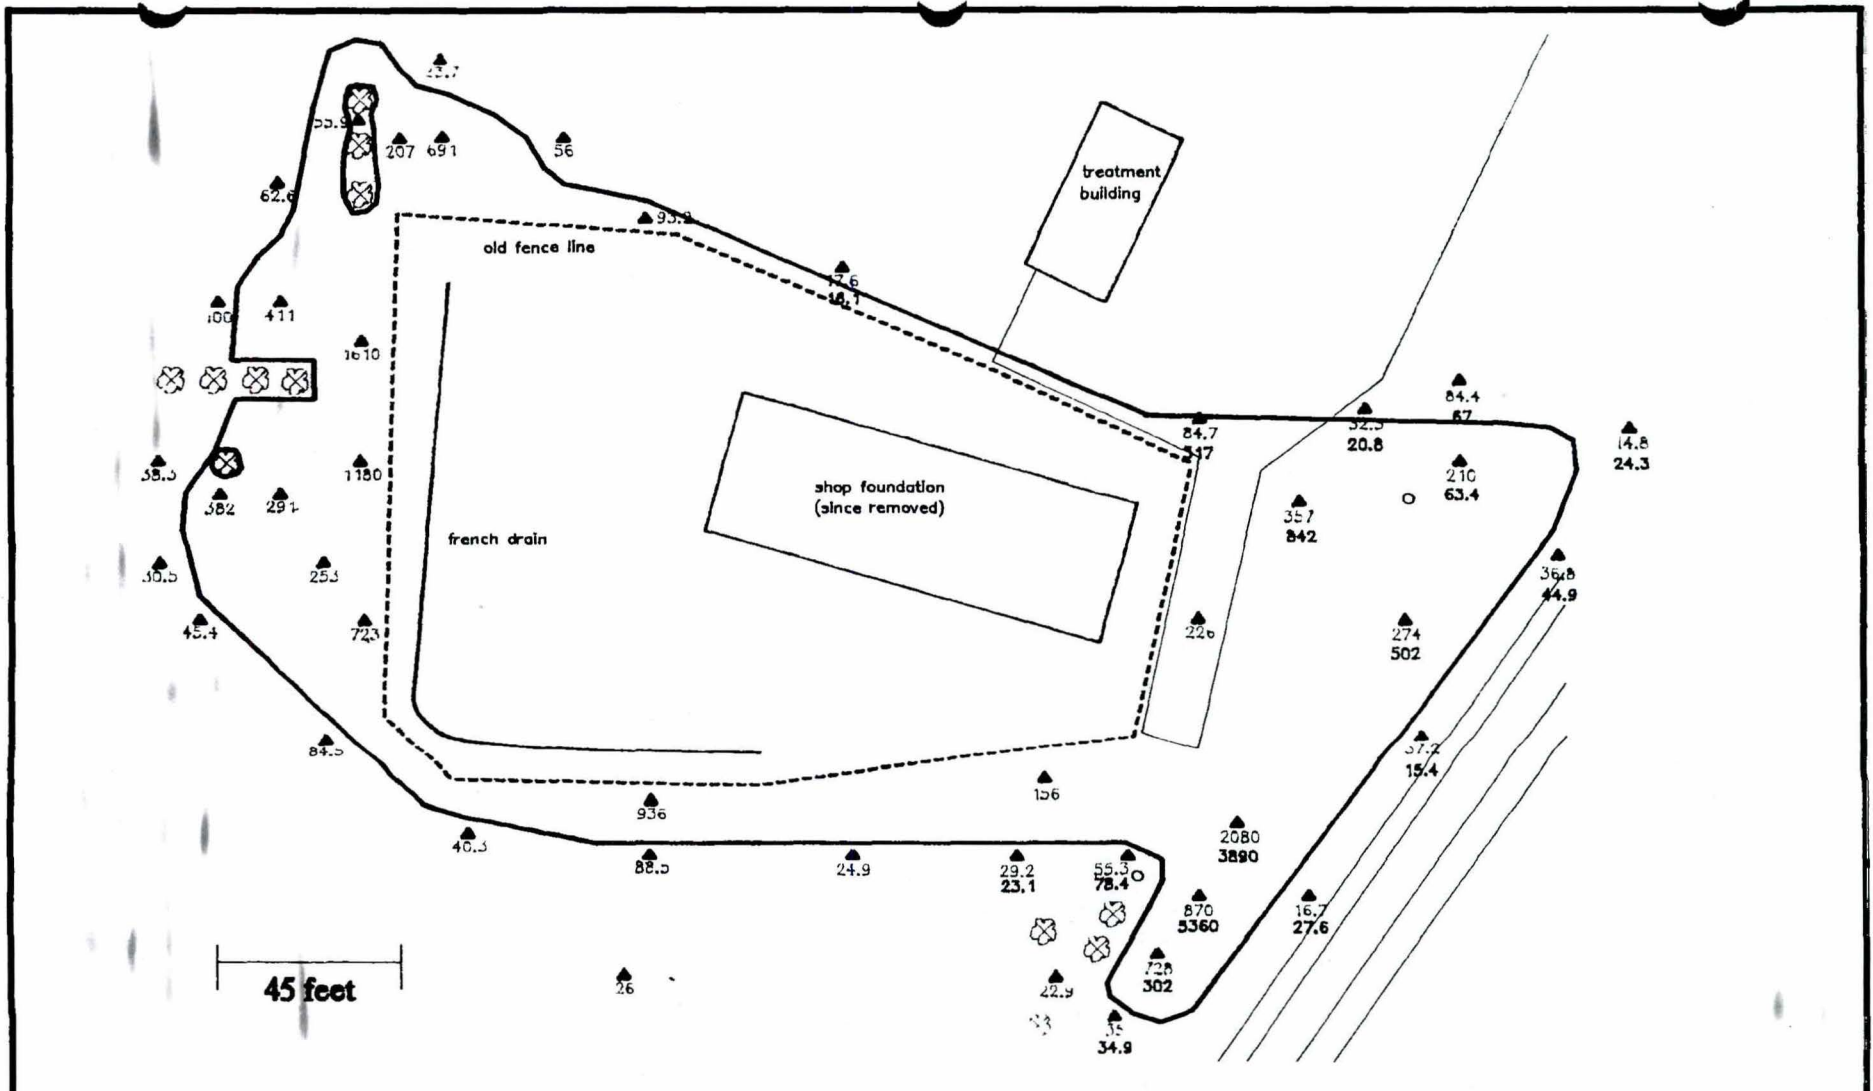
<b>BETTER BRITE DePERE, WISCONSIN</b>		DATE: 05/18/95
<b>CHROME SHOP SURFACE SOIL EXCAVATION EXTENT 1993</b>		DESIGNED: RAG
		CHECKED: JEN
		APPROVED: JLF
		DRAWN: RAG
		PROJ: 301483158
<b>HYDRO-SEARCH, INC.</b> A Tetra Tech Company		<b>Figure 2-13</b>

2. sand fill beneath the foundation.
3. surface soil from around the Chrome Shop and on properties adjacent (see attached Figure 2-13 from *Remedial Investigation Better Brite Plating, Inc.*, Hyrdo-Search, March 13, 1996). Surface soil was excavated to depths of approximately 1.0 to 1.5 feet. Analytical data for surface (0 to 0.5 feet bgs) and subsurface (2.5 to 3.0 feet bgs) soil samples collected from across the Chrome Shop and adjacent properties were used to define the extent of surface soil impacts and direct the excavation activities. This data along with the removal of garden soil by Better Brite in 1980 indicates that contamination from surface run-off extended well beyond the Chrome Shop property.

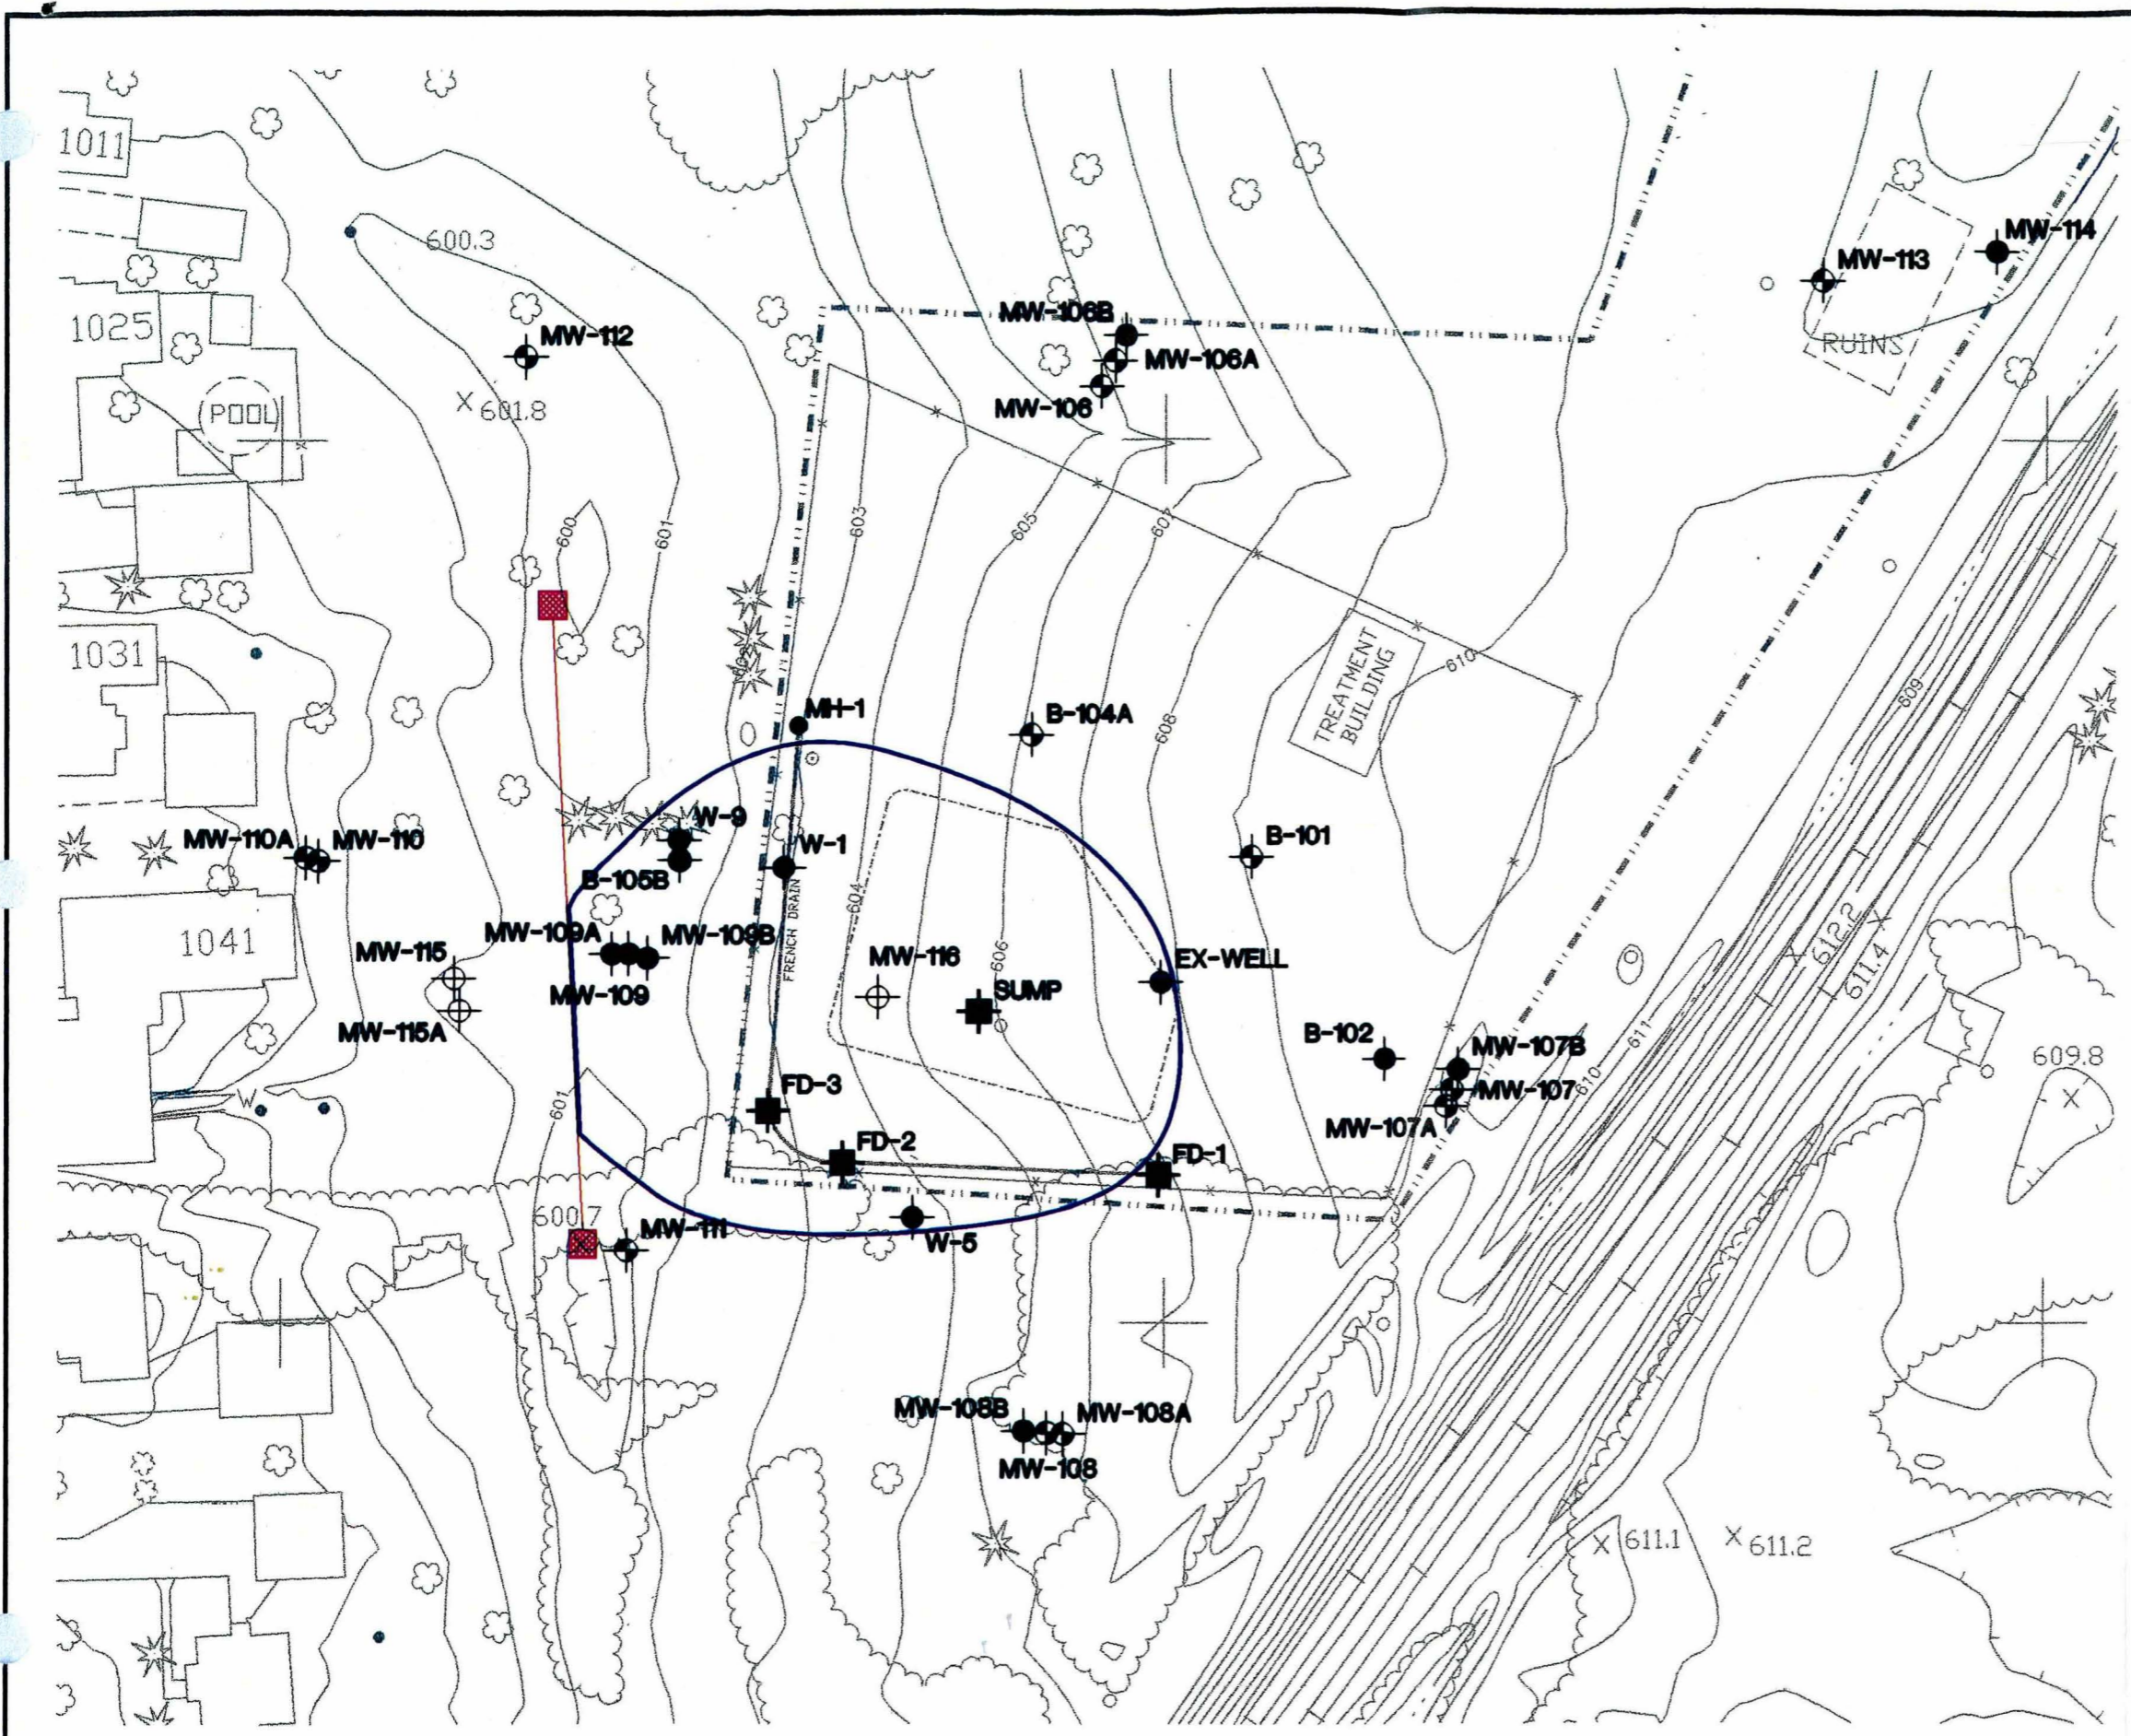
<b>BETTER BRITE</b> DePERE, WISCONSIN  <b>PROPOSED</b> <b>WELL LOCATIONS</b> <b>CHROME SHOP</b>	DATE: 12/1/99
	DESIGNED: BOB
<b>HSI</b> <b>GEOTRANS</b> <small>A TETRA TECH COMPANY</small>	CHECKED: KEB
	APPROVED: JLF
	DRAWN: BOB
PROJ: F119	
<b>Figure 7-3</b>

1. The sump area (see approximate limits of excavation are shown by the sump boundary on Figure 7-3). Soil was excavated to a depth of approximately 20 feet below ground surface (bgs). Soil samples collected from the bottom of the excavation confirmed that the soil left in place was not impacted with metals.

In 1999, natural soils and fill soils and gravel within the area of groundwater contamination (see Figure 7.3) were treated to a 20 foot depth by mixing with a proprietary reagent primarily consisting a blend of iron sulfates. The intention of the treatment was to reduce  $\text{Cr}^{+6}$  to insoluble and less toxic trivalent chromium ( $\text{Cr}^{+3}$ ), so that Wisconsin groundwater standards would be achieved quickly and no further groundwater withdrawal or treatment would be required. In addition in 1999, the Chrome Shop groundwater treatment plant was relocated to the Zinc
