SUPERFUND PRELIMINARY CLOSEOUT REPORT

Better Brite Superfund Site De Pere, Brown County, Wisconsin *w/ SL*

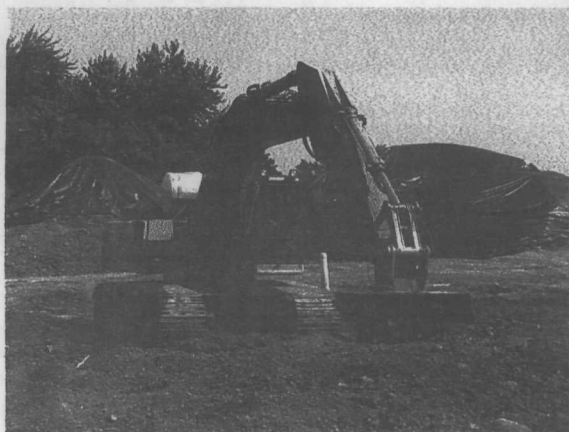
Backhoe with roto-tiller attachment

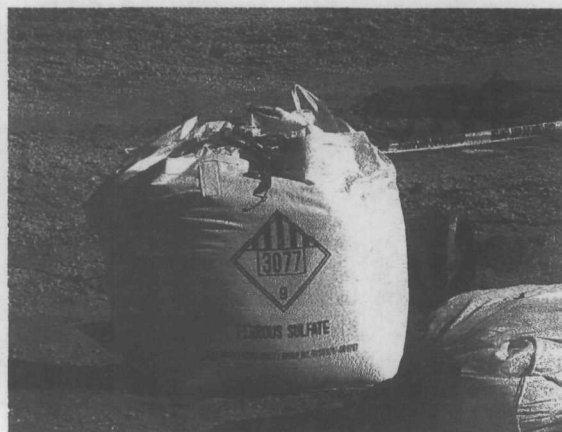
Iron Sulfate Stabilization compound

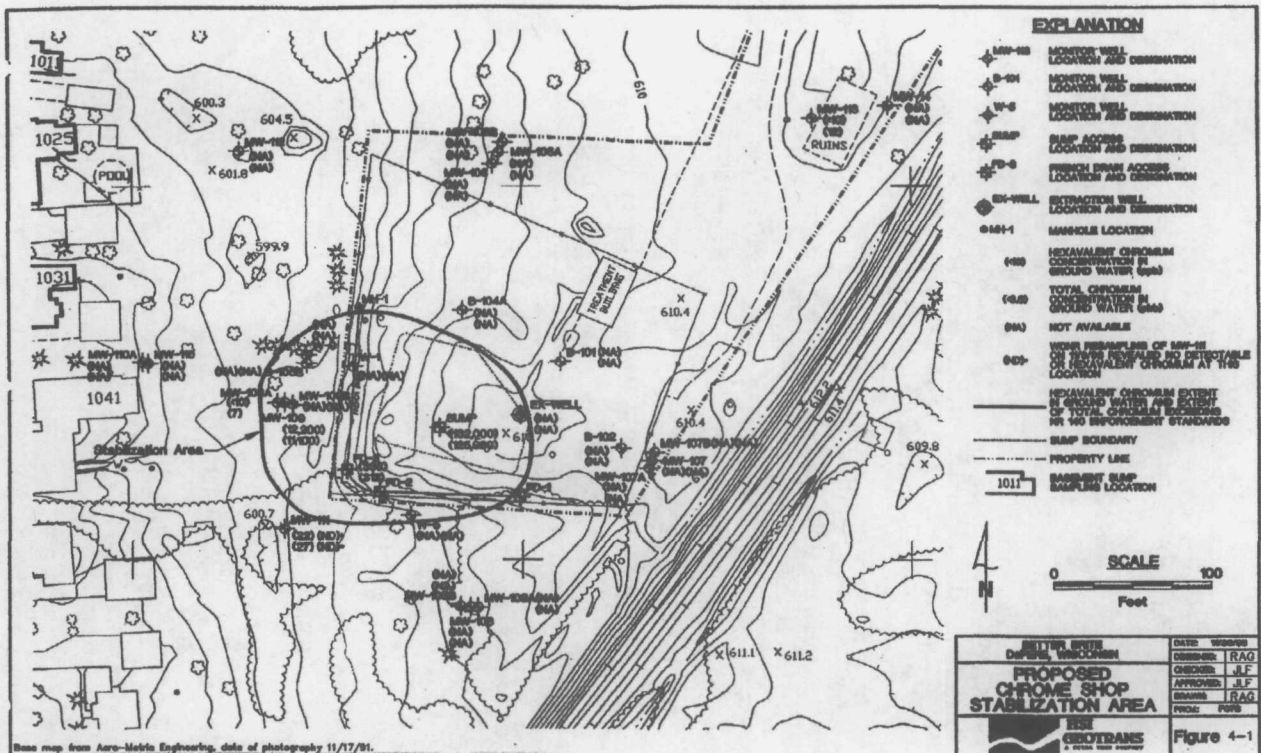
Base map from Aero-Metric Engineering, date of photography 11/17/91.
Stabilization area at Chrome Shop (indicated by heavy line)

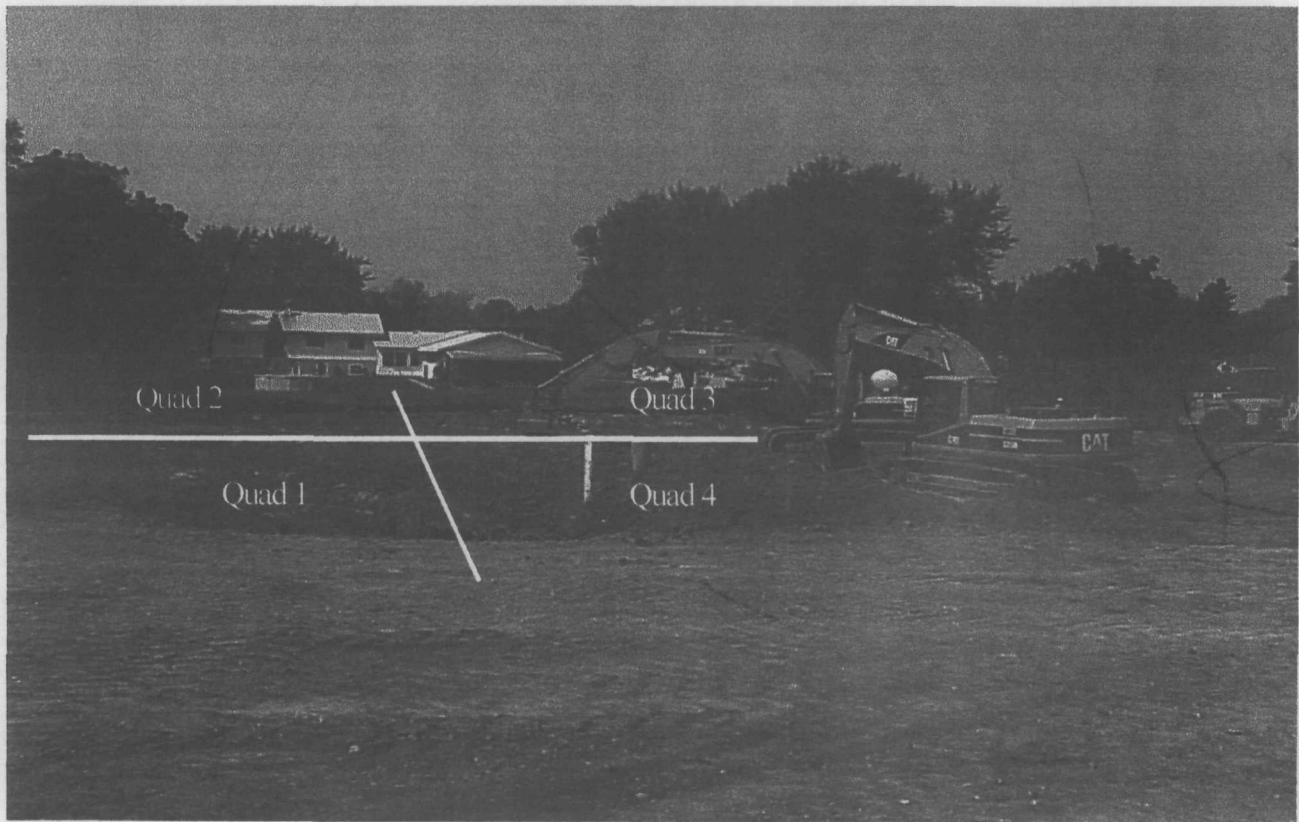
Extent of excavation at Chrome Shop Site with approximate excavation quadrants indicated

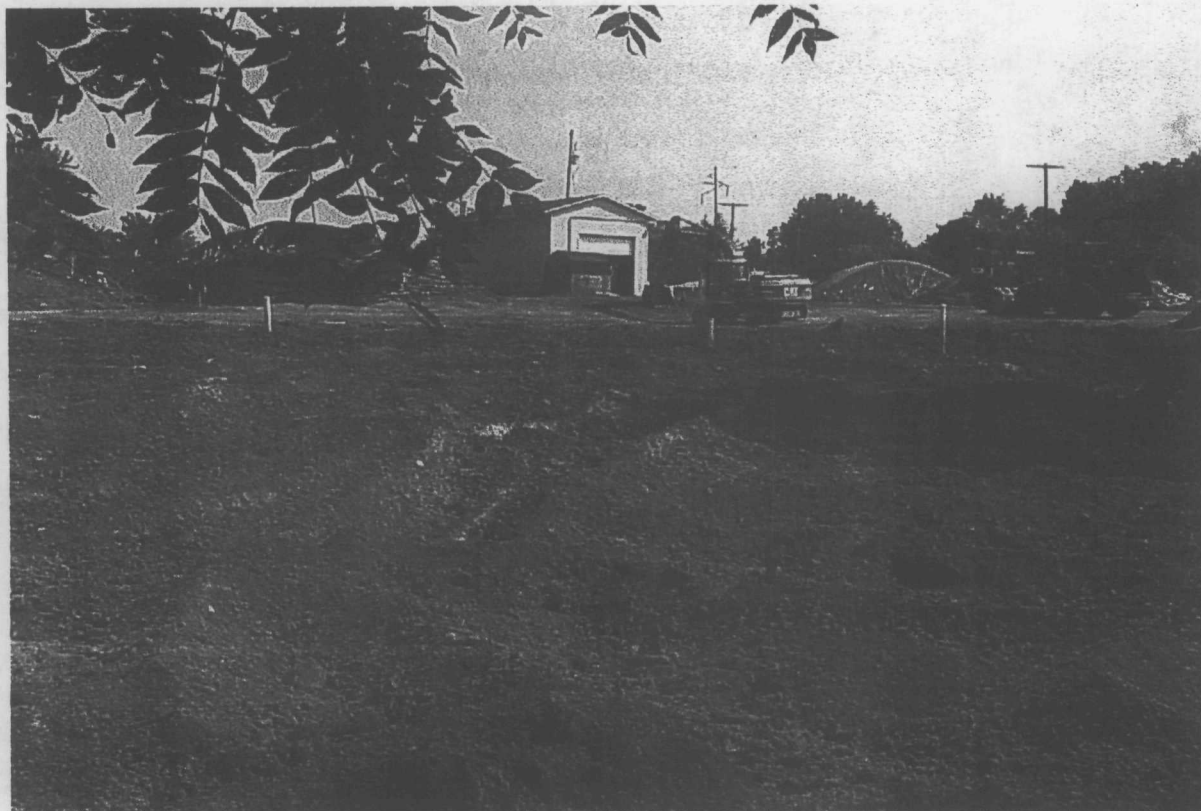
Excavated area at Chrome Shop looking northeast from southwest property corner. Treated soil in foreground (Quad. 2) prior to stockpiling.

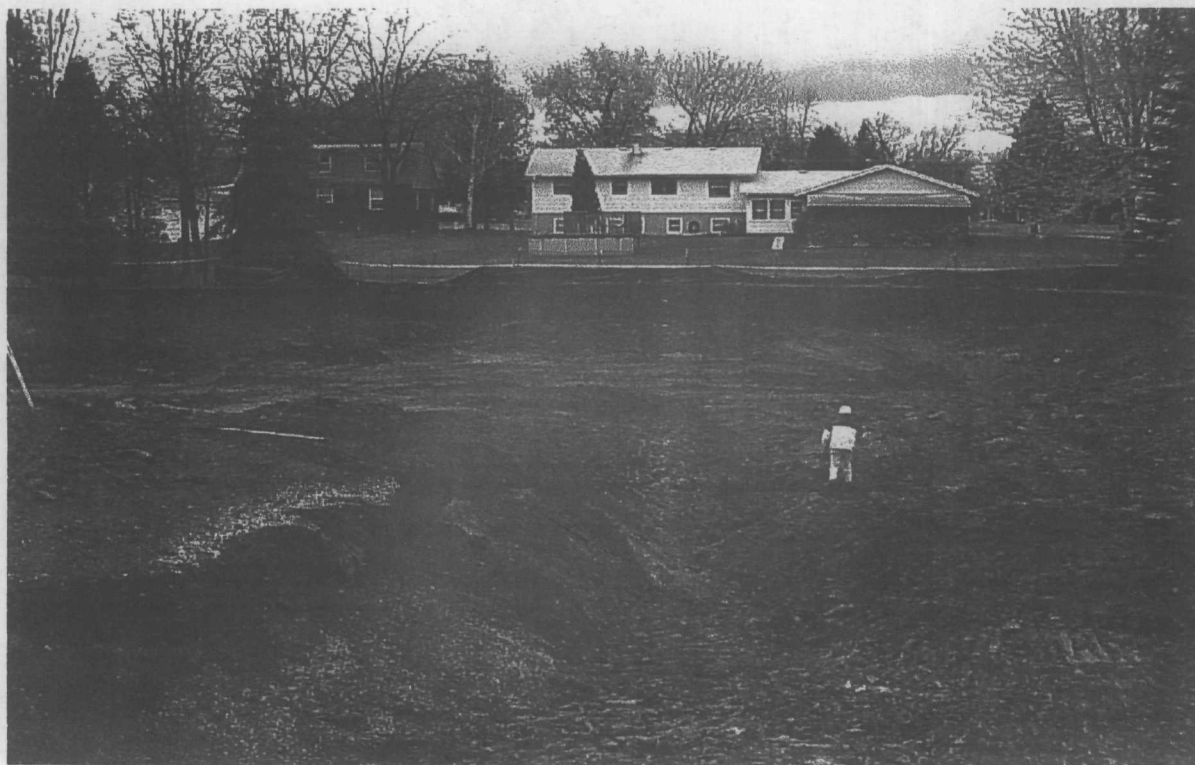
Chrome Shop excavation nearing completion. Quadrants 1, 2, and 3 partially backfilled. Quadrant 4 excavated to depth. Gravel sump area installed by the EPA in the early 1990s visible on left.

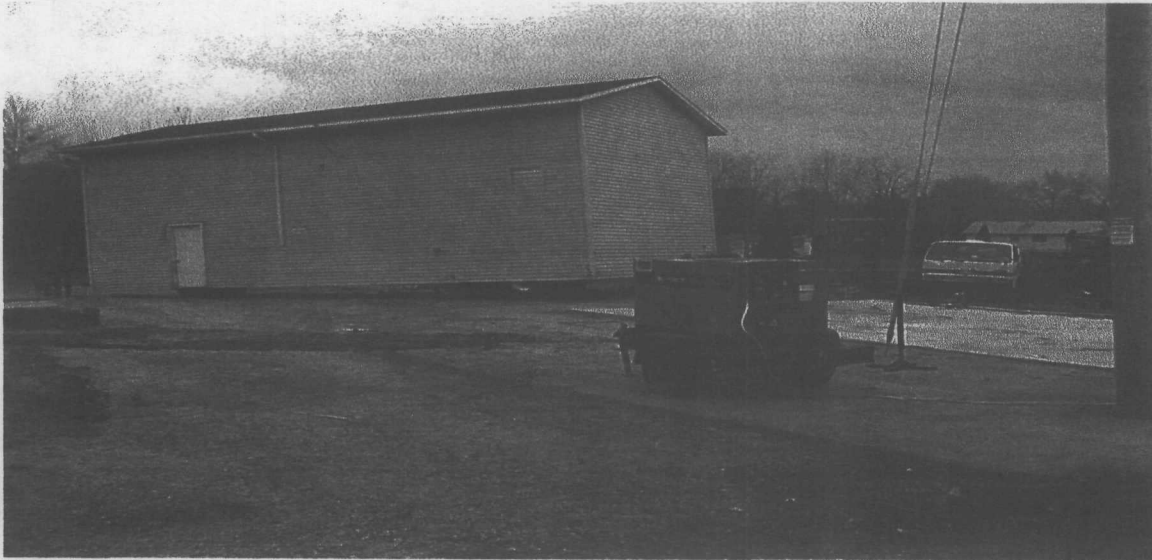
Treatment building moved off foundation at Chrome Shop

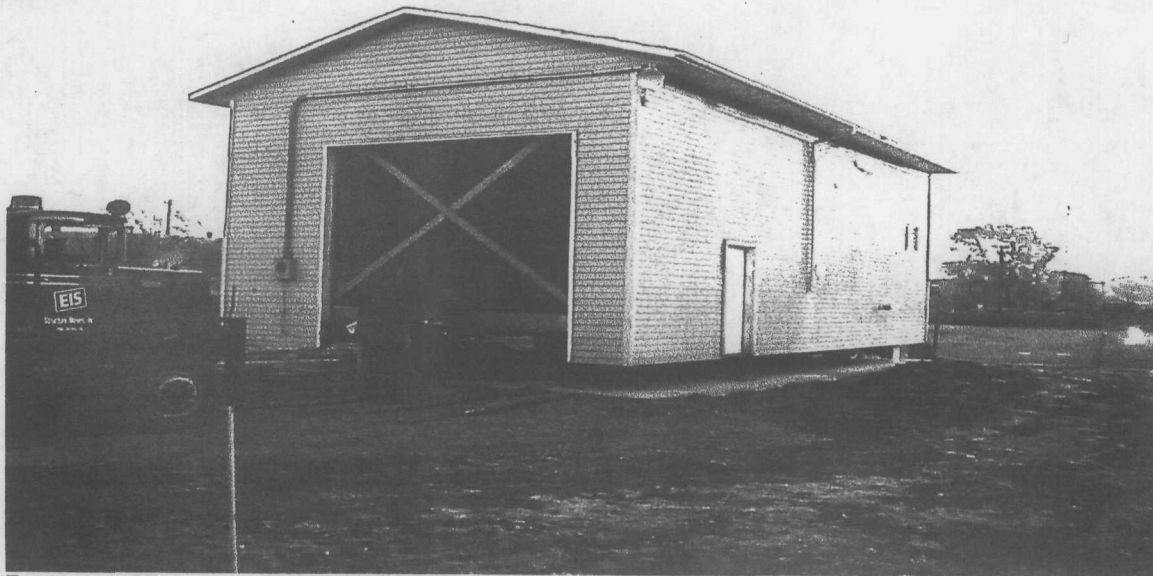
Treatment building on new slab foundation at Zinc Shop

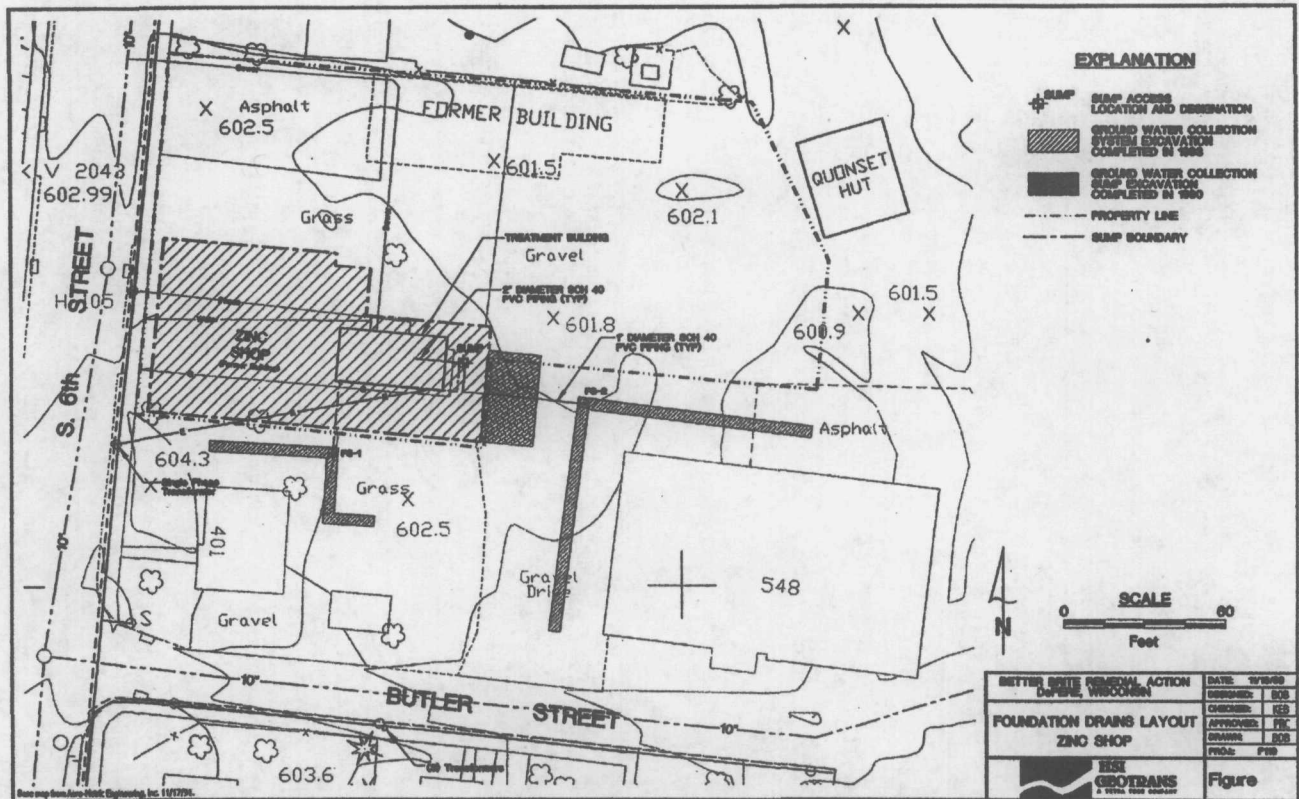
Zinc Shop site layout following groundwater recovery sump installation and treatment system relocation.

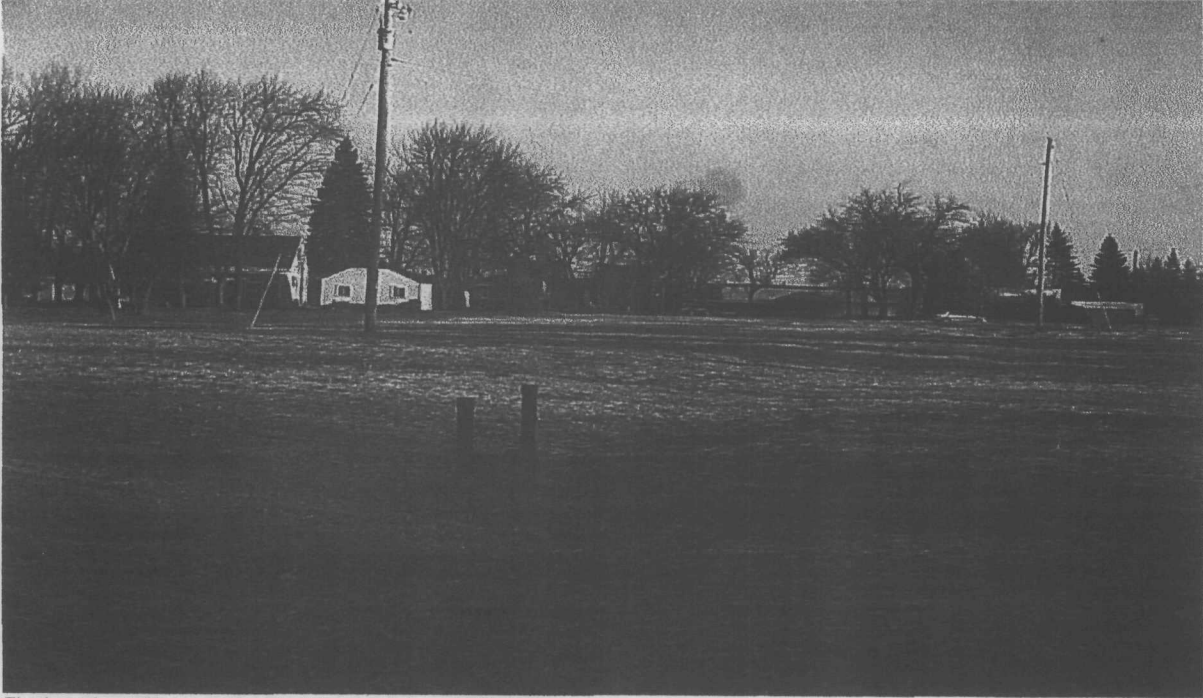
Work was completed at the Chrome Shop at the time of the pre-final inspection. The final grade, seeding and mulching of the site was adequate. No further work is necessary at the Chrome Shop. Replacement of the monitoring wells removed during the remedial action is tentatively scheduled for the winter of 1999-2000.

Final grade at Chrome Shop looking north from MW-107.

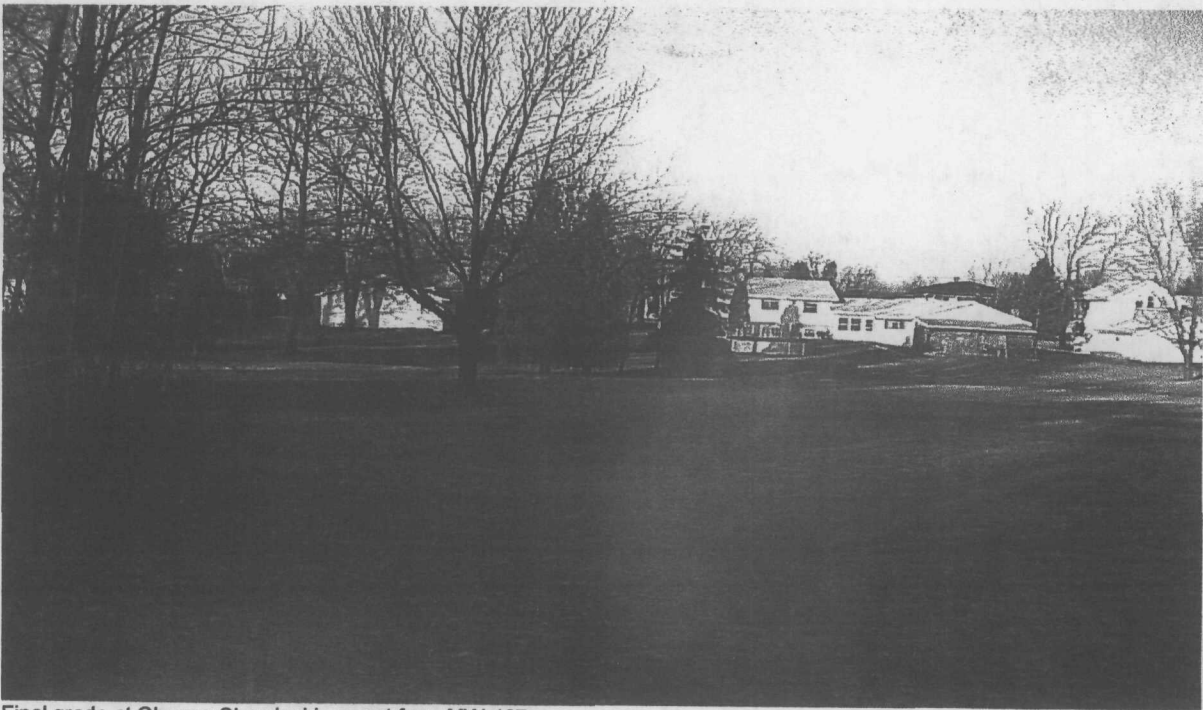
Final grade at Chrome Shop looking west from MW-107.

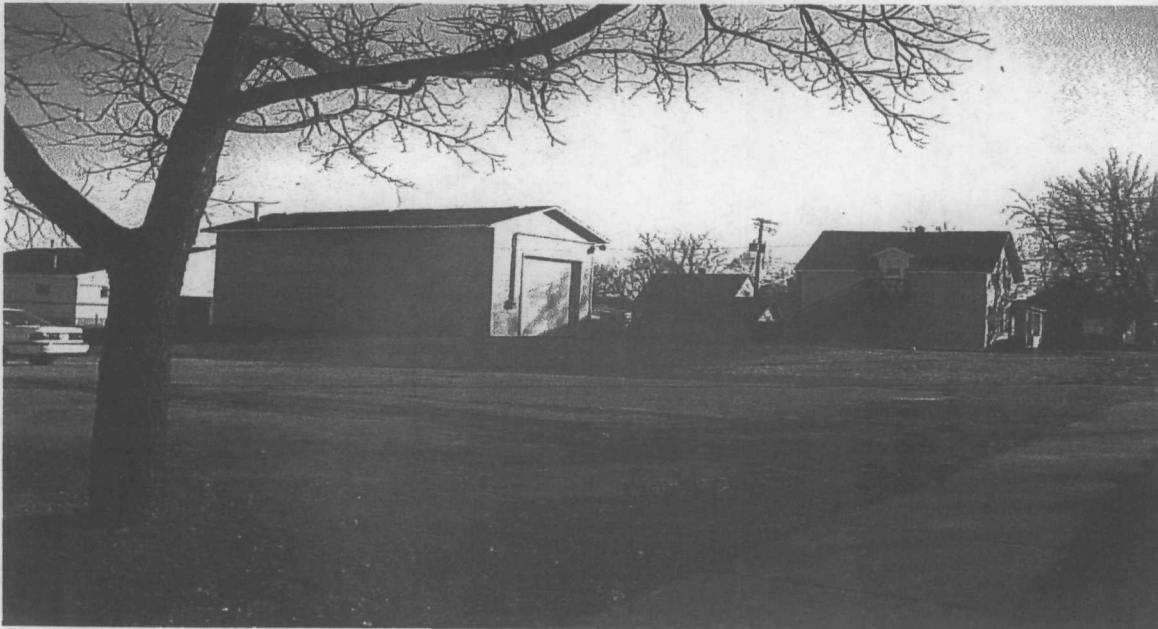
The treatment system building and the water treatment equipment installation were complete at the time of the pre-final inspection. The foundation drains were installed and the majority of the utility installation was completed. The following items that required completion were noted during the pre-final inspection of the Zinc Shop site:

Relocated treatment building at Zinc Shop.

- Repair a broken potable water supply line.
- Repair the foundation drain line from the treatment building to the residence.
- Sawcut the foundation slab around the exterior of the treatment building flush with the exterior building wall.

- Repair the joint between the base plate and the concrete foundation to minimize leakage of rainwater into the building.
- Repair the concrete floor of the treatment building to eliminate areas of puddling.

- Landscape around building and in area of the foundation drain water lines where settling has occurred.
- Complete the grading, topsoil replacement, and seeding surrounding the treatment building.

- Install the blacktop apron to the overhead door.
- Replace the 90 angle on the discharge of the filter press to a 45 to increase the efficiency of the discharge.

- Install a moisture sensor connected to the auto dialer.
- Install and test a new auto dialer system.
