Re: Better Brite

DATE: December 15, 2010

SUBJECT: Further evaluation of effectiveness of soil stabilization and potential for off-site migration of chromium contaminated groundwater at the Better Brite, Chrome Shop

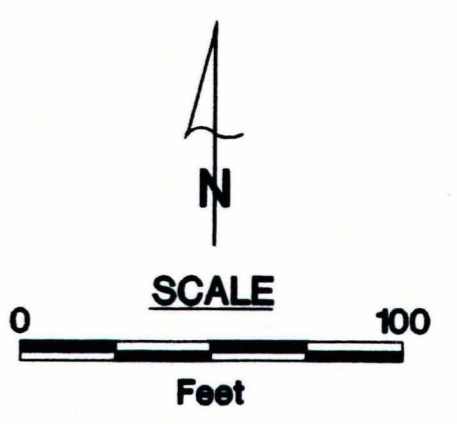
BETTER BRITE DePERE, WISCONSIN PROPOSED WELL LOCATIONS CHROME SHOP	DATE: 12/1/99
	DESIGNED: BOB
	CHECKED: KEB
	APPROVED: JLF
	DRAWN: BOB
	PROJ: F119
Figure 7-3

1. The sump area (see approximate limits of excavation are shown by the sump boundary on Figure 7-3). Soil was excavated to a depth of approximately 20 feet below ground surface (bgs). Soil samples collected from the bottom of the excavation confirmed that the soil left in place was not impacted with metals.

In 1999, natural soils and fill soils and gravel within the area of groundwater contamination (see Figure 7.3) were treated to a 20 foot depth by mixing with a proprietary reagent primarily consisting a blend of iron sulfates. The intention of the treatment was to reduce Cr^{+6} to insoluble and less toxic trivalent chromium (Cr^{+3}), so that Wisconsin groundwater standards would be achieved quickly and no further groundwater withdrawal or treatment would be required. In addition in 1999, the Chrome Shop groundwater treatment plant was relocated to the Zinc
