Re: Canal Dewatering Report
We Energies' Appleton MGP Site, FID #445033380; BRRTS #02-45-000042

Date: July 12, 2012
To: Tiffany Goebel, We Energies
From: Chris Robb and Brian Hennings
Subject: 2011 Canal Dewatering Assessment
We Energies Appleton Former MGP Site

Attachment A: Photographic Log

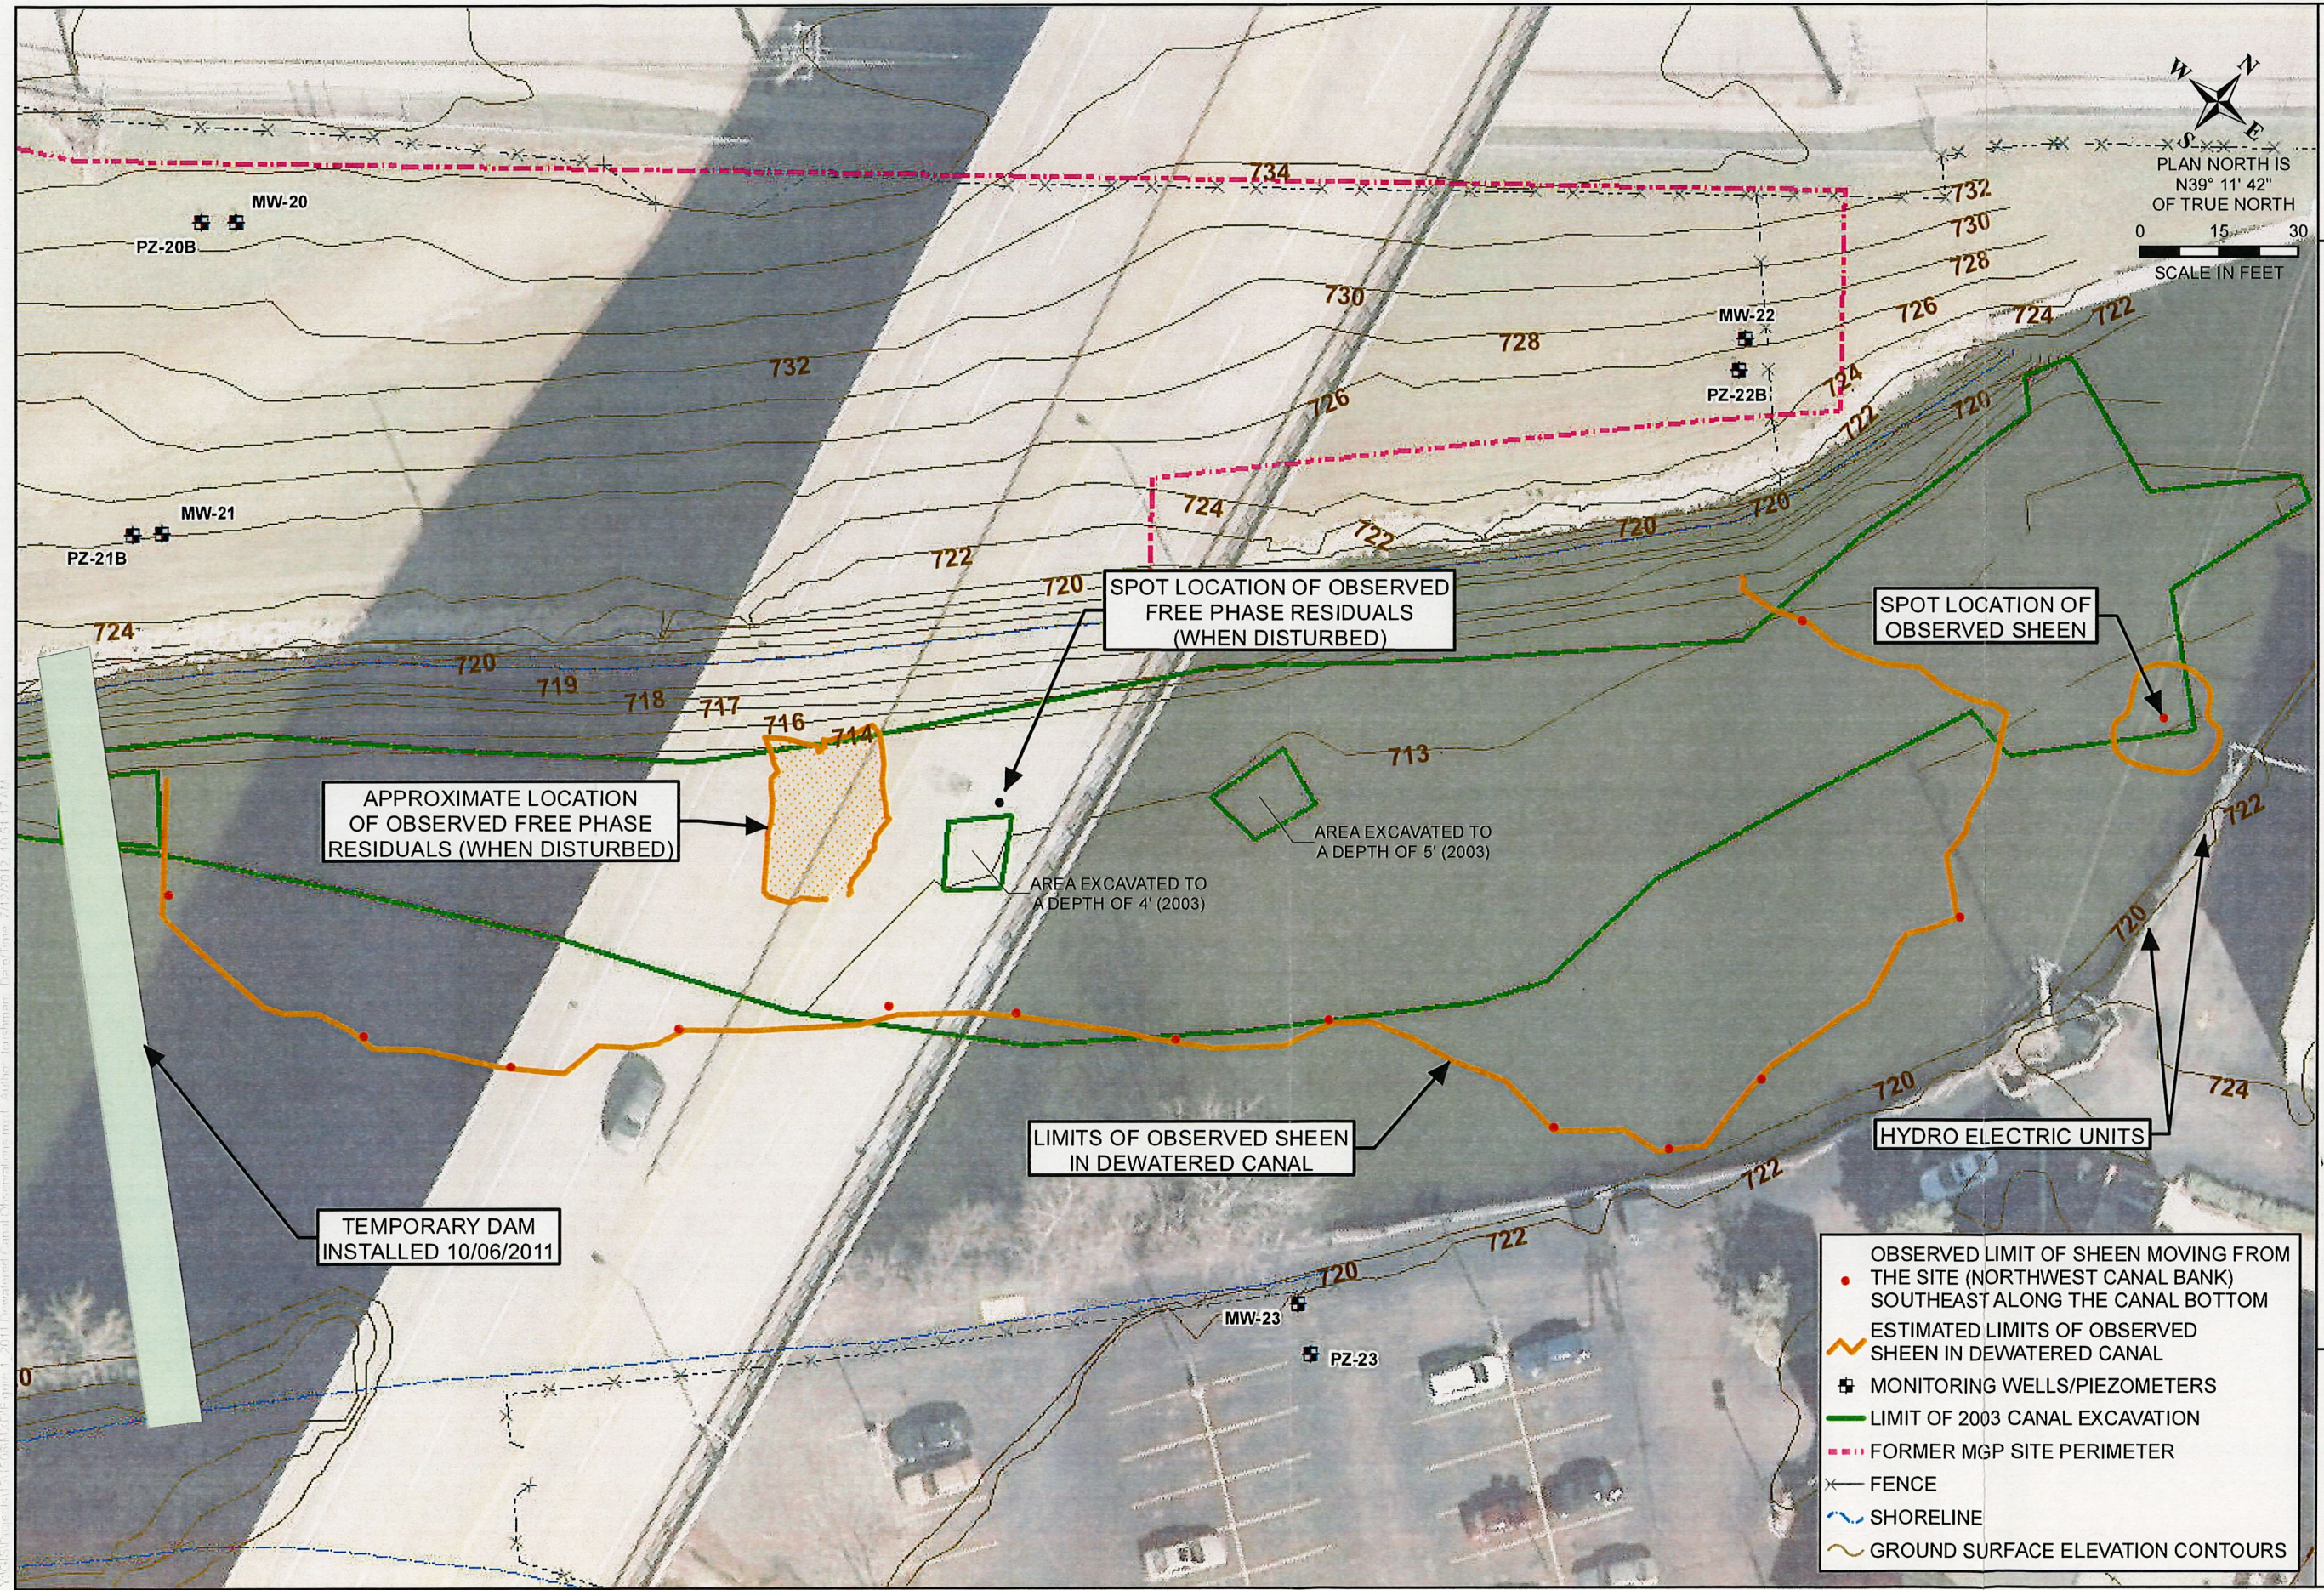
PROJECT NO. 1508/19
FIGURE NO. 1

Using this procedure, NRT walked a total of 11 transects ranging from approximately 25 to 40 feet apart. NRT inspected the entire dewatered portion of the canal. The results of the assessment and limits of observed sheen are shown on Figure 1. In addition, NRT recorded the following observations:

When the limits of observed sheen were mapped, NRT observed that these limits generally correlate with the limits of canal excavation performed in 2003 (Figure 1).

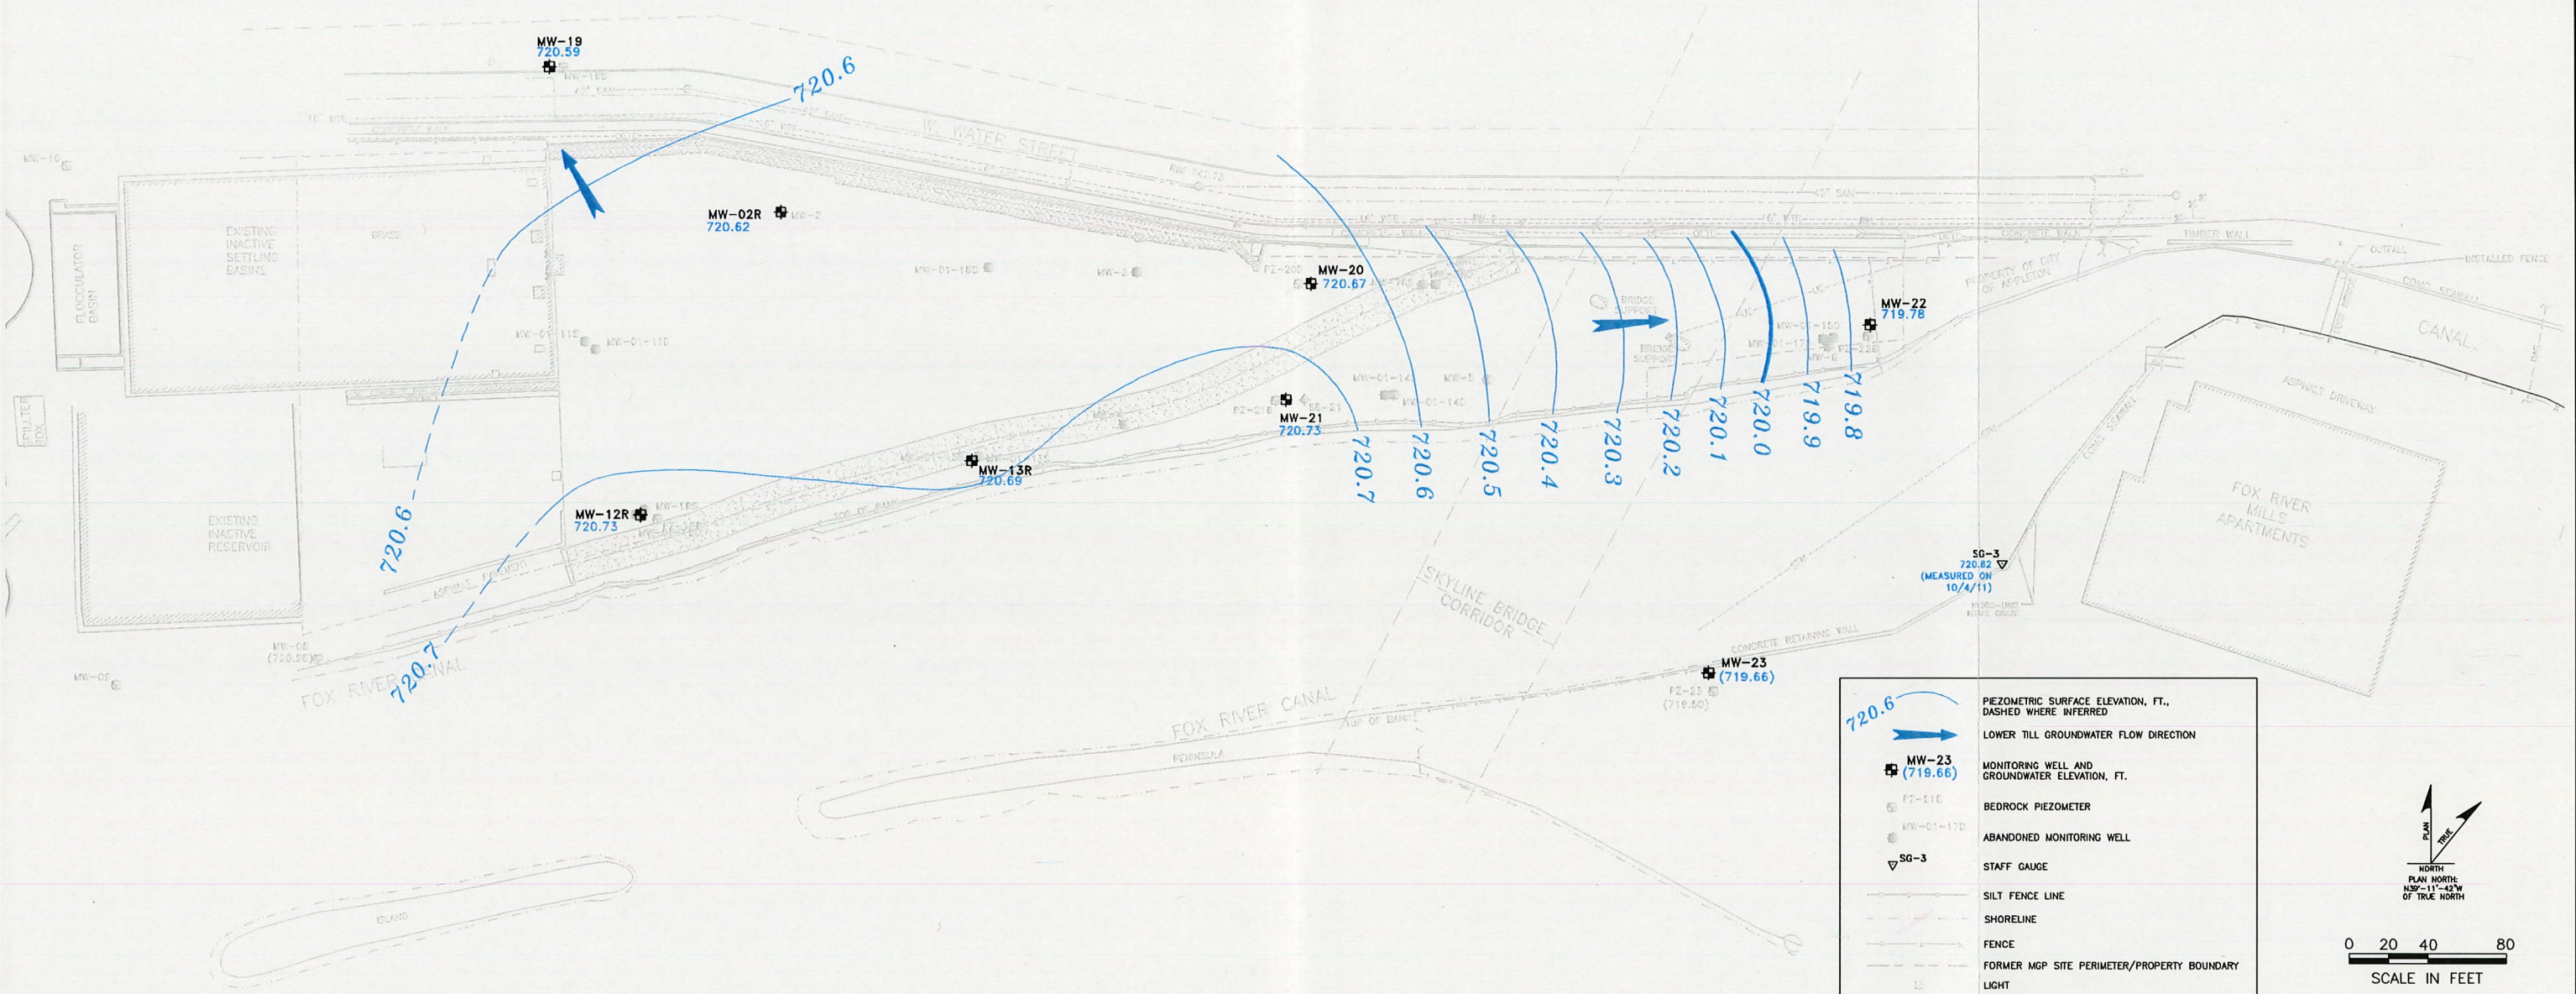
It was expected that the canal would be completely dewatered after installation of the temporary dam and the groundwater in the lower till would respond. Figure 2 indicates the water level in the canal was at 720.82 feet three days prior to dewatering. Following dewatering, the bed of the canal (which is at an elevation of approximately 713 feet) was mostly exposed. NRT photographed weathered bedrock in the canal bottom (Photo 12, Attachment A), which is likely connected to the lower till groundwater flow system.

Observations collected three days prior to dewatering (Figure 2) are representative of normal flow at the site north of the canal. The gradient is low across the site such that the piezometric surface is contoured 0.1-foot intervals to evaluate flow directions. The gradient is very flat west of MW-21, and past monitoring events indicate that flow direction can be variable in this area. The gradient is steeper east of MW-21 and groundwater flow is consistently northeast (parallel to flow in the canal) as it approaches the Middle Appleton Dam (located just off the map to the east of the Fox River Mills apartments). Under normal conditions, the potentiometric surface of the lower till unit in wells adjacent to the canal is lower than the surface water elevation of the canal (suggesting that the canal typically behaves as a losing stream).

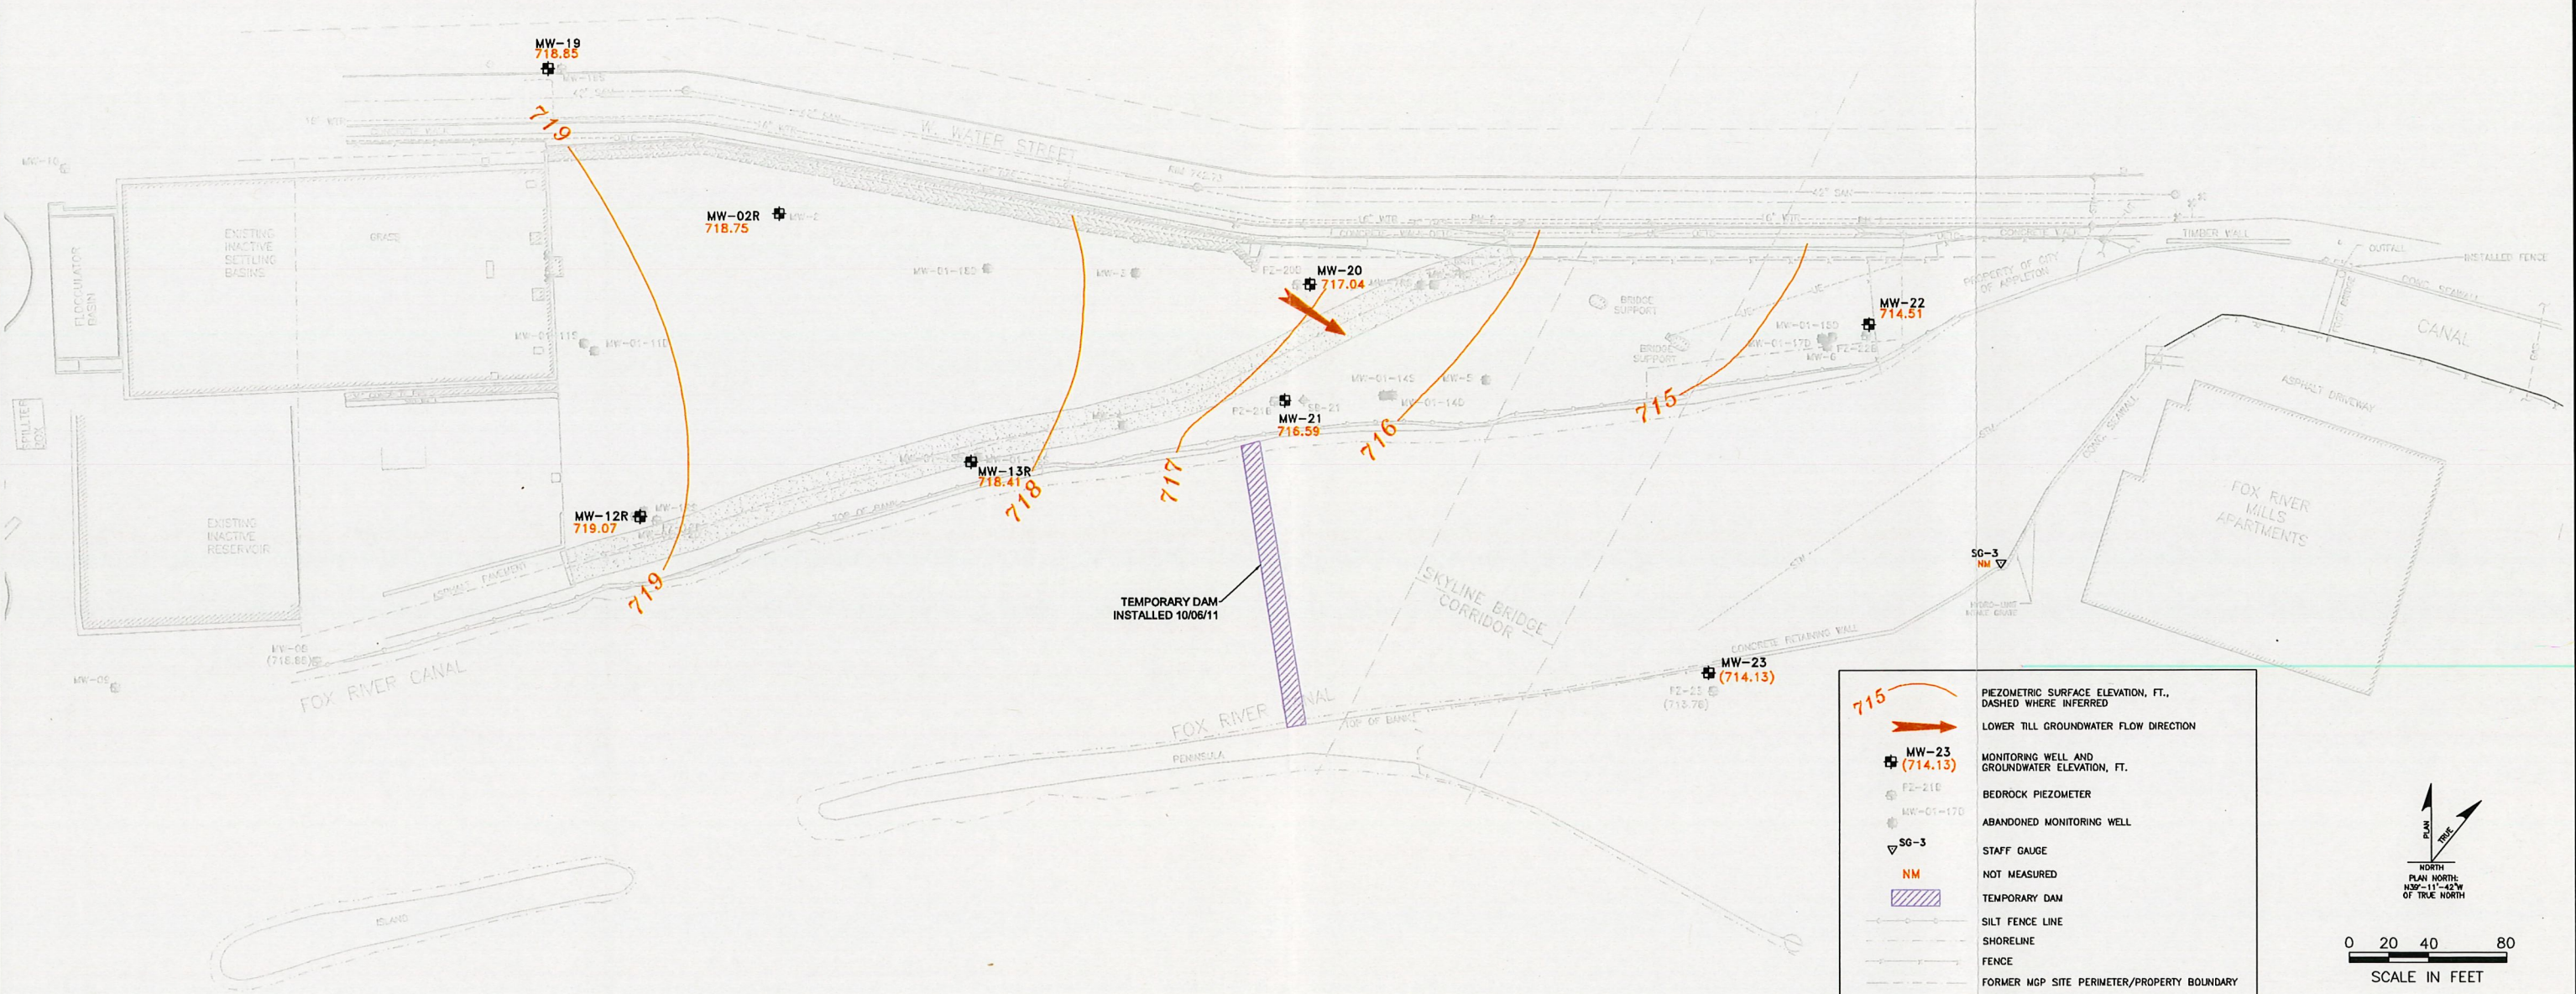
Observations collected during dewatering of the canal (Figures 3, 4, and 5) suggest that dewatering rapidly changed groundwater flow direction and gradient north of the canal. The first round of measurements collected four days after dewatering indicate the piezometric surface of the lower till downstream of the temporary dam had decreased between 4 and 5 feet (Figure 3). The gradient across the site increased such that the piezometric surface could be contoured at 1-foot intervals.

The relationship between groundwater and surface water also changed within those four days after dewatering. Under normal conditions, the potentiometric surface of the lower till unit is lower than the surface water elevation of the canal and groundwater would flow roughly parallel to the canal northeast toward the Middle Appleton Dam. During dewatering the relationship was reversed and the potentiometric surface of the lower till was higher than the elevation of the bed of the canal (around 713 feet); which suggests that the dewatered section of the canal started behaving like a gaining stream. Groundwater flow direction changed during dewatering by rotating slightly eastward to flow sub-parallel with the canal.

The flow pattern present four days after dewatering (illustrated on Figure 3) is consistent with observations one week (Figure 4) and two weeks (Figure 5) after dewatering. This suggests that groundwater in the lower till had reached a new equilibrium within four days.

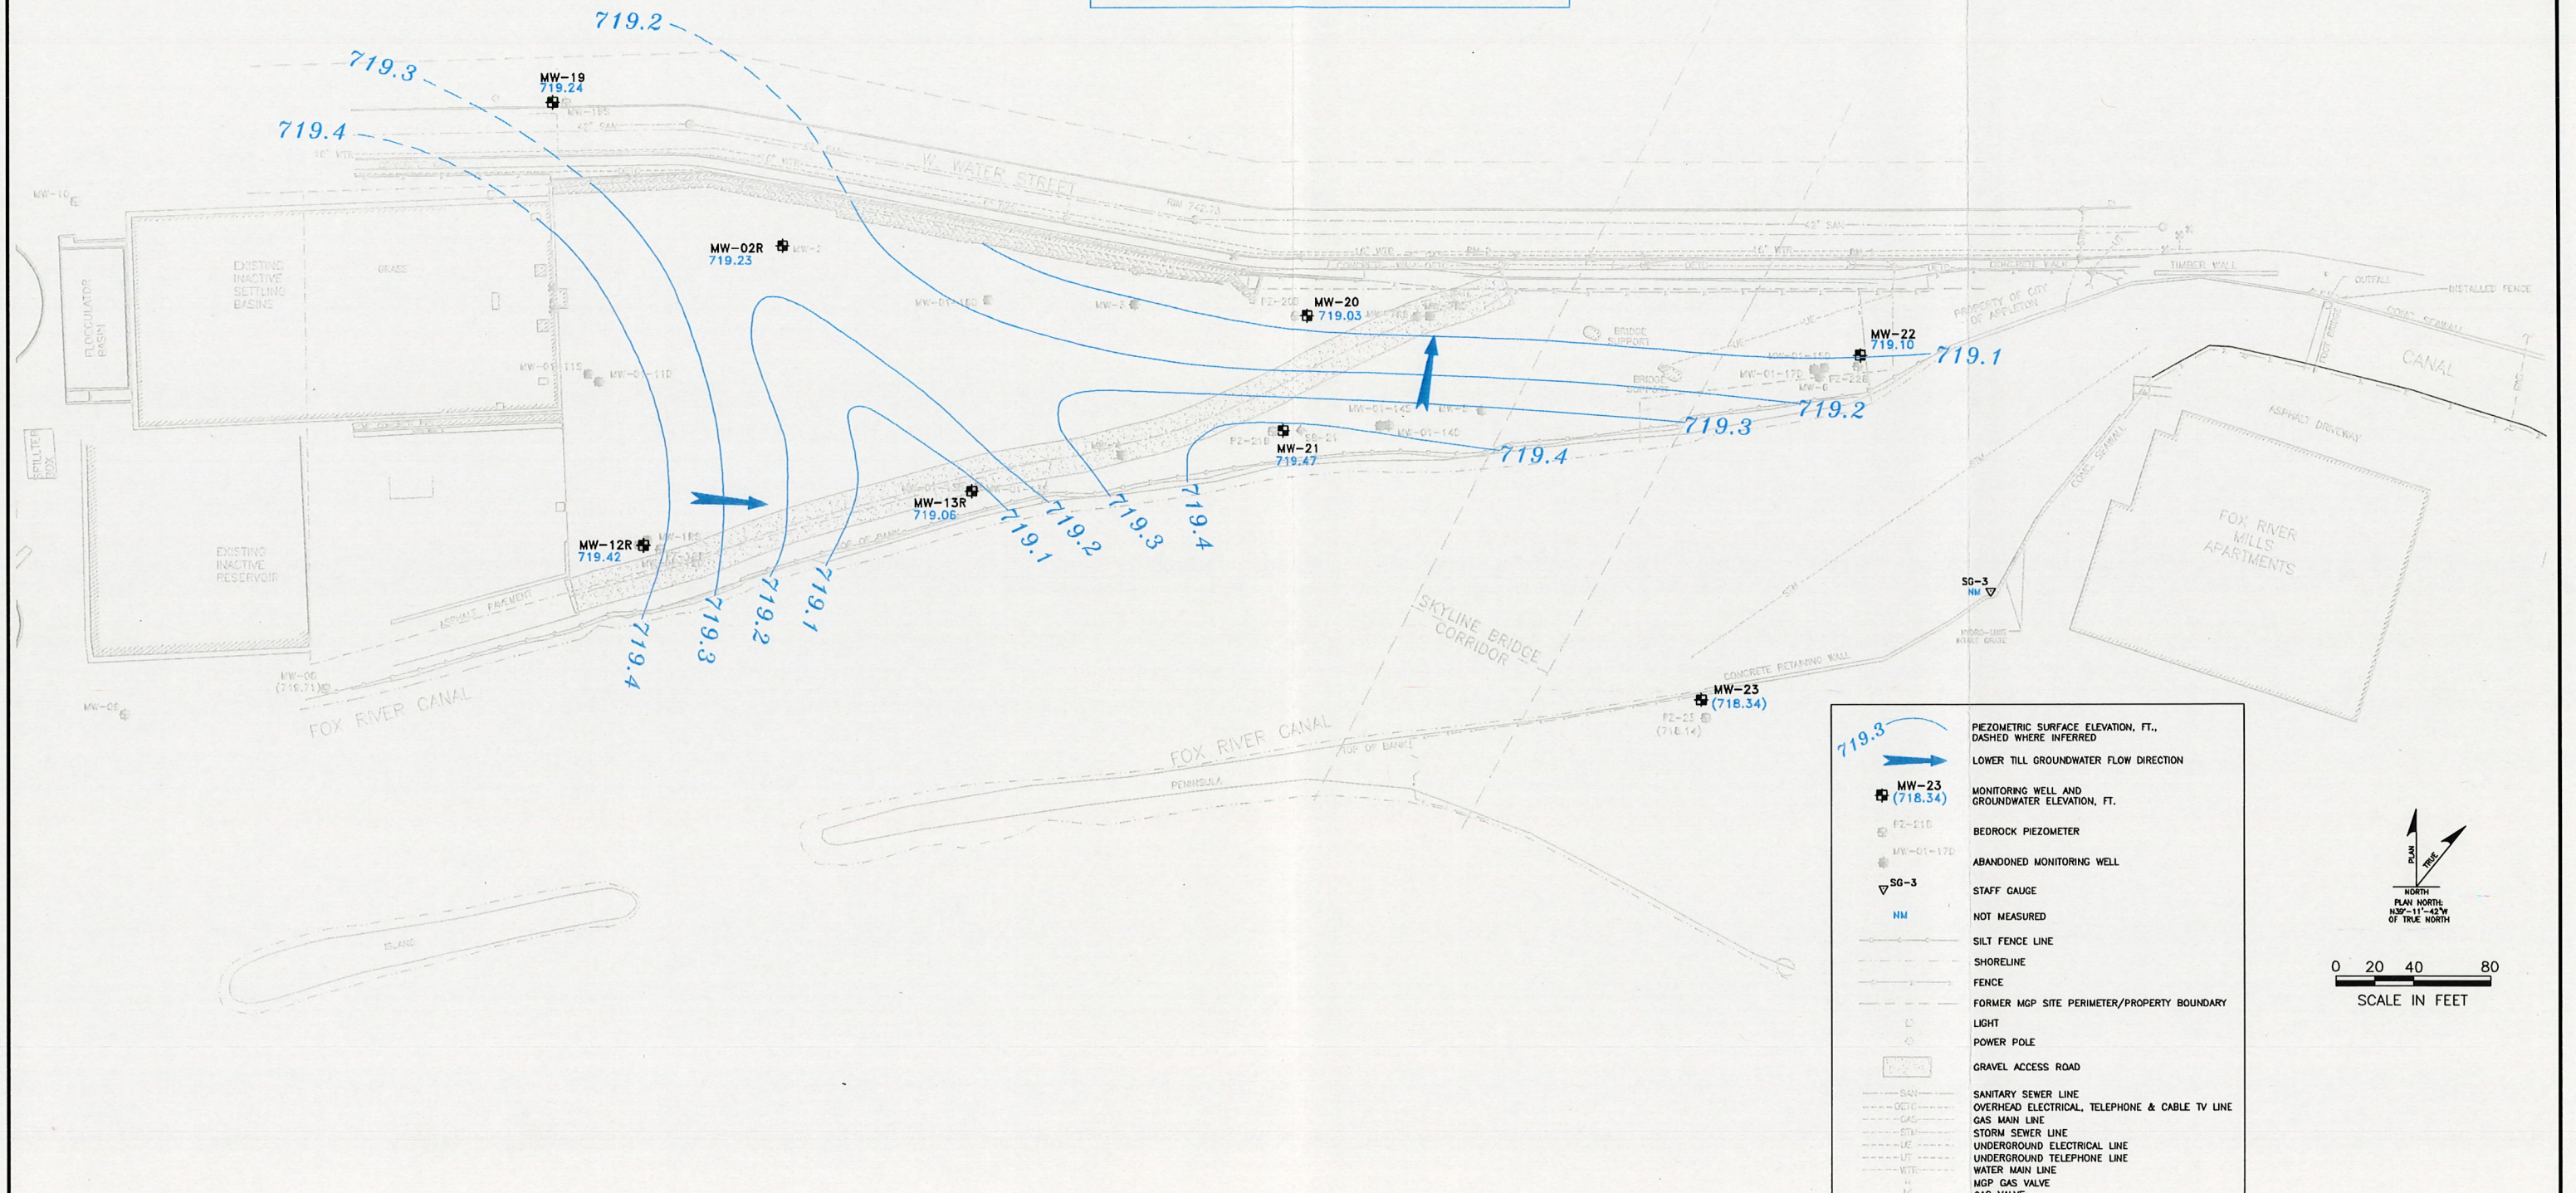
Observations collected eight days after dam removal (Figure 6) indicated a return to more normal flow conditions. The gradient across the Site returned to low levels such that the contours need to be plotted at 0.1-foot intervals to evaluate flow direction. West of MW-21, where groundwater flow direction is variable, MW-13R appeared to be recovering more slowly than the other wells. East of MW-21, it appeared that a full recovery to normal flow direction takes longer than eight days as flow direction is more northerly than northeasterly.

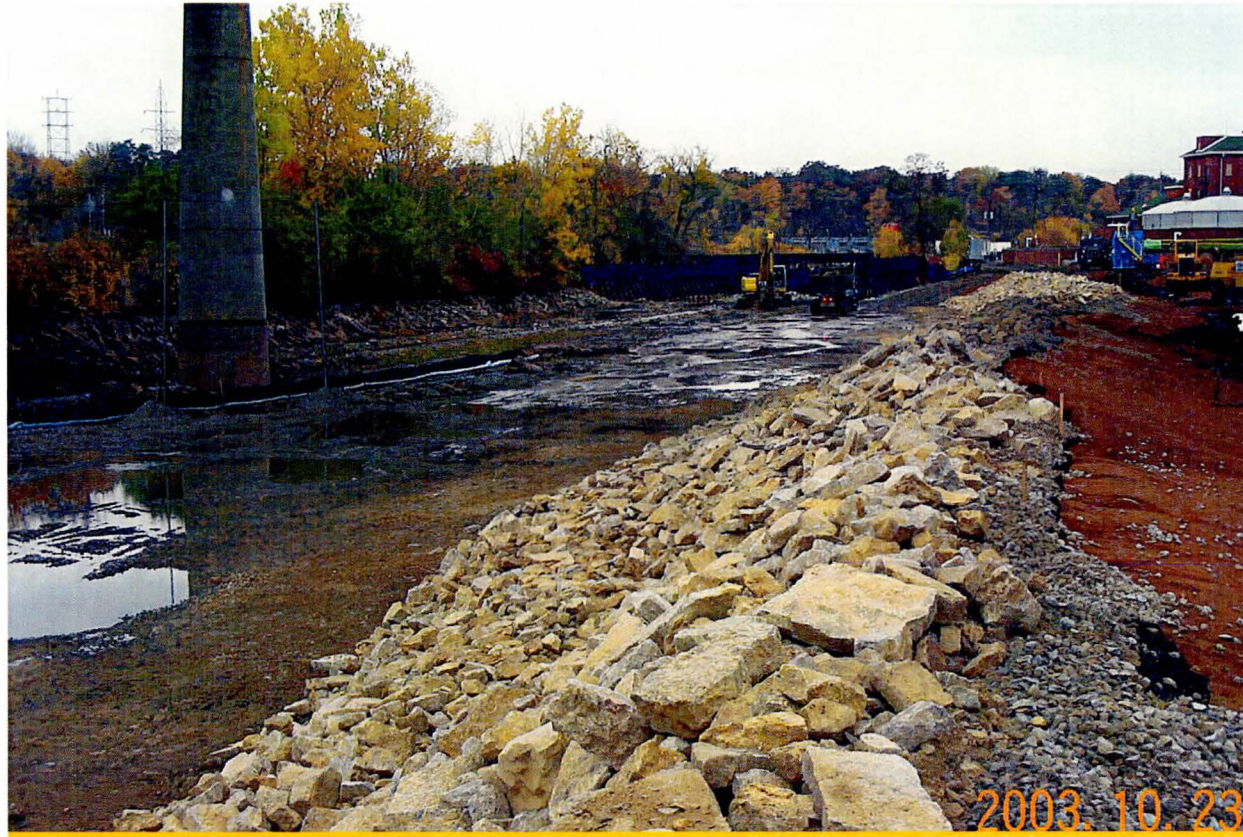
Photo Number: 3

- The excavated canal substrate was replaced with 3-inch crushed, washed stone to the original canal bottom grades (Photo 3, Attachment A).
- Prior to 2002 and since completion of the Fox River Canal remedial action in 2003, We Energies has not observed sheen, ebullition mobilizing MGP residuals, or free phase residuals appearing on the water surface within the canal. *a state of bubbling up or boiling with exception of 2011 drawdown*

Description: Restoration of Fox River Canal; near completion of stone placement along canal bottom

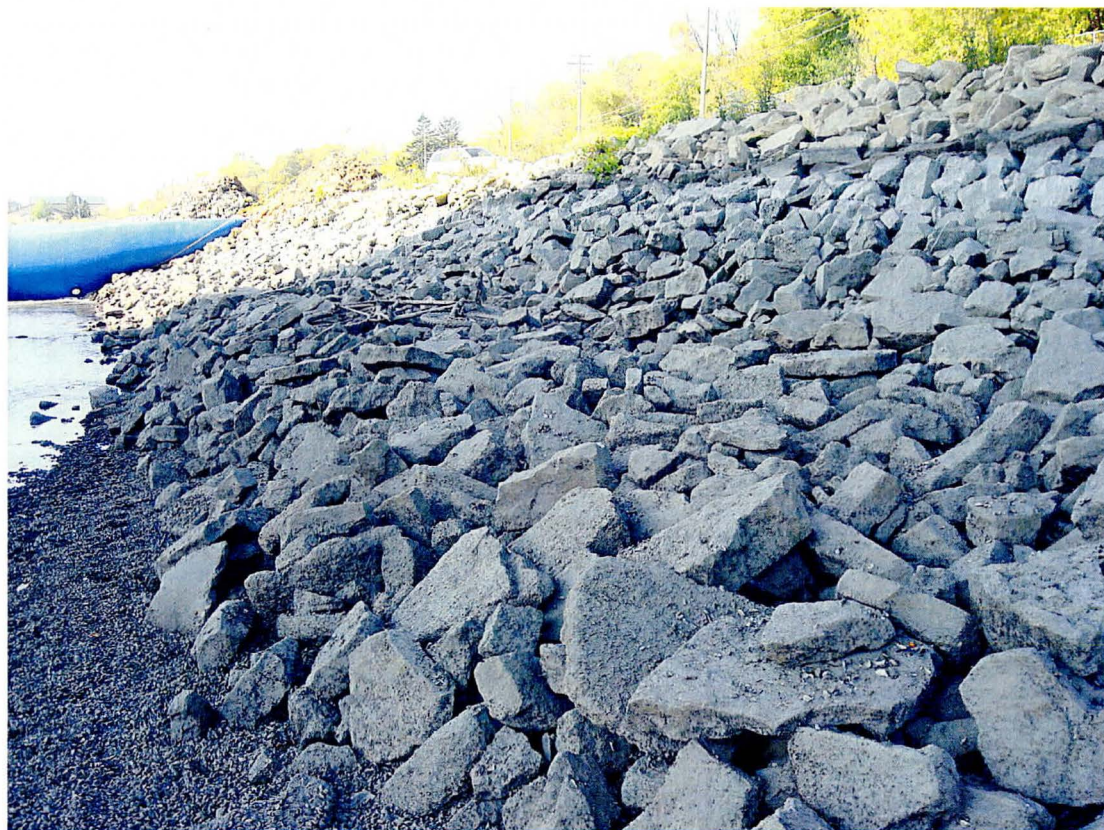
Photo Number: 6

- The riverbank adjacent to the Site is in excellent condition. No evidence of scour, rip rap displacement, rip rap degradation, or river bank failure was observed during the inspection (Photo 6, Attachment A).

Description: Riverbank inspection adjacent to former Appleton MGP site

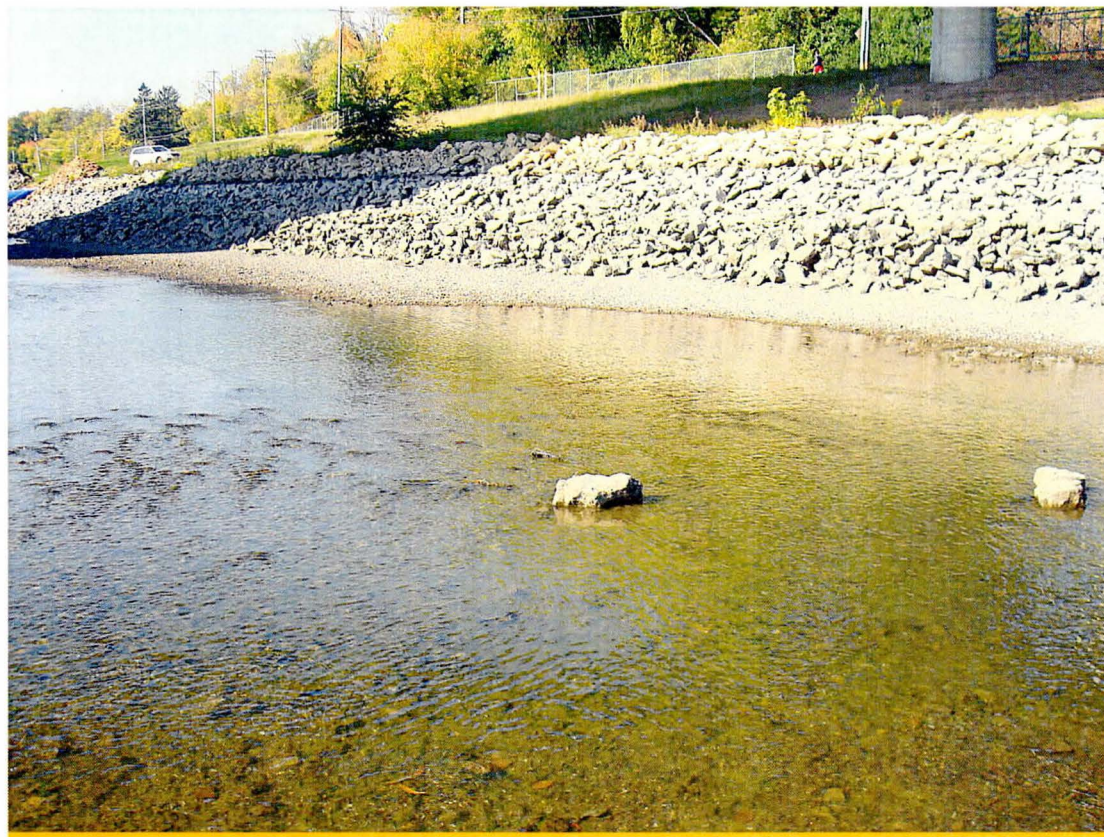
Photo Number: 7

- No evidence of sheen or MGP residuals was observed along or at the toe of the riverbank.
- Leakage around the temporary dam resulted in water flowing along the canal bottom from 1 to 6 inches in depth (Photo 7, Attachment A).

- No evidence of sheen or MGP residuals were observed on the water surface in the dewatered canal (Photo 7, Attachment A) or upstream of the temporary dam.

Description: Dewatered canal inspection adjacent to former Appleton MGP site

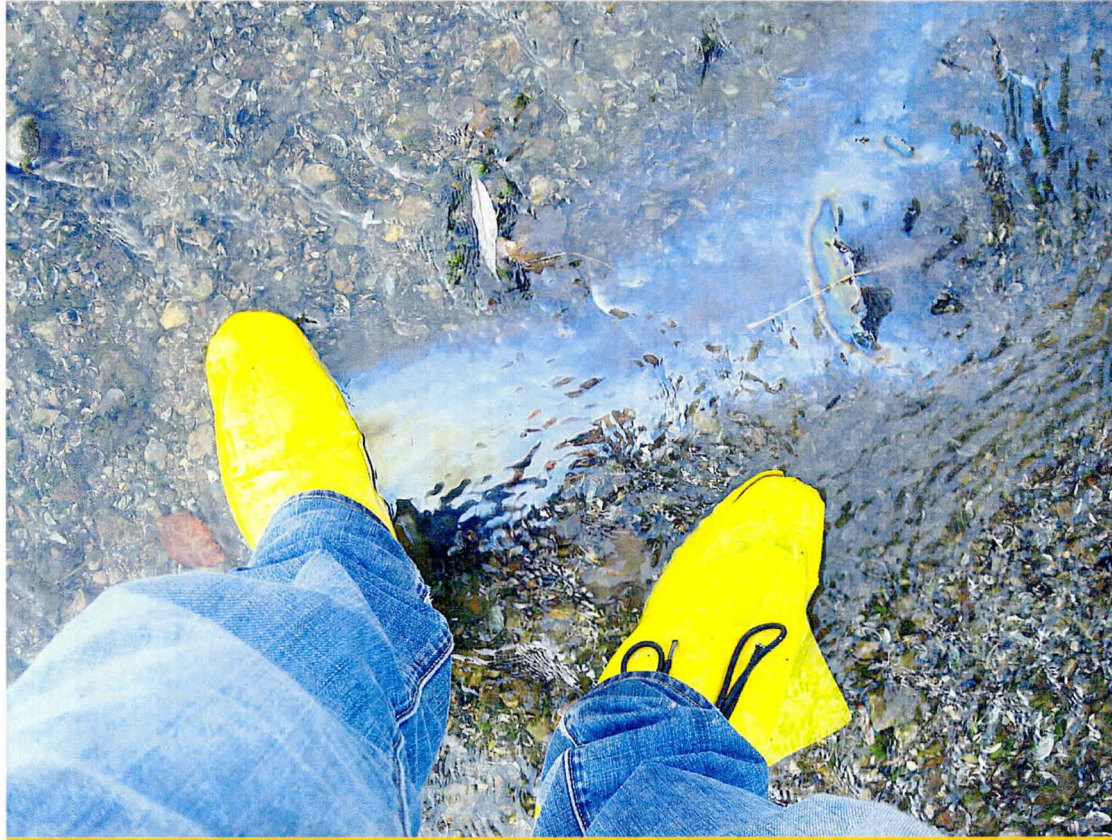
Photo Number: 8

- Some areas of the dewatered canal bottom exhibited sheen when disturbed or agitated (Photo 8, Attachment A). These areas were adjacent to the riverbank along the former MGP site near MW-21. No free phase MGP residuals were observed.

Description: Dewatered canal inspection adjacent to former Appleton MGP site. Sheen observed when canal bottom disturbed.

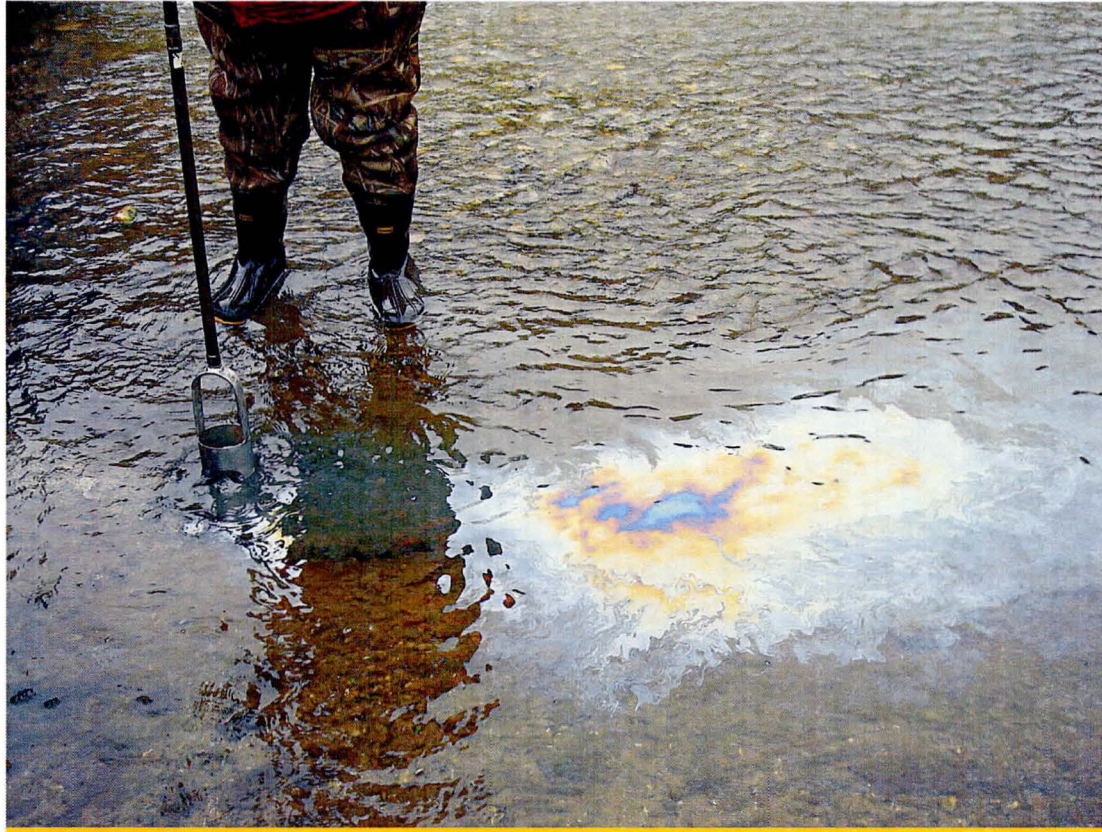
Photo Number: 9

Description: Poling/disturbing canal bottom. Sheen observed when canal bottom disturbed.

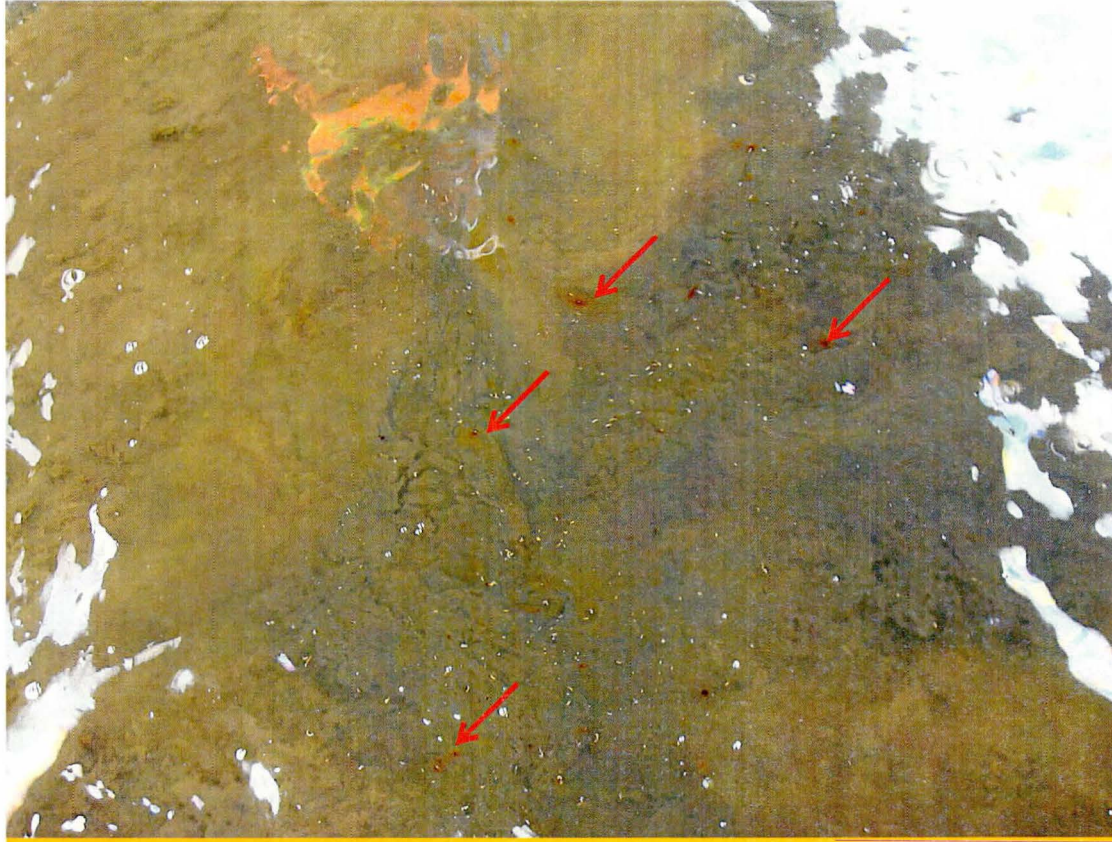
Photo Number: 11

Description: Poling/disturbing canal bottom. Red arrows indicate free phase droplets.

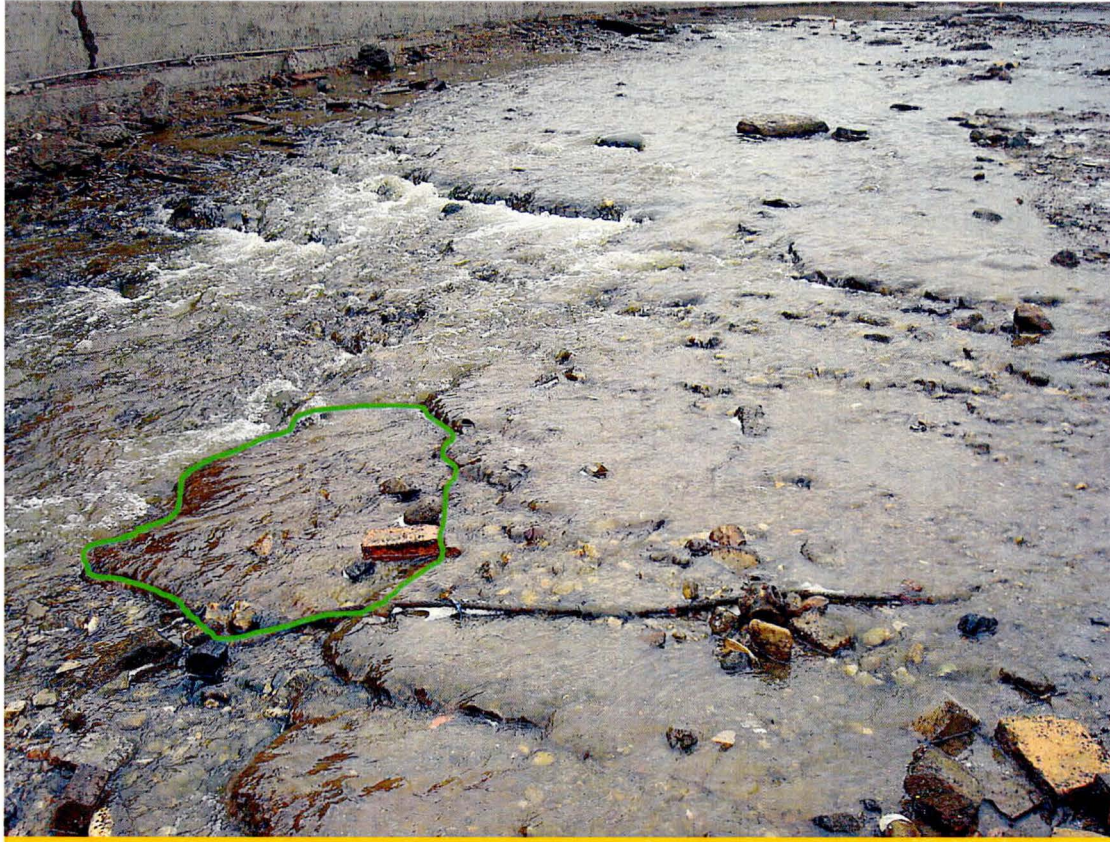
Photo Number: 12

Description: Evidence of upper weathered bedrock (“lower till”) at bottom of Fox River Canal. Green line outlines flat plane of upper weathered bedrock. Additional planes of upper weathered bedrock can be observed in photo.
