DATE: November 6, 1995

SUBJECT: October 9 - 11, 1995 Sampling of the C.M. Christiansen Wood Treatment Facility at Phillips, Wisconsin by Janisch, Amrhein, Kreitlow, and Boheim.

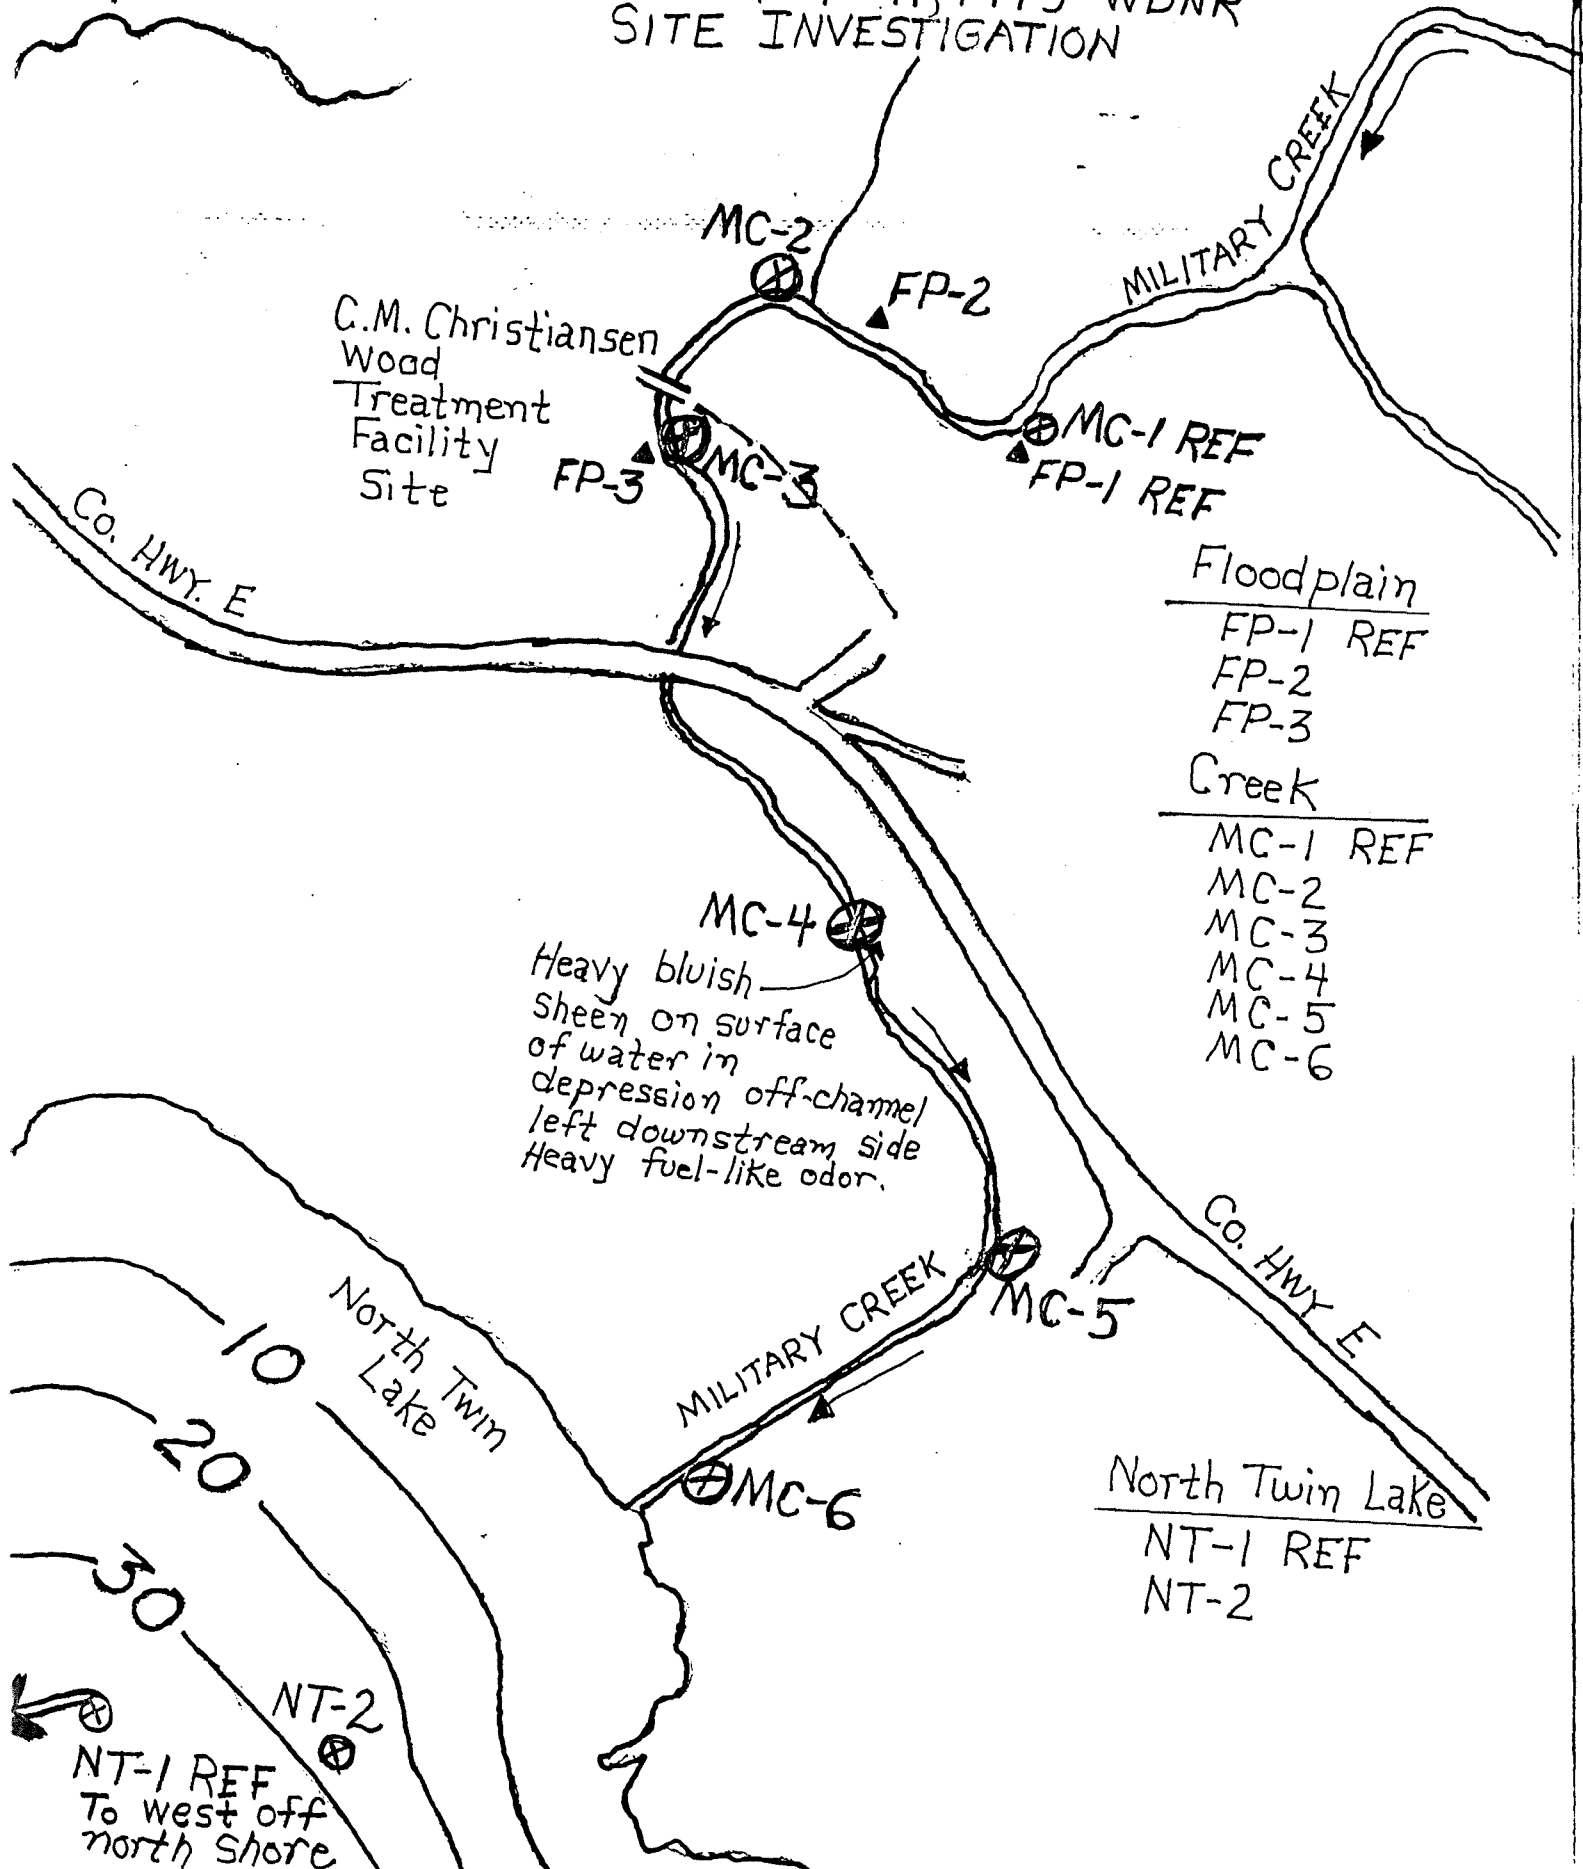
FIGURE 1. General Location of Floodplain Soil, MILITARY CREEK and NORTH TWIN LAKE SEDIMENT SAMPLING SITES FOR THE OCT. 9-11, 1995 WDNR SITE INVESTIGATION

The floodplain sampling sites shown in Figure 1 have the following characteristics:

FP-1A - Reference floodplain sample site. 0-6 inches from 2 shovel cores composited. Samples taken 25 feet from the creek channel and under a tag alder overstory. The floodplain site is near the creek channel reference site previously used by Kreitlow for caged fish

FP-2A/B- One of the two study site floodplain soil sites. Two segments sampled - 0-3 inches and 3-8 inches. Each segment was a composite of soil material obtained in three shovel cores taken 10-15 feet from the creek channel bank. The site is in a tag alder shrub area in wetland. This site was selected for sampling because of log remnants and treated log sawed ends that are strewn about the area. Based on an old aerial photograph, the location may have been a drying and drip area for treated logs. Also there are some rusted 5 gallon containers around a junk pile near the creek bank in this area. Analysis of FP-2 segments will include the full suite of compounds (i.e., DRO, pesticides, and priority pollutants which includes chlorinated pesticides, PAHs and chlorophenolics, TOC, and particle size). The potential interferences from PCDFs with chlorinated pesticide analysis as referenced in the October 30, 1995, letter from White Water Assoc. is being discussed with the SLOH.

FP-3A/B- Study site floodplain soil. Two segments sampled, again 0-3 inches and 3-8 inches. Both segments will be analyzed for the full suite of chemicals. The sample site was chosen based on an old aerial photo that showed log piles in the vicinity although it is unknown if the logs were treated or untreated log storage piles. It is also an area adjacent to Military Creek where stream velocity is increased near the bank resulting in a higher potential of erosion during periods of high flow. Shovel probing of soils in the vicinity of the site on a June 22, 1995 site visit had a faint fuel oil-like odor and a grayish substrata. The sample site is within eight feet of the creek channel and is in grass-sedge-forb wetland vegetation.

The Military Creek sediment sample sites are shown on Figure 1. The assessment of sediments will focus on assessing the biological component, namely the in-field macroinvertebrate community and laboratory toxicity testing. No chemical analysis will be performed on creek sediments.

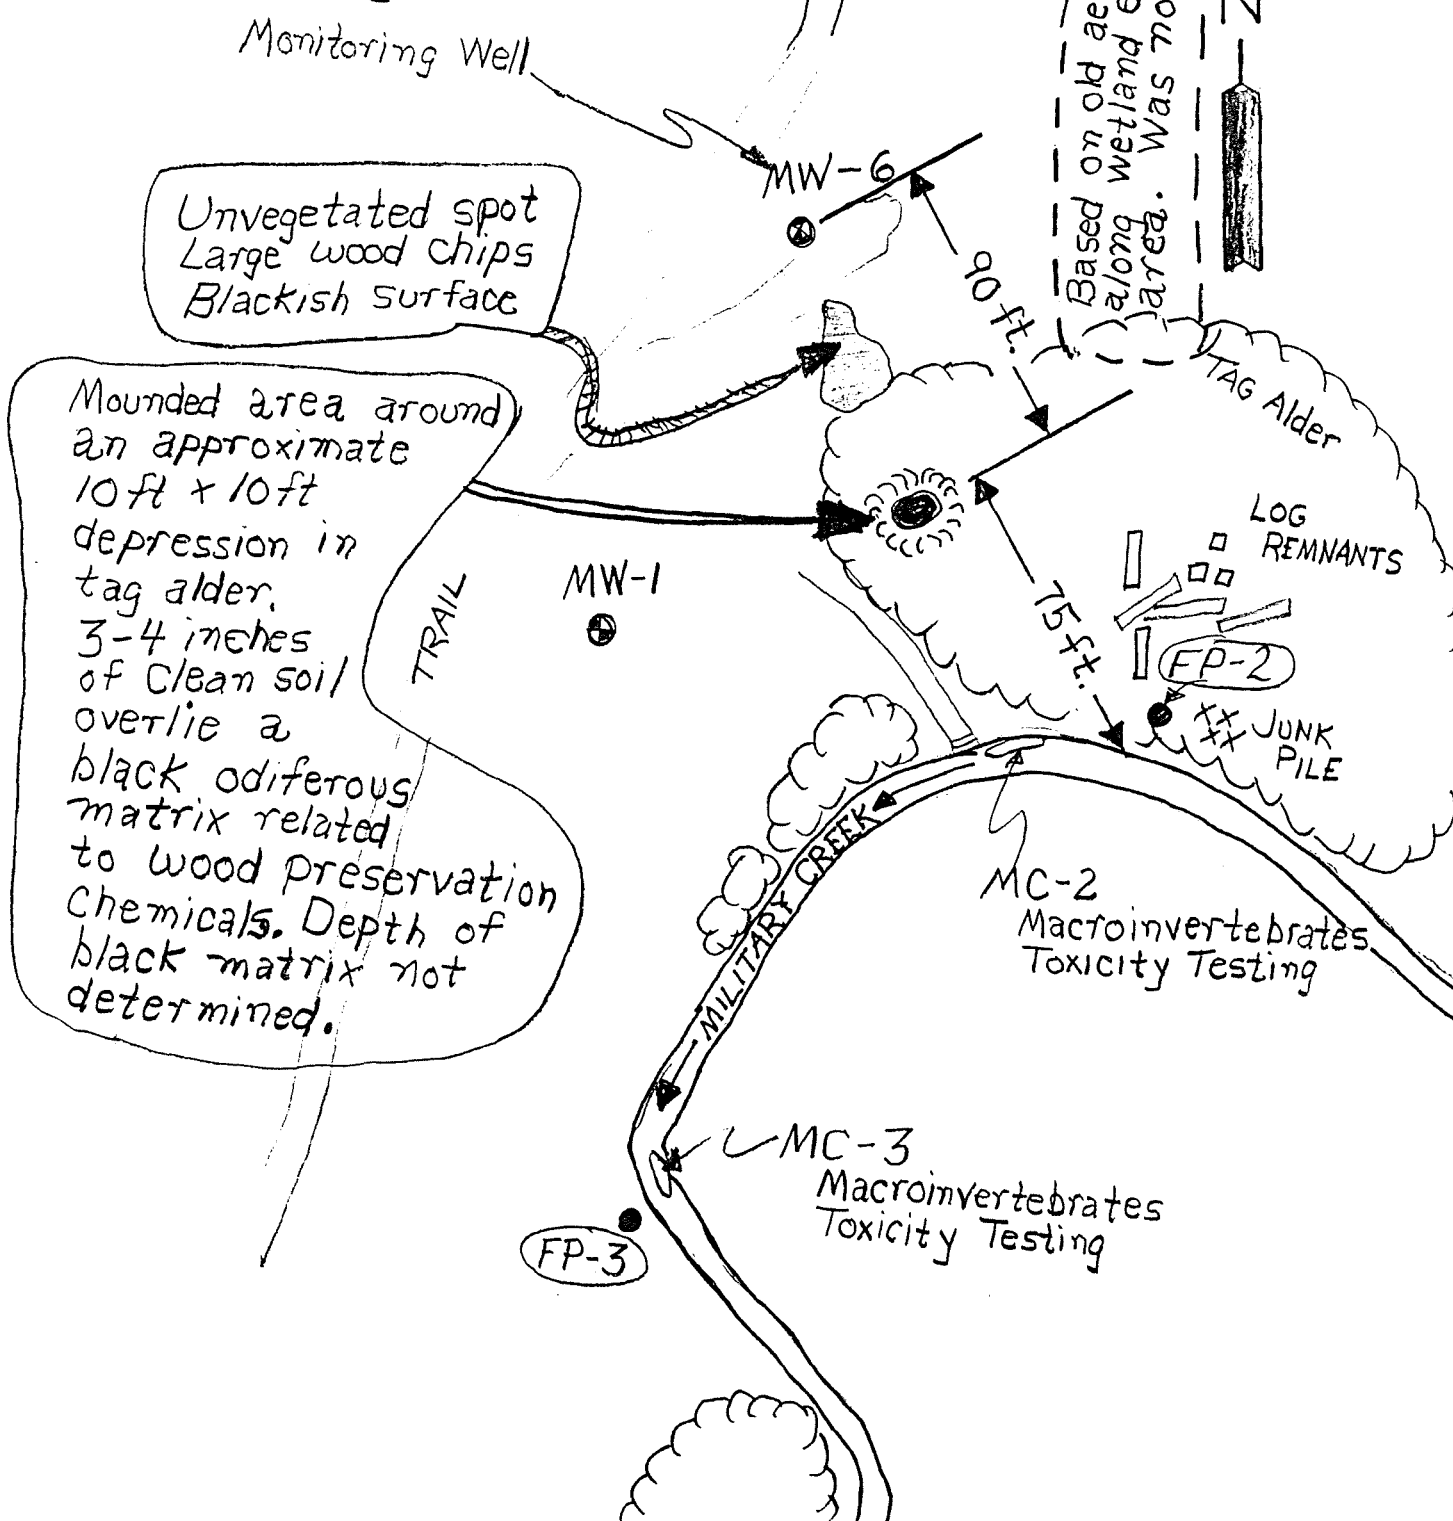
FIGURE 2. General Location of a Visibly Contaminated Wetland Site Associated With The C.M. Christiansen Wood Treatment Facility

Most of the money available for chemical analysis was allocated to do a full chemical analysis of floodplain soils on the site, adjacent to the creek. Some initial probing was done by shovel on the site floodplain soils looking for visual or odor characteristics associated with the wood treatment compounds used i.e., creosote, diesel oils, or PCP. The probing of the floodplain was not systematic or thorough given the time constraints. The probing was mostly concentrated in areas where because of the creek physical characteristics and energy dynamics would potentially result in erosion of floodplain soils. Generally, visual gross floodplain contamination was not found. The exceptions were some sites that appeared to have a faint diesel-like odor and one localized site that had gross contamination. This heavily contaminated site is located and described in Figure 2.

Unvegetated spot  
Large wood chips  
Blackish surface

Mounded area around an approximate 10ft x 10ft depression in tag alder. 3-4 inches of clean soil overlie a black odiferous matrix related to wood preservation chemicals. Depth of black matrix not determined.

Based on old aerial photo, this area along wetland edge was log storage area. Was not probed by us.
