FIVE-YEAR REVIEW REPORT #2 FOR THE UPLAND OPERABLE UNIT

WSPC CAMPMARINA MGP (ALT SF)

SHEBOYGAN, WISCONSIN

Prepared by the
Southeast Region
Wisconsin Department of Natural Resources
Plymouth, Wisconsin

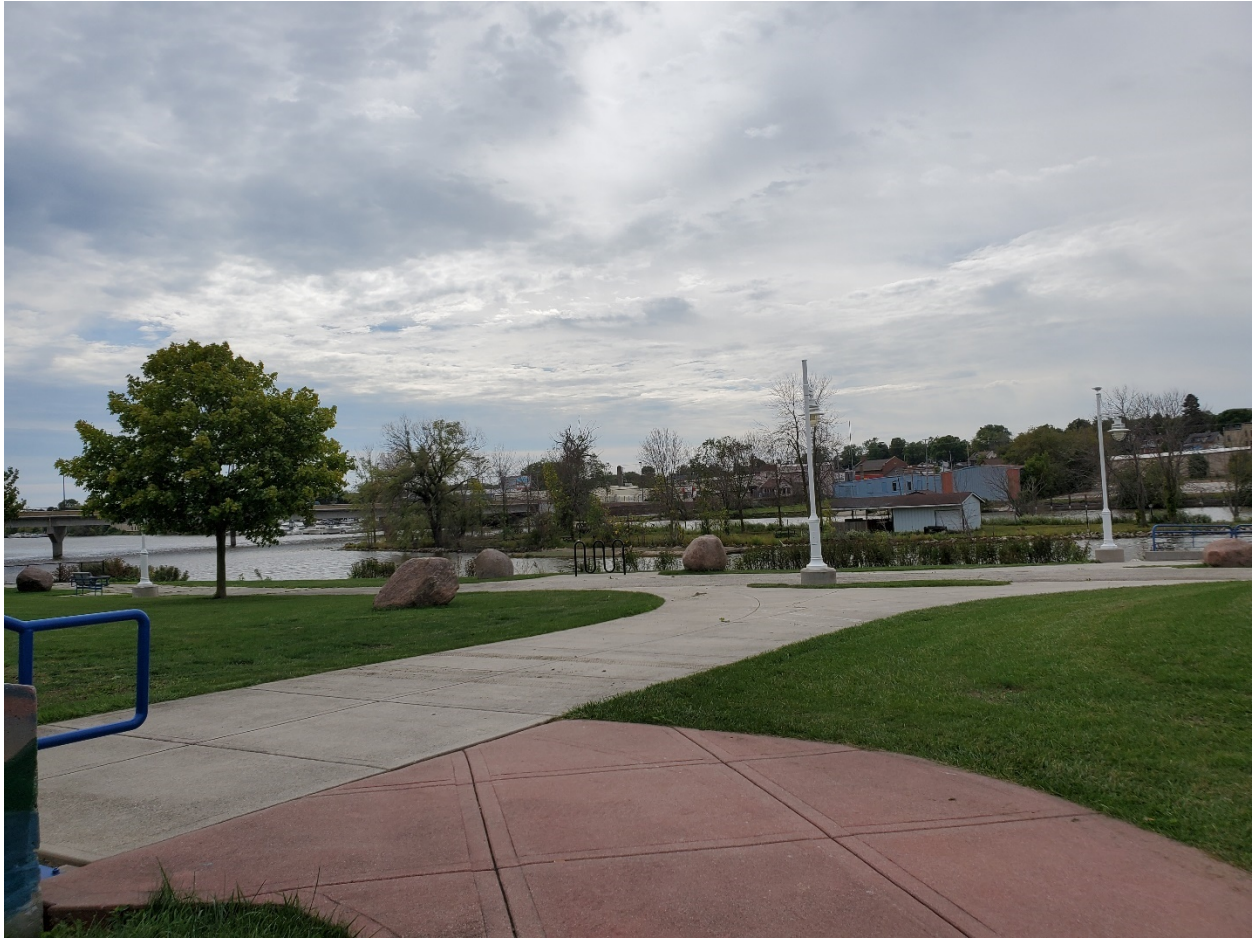
Photo 1. Central lower part of the containment area looking southwest towards Boat Island (center) and the Pennsylvania Avenue Bridge (left). The guardrail for the river overlook bench is far center right of photo. Photo taken September 21, 2022.

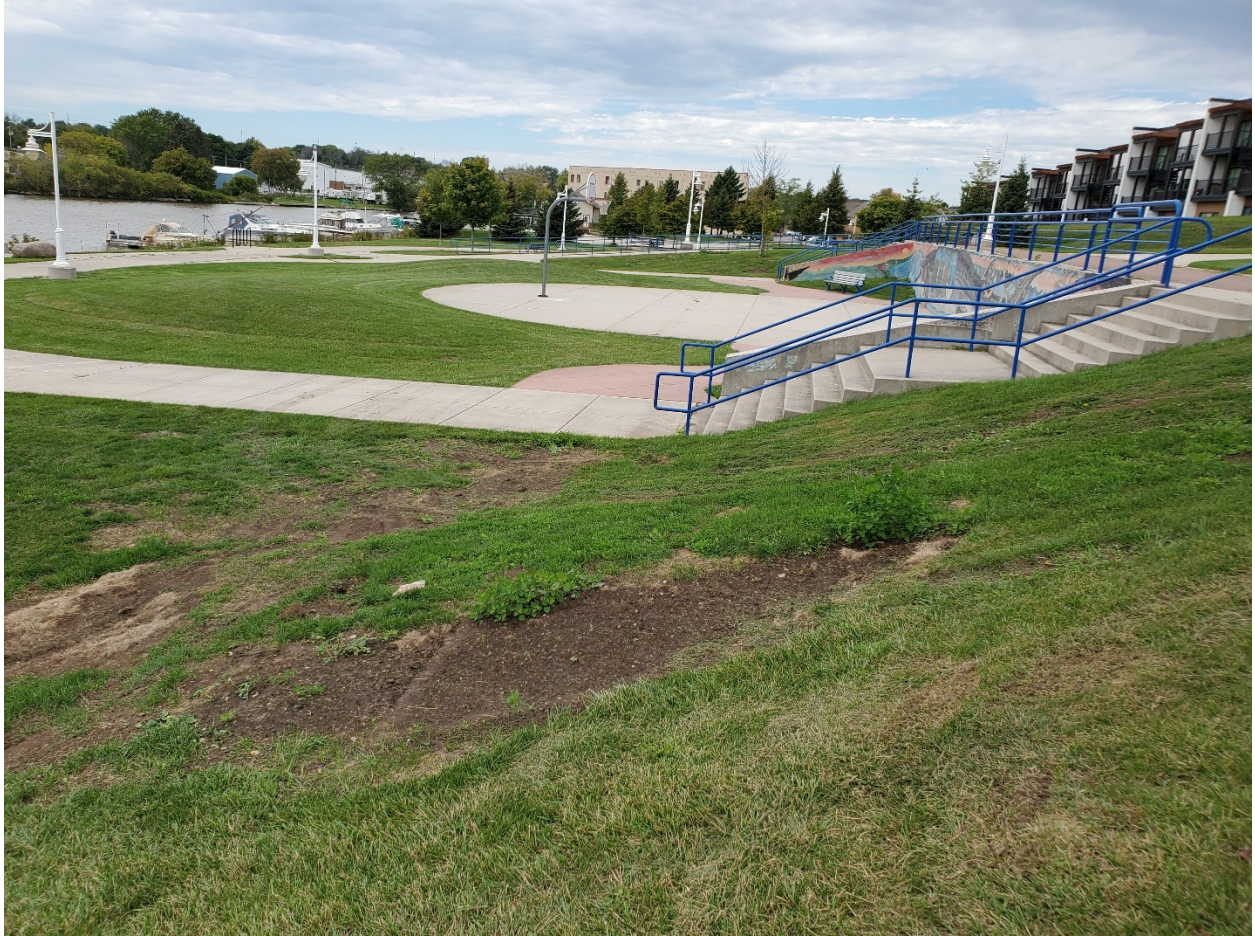
Photo 2: Re-seeded exposed soil on the top of the cover south of the basketball court looking northwest. New condominiums are in the upper right of photo. Photo taken September 21, 2022.

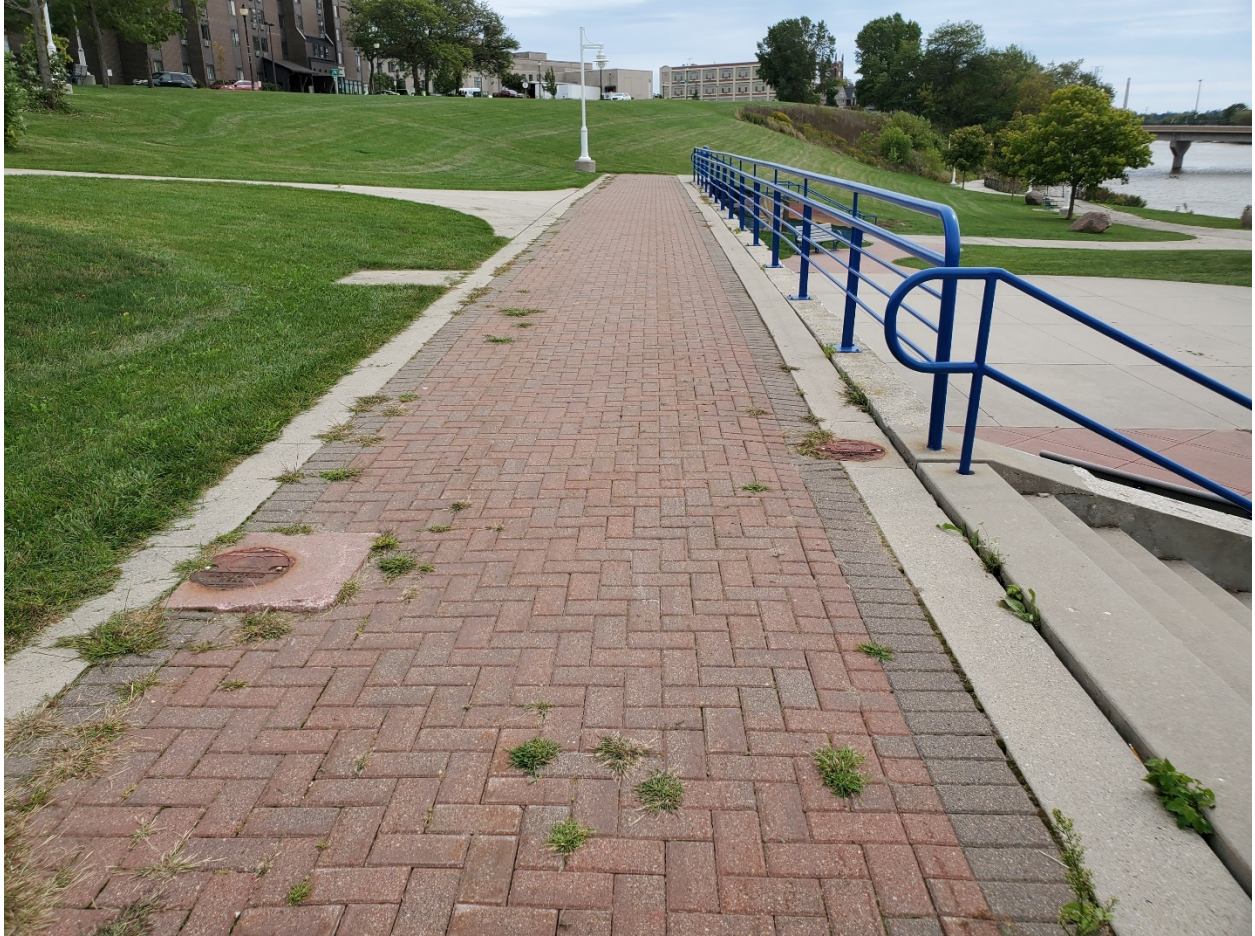
Photo 3: Unknown well nest at the top of the former gas plant foundation. Photo looking southeast, taken September 21, 2022.

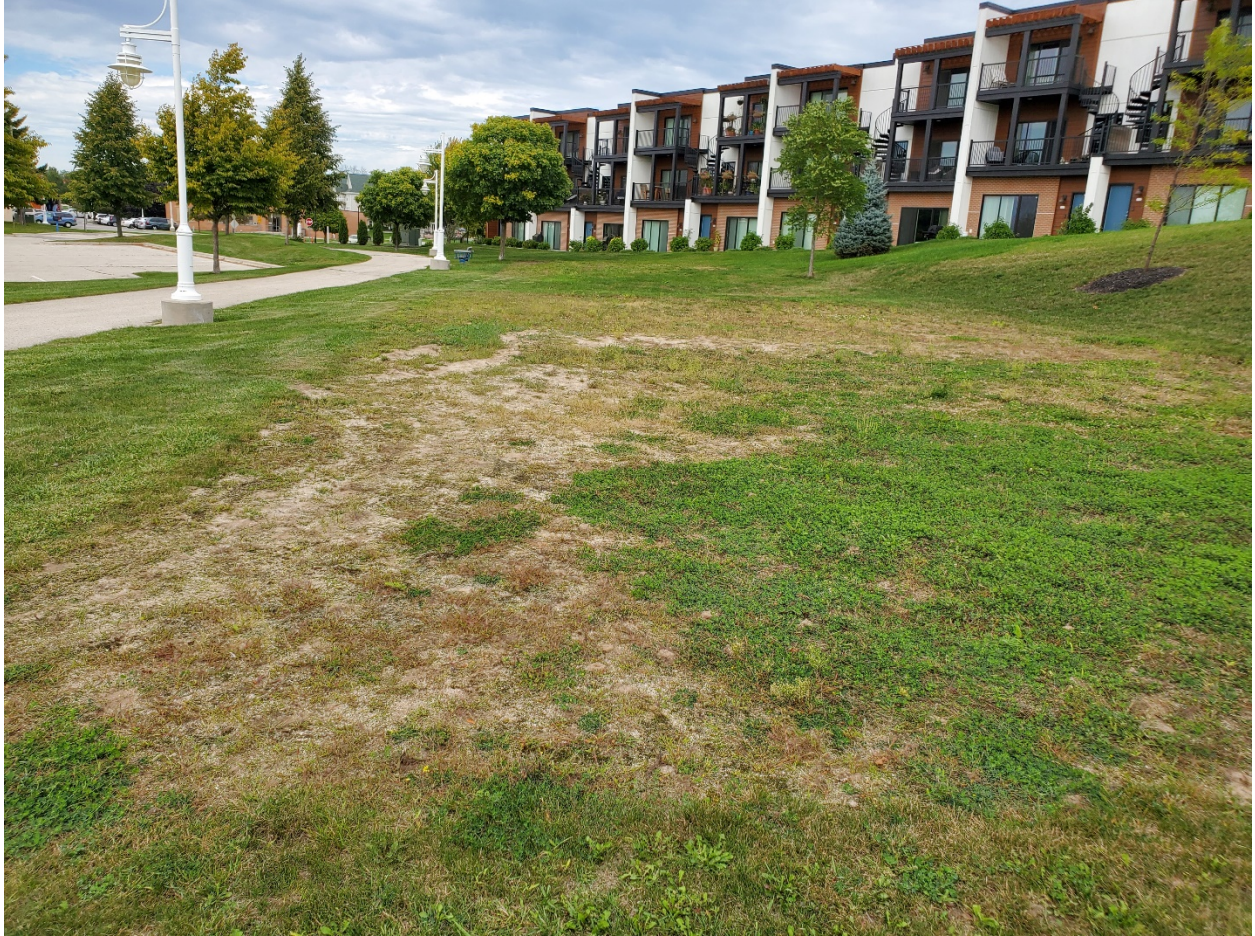
Photo 4: Recreation Area (volleyball court) off the containment area to the northeast side. New condominiums are in the upper right of photo. Photo taken September 21, 2022.

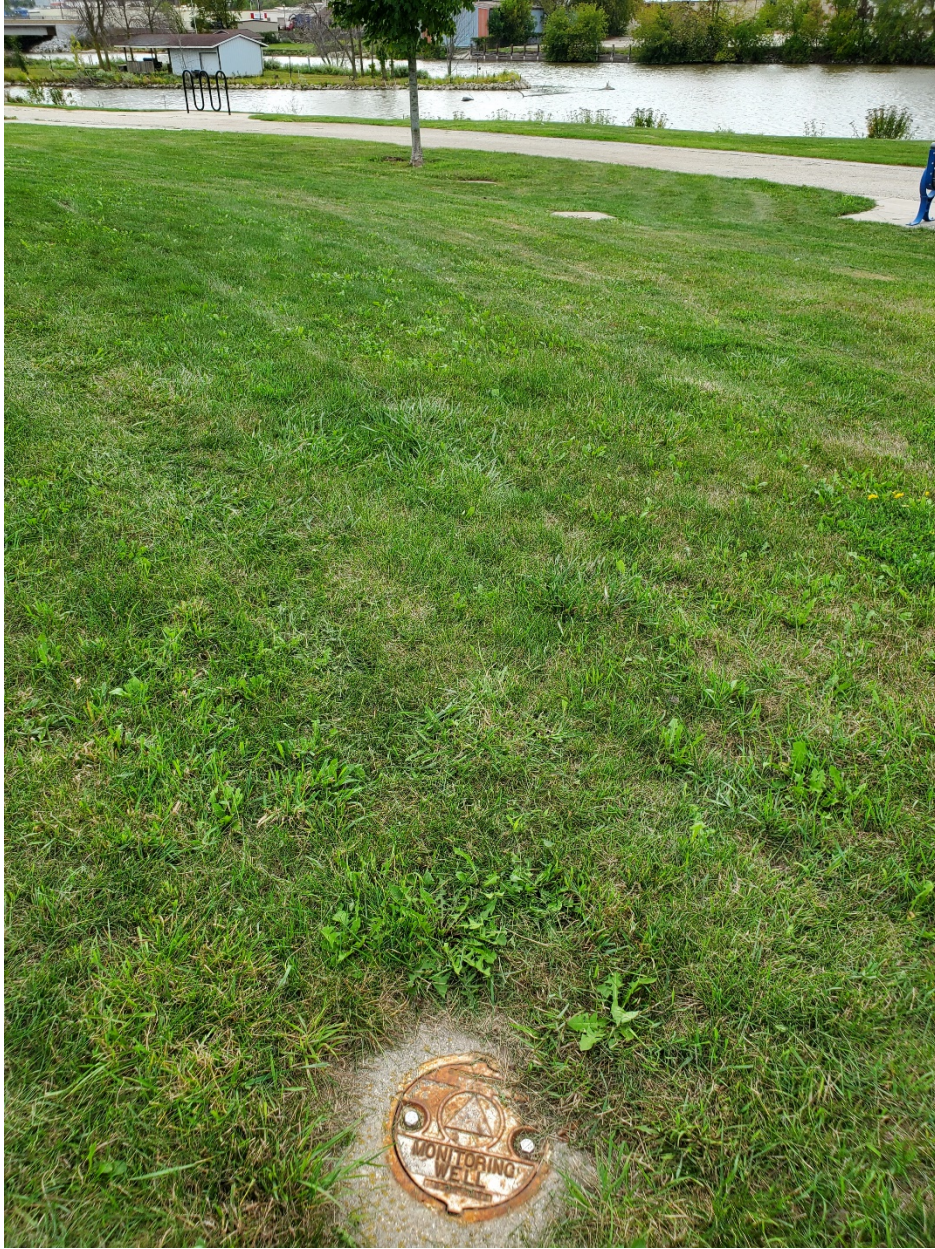
Photo 5: Possibly monitoring well MW-709R. Photo looking southwest towards two wells pictured near the top of the photo which may be MW-703 (reported as abandoned) and possibly air sparge well. Photo taken September 21, 2022.

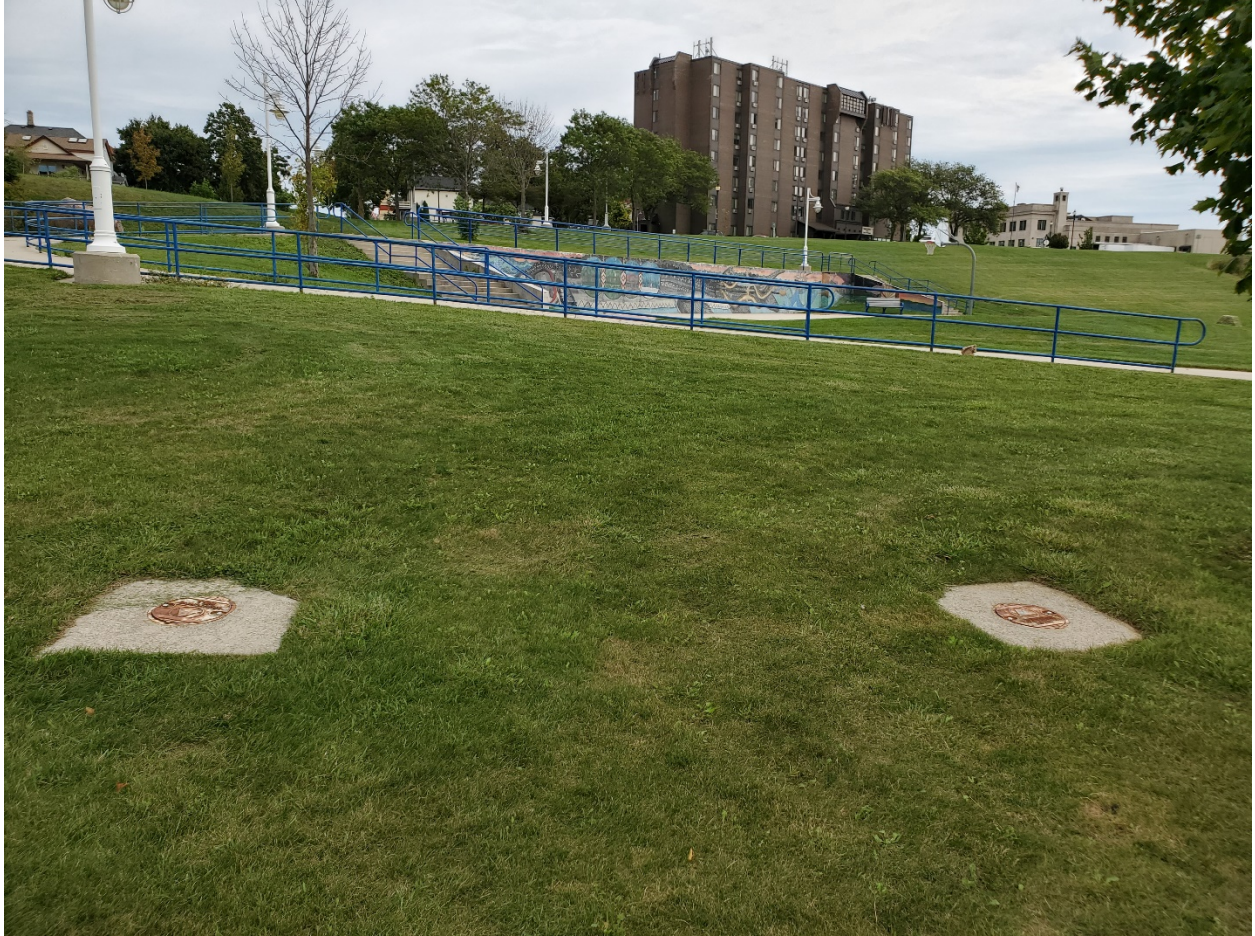
Photo 6: Two wells possibly MW-703 (reported as abandoned) and possibly air sparge Well BW-16. Photo looking east, taken September 21, 2022.

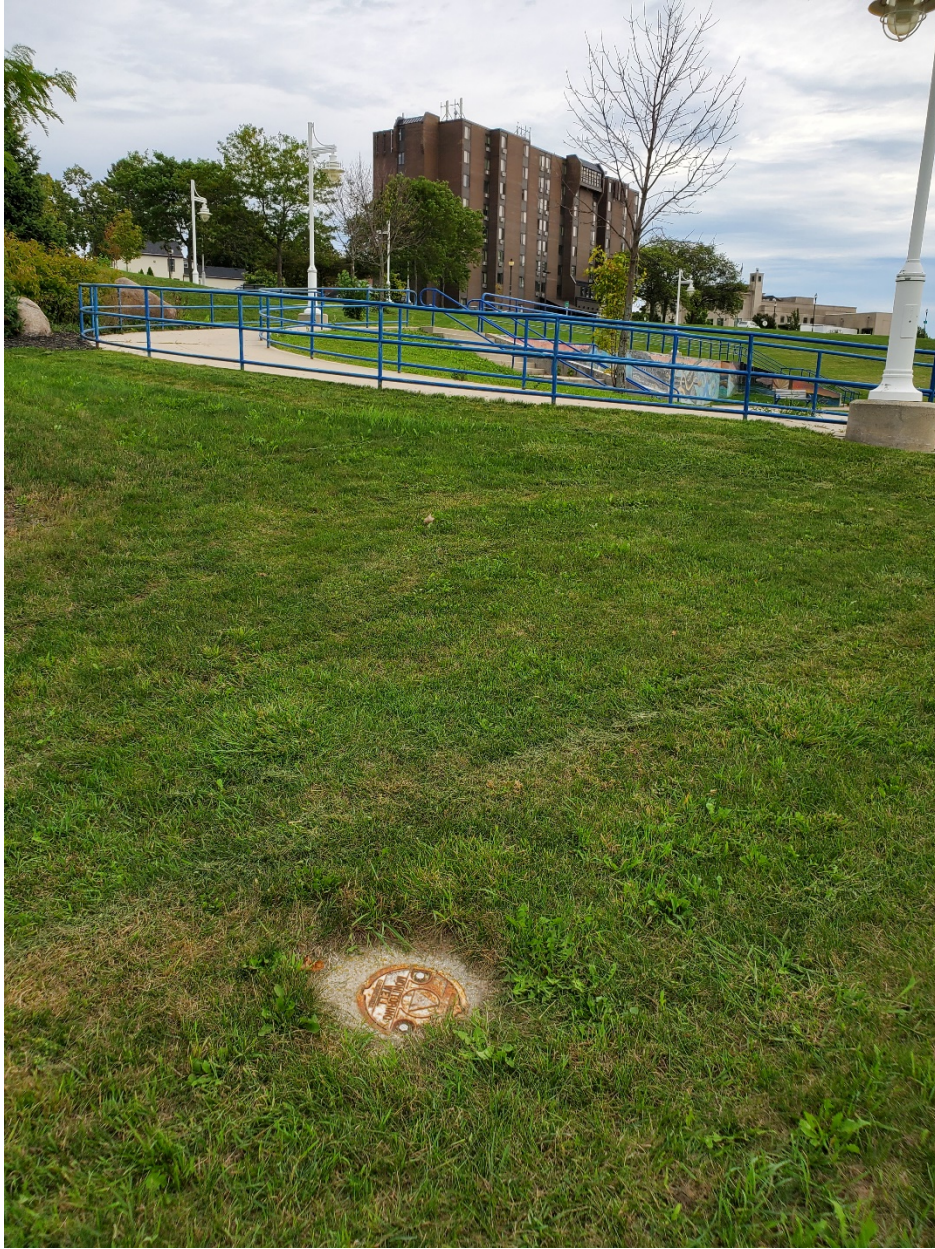
Photo 7: Likely Monitoring Well MW-705. Photo looking east-southeast, taken September 21, 2022.

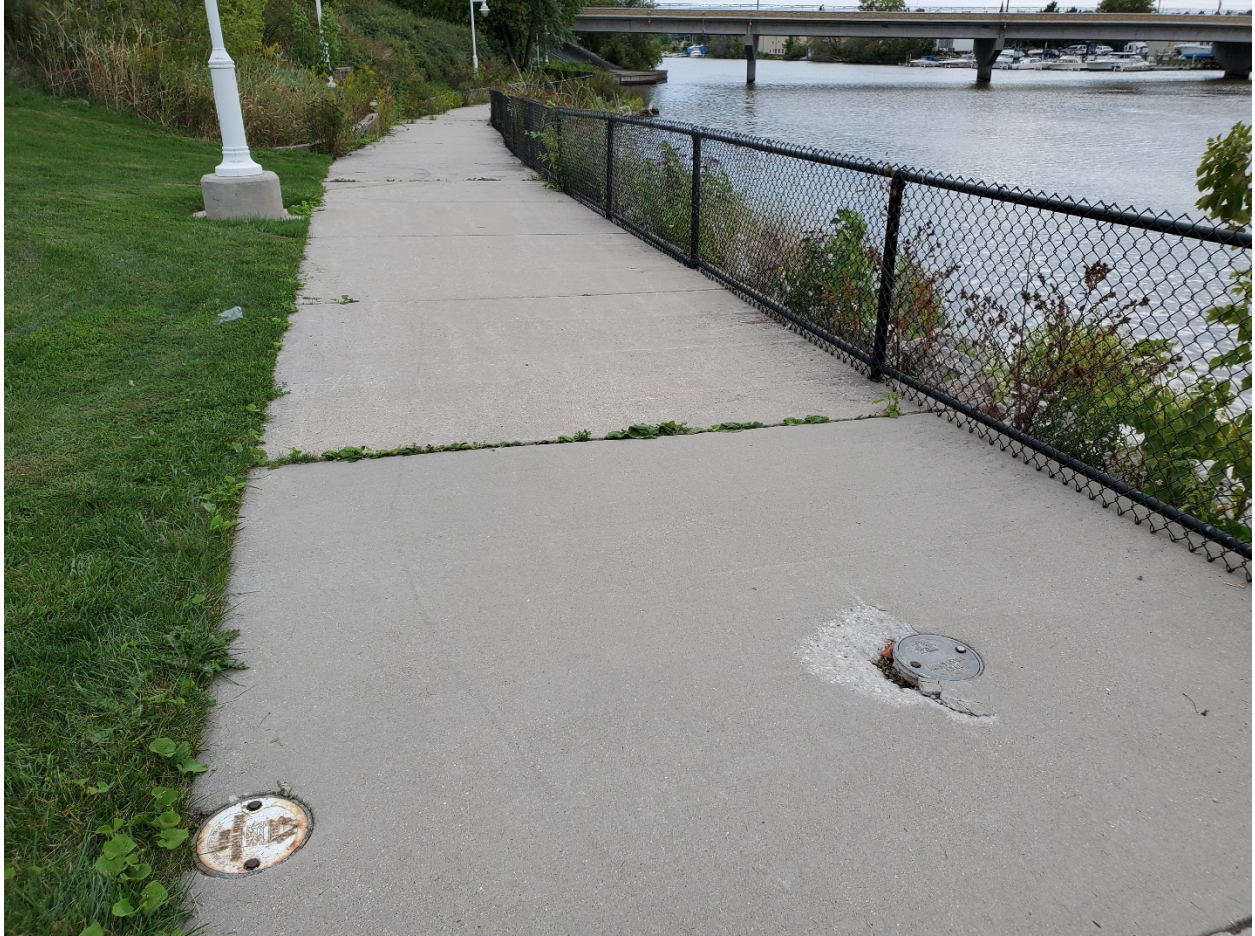
The visible portions of the cover were in good shape. There was adequate sod cover with no exposed soil and no erosion occurring on the slope towards the river except for a small bare spot northwest of the basketball court that appeared to be recently re-seeded with grass. The pavement of sidewalks, courtyards, stairs and river walk were all in good repair. There were no open or broken monitoring well covers. The pavement surrounding PZ-703 was observed to be in need of repair (see Photo 8, Appendix F2). The site was

Concrete @ PZ-703 needs repair. See photo.

Photo 8: Likely MW-707R (left) and PZ-703 (right) showing damage to surface pavement. Photo looking southeast from near the southeast end of the site taken September 21, 2022.

Pavement at PZ-703 needs repair.

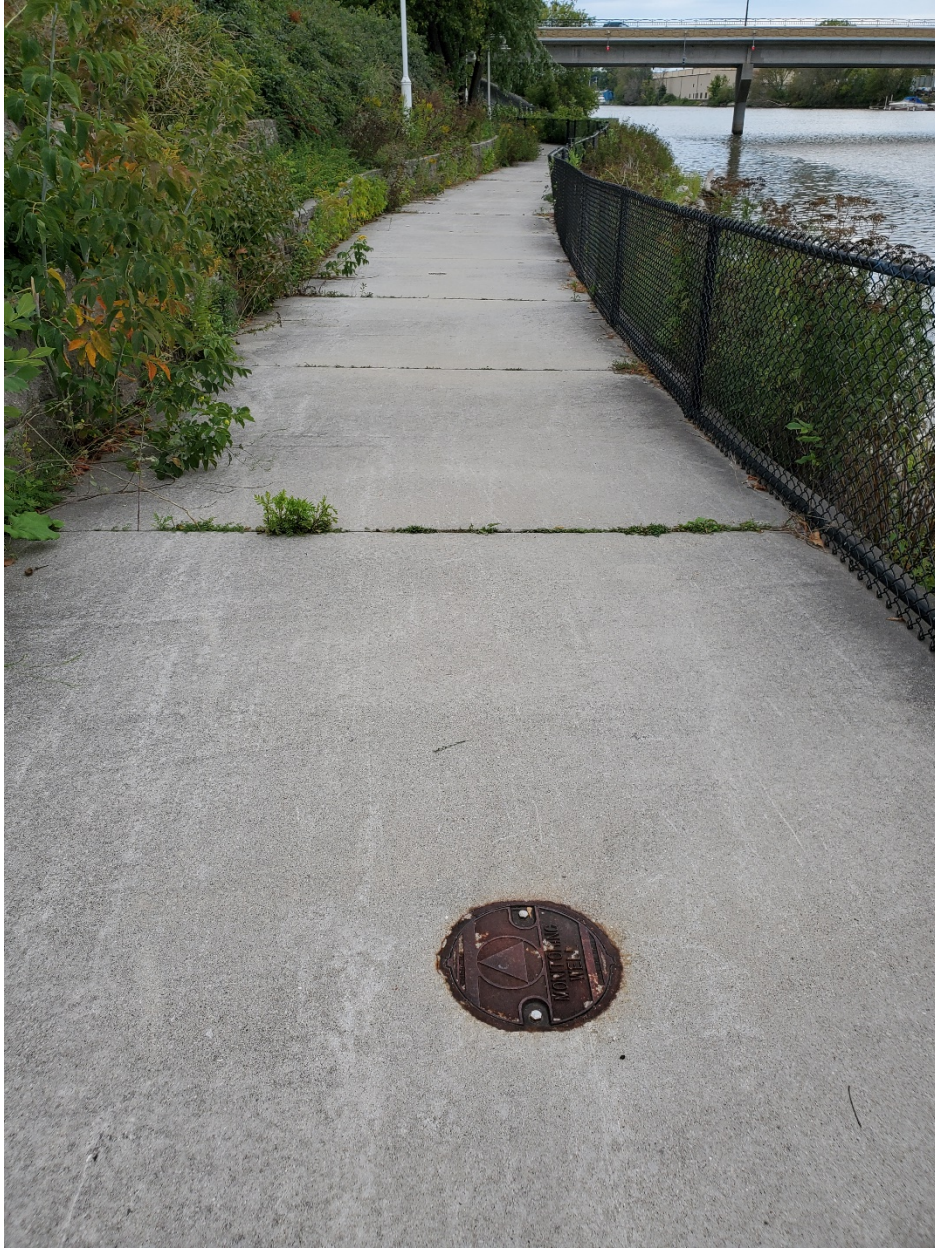
Photo 9: Possibly air sparge Well BW-08. Photo looking southeast from southeast end of site, taken September 21, 2022.

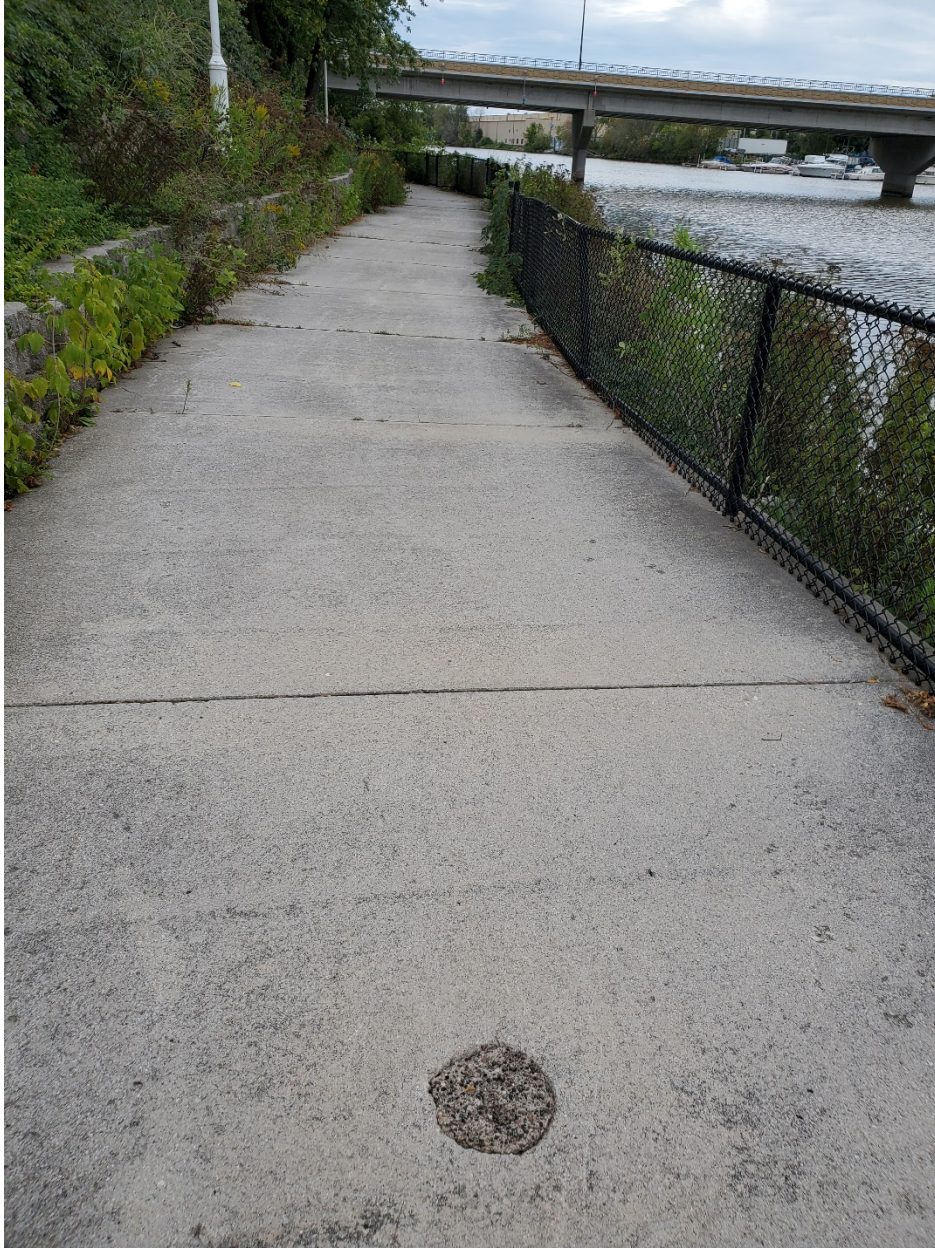
Photo 10: Possible abandoned boring/geotechnical boring at the extreme southeast end of the site near retaining wall (left side of photo). Looking Southeast, taken September 21, 2022.
