Re: **801 South Outagamie Street Sump Pit/Foundation Drain Documentation Report**
N.W. Mauthe Superfund Site
725 South Outagamie Street
Appleton, Wisconsin
Terracon Project No. 58117057
BRRTS No. 02-45-000127

801 South Outagamie Street Sump Pit/Foundation Drain Documentation

N.W. Mauthe Superfund Site ■ Appleton, Wisconsin

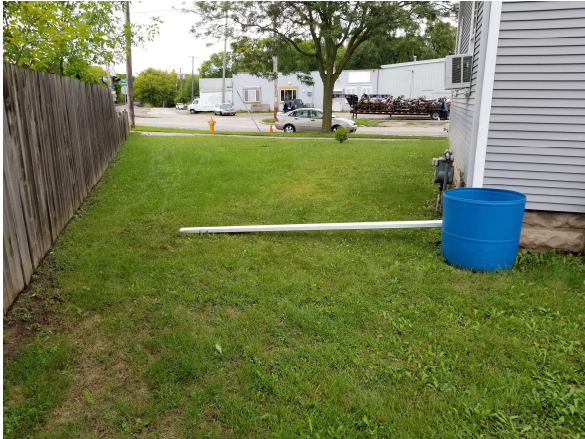
Photo #1 Looking east at the northwest roof drain.

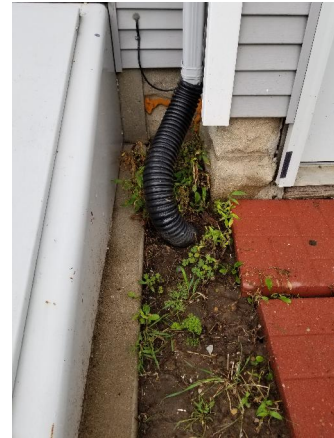
The western foundation drain was also investigated from the western downspout northward toward the northwestern foundation corner, but refusal occurred in an area of sediment within the pipe short of the northwest foundation corner. Again, the foundation drain was full of water. The owner indicated that they had observed water leaking from the corrugated tubing attached to the western downspout at a point where it curved downward before going beneath the ground surface. Ogden Plumbing taped over the hole to seal it.

Photo #2 West roof drain. The corrugated connecting tubing was observed to be leaking at the bend.

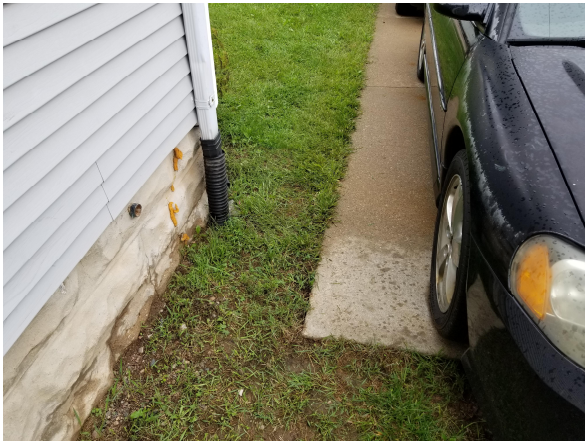
Photo #3 Looking east at the southeast roof drain.

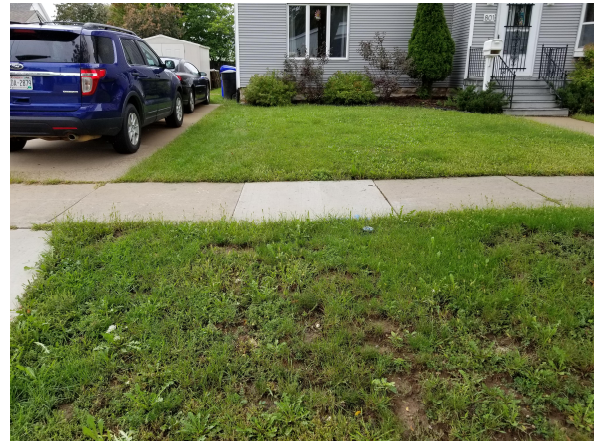
Photo #4 View west from the street.

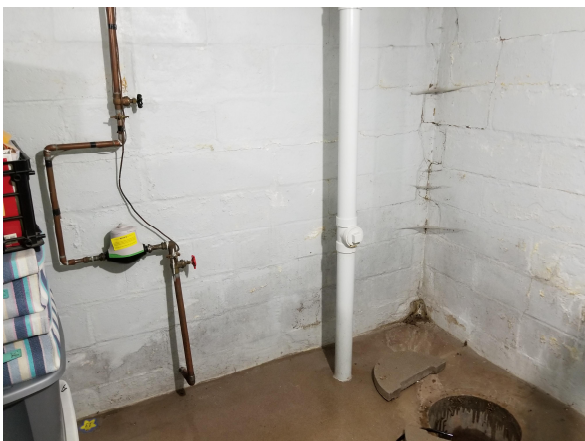
Photo #5 Sump pit, water line, and sanitary sewer line in the southeast corner of the basement.

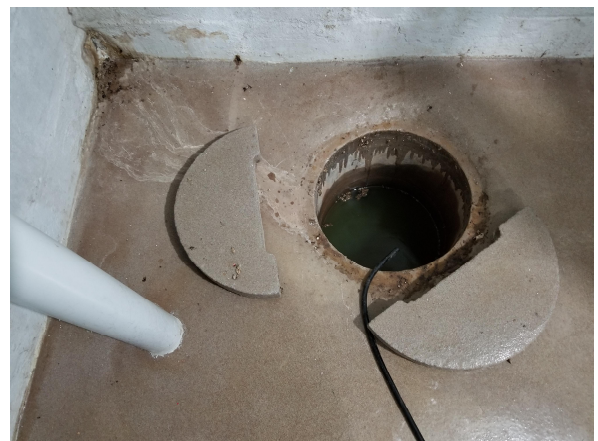
Terracon met Ogden Plumbing at the residence on September 5, 2018, to perform the inspection. At that time, water had receded to below the top of the sump pit and was approximately 2 to 3 inches above the sump outlet pipe. Ogden placed a tracer dye in the sump pit water, but no movement was observed, and the dye remained in the sump pit. On the exterior, Terracon observed that the southeastern and western roof drain downspouts discharge into corrugated drain tubing extending beneath the ground surface. The northwestern roof drain downspout discharged to the lawn approximately 10 feet from the house. A photolog demonstrating site conditions is attached.

Photo #6 Sump pit with standing water above the discharge pipe.
