CAP MAINTENANCE AND
REPAIR REPORT
SANITARY TRANSFER AND LANDFILL
DELAFIELD, WISCONSIN

**Subject: Cap Maintenance and Repair, Delafied Sanitary Transfer
and Landfill, Delafield, Wisconsin**

CAP MAINTENANCE AND REPAIR REPORT
DELAFIELD SANITARY TRANSFER AND LANDFILL
DELAFIELD, WI

JOB # 4025

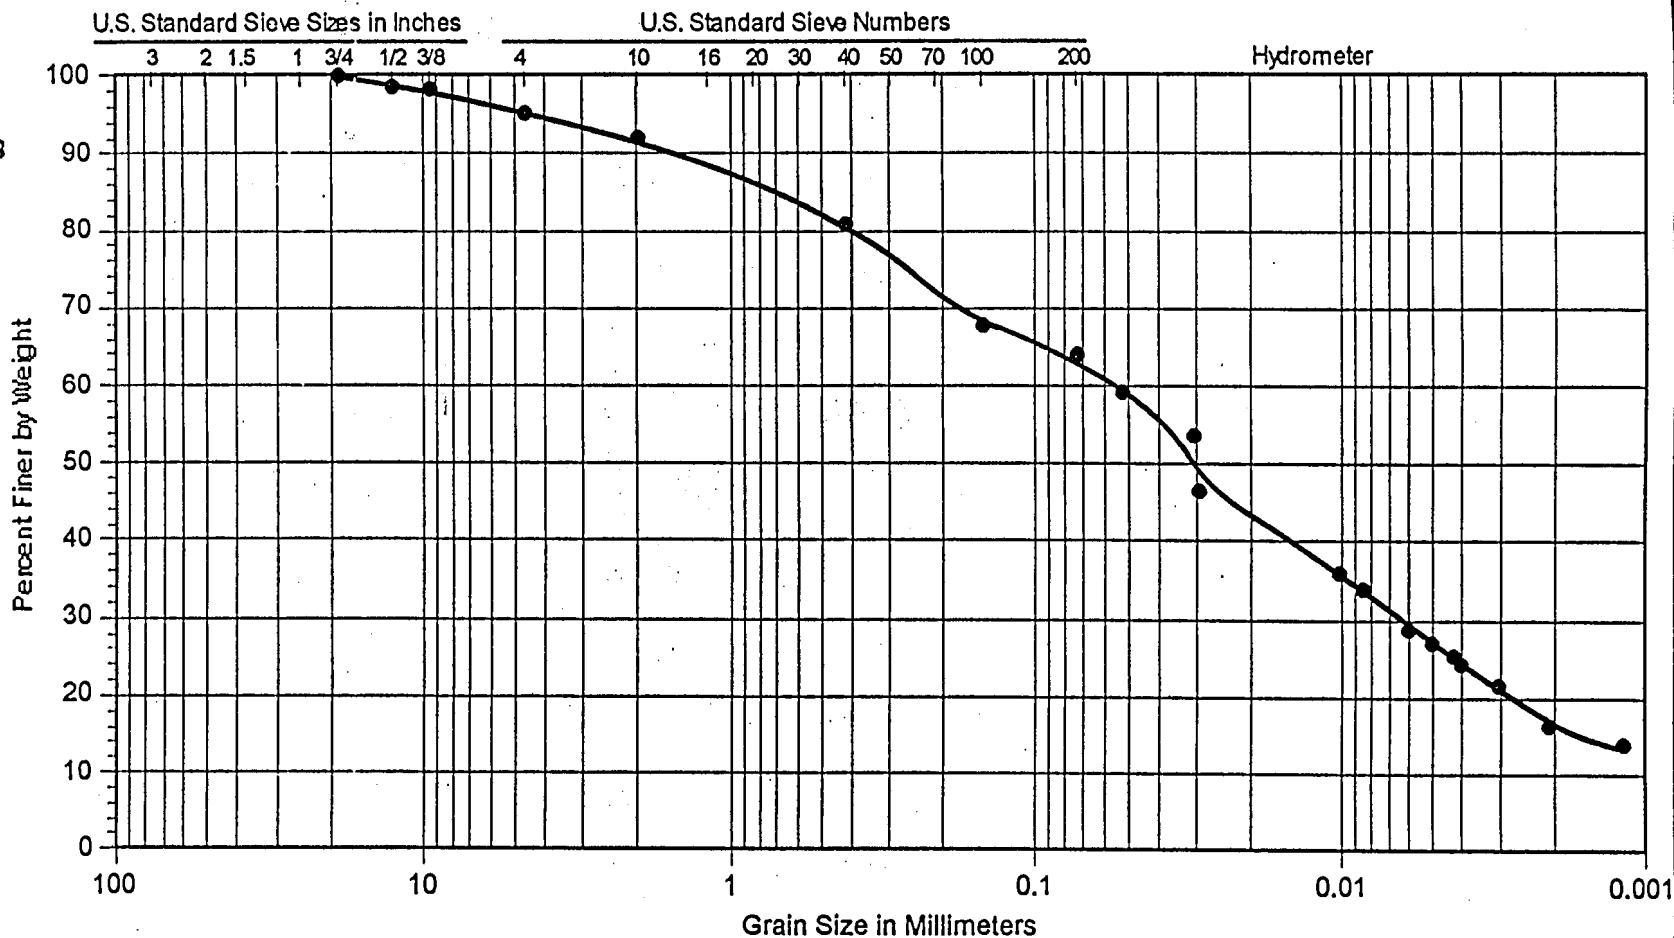
GRAIN SIZE ANALYSIS

Sieve Size	Percent Passing
3/4"	100.0
1/2"	98.7
3/8"	98.2
No. 4	95.2
No. 10	92.1
No. 40	81.0
No. 100	67.8
No. 200	64.2

NUMBER	DEPTH	W	W _L	W _P	CLASSIFICATION
		18.9	62	25	Sandy Fat Clay (CH)

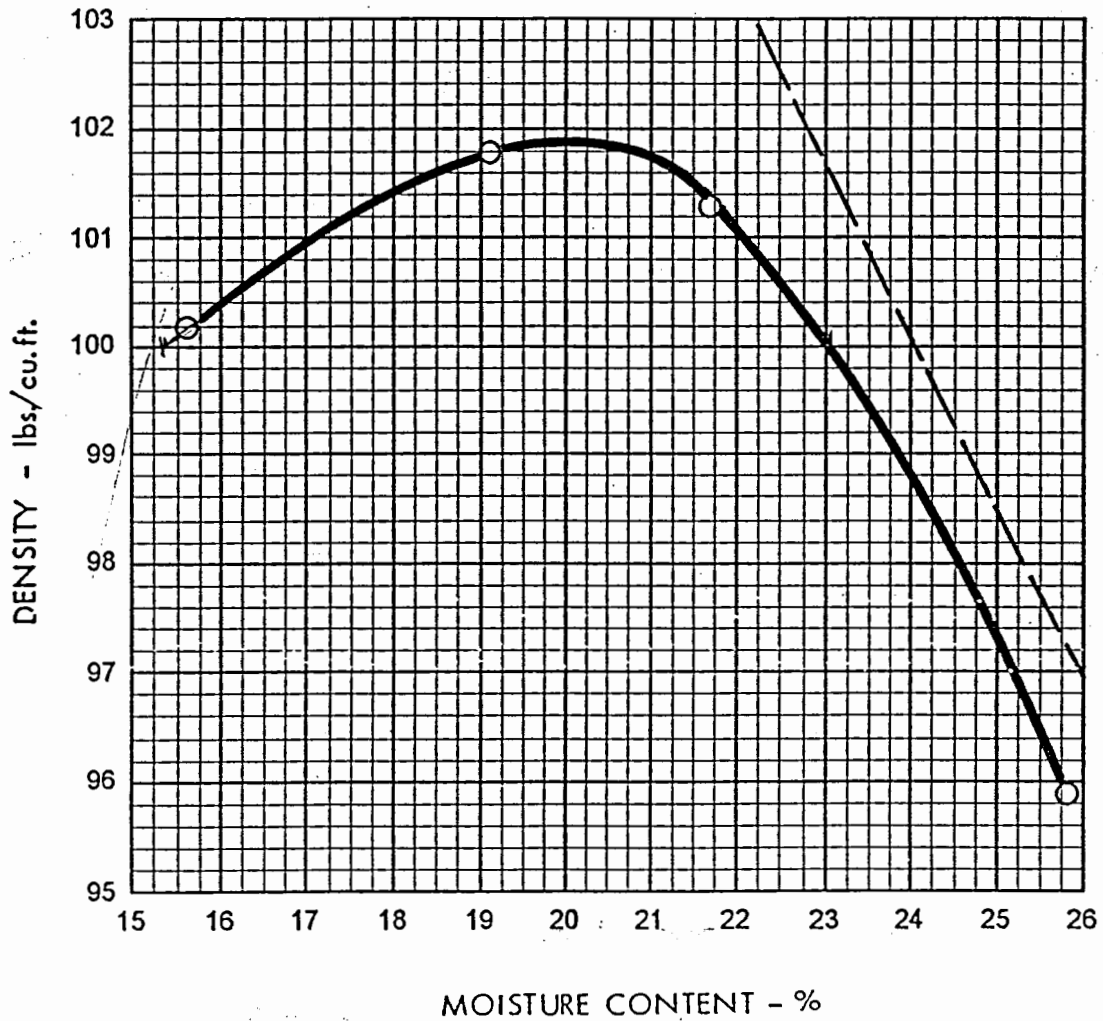
LABORATORY MOISTURE-DENSITY RELATIONS TEST

Maximum Dry Density 101.9 lbs./cu. ft. Optimum Moisture 20.1 %

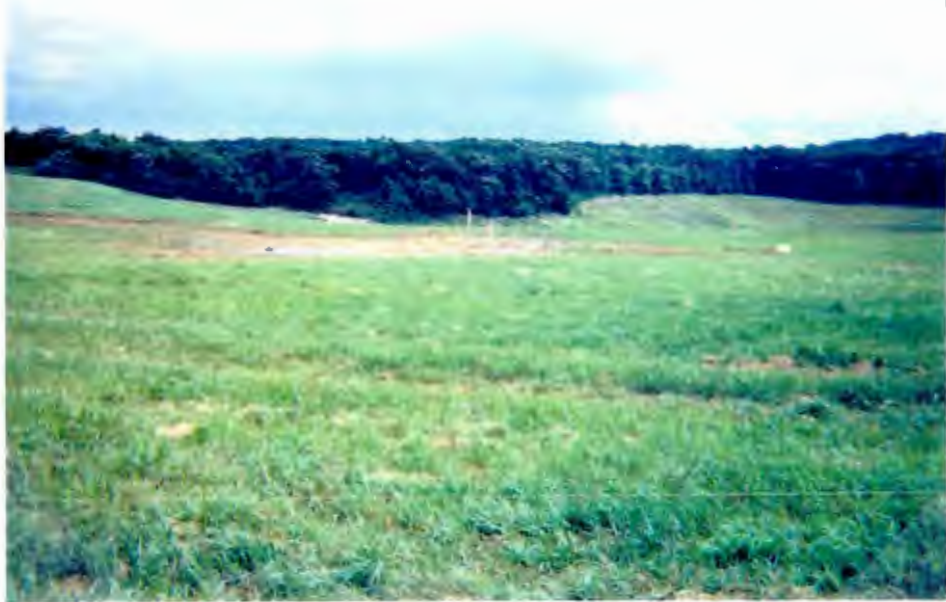
Photograph 1: Area Staked Out for Backfilling

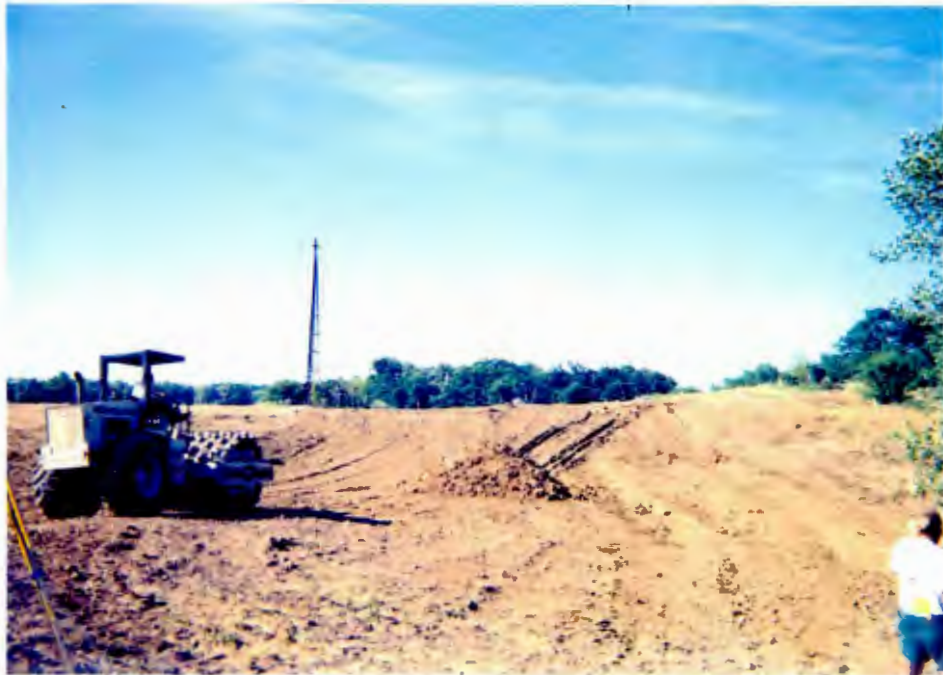
Photograph 2: Compaction Activities

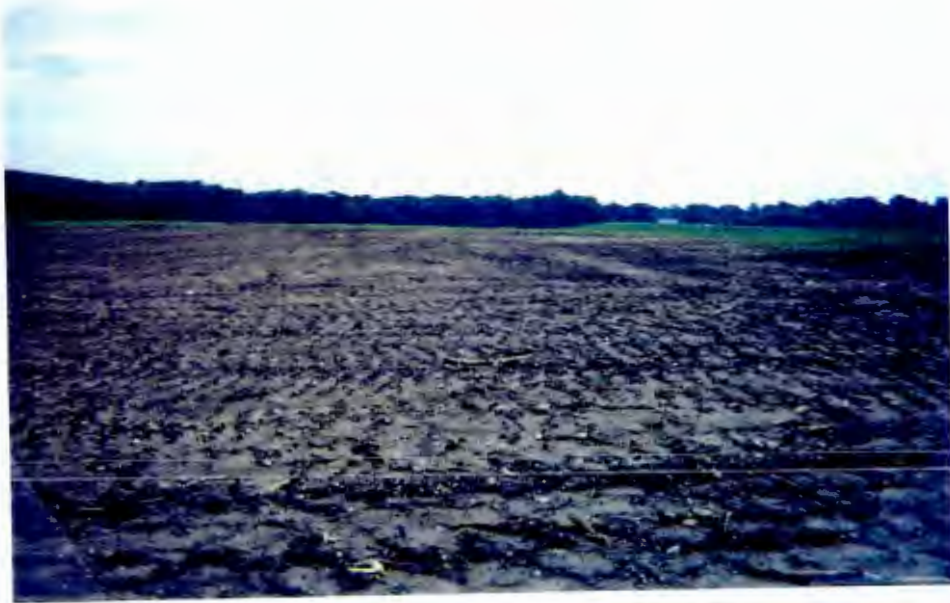
Photograph 3: Closeup of Compacted Fill Area

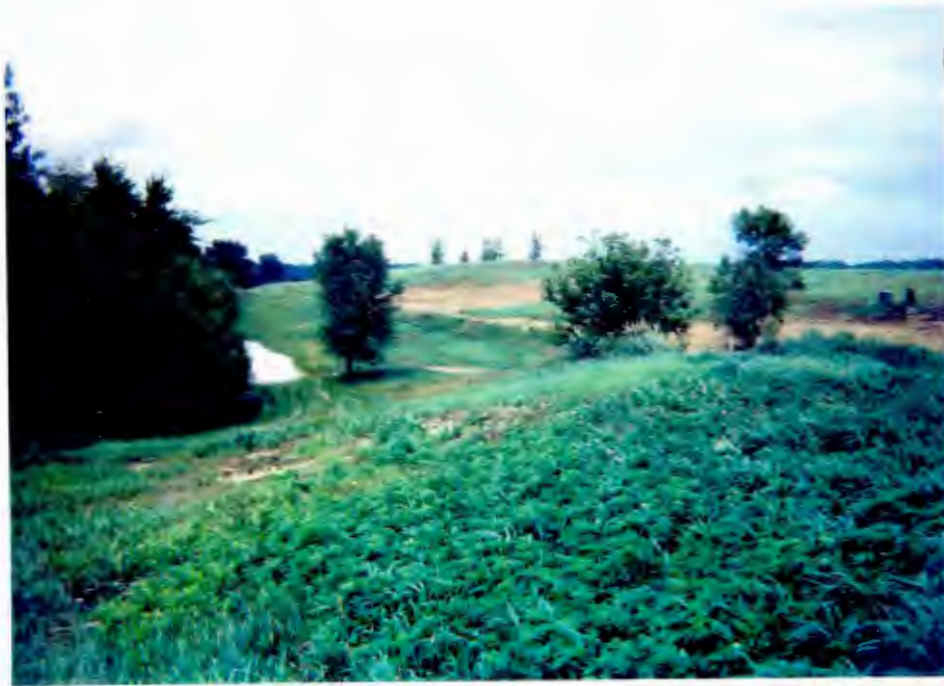
Photograph 4: Finished Western Edge Prior to Reseeding
