Activity (Site) Name Former Desmond's Formal Wear Facility	BRRTS No. 02-32-000203
--	----------------------------------

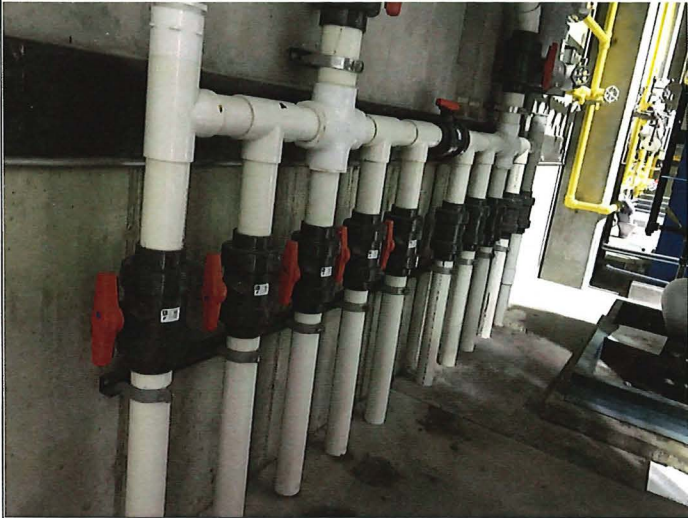
Date added: 05/17/2018

Title: VMS manifold piping - all valves open

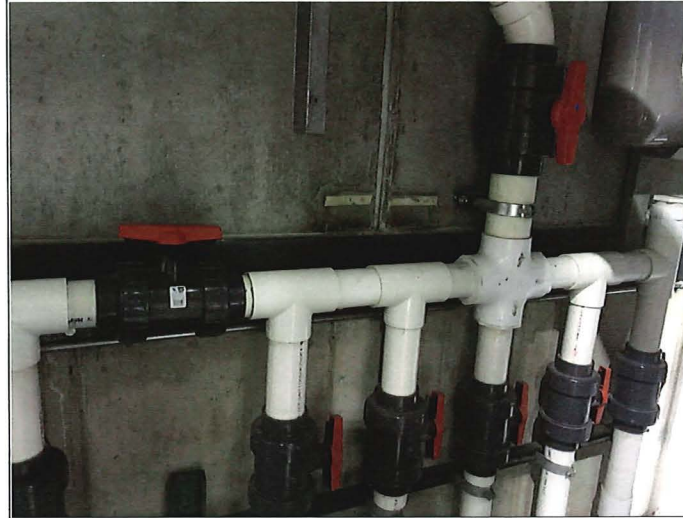
Date added: 05/17/2018

Title: VMS manifold piping - all valves open

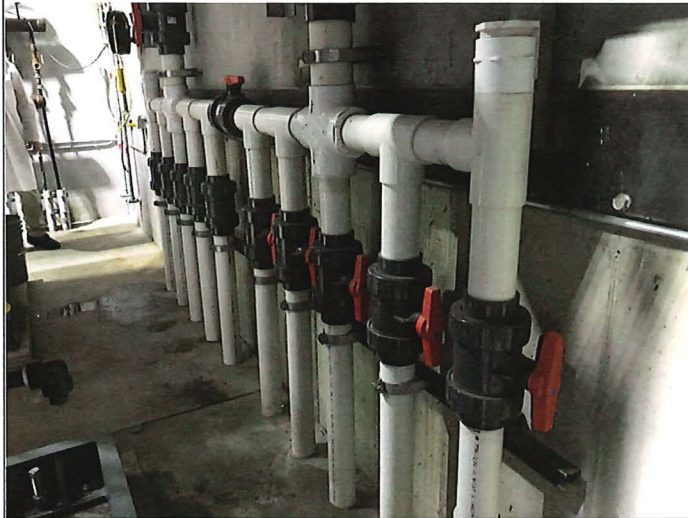
Date added: 05/17/2018

Title: VMS manifold piping - all valves open

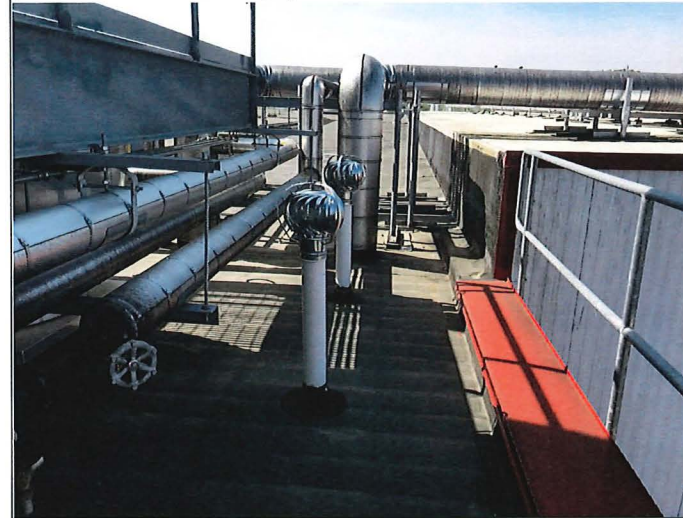
Date added: 05/17/2018

Title: VMS exhaust with wind turbines functioning properly

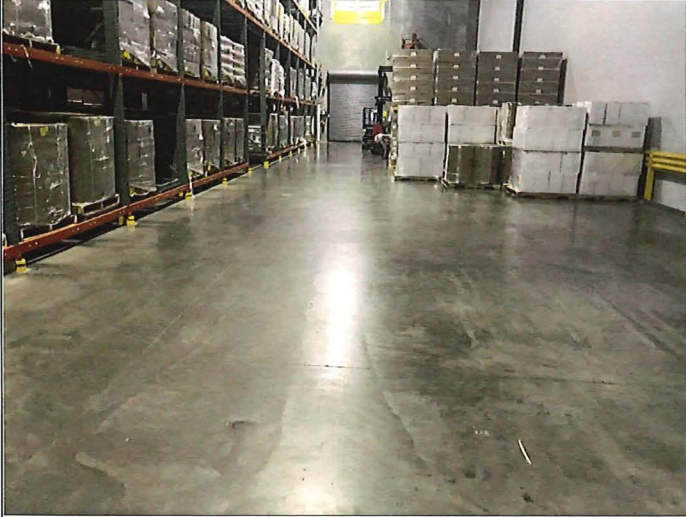
Date added: 05/17/2018

Title: Concrete floor in good condition

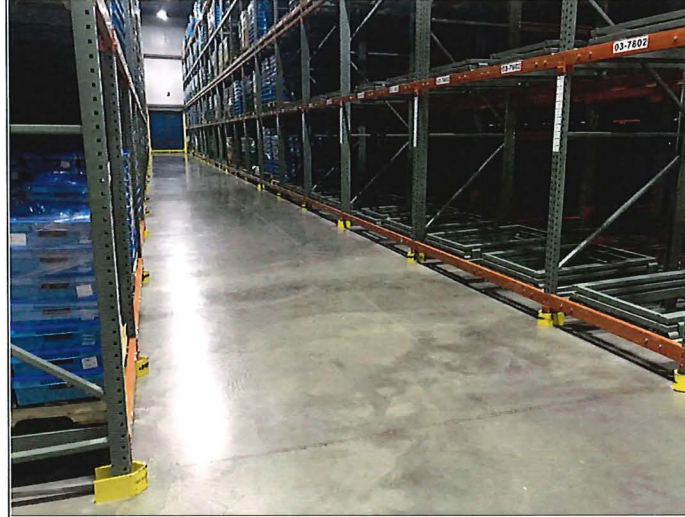
Date added: 05/17/2018

Title: Concrete floor in good condition

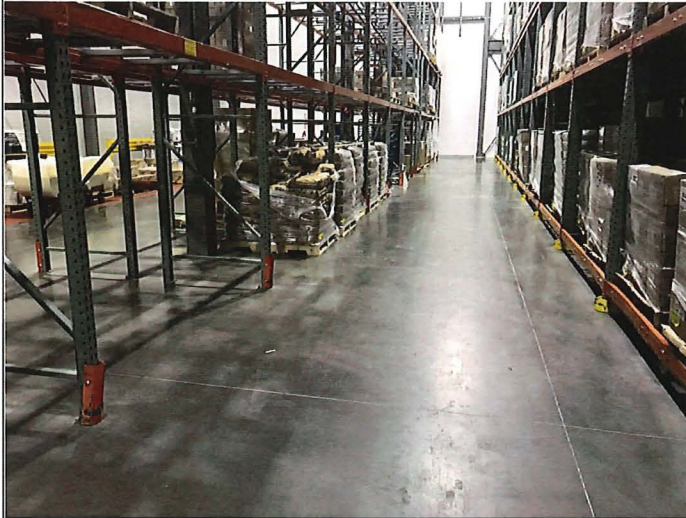
Date added: 05/17/2018

Title: concrete floor in good condition

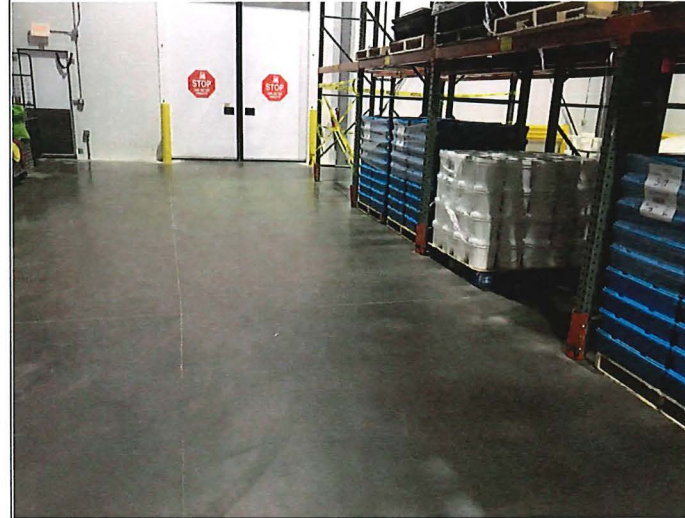
Date added: 05/17/2018

Title: Concrete floor in good condition

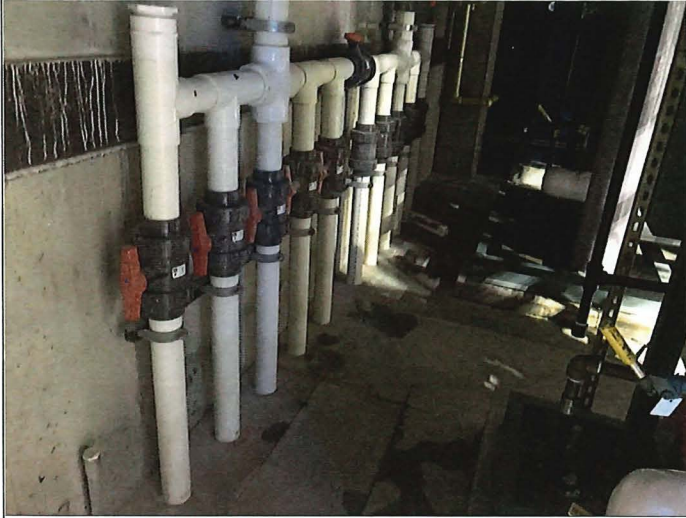
Date added: 06/06/2019

Title: VMS manifold piping - all valves open

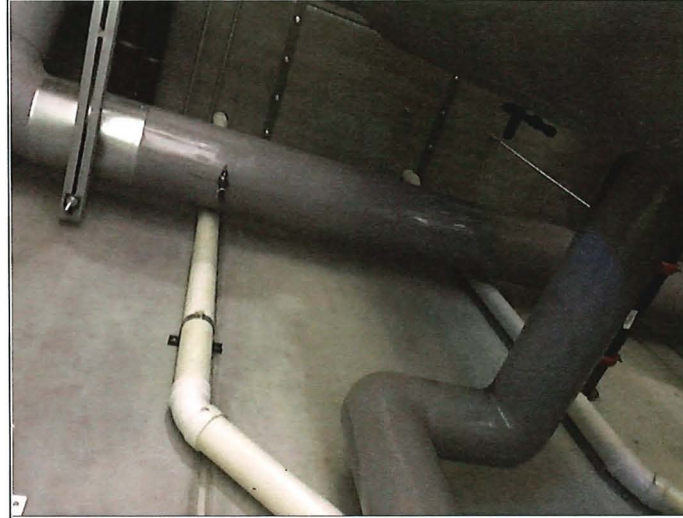
Date added: 06/06/2019

Title: VMS piping to roof

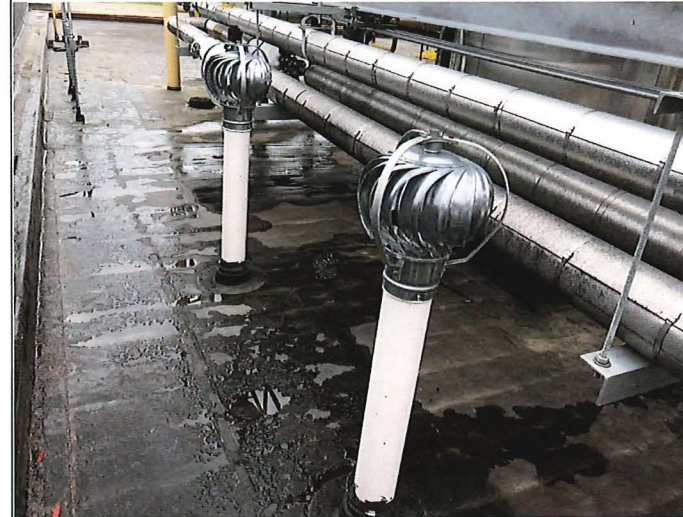
Date added: 06/06/2019

Title: VMS exhaust with wind turbines functioning properly

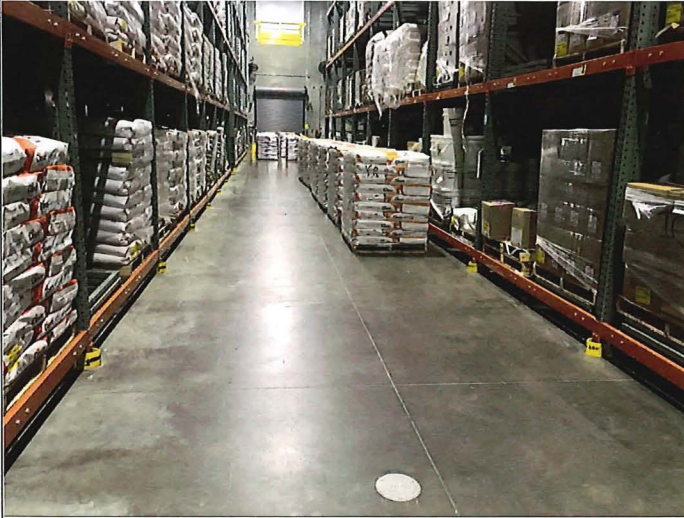
Date added: 06/06/2019

Title: Concrete floor in good condition

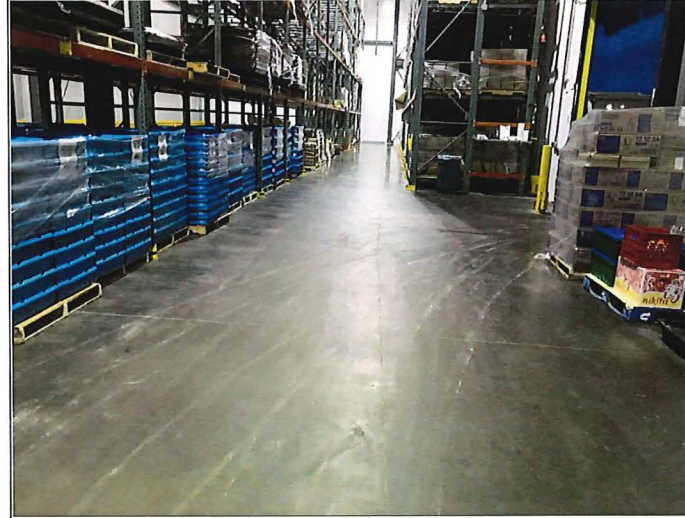
Date added: 06/06/2019

Title: Concrete floor in good condition

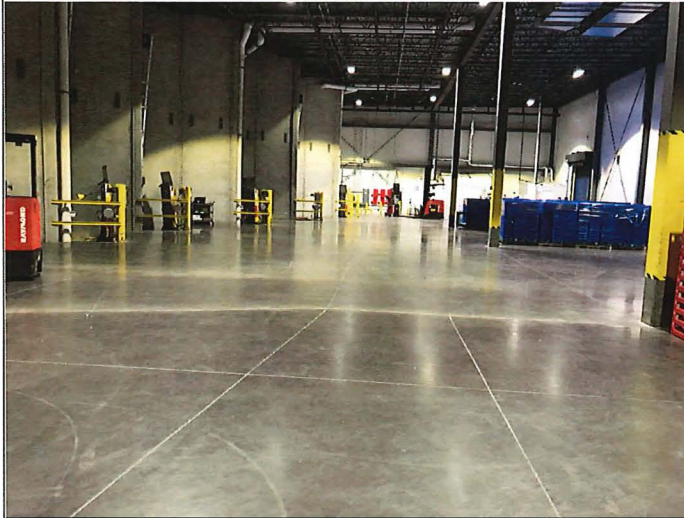
Date added: 06/06/2019

Title: Concrete floor in good condition

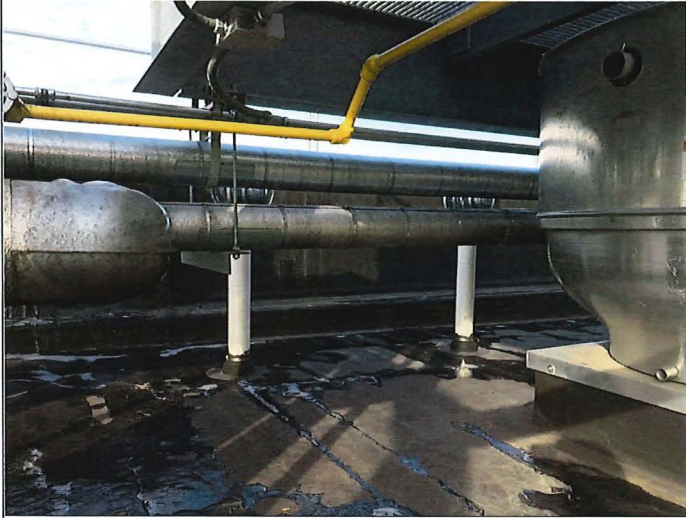
Date added: 02/07/2020

Title: VMS exhaust with wind turbines functioning properly

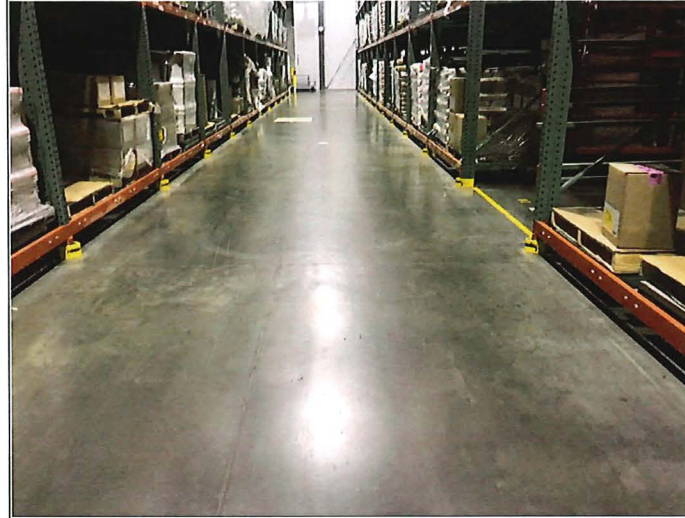
Date added: 02/07/2020

Title: Concrete floor in good condition

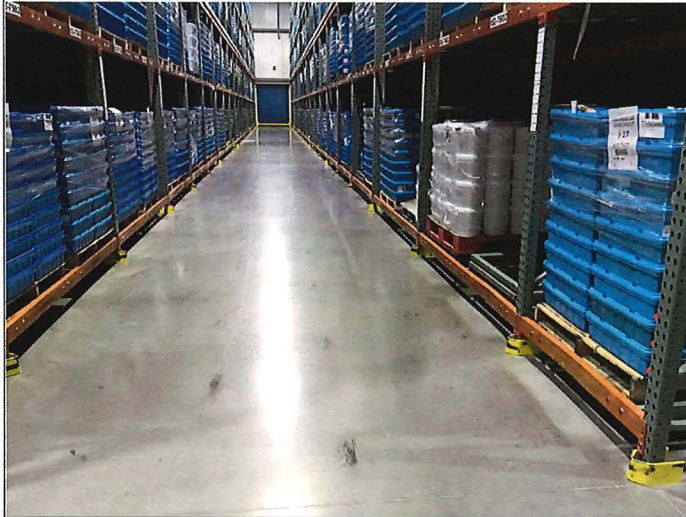
Date added: 02/07/2020

Title: Concrete floor in good condition

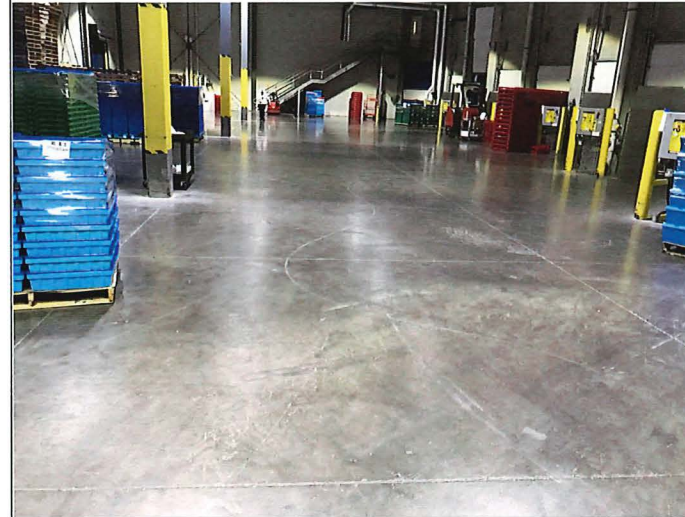
Date added: 02/07/2020

Title: Concrete floor in good condition

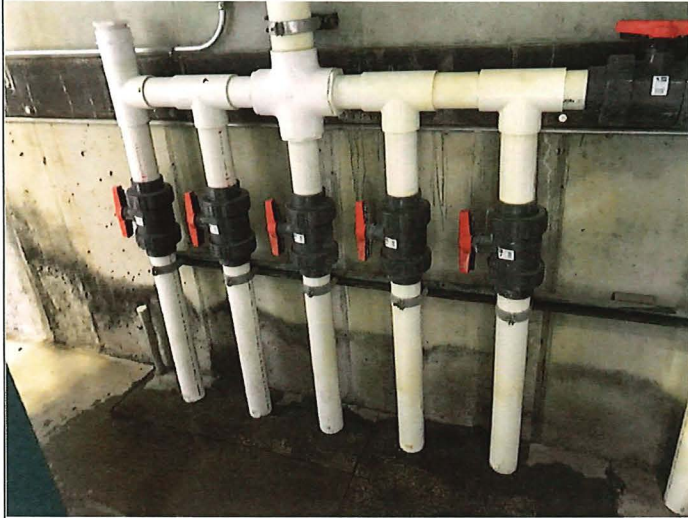
Date added: 12/15/2021

Title: VMS manifold piping - all valves open

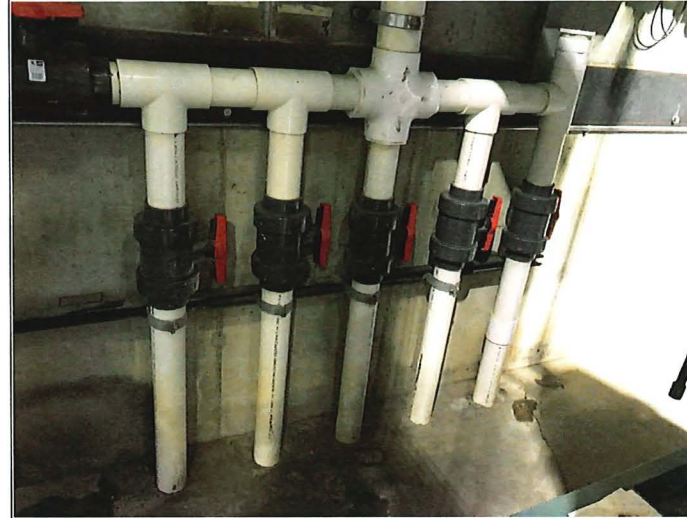
Date added: 12/15/2021

Title: VMS manifold piping - all valves open

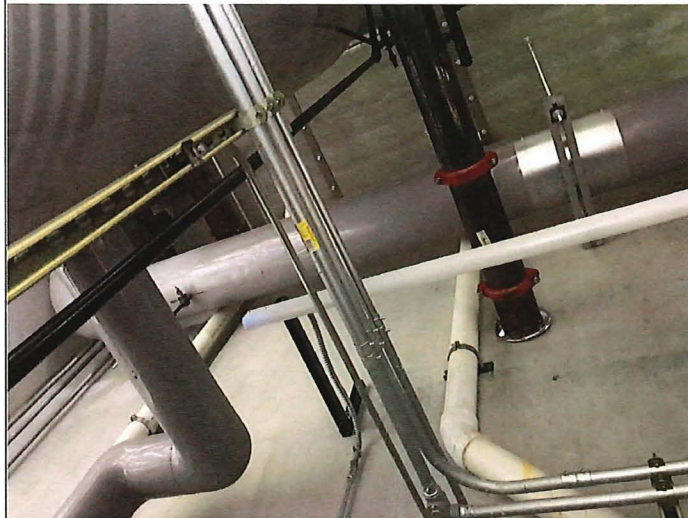
Date added: 12/15/2021

Title: VMS exhaust piping to roof

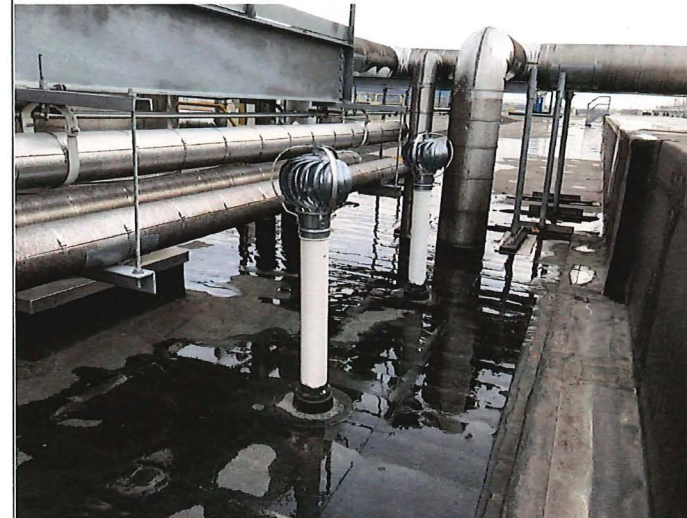
Date added: 12/15/2021

Title: VMS exhaust with wind turbines functioning properly

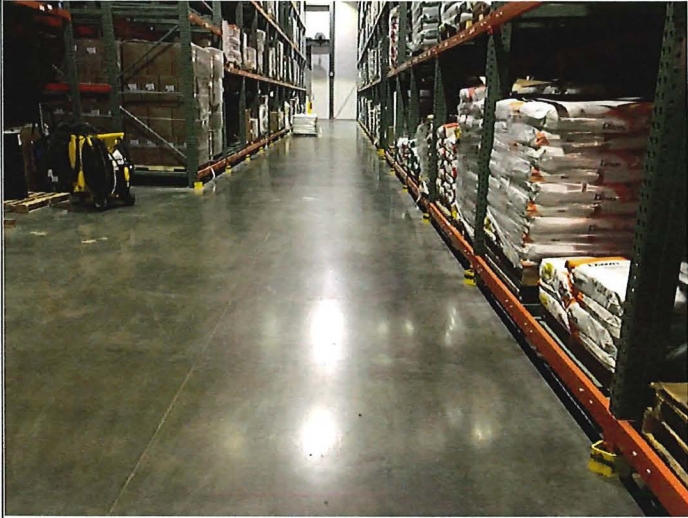
Date added: 12/15/2021

Title: Concrete floor in good condition

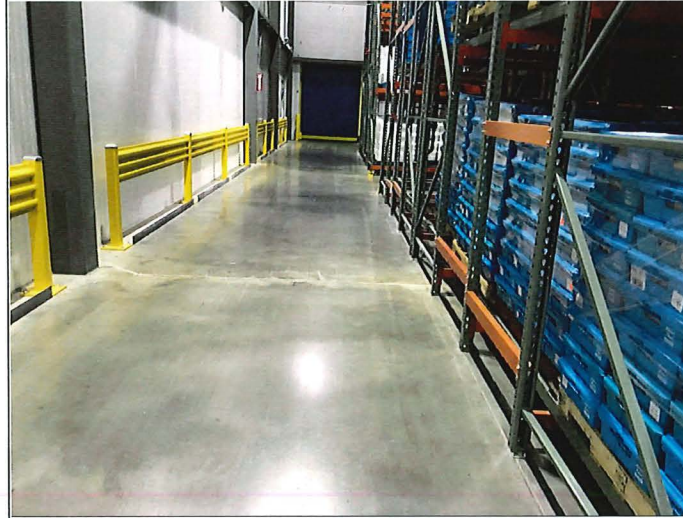
Date added: 12/15/2021

Title: Concrete floor in good condition

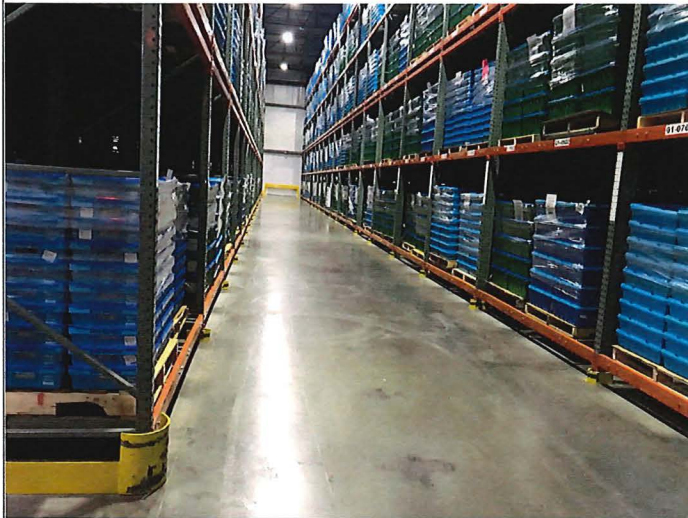
Date added: 12/15/2021

Title: Concrete floor in good condition

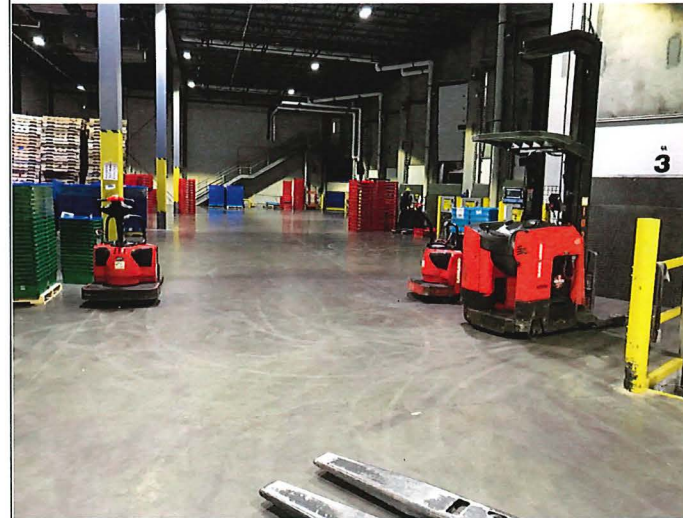
Date added: 12/15/2021

Title: Concrete floor in good condition
