Activity (Site) Name Former Desmond's Formal Wear Facility	BRRTS No. 02-32-000203
--	----------------------------------

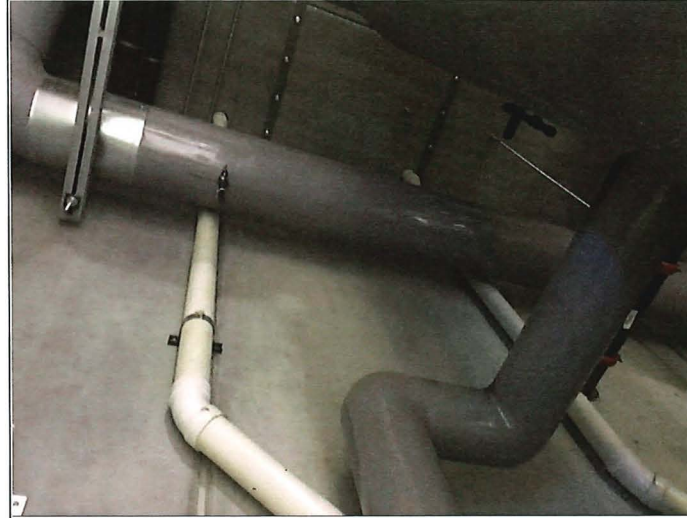
Title: VMS piping to roof

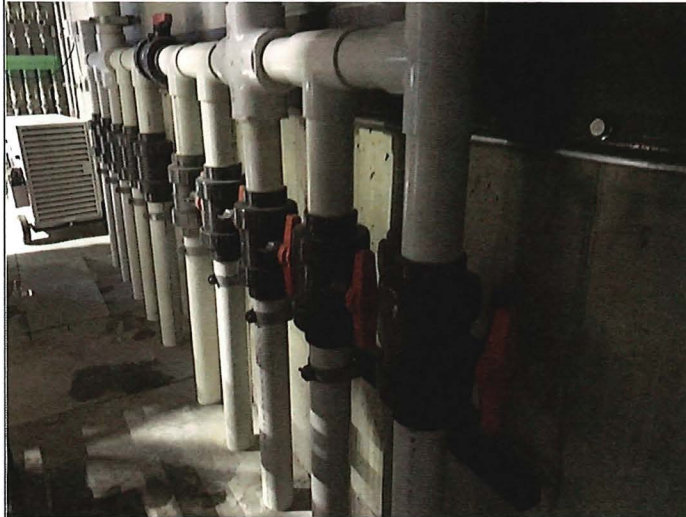
Title: VMS manifold piping - all valves open

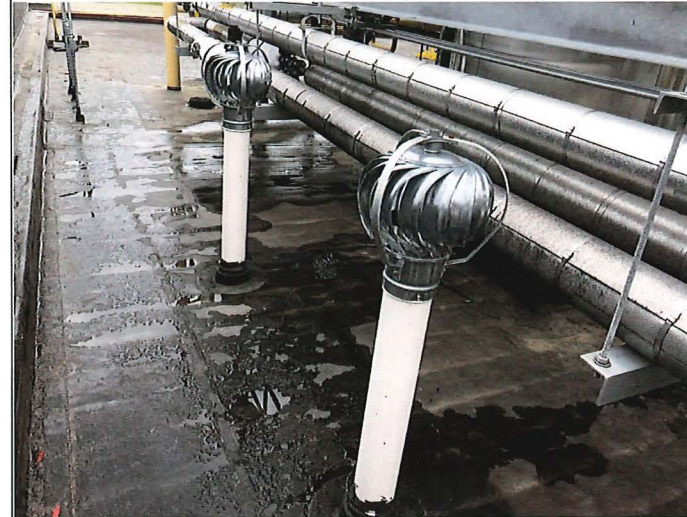
Title: VMS exhaust with wind turbines functioning properly

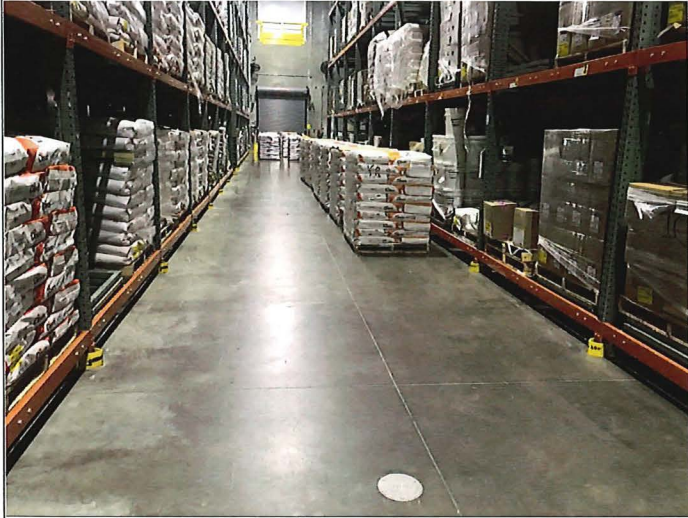
Title: Concrete floor in good condition

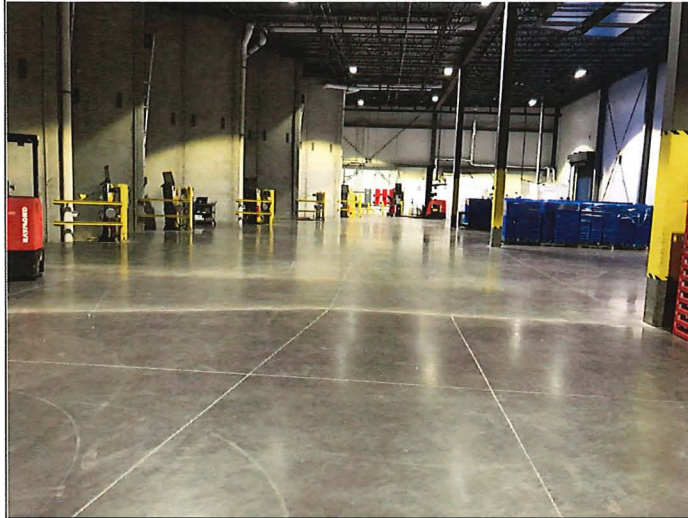
Title: Concrete floor in good condition

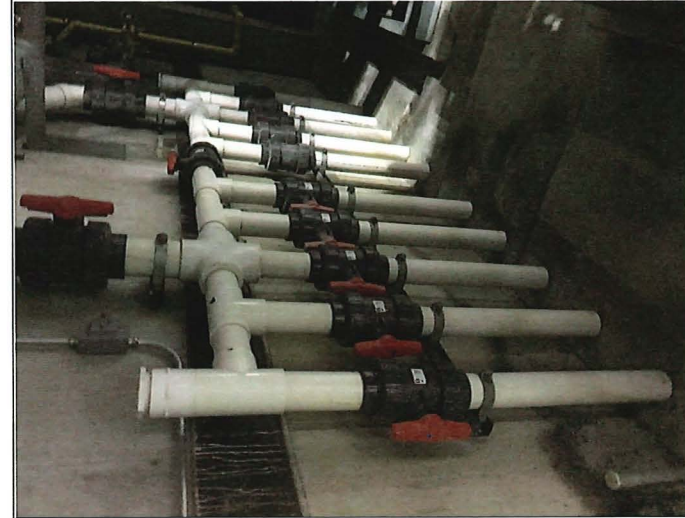
Title: VMS manifold piping - all valves open

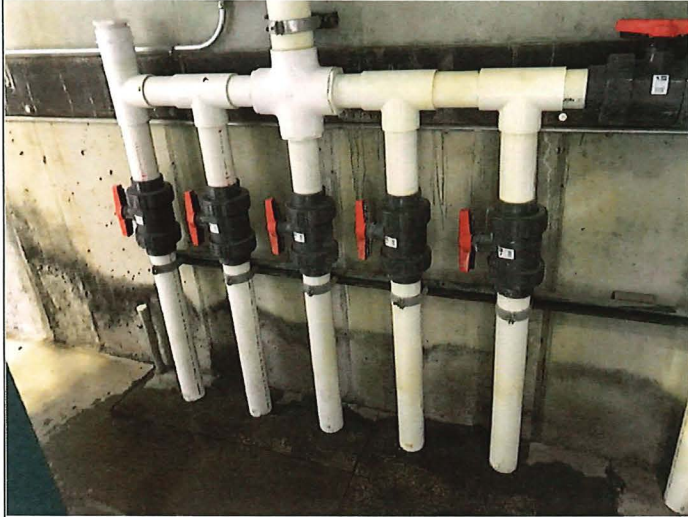
Title: VMS manifold piping - all valves open

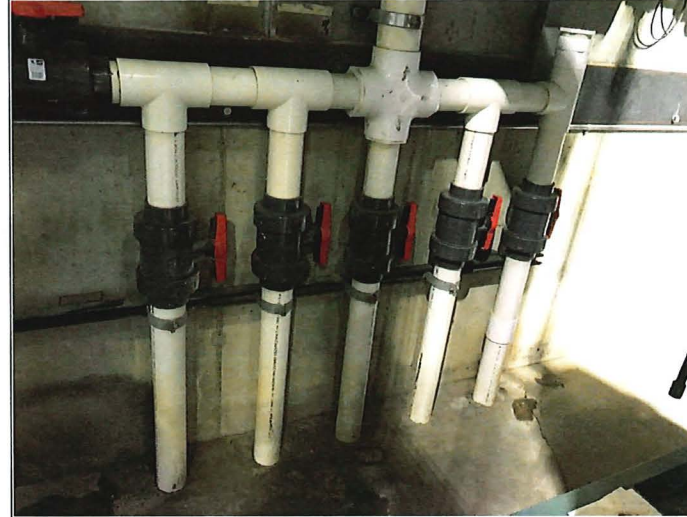
Title: VMS manifold piping - all valves open

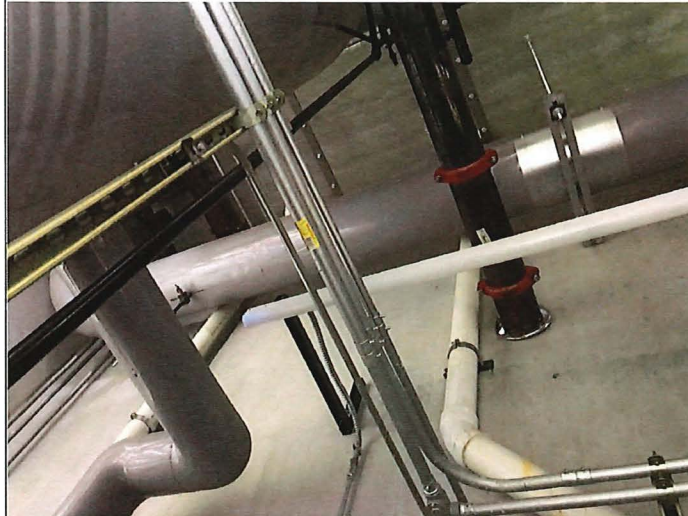
Title: VMS exhaust piping to roof

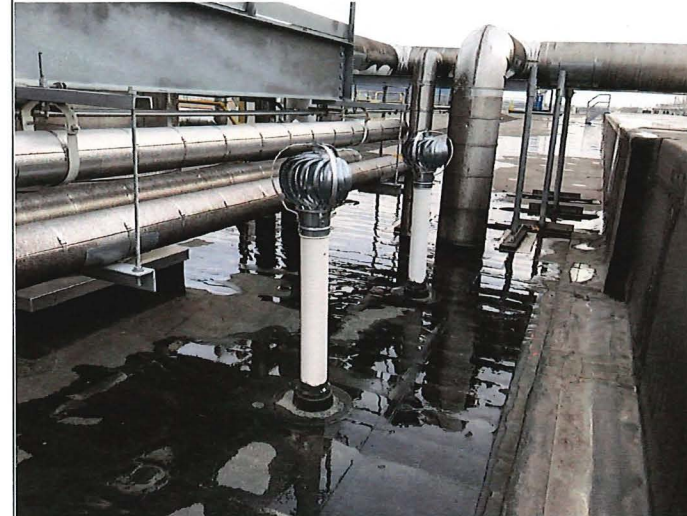
Title: VMS exhaust with wind turbines functioning properly

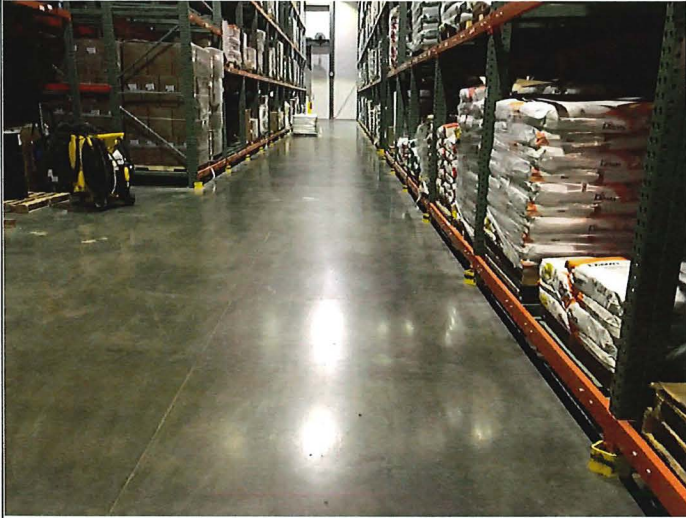
Title: Concrete floor in good condition

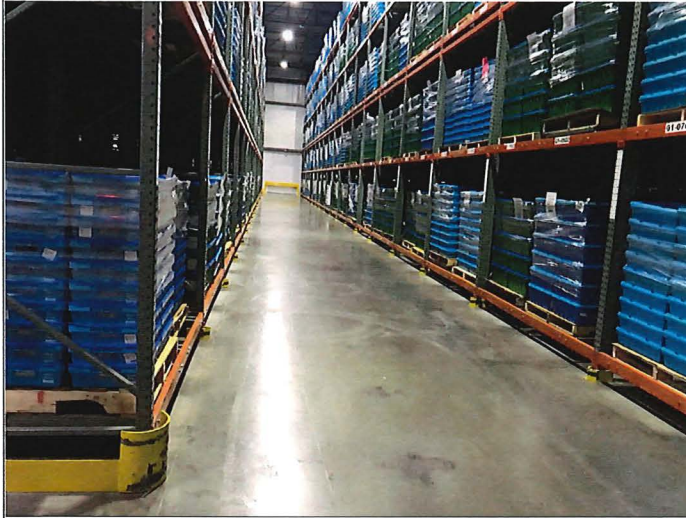
Title: Concrete floor in good condition

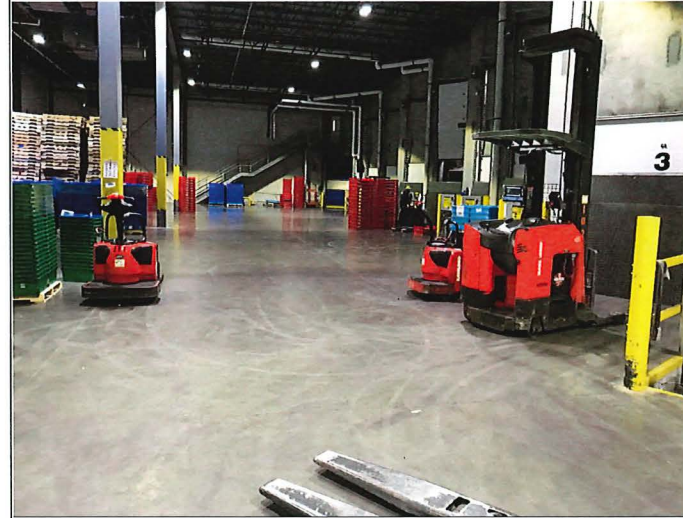
Title: Concrete floor in good condition
