**RE: OU2 Sediment Stability Monitoring Memorandum  
Former WPSC Green Bay Manufactured Gas Plant Site, Green Bay, Wisconsin,  
Wisconsin Public Service Corporation  
CERCLA Docket No. V-W-06-C-847, CERCLIS ID – WIN000509948, BRRTS # - 02 05  
000254**

Project name **Green Bay OU2 Sediment Stability Monitoring**  
 Project no. **1940101550**  
 Client **Wisconsin Public Service**  
 Memo no. **1**  
 Version **1**  
 To **Glenn Luke, PE**  
 From **Staci Goetz, PhD, PG and Julie Zimdars, PE**  
 Copy to **Frank Dombrowski**  
 Prepared by **Staci Goetz**  
 Checked by **Abigail Small**  
 Approved by **Eric Hritsuk**

**SEDIMENTS STABILITY MONITORING EVALUATION**  
**FORMER GREEN BAY MANUFACTURED GAS PLANT SITE SEDIMENTS, OPERABLE UNIT 2**  
 WISCONSIN PUBLIC SERVICE CORPORATION  
 CITY OF GREEN BAY, WISCONSIN

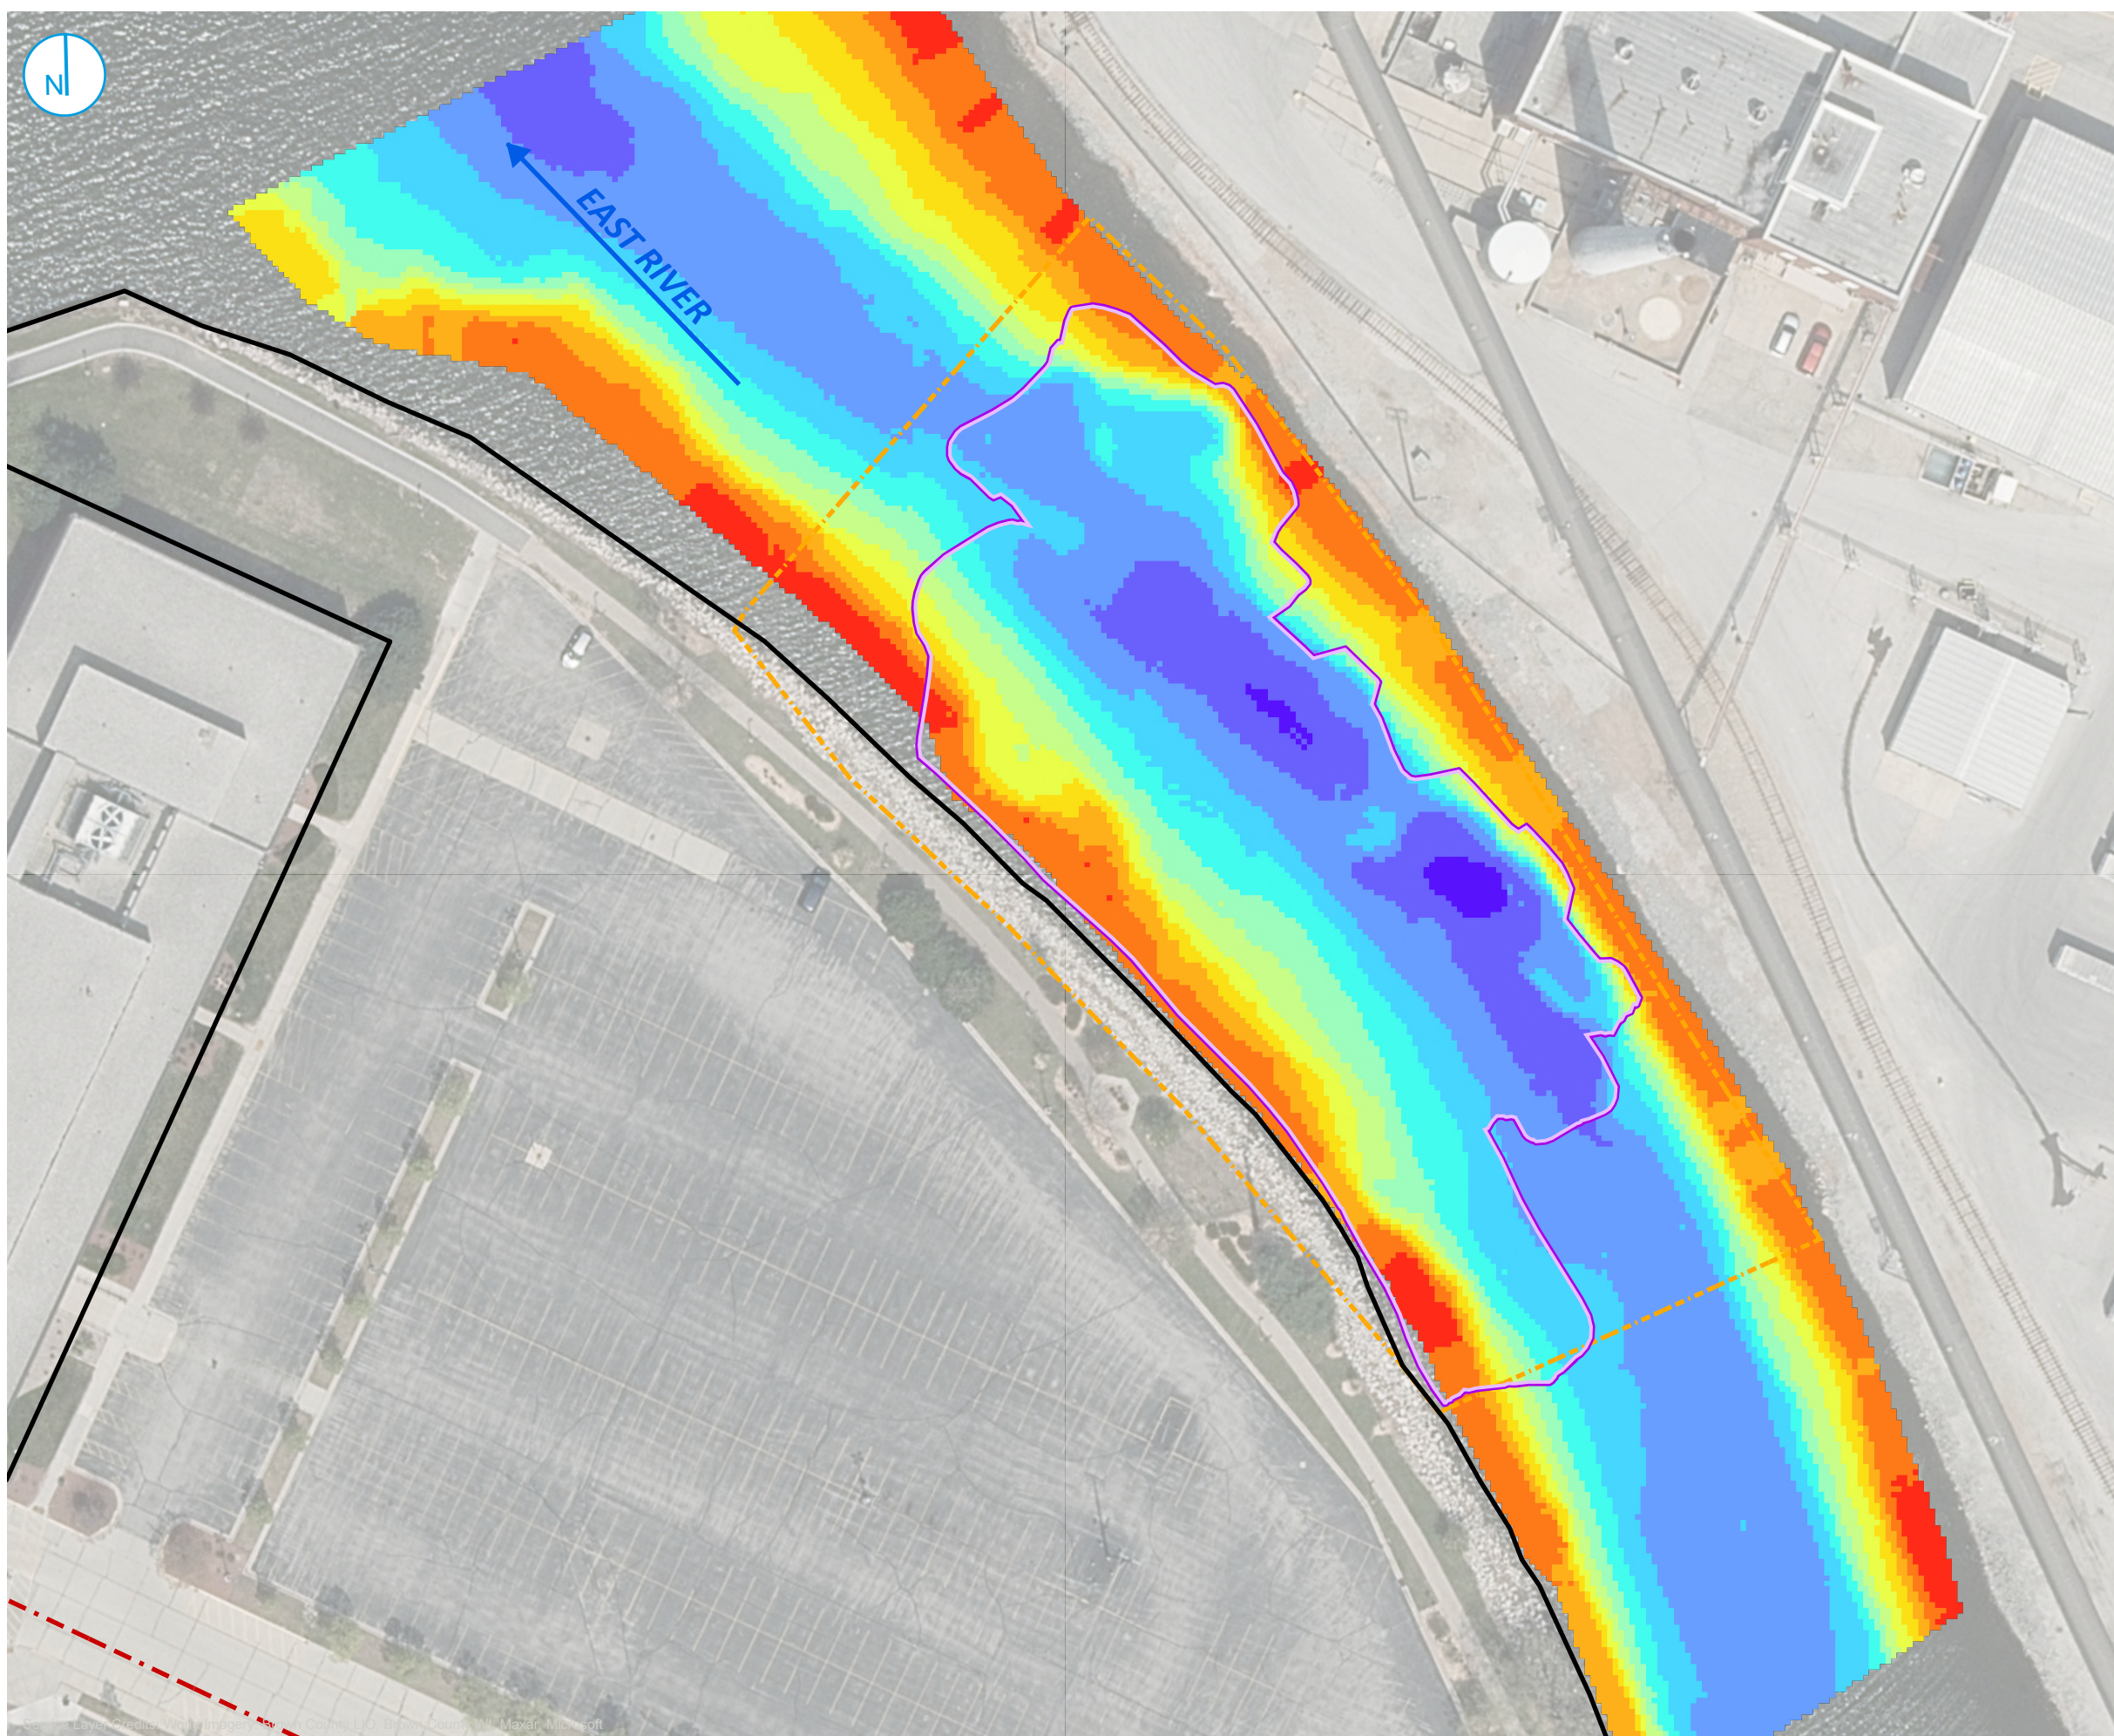
**FIGURE 2**

Figure 2 presents the 2022 SFA hydrographic survey. The channel thalweg (deepest portion) runs from the southeast to the northwest through the midportion of the SFA with the riverbanks on either side. Channel elevations range from a depth of 566 feet in the North American Vertical Datum of 1988 (NAVD88) in the deepest portion of the channel thalweg to the shallowest elevations 577 feet NAVD88, located near the riverbanks. Figure 3 presents a comparison of the 2022 (Year-4) survey to the 2019 (Year-1) survey. The comparison evaluates where both years had survey coverage to document conditions in the SFA.

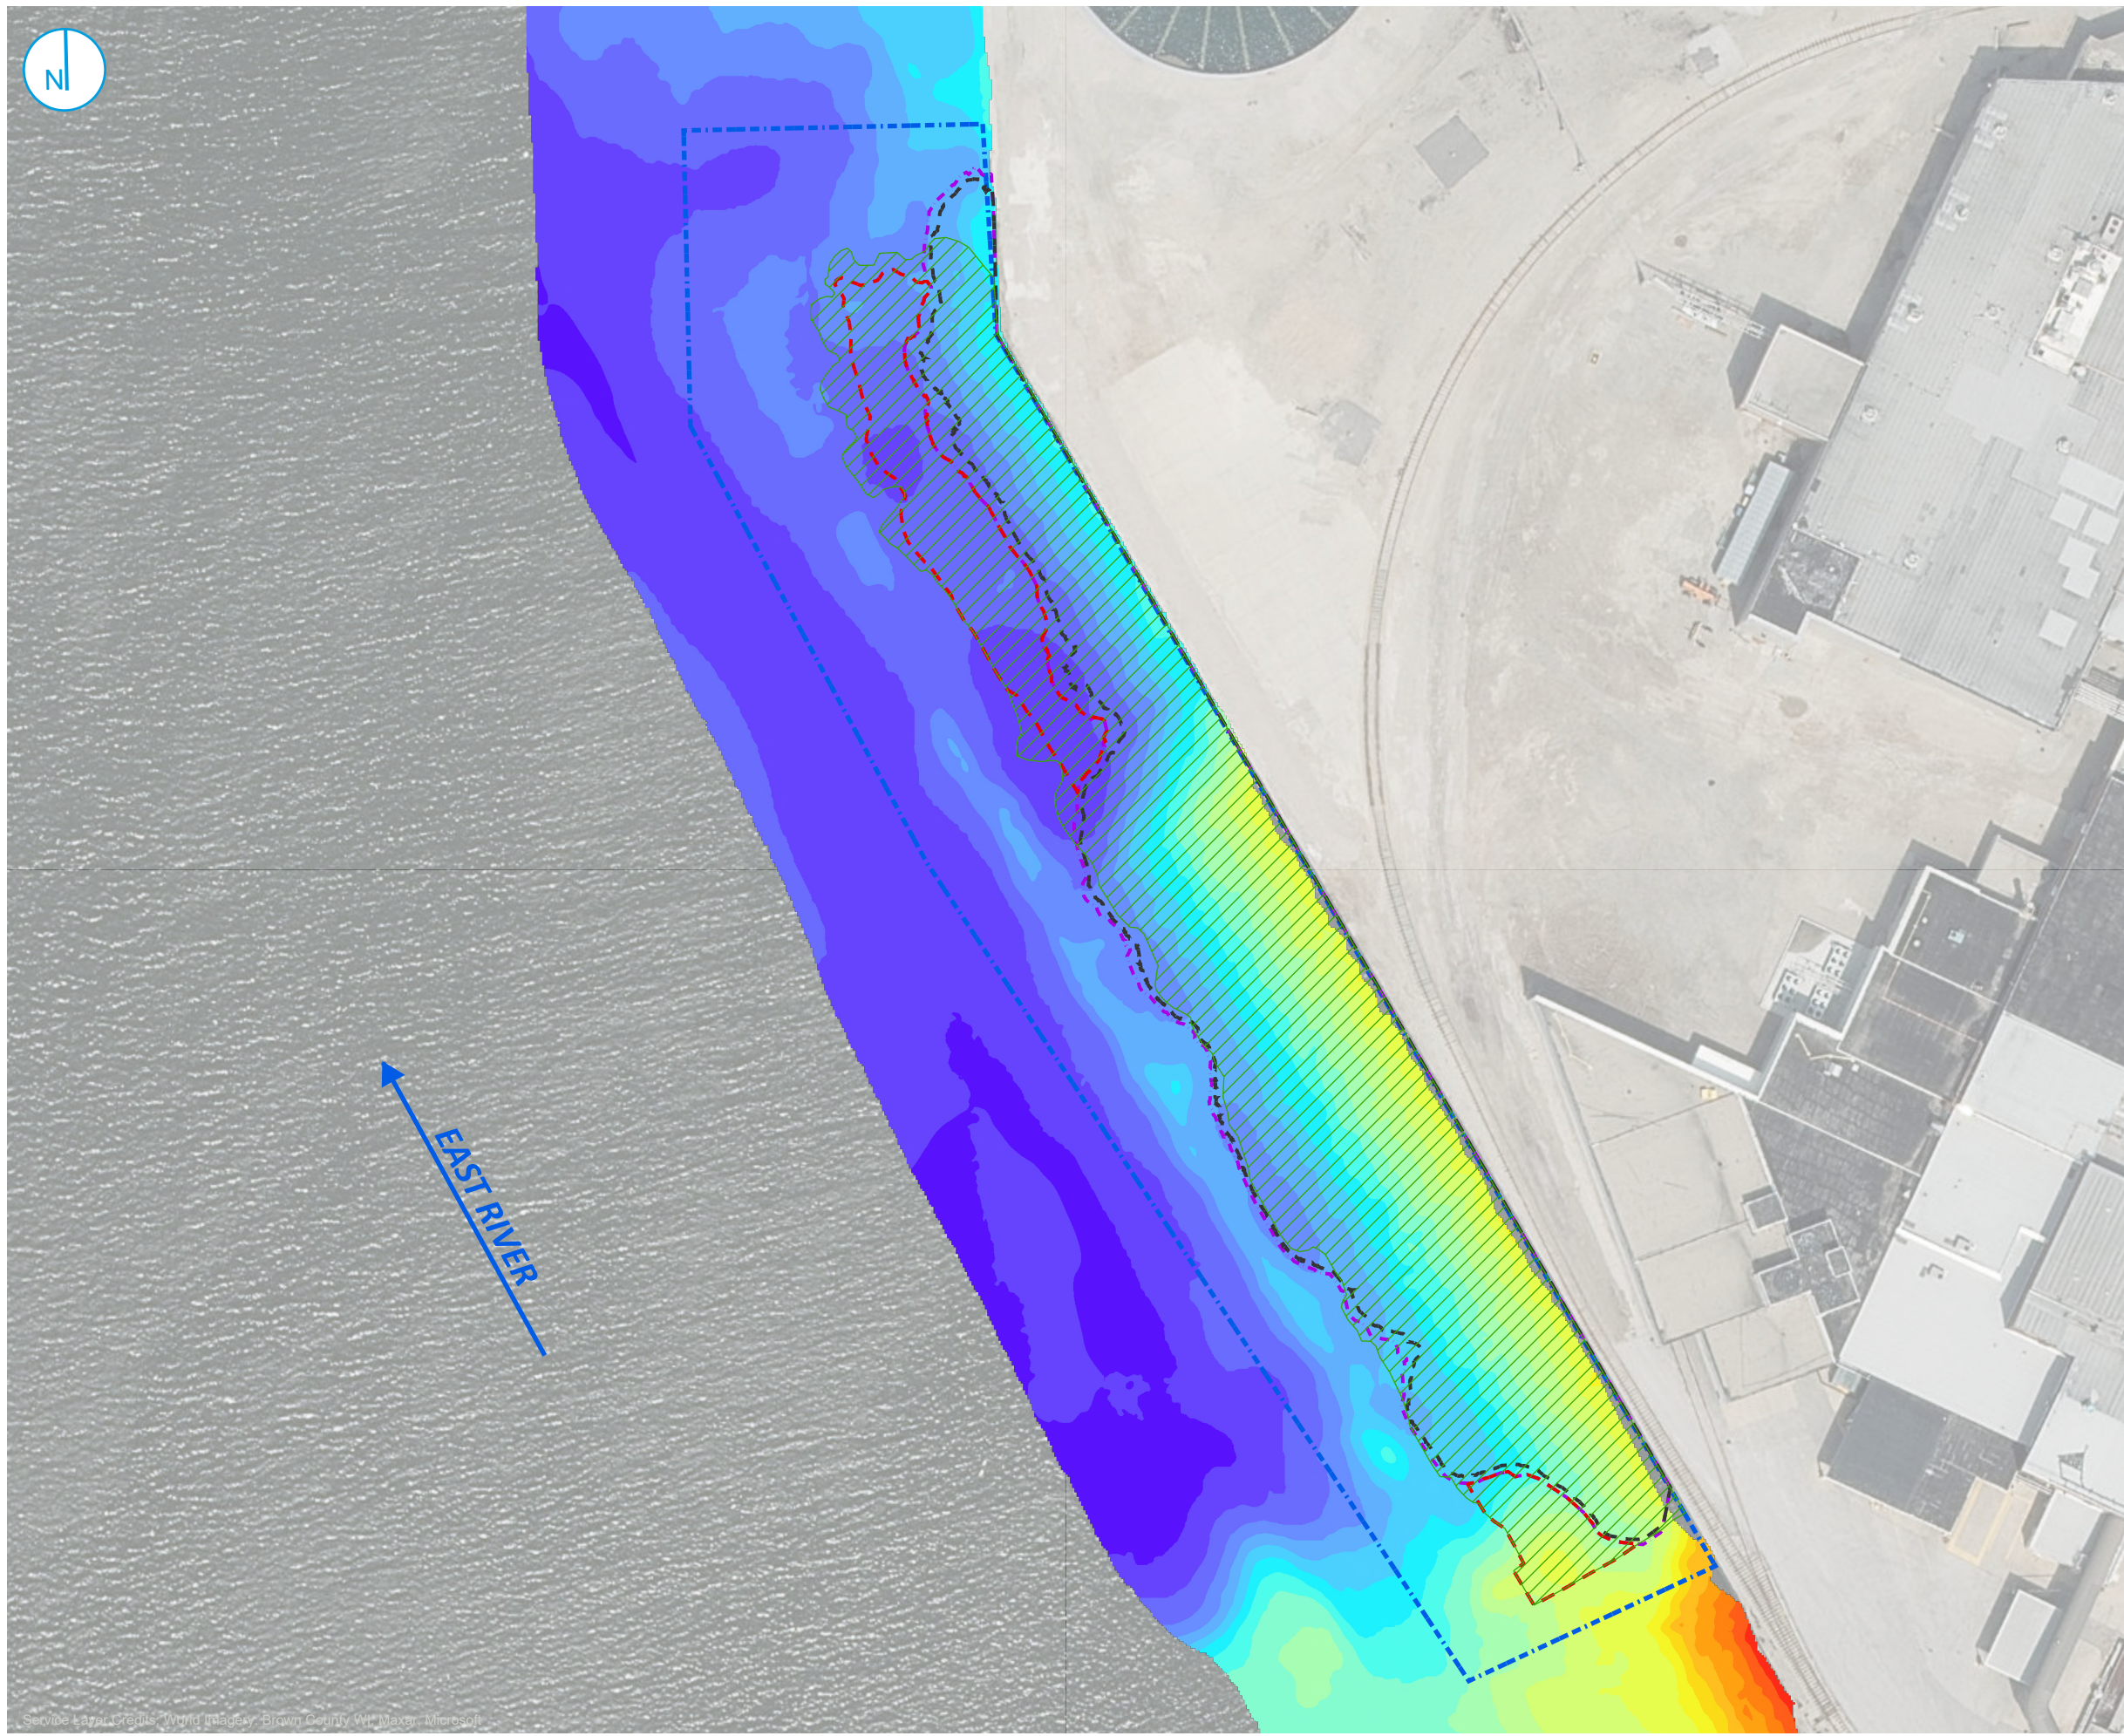
**FIGURE 4**

Figure 4 presents the 2022 NFA hydrographic survey. The NFA lies adjacent to the Georgia Pacific (GP) bulkhead wall with the deepest elevations inside the cap footprint occurring around 552 feet NAVD88 and the shallowest elevation of 578 feet NAVD88 occurs adjacent to the bulkhead near the GP rail line. Figure 5 presents a comparison of the 2022 survey (Year 3) to the 2019 (Year-0) survey.

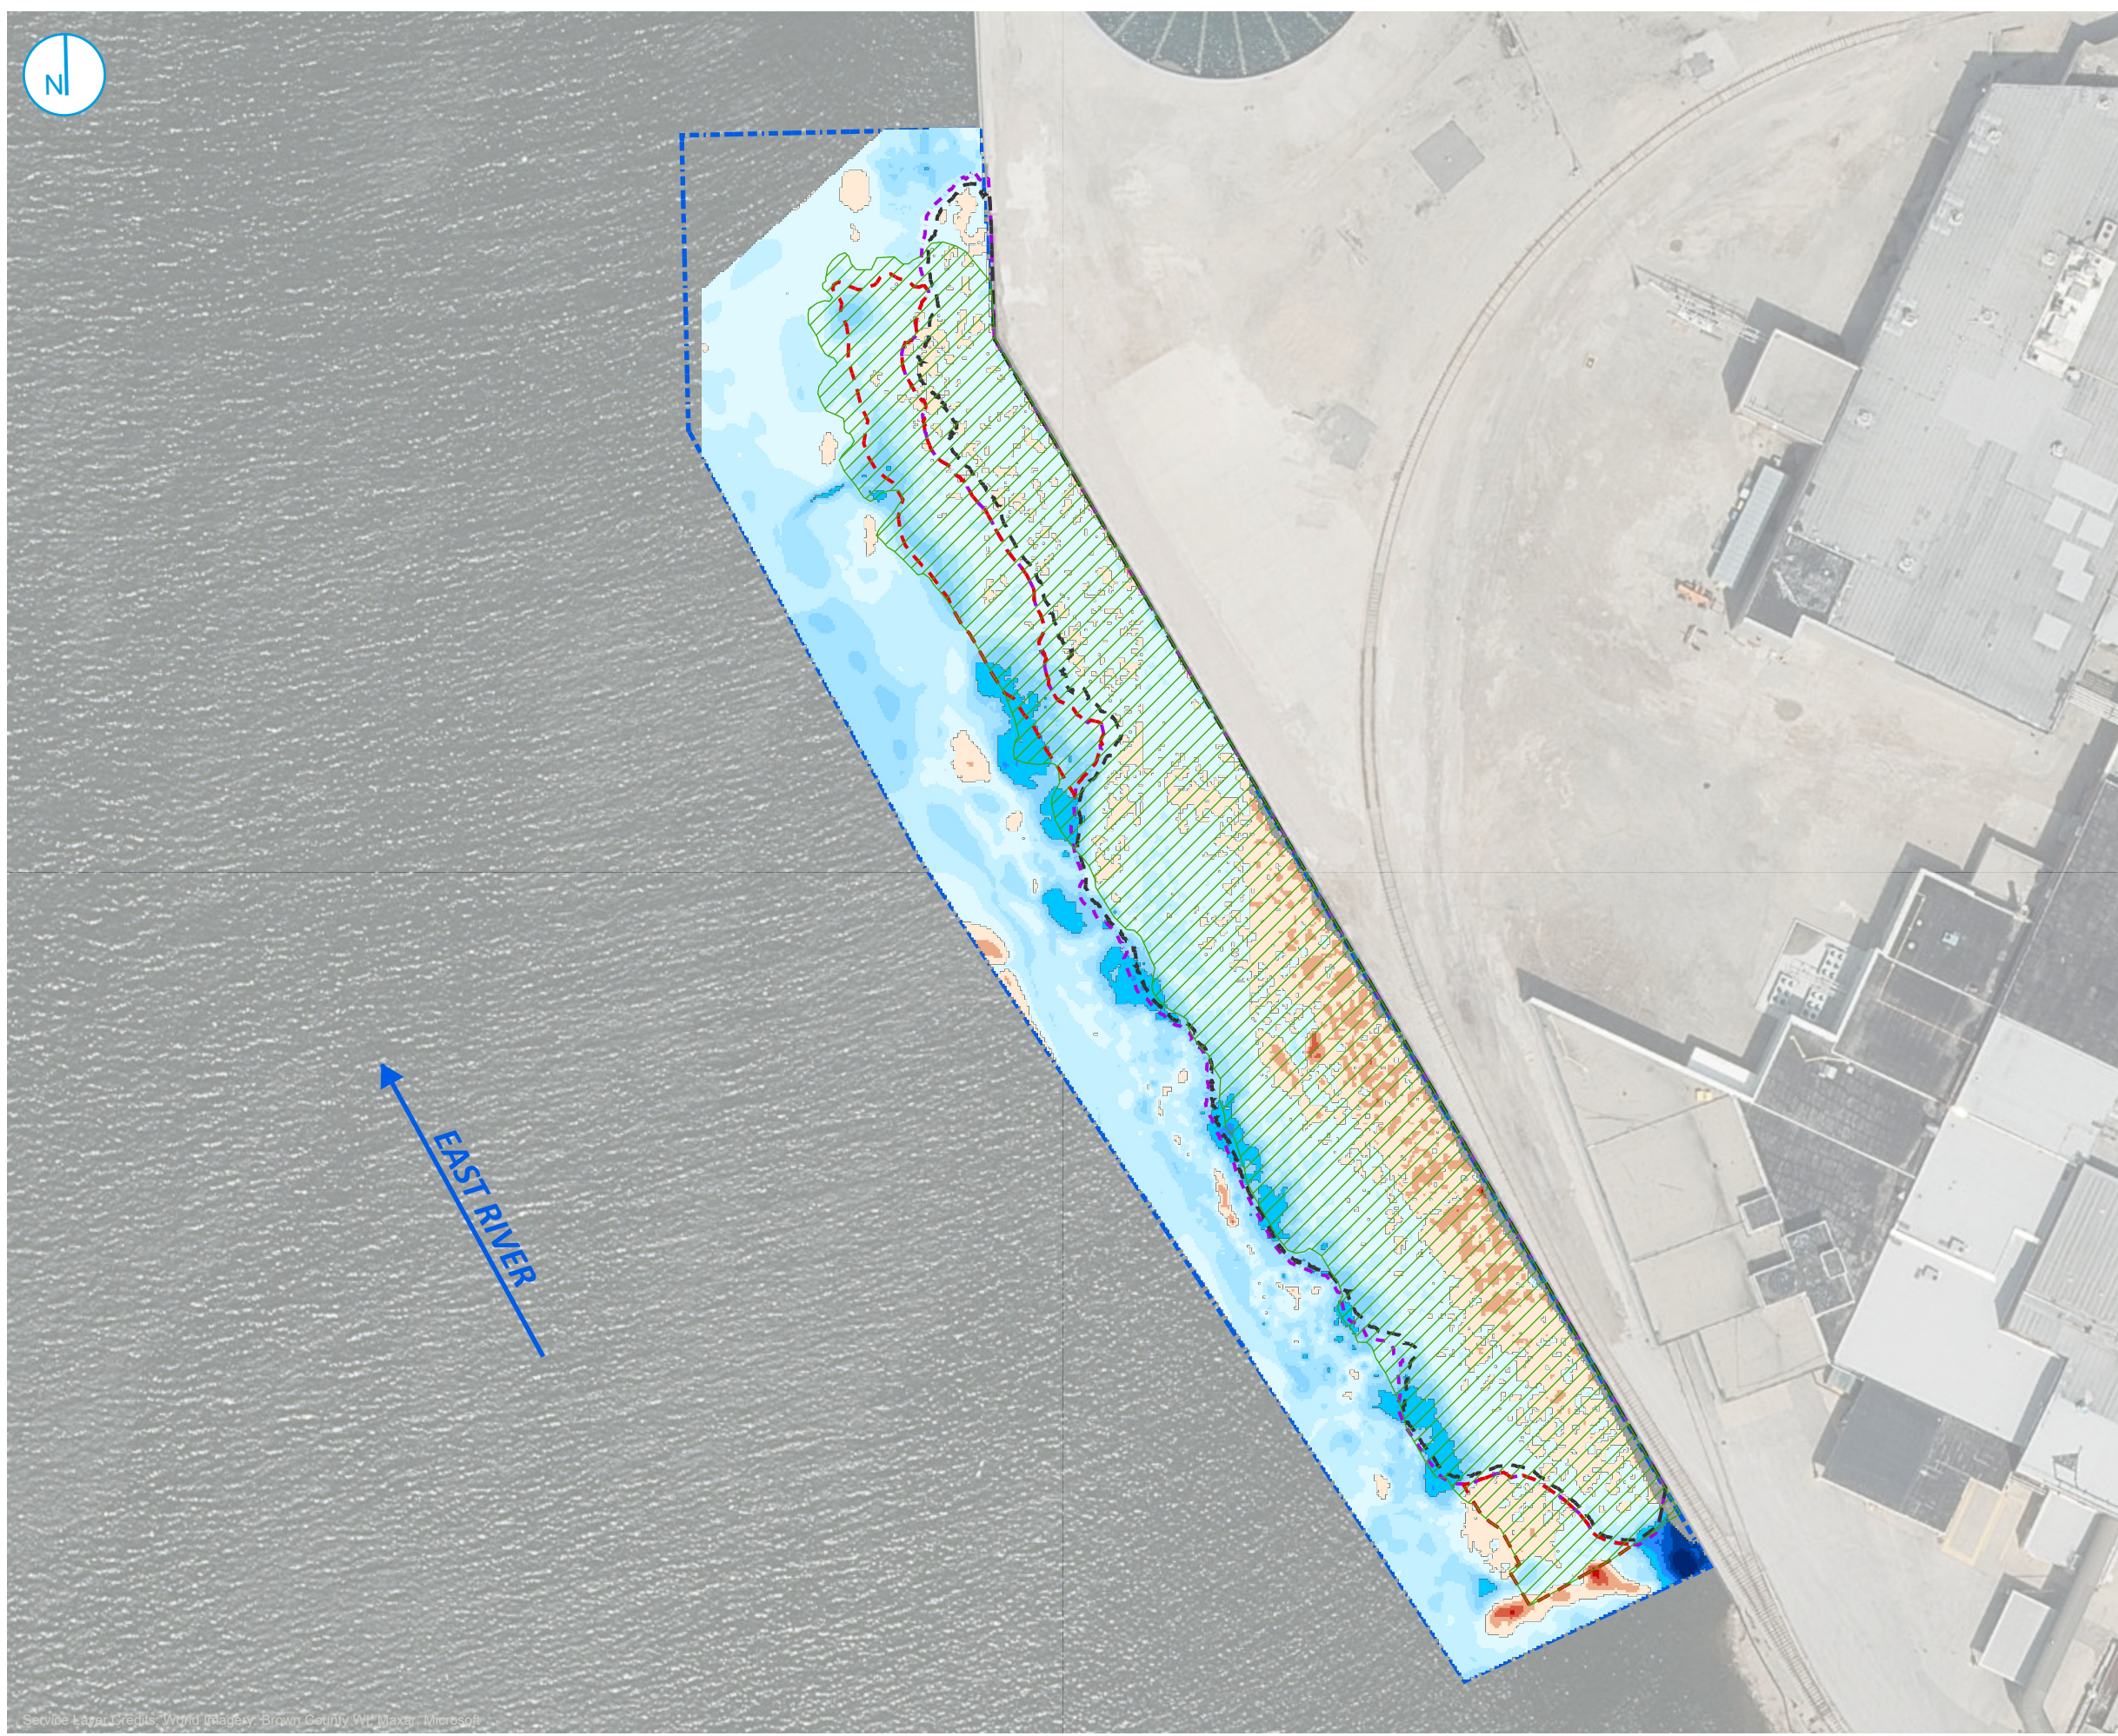
**FIGURE 5**

- Sediment has aggraded (deposited) since 2019 throughout areas within and beyond the extent of the armored cap as shown on Figure 5 in blue. This represents 72% of the NFA area (71,436 square feet of 98,877 square feet of NFA footprint with both years' survey coverage).
- Sediment has scoured (eroded) or the cap has settled since 2019 in areas within and beyond the extent of the armored cap as shown on Figure 5 in shades of cream to red. The cap settlement or scour is less than 12-inches (1-foot) over an area of 12,685 square feet (13%). The extent of more than a -1-foot change is 170 square feet. This represents 0.2% of the NFA area.
- The remaining 15% did not have significant change (erosion or deposition).

Per the Monitoring Plan, a significant differential lowering in cap elevation (12-inches or greater) over a contiguous area larger than 3,050 square feet (5% of the cap area), will trigger additional investigation to determine if cap maintenance activities are warranted.

Overall, the NFA cap elevation has settled, but less than 12-inches and is limited in area. Isolated scour has occurred over much less than 5% of the cap area. Based on these results, no additional investigation or cap maintenance activities are warranted. Porewater monitoring is scheduled for 2024, per the Monitoring Plan.
